UNITED STATES  
DEPARTMENT OF LABOR  
MINE SAFETY AND HEALTH ADMINISTRATION  
COAL MINE SAFETY AND HEALTH

REPORT OF INVESTIGATION

Noninjury Impoundment Failure/Mine Inundation Accident  
October 11, 2000

Big Branch Refuse Impoundment, I. D. No. 1211KY60035-01  
Preparation Plant, I. D. No. 15-05106  
1-C Mine, I. D. No. 15-03752  
Martin County Coal Corporation  
Inez, Martin County, Kentucky

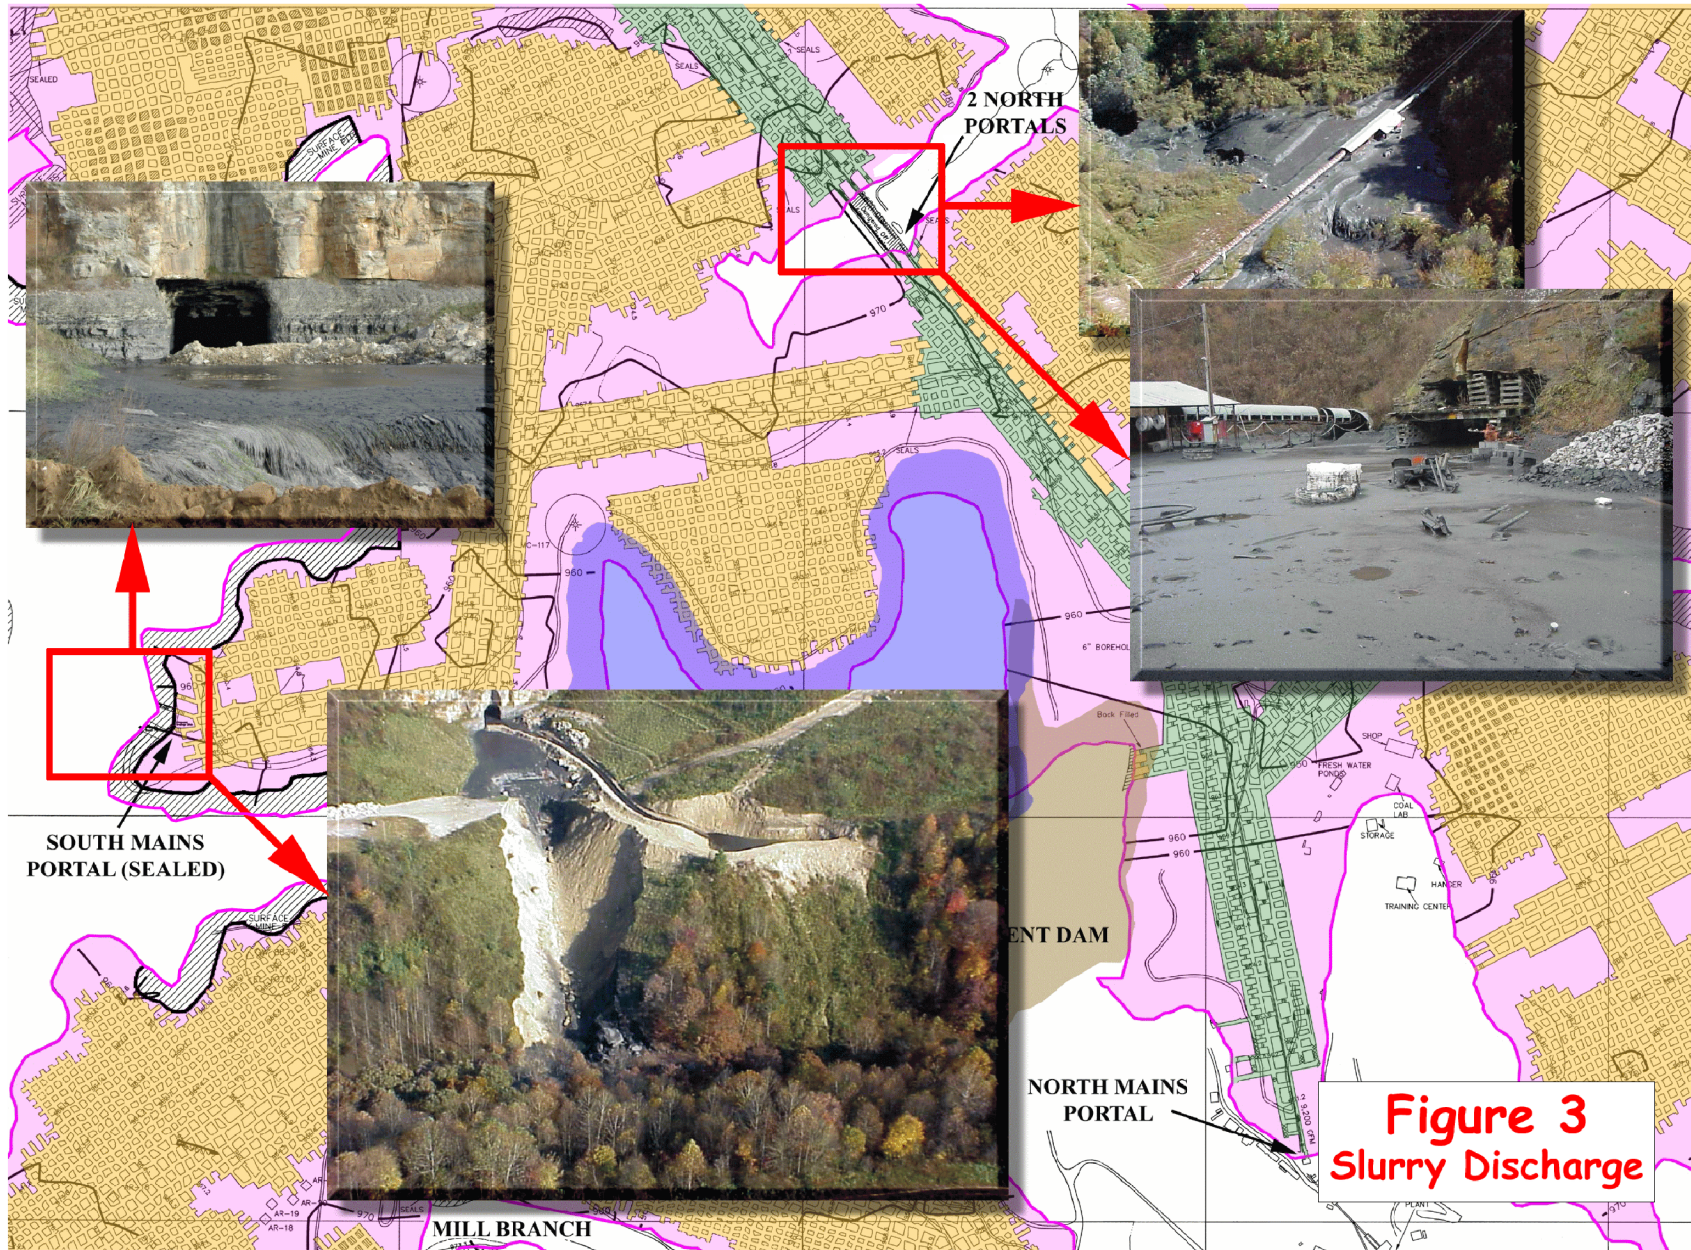
Breached  
Seals

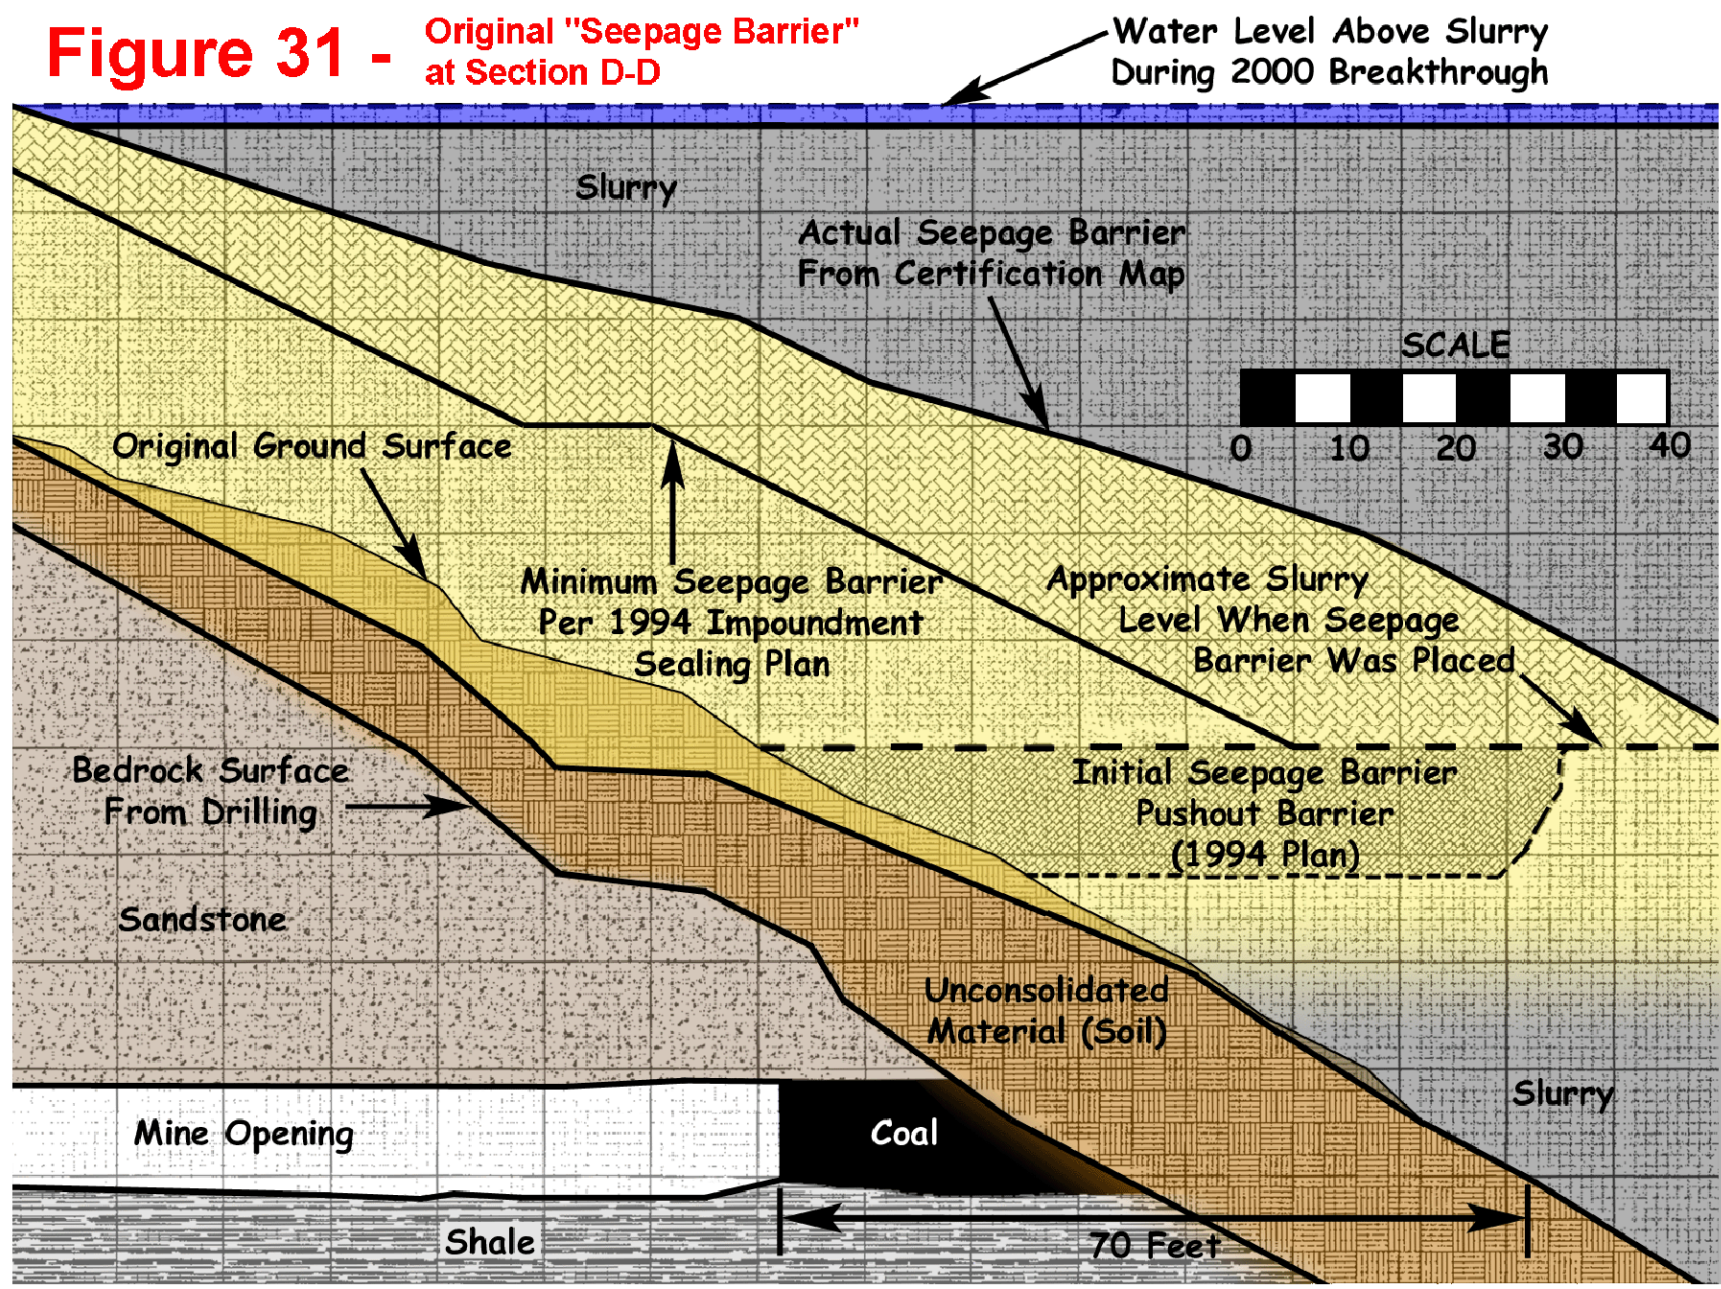
**Figure 31 - Original "Seepage Barrier" at Section D-D**

The drilling results and available contour mapping were combined to estimate the prefailure conditions at the breakthrough as shown in Figure 31. These results confirmed that MCCC's mine mapping accurately depicted the extent to which entries had been mined toward the outcrop in the area of the breakthrough. At the base elevation of the Coalburg seam, the horizontal distance from the face of the 50-foot long entry (Number 1 Entry) to the original hillside was approximately 70 feet. This is consistent with the topographic map submitted by MCCC with their Impoundment Sealing Plan. Of this 70-foot horizontal distance, there was 15 to 18 feet of

A potential mode of failure was that the material between the end of the 50-foot long entry and the impoundment failed suddenly from the shear stresses imposed by the ground and water pressures. As indicated by the drilling program and illustrated in [Figure 31](#), such a failure would have required shearing through at least 65 feet of sandstone, natural soil and the “seepage barrier”. With this amount of material, the shear stresses would be low and a shear failure would not occur.

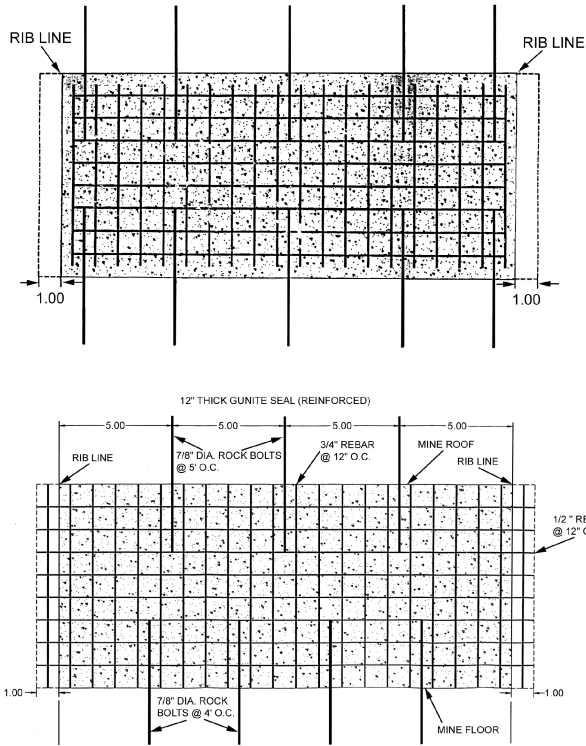
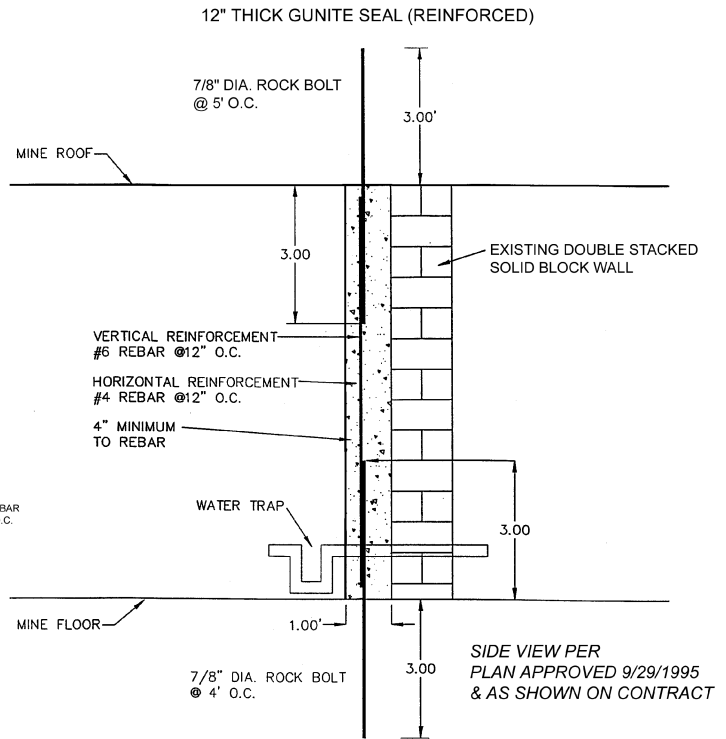
**Figure 32**

Construction of the revised mine seals was performed by H&B Contractors, Inc. (H&B), in February and March, 1996. The construction drawings provided by MCCC to H&B showed the mine seals being hitched into the rib to a depth of one foot with a # 6 vertical rebar near the midpoint of the hitch and # 4 horizontal rebars extending to the edge of the coal ([Figure 32](#)). The construction drawings also showed three 7/8-inch diameter rock bolts being installed on 5-foot centers into the mine roof, and four 7/8-inch diameter rock bolts on 4-foot centers being installed into the mine floor. However, the mine seal drawing approved by MSHA showed five rock bolts in the mine roof and five rock bolts in the mine floor. The changes incorporated into the construction drawings provided by MCCC to H&B had not been submitted to and approved by the District Manager prior to implementation.

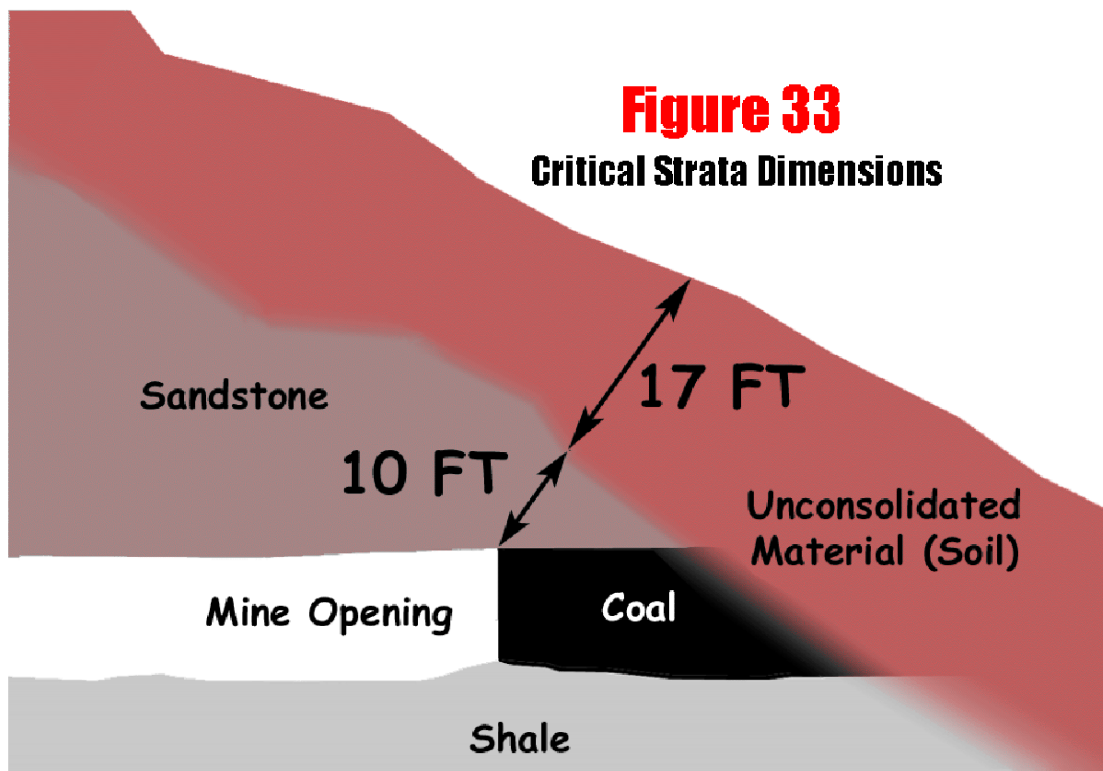
**Figure 33**  
**Critical Strata Dimensions**

As also shown on this cross-section, at the end of the 50-foot long entry, the minimum overburden thickness was about 27 feet (Figure 33). Because of the depth of weathered and unconsolidated material, the amount of rock vertically above the face was less than 15 feet thick, with the minimum thickness of rock above the face being approximately 10 feet.

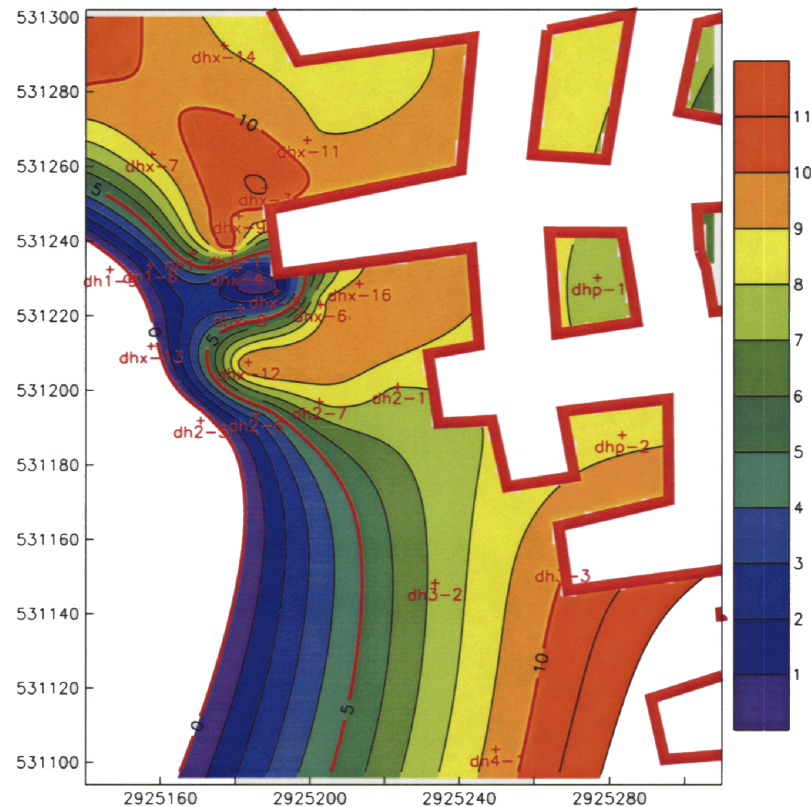
**Figure 35**  
**Coal Isopach Map**

Figure 35 is an isopach map of the Coalburg seam thickness in the area of the breakthrough. Examination of this map reveals a “bulls eye” area, at the end of the 50-foot long entry, showing a thinning of the coal seam due to the washout effect during the breakthrough.

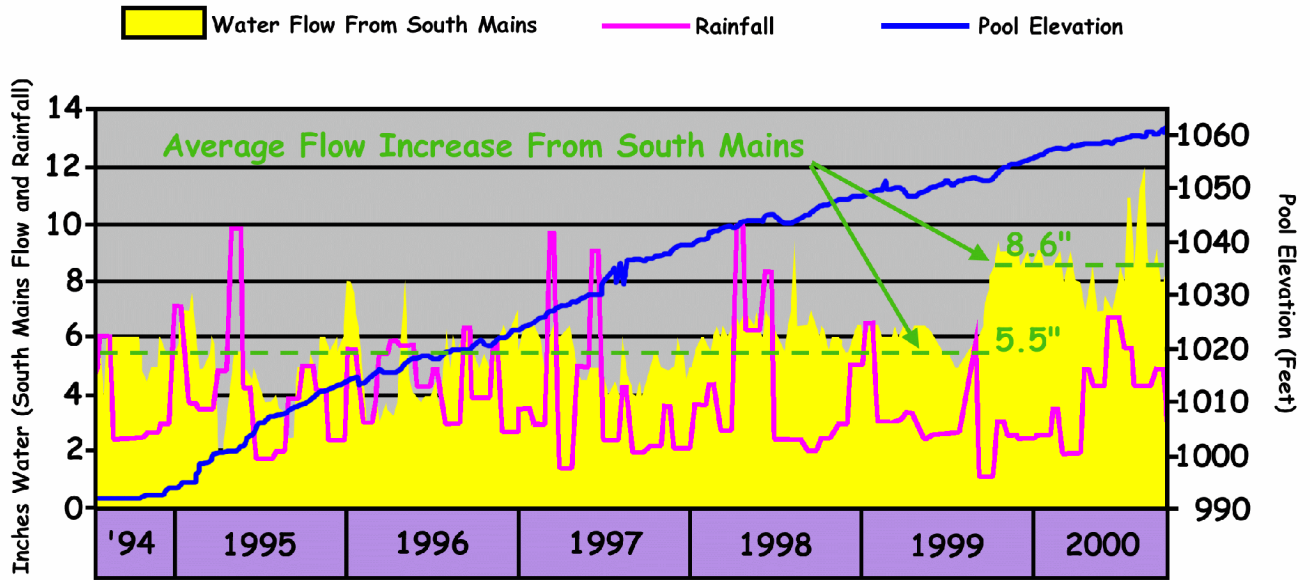
**Figure 38**  
**South Mains Portal Outflow vs Water Sources**

Figure 38 shows the outflow readings at the South Mains Portal compared to the pool level in the impoundment and the monthly rainfall recorded at Jackson, Kentucky. Jackson, located approximately 50 miles to the southwest of the impoundment, is the closest National Weather Service station to the Big Branch Impoundment. At the time that the readings increased at the South Mains Portal, in September 1999, the rise in the pool level was steady. The amount of rainfall recorded at Jackson for the previous four months was 6 inches below normal, and the rainfall at Jackson for the following six months was over 7 inches below normal. Considering the rainfall records, the South Mains Portal discharge readings indicated that the rate of seepage from the impoundment into the mine more than doubled approximately one year before the breakthrough.

**Violation 2:** Martin County Coal Corporation did not follow its approved plan for the Big Branch Refuse Impoundment, ID No. 1211KY060035-01, by failing to immediately report to the MSHA District Manager any unusual change in flow quantity or quality from the South Mains Portal that would indicate possible impoundment leakage and by failing to implement necessary remedial measures. A significant increase in water flow from the South Mains Portal started during September of 1999 and continued until the breakthrough occurred on October 11, 2000. During this period the company's impoundment inspection records, co-signed by Mine management persons, indicate that the average flow rate from the South Main Portal more than doubled.

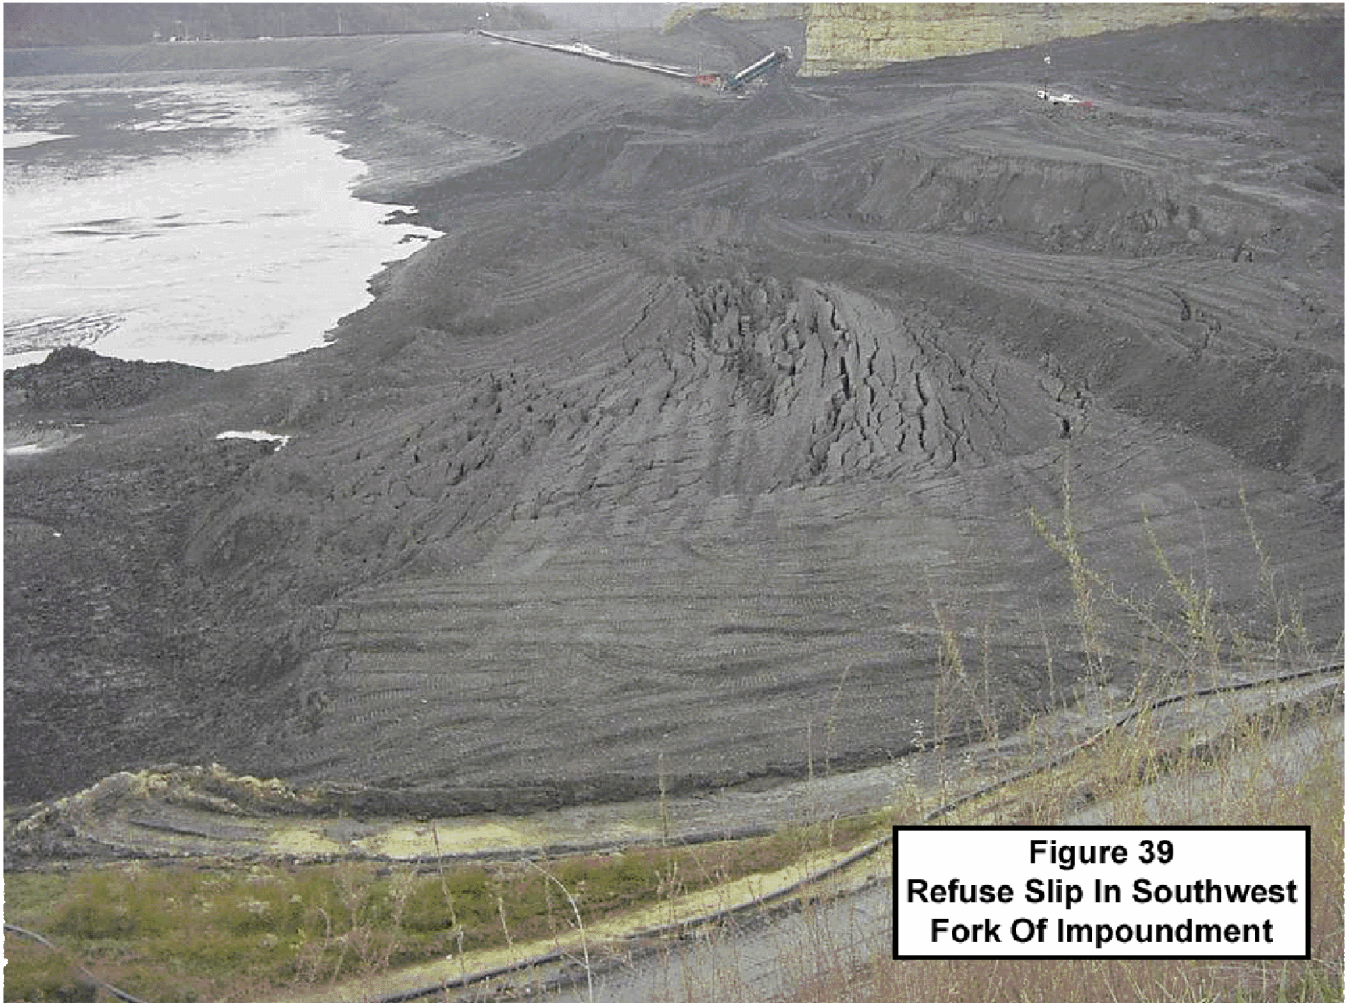
**Figure 39**  
**Refuse Slip In Southwest Fork Of Impoundment**

Refuse Slippage: Sometime during the breakthrough of the slurry into the 1-C Mine, about 5 surface acres of coarse refuse fill in the southwest fork area of the impoundment moved downward and toward the center of the pool (Figure 39). While the amount of vertical movement varied, it was as much as 25 feet in some locations. Testimony by MCCC personnel indicated the area was being filled with coarse coal refuse overtop the slurry to extend the refuse belt and that it had been experiencing incremental vertical movement prior to the failure. This is consistent with normal displacement and the consolidation of underlying fine refuse. The timing and extent of the sudden movement of the coarse refuse fill during the breakthrough event indicates this movement was due to a foundation failure. This was as a consequence of a loss of the fine refuse adjacent to and beneath the fill into the 1-C Mine.
