Office of Compliance **Report on Occupational Safety and Health Inspections**

Conducted in the Legislative Branch during the 108th
Congress pursuant to the Congressional
Accountability Act

October 2005

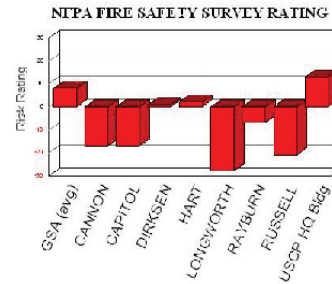
Hart Senate Office Building RAC/Hazard	
RAC 1	1
RAC 2	63
RAC 3	55
RAC 4	8
TOTALS	127

Only a limited inspection was conducted of the Hart Senate Office Building. The inspection team inspected approximately 95,000 of 1,094,805 square feet, identifying 125 hazards, of which one was ranked as RAC 1 and 62 were ranked as RAC 2.

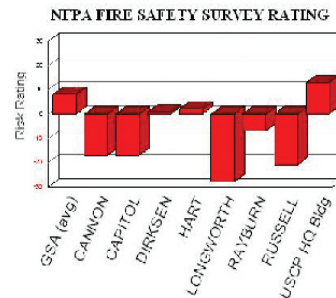
Russell Senate Office Building RAC/Hazard	
RAC 1	5
RAC 2	31
RAC 3	60
RAC 4	5
TOTALS	101

The Russell Senate Office Building was constructed in 1908 and 1909, long before most Fire and Safety Codes existed. Therefore, it, like the Capitol Building, presents a unique challenge. As with the other Senate Office Buildings, only a partial inspection could be conducted. No office space was inspected. The inspection team inspected approximately 161,000 square feet of the total 661,000 square feet in the building. One hundred one hazards were identified. Five were rated as RAC 1 and 31 were rated as RAC 2.

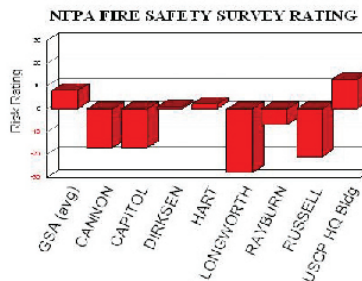
Cannon House Office Building	
RAC 1	9
RAC 2	22
RAC 3	45
RAC 4	3
TOTALS	79

As with the Capitol and Senate Office Buildings, only limited inspection of the Cannon House Office Building could be conducted by the OGC inspection team due to time and resource constraints. The inspection team inspected approximately 76,000 square feet of the total 776,000 square feet in the building. Seventy-nine hazards were identified. Nine were rated as RAC 1 and twenty-two were rated as RAC 2.

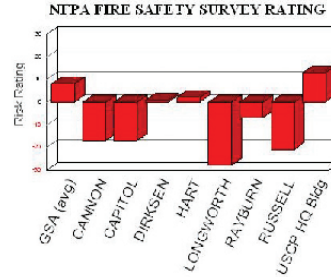
Longworth House Office Building RAC/Hazard	
RAC 1	6
RAC 2	41
RAC 3	80
RAC 4	9
TOTALS	136

As with the Cannon House Office Building, only a limited inspection was conducted of the Longworth House Office Building. The inspection team inspected approximately 37,000 of 637,000 square feet, identifying 136 violations, of which six were ranked as RAC 1 and 41 were ranked as RAC 2.
