U.S. Department
of Transportation
**Federal Railroad
Administration**

Safety Testing of Intermodal Hazmat Configurations, Summary Report

1. Report No. DOT/FRA/ORD-88/04		2. Government Accession No.		3. Recipient's Catalog No.	
4. Title and Subtitle Safety Testing of Intermodal Hazmat Configurations, Summary Report				5. Report Date March 1988

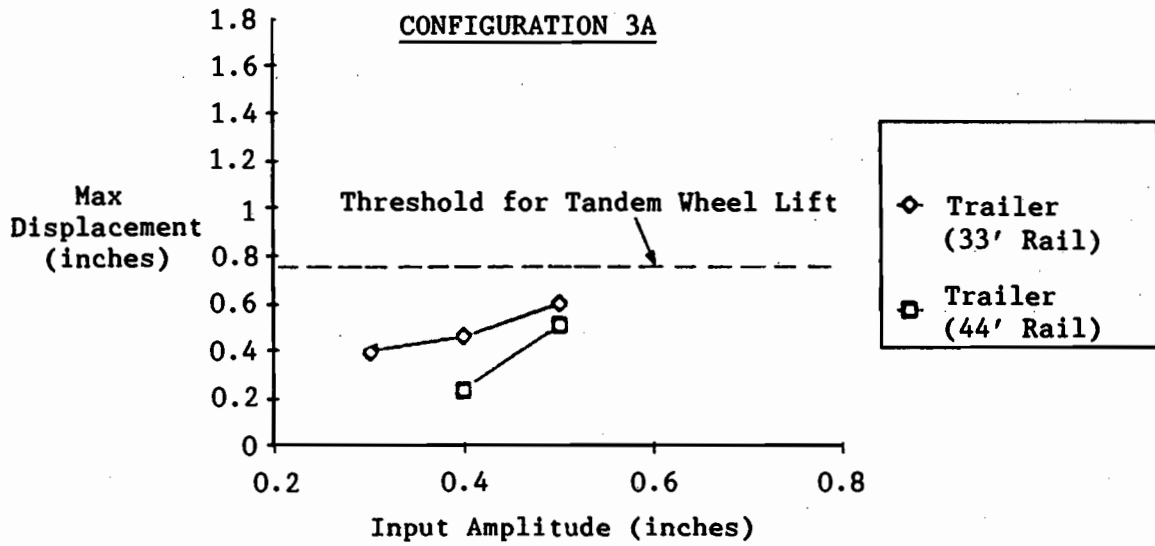
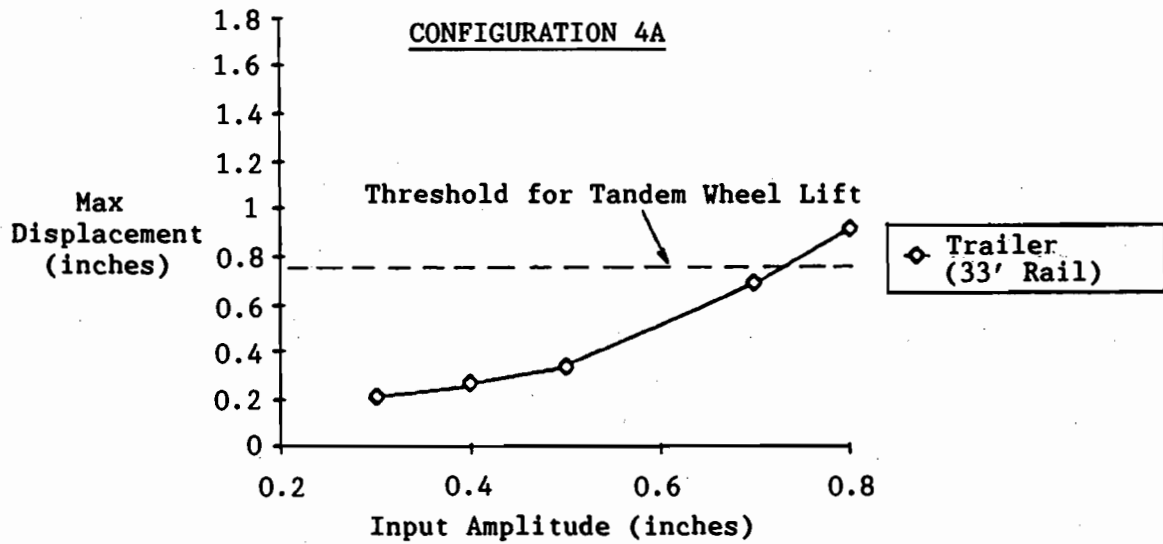
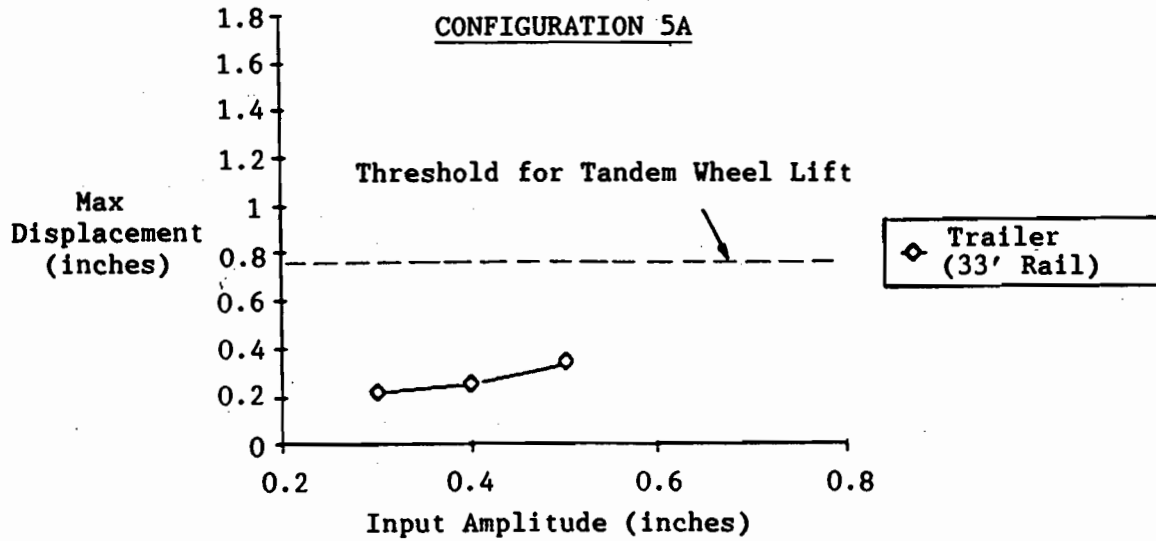
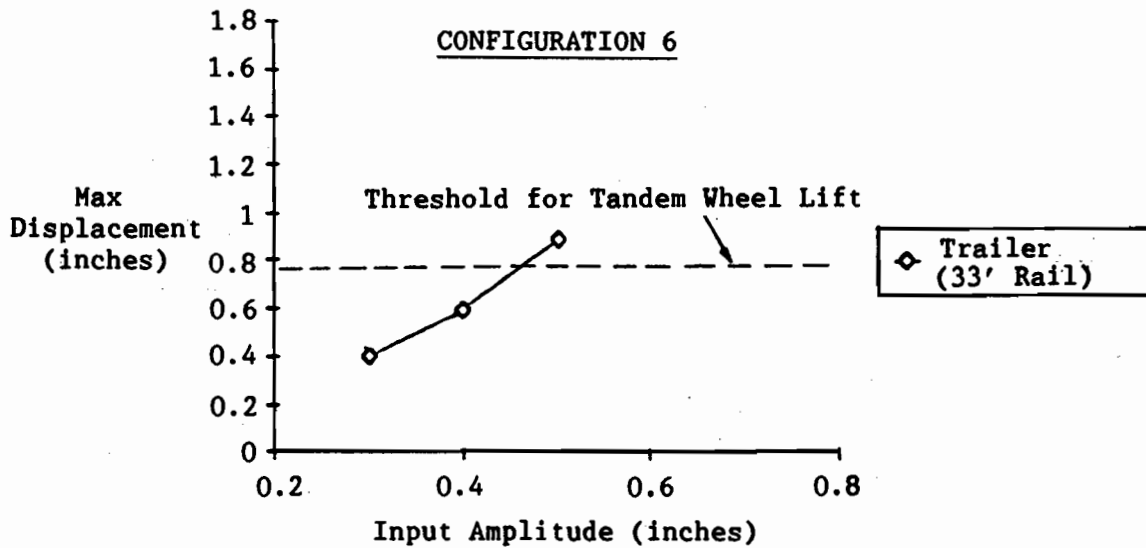
FIGURE 2-2
MAXIMUM TANDEM WHEEL DISPLACEMENTS RELATIVE TO
FLATCAR DECK, CONFIGURATIONS 3A AND 4A,
BOUNCE AND PITCH TESTS

FIGURE 2-3
MAXIMUM TANDEM WHEEL DISPLACEMENT RELATIVE TO
FLATCAR DECK, CONFIGURATIONS 5A AND 6,
BOUNCE AND PITCH TESTS

had wheel lift of the tandems at bump heights of less than 0.8 inches: Configurations 4A and 5A were between 0.7 and 0.8 inches, Configuration 3A was between 0.5 and 0.6 inches, and Configuration 6 was between 0.4 and 0.5 inches. Vertical wheel loads for the flatcar reached a maximum unloading of about 70% (where wheel lift would be 100%). Critical speeds ranged from 45 to 75 mph.

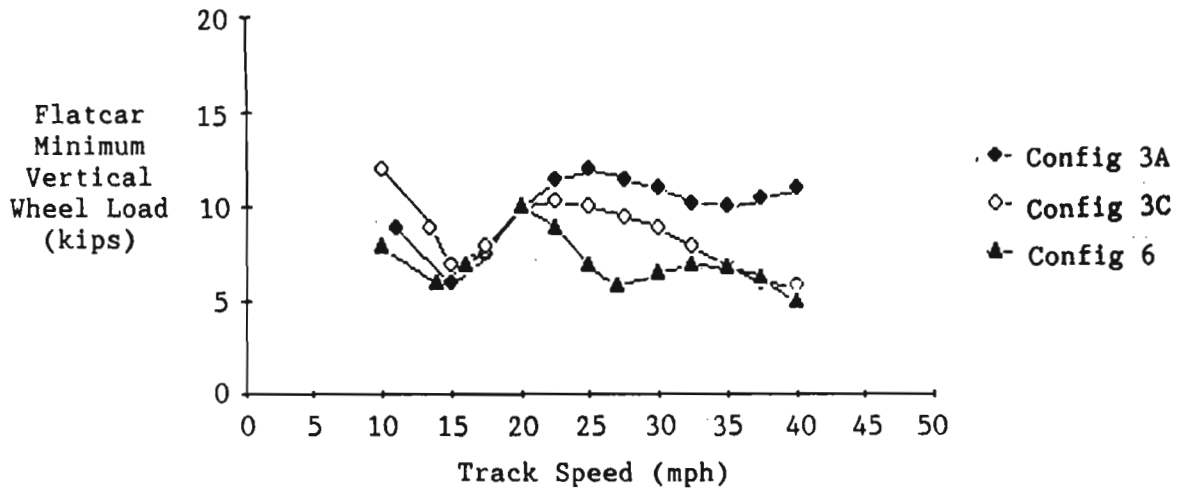
FIGURE 4-7
CONFIGURATIONS 3A, 3C, AND 6 BALLOON TRACK,
PERTURBED SECTION MINIMUM VERTICAL WHEEL-RAIL FORCES

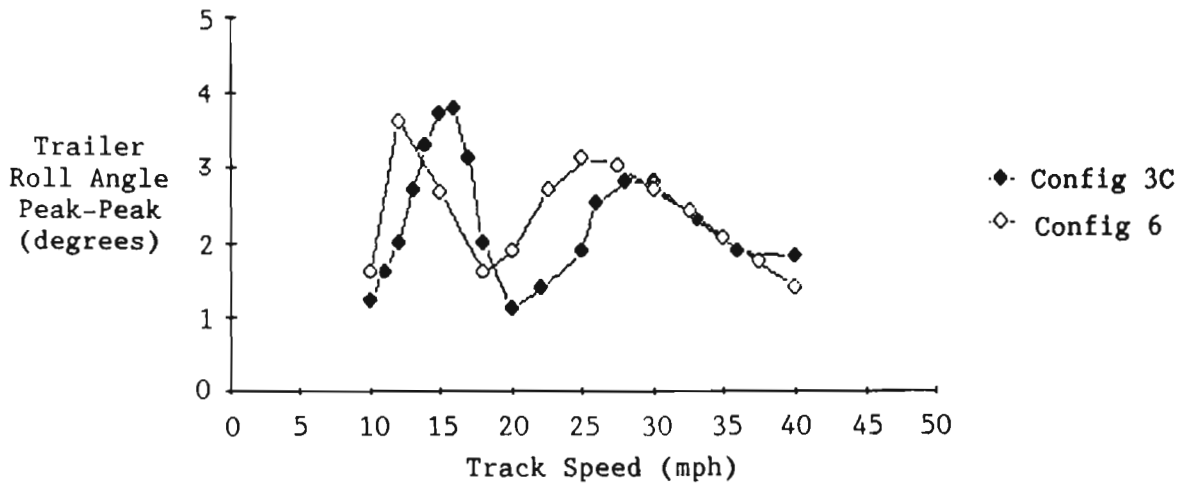
The trailer roll angles, Figure 4-8, reached maximums of 4 degrees peak-to-peak in the first roll mode, and 3 degrees in the trailer roll mode. These are relatively mild responses for the perturbed track test.

FIGURE 4-8
CONFIGURATIONS 3-C AND 6, BALLOON TRACK, PERTURBED SECTION
TRAILER ROLL ANGLES

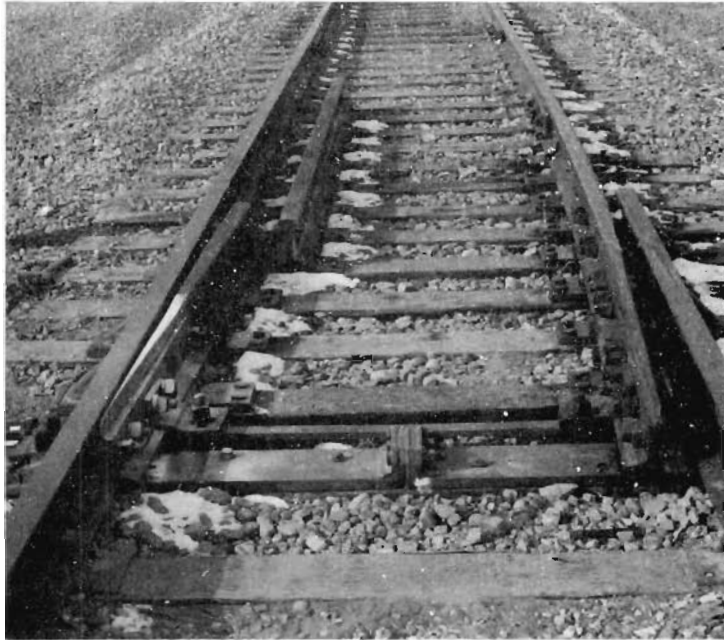
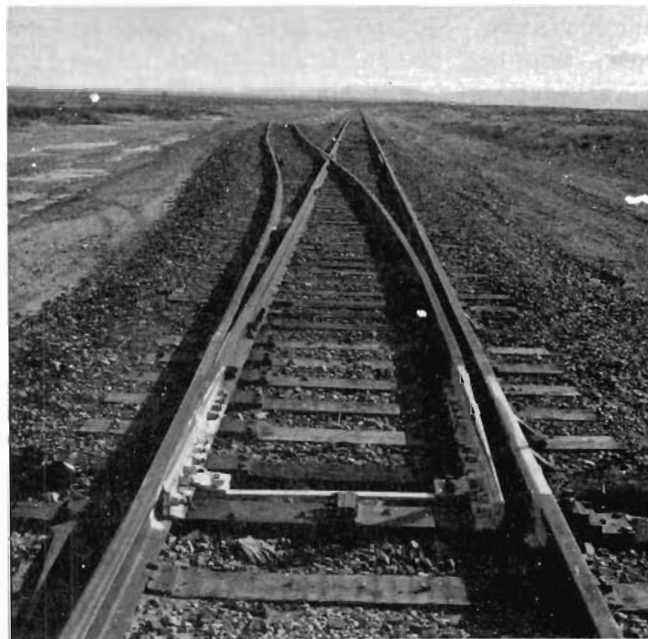
**FIGURE 5-2
DERAILING SWITCHES**

Photographs of the derailing switch are shown in Figure 5-2 for broken rail derailment Test 3 and the accordion derailment test.

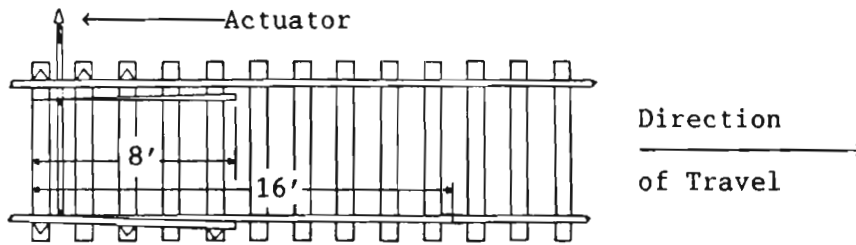
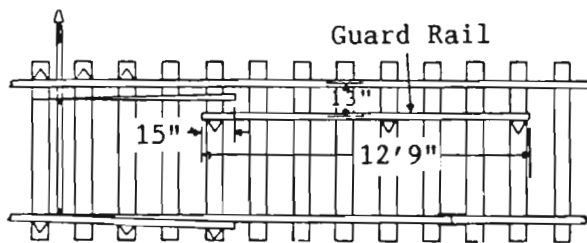
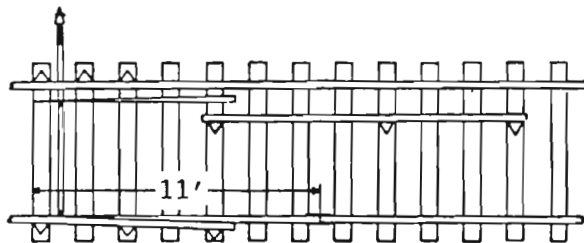
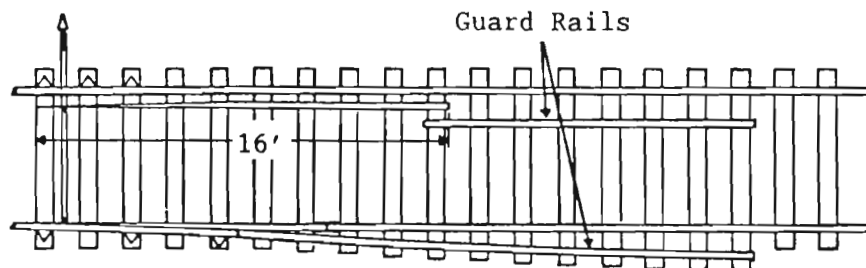
**FIGURE 5-6
DERAILING SWITCH CONFIGURATIONS FOR THE
BROKEN RAIL DERAILMENTS**

There were three changes made to the derailing switch. For Test 3, a guard rail was placed on the gage side of the left rail in an attempt to cause the derailed car to run parallel to the rails rather than move to the right. In Test 4 the right switch point was shortened from 16 to 11 feet to shorten the switch response time. In Test 6, the left switch point (8-foot) was replaced with a 16-foot switch point because it was found in Test 5 that at 60 mph the wheels were climbing the left switch point. Also, a guard rail was added outside the right rail to help keep the derailed car from moving to the right. Diagrams of the derailing switch in its several configurations are shown in Figure 5-6.

TEST 3 Guard rail added inside left rail.

TESTS 4 and 5 Right switch point shortened to 11 feet.

TEST 6 Left switch point lengthened to 16 feet and guard rail added outside right rail.

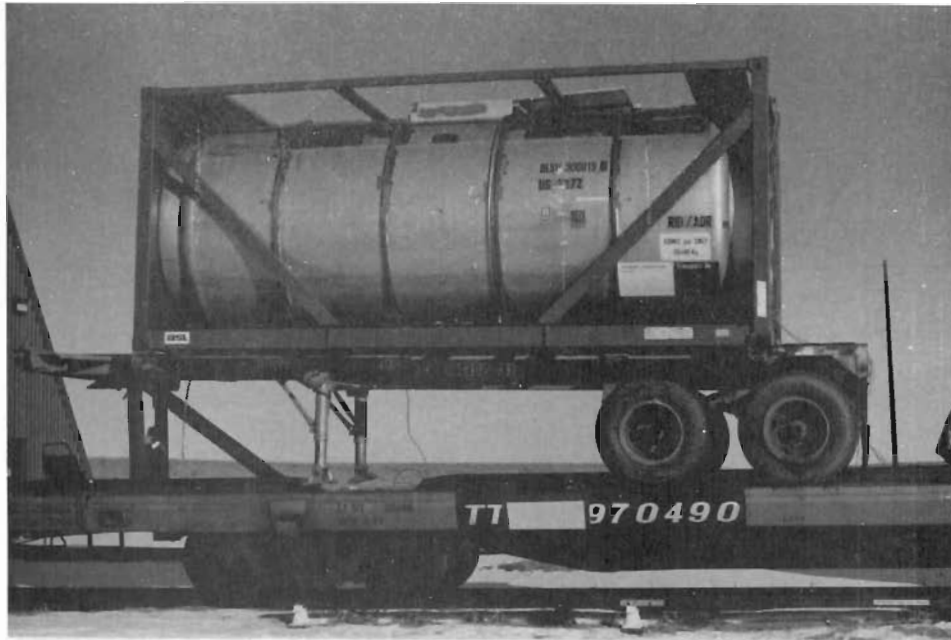
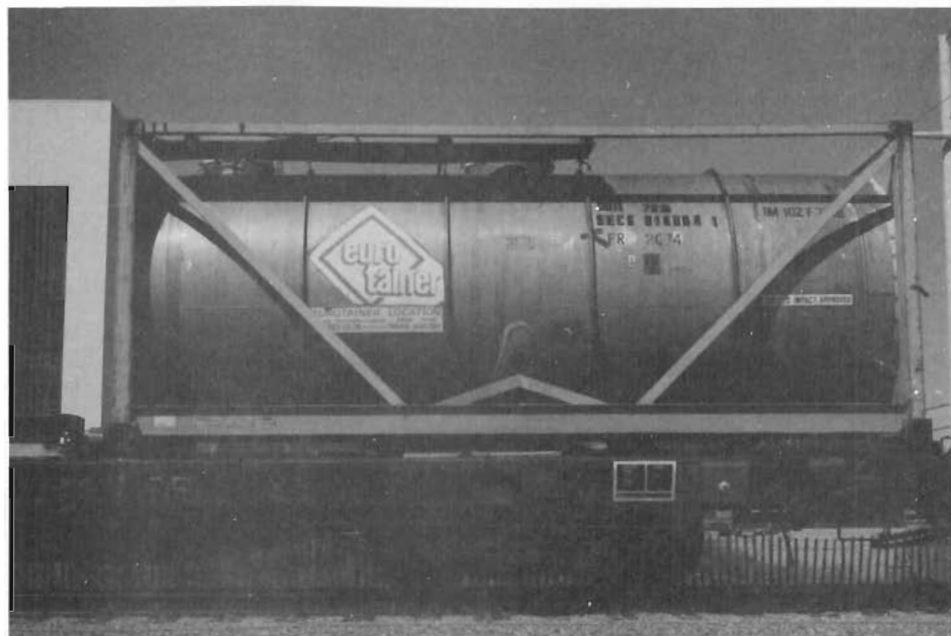
FIGURE 5-17
IM 102 PORTABLE TANKS BLSU 300019 AND FR 2074

contact. The tank remained attached to the trailer. There was some bending of the frame structure but the most significant damage was deep buckling at one end of the tank shell. Two photographs of these buckles are shown in Figure 5-19. There were no leaks other than through an opening used for wiring to the slosh gages inside the tank.
