**U.S. CONSUMER PRODUCT SAFETY COMMISSION
WASHINGTON, D.C. 20207**

**OFFICE OF COMPLIANCE
AND ENFORCEMENT**

PRODUCT SAFETY ASSESSMENT (PSA) TECHNICAL EVALUATION REQUEST

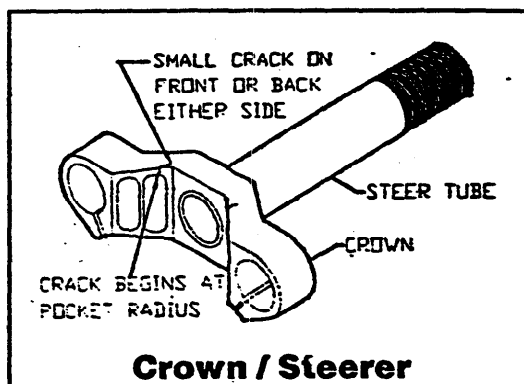
The cracks in the crown are the result of a small percentage of defective material that was used in the manufacture of the crowns. The cracks, if present, are plainly visible from the outer surface of the fork crown and require no disassembly to see. If cracks have developed and the fork continues to be used, the cracks may grow to a point where the crown may fail, completely separating the fork from the bicycle. This situation would result in loss of control of the bicycle with risk of physical injury to the rider.

1. Notify all known purchases and owners to STOP USING THE MANITOU 2 AND '92 M-SPORT FORKS IMMEDIATELY UNTIL THE CROWN CAN BE INSPECTED by the individual or by Shop Personnel if necessary. If any cracks are apparent, then the crown must be removed and Answer will replace the crown at No Charge to the dealer or the consumer.
2. Post the enclosed notice in your store(s) in a conspicuous place.
3. Visually inspect all crowns in use for presence of cracks in the areas noted in Fig. 1.
4. Remove and replace crown / steerers if any cracks are visually evident.
5. Send the cracked crown / steerer to ANSWER PRODUCTS, 27460 AVENUE SCOTT, VALENCIA, CA 91355. (Do not send the entire fork, just the crown/steerer) Write "DEFECTIVE CROWN" on the package for quick identification and turn-around. It will be replaced at No Charge.
