## **Damage Evaluation of the Taum Sauk Reservoir Failure using LiDAR**

**ABSTRACT:** The Taum Sauk Dam Upper Reservoir located in southeast Missouri failed on December 14, 2005. Two days after the catastrophic failure event an aerial survey were conducted to collect Light Detection and Ranging (LiDAR) data. The LiDAR data were interpreted and evaluated to a sub-meter resolution. The data were used to quantify the extent of the damage produced by the water released into a Missouri State Park. Damage consisted of washing out trees, soil, and the reservoir embankment, and scouring the ground to bedrock in places. Additionally, the data also were used in the evaluation of the reservoir damage, which consisted of a 207.3m (680ft) wide breach and scoured slopes. This paper focuses on the multiple uses of LiDAR data to assess damage to natural resources, and hydraulic and geotechnical evaluation of the failure.

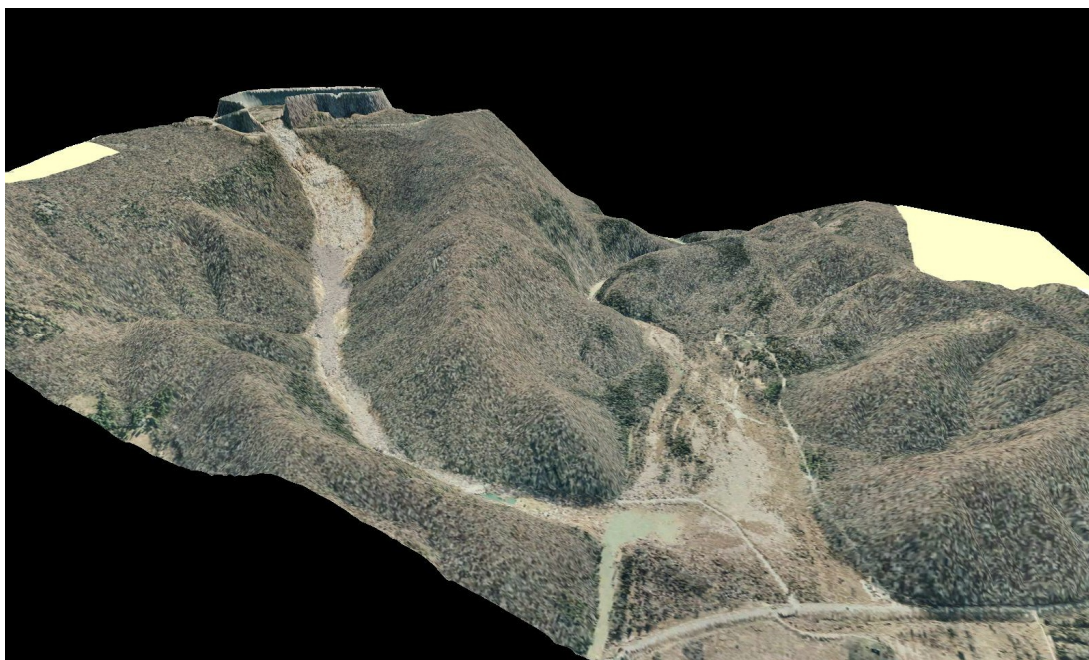
Dynamic flood wave routing models use an input hydrograph to route the flood wave. Steady state models use peak discharge to develop flood profiles used to map inundation extents. LiDAR provides the geometric basis for contour data sets that are used in modeling, as well as point data necessary to create a triangulated irregular network (TIN) surface (Figure 5) used to produce flood inundation maps and qualitatively estimate the volume of debris movement.

**FIG. 5.** High resolution imagery overlain on LiDAR derived surface (imagery courtesy of Sanborn Inc, proprietary to MACTEC, Inc.)

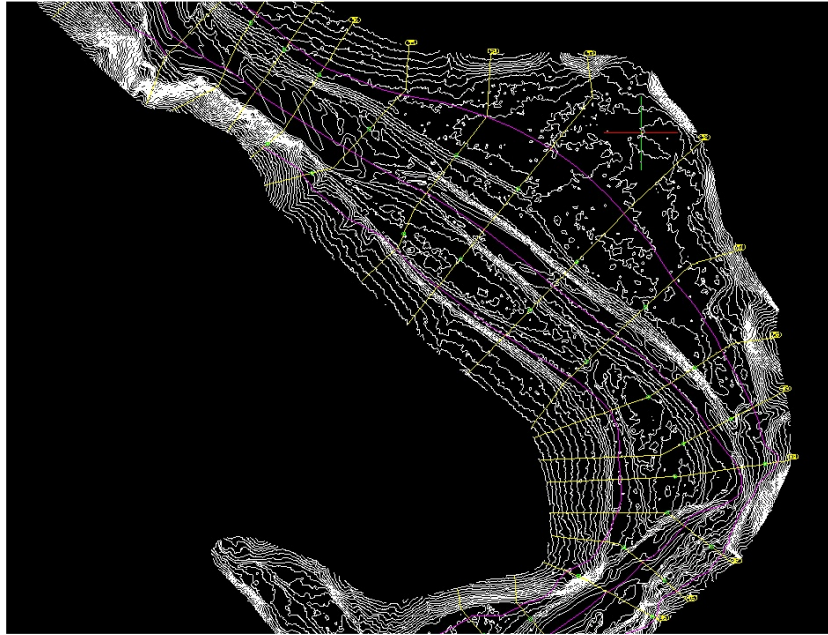
Use of pre- and post-processing software known as BOSS RiverCAD from BOSS International Inc., allowed a georeferenced and attributed contour data set to be input, and cross-sections to be cut in a manner perpendicular to conceptualized flow (Figure 6). The modeling effort analyzed each cross-section as a “slice” of flow in one dimension. All cross sections were combined and used with steady and unsteady flow simulations to produce hydrographs, flood profiles, and inundation extents. Volume estimates of debris movement were derived from differencing the LiDAR surface with a digital elevation model (DEM) surface before the failure. The

**FIG. 6.** Cross-sections developed from LiDAR derived contour data set.
