EPA/OSHA JOINT CHEMICAL ACCIDENT INVESTIGATION REPORT

**Surpass Chemical Co., Inc.
Albany, NY**

Accident Investigation Report
Surpass Chemical Company, Inc., Albany, New York, April 8, 1997

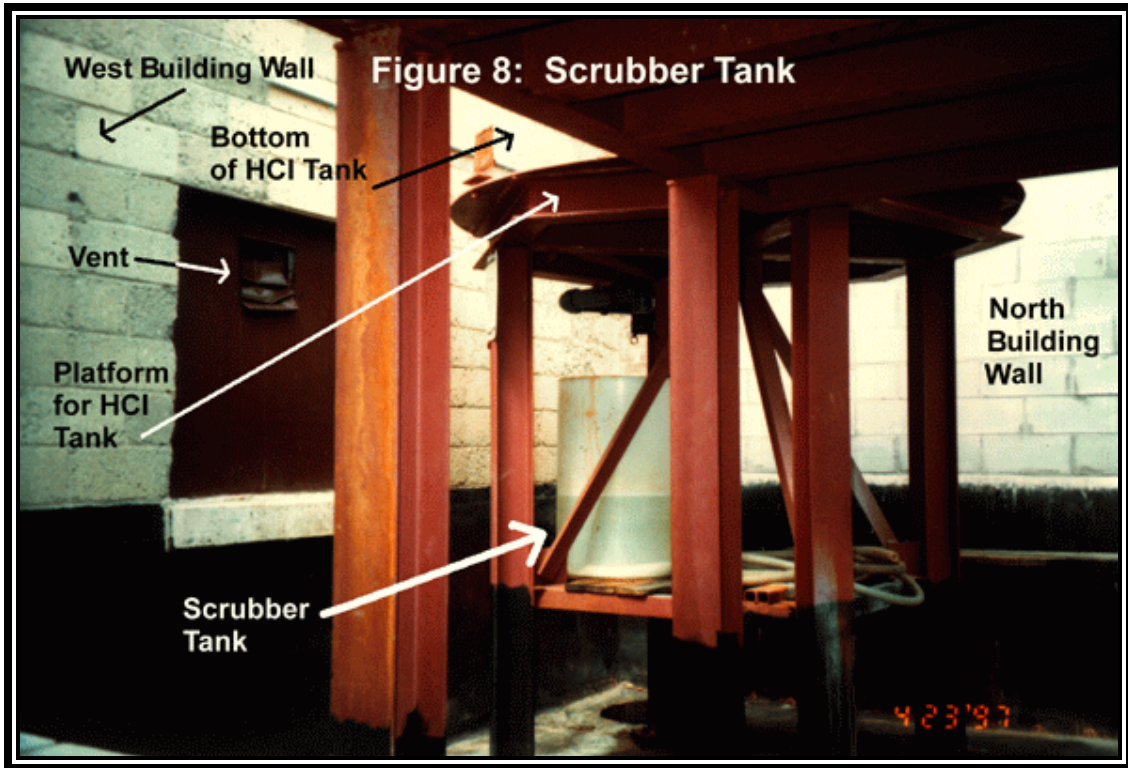
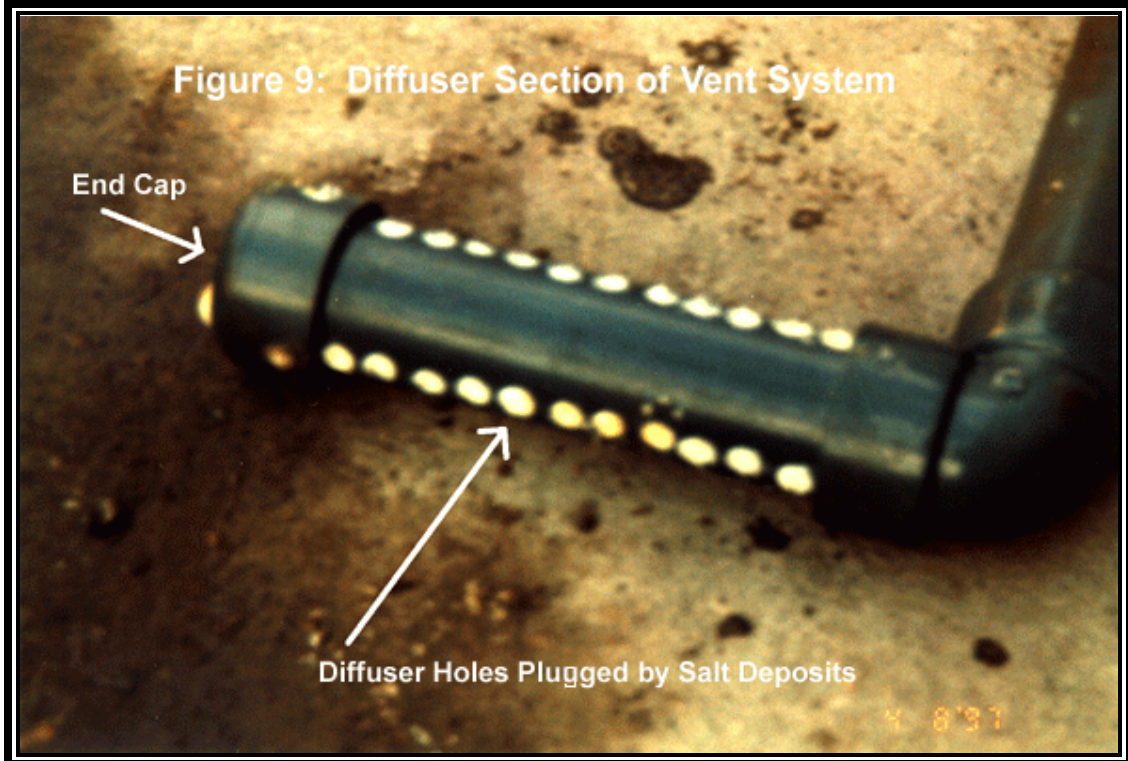
- The scrubber tank was not affected by the tank failure; it was found intact in its original position after the incident. (See **Figure 8**.)
- After the incident, the diffuser in the scrubbing tank was removed by disconnecting the vent line quick connect and removing the lid from the scrubber tank. The holes in the diffuser were found to be clogged with a white crystalline substance, as shown in **Figure 9**. This substance was sodium chloride, according to laboratory analysis.

- A layer of white crystalline material was also found in the bottom of the scrubber tank. This substance also was sodium chloride, according to laboratory analysis.
