Highway Concrete Pavement Technology Development and Testing: Volume II— Field Evaluation of Strategic Highway Research Program (SHRP) C-203 Test Sites (Freeze-Thaw Resistance)

PUBLICATION NO. FHWA-RD-02-083

AUGUST 2006

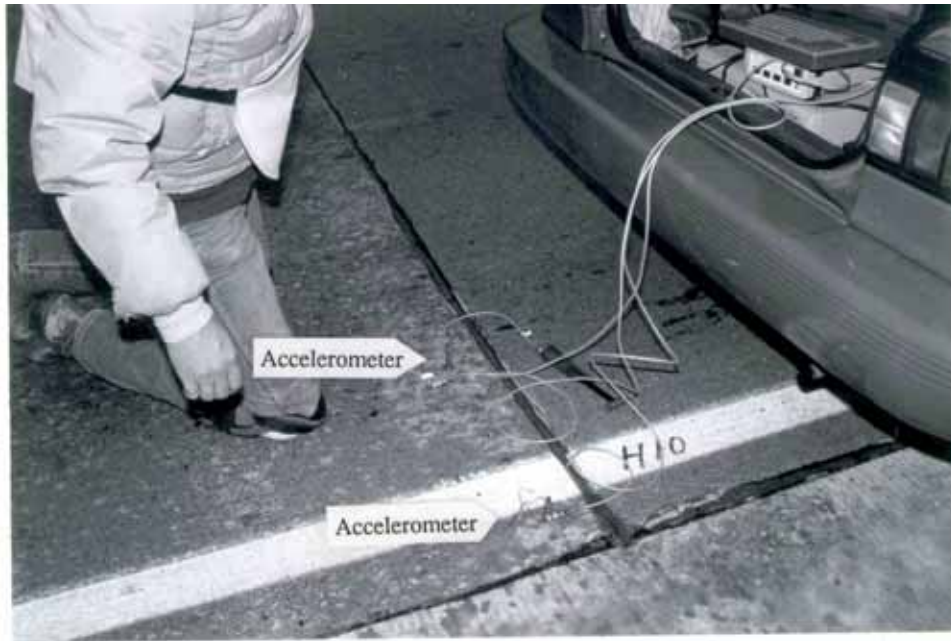
Figure B3. SASW testing at the Ohio test sections.

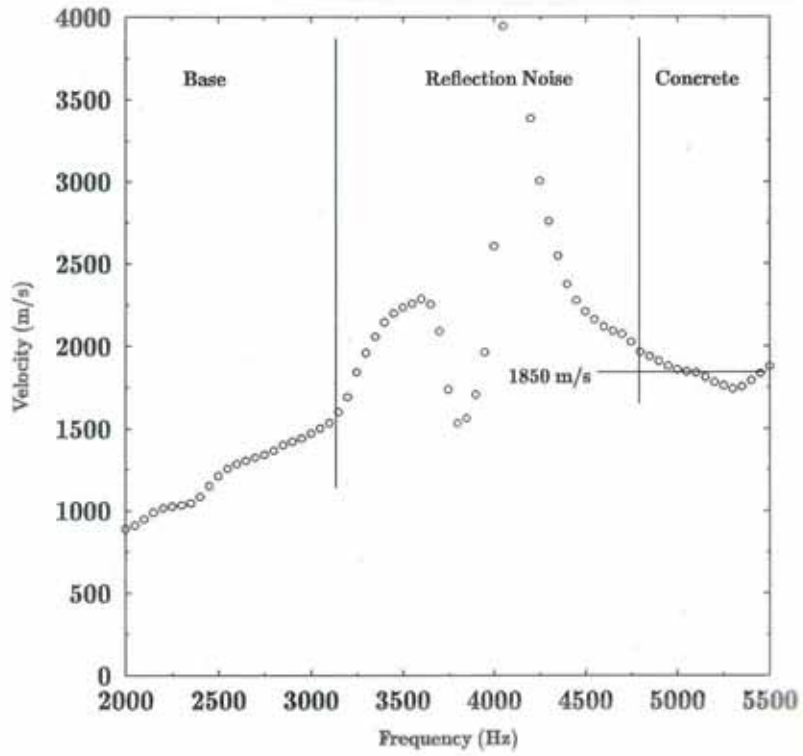
Figure B4 shows a typical R-wave velocity versus vibration frequency plot. The concrete pavement and subbase (base) portion are easily identified. The central section of the graph is dominated by noise resulting from waves reflected by the vertical edge of the pavement. This phenomenon is present in most of the R-wave velocity versus vibration frequency plots from the Ohio testing. Extensive analysis was conducted to filter out this reflection noise from the digital data obtained in Ohio.

Figure B4. Typical R-wave velocity versus vibration frequency plot.
