December 13, 2007
Project No. J1447-01-02

**Semi-Annual Inspection
Building Demolition Barrier Areas
December 2007
20s and 30s Complexes
William Stanley Business Park
Pittsfield, Massachusetts**

Building Demolition Barrier Areas
20s and 30s Complexes
William Stanley Business Park
Pittsfield, Massachusetts

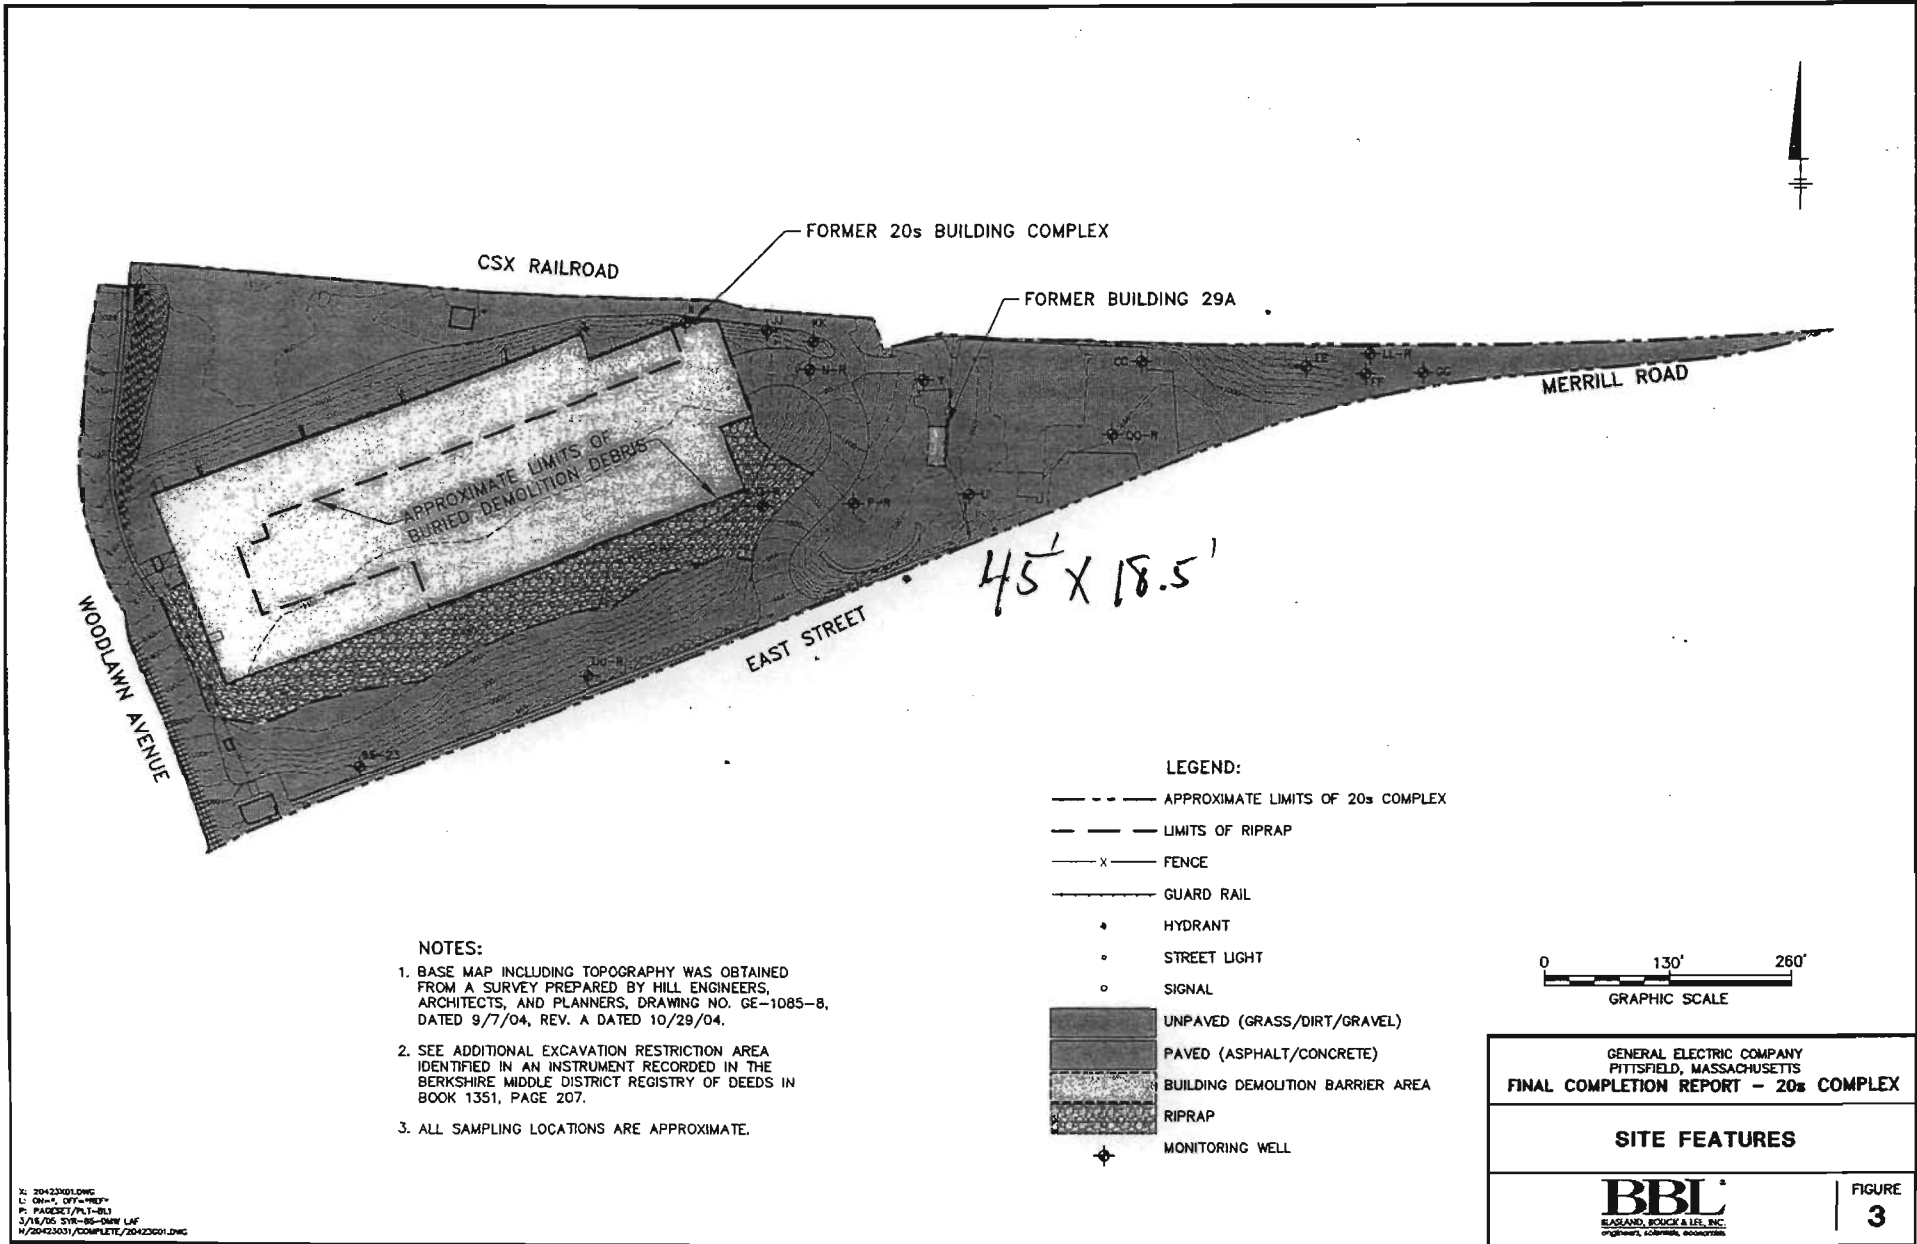
**20s Complex
Barrier Area 1**

Date	12-10-07
Inspector	J GAGNON
Weather Conditions	COLD; CLOUDY
Evidence Of Change In Use	NONE
Physical Changes And Conditions Adjacent To Barrier Area	NONE observed
Soil Erosion	NONE observed
Excessive Vegetative Growth	VEGETATIVE GROWTH INCREASING
Excessive Cracking	NONE observed
Fissures	NONE observed
Spalling	NONE observed (SNOW COVER)
Potholes	NONE observed
Heaving or Uneven Settling	NONE observed
Vehicular Use	NONE observed
Depressions	NONE observed
Water Ponding	NONE observed
Excessive Rutting	NONE observed
Exposed Subbase	NONE observed (SNOW COVER)
