**Re: GE-Pittsfield/Housatonic River Site
East Street Area 2-South (GECD150)
Summary of November 2005 Inspection Activities – City Recreational Area**

**INSPECTION SUMMARY AND CHECKLIST
CITY RECREATIONAL AREA**

GENERAL ELECTRIC COMPANY
PITTSFIELD, MASSACHUSETTS
SUMMARY OF NOVEMBER 2005 INSPECTION
ACTIVITIES - CITY RECREATIONAL AREA

**BALLFIELD AREA AND
ACCESS ROAD AREA**

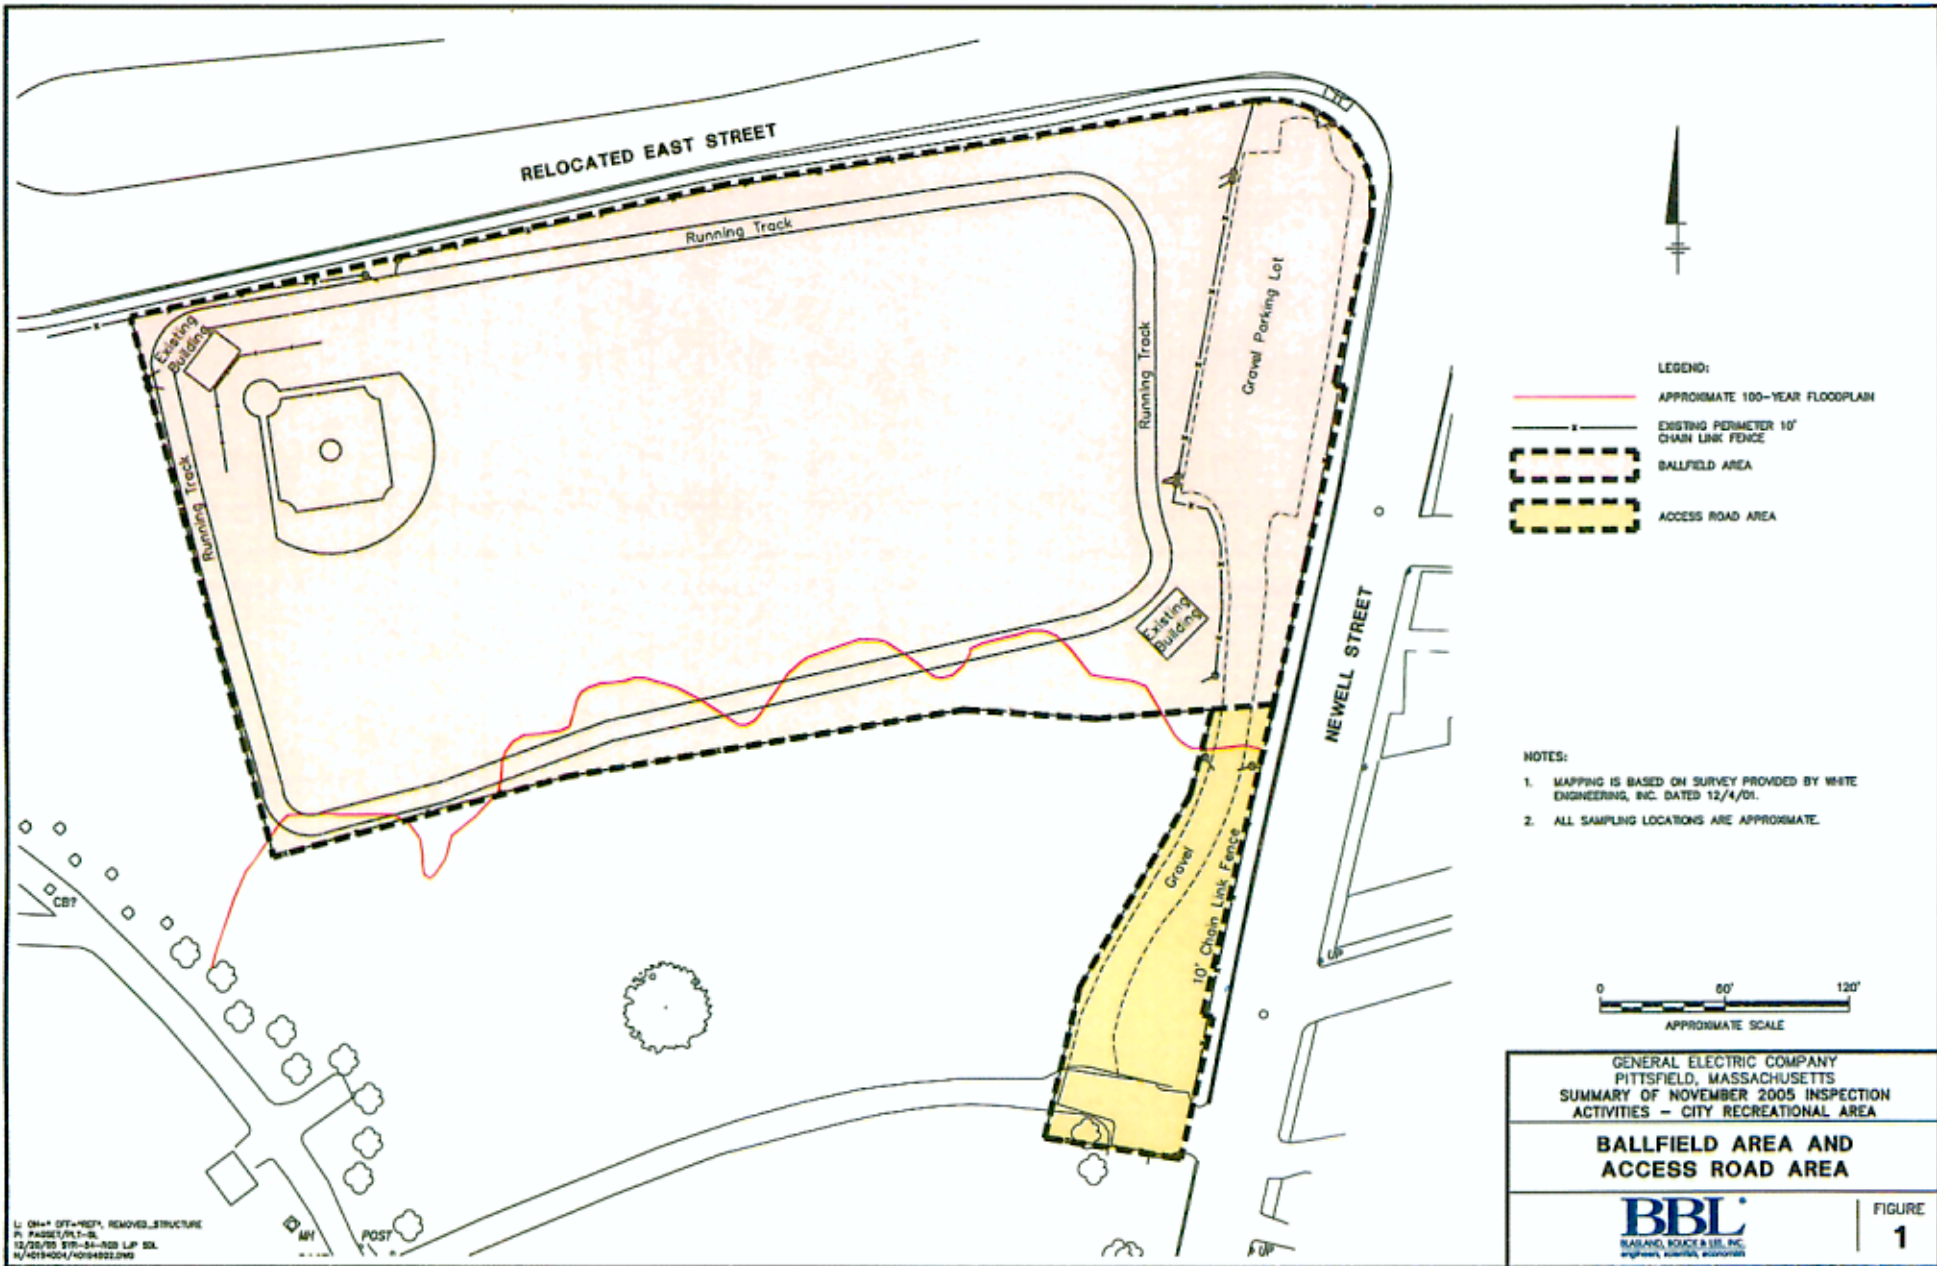
- Gravel surfaces all in good condition; no signs of settlement, erosion, etc.
- Some areas adjacent to gravel surfaces void of vegetation (may be due to vehicle traffic/parking); need to discuss future use of this area with City.

Photo #8: Absence of Vegetative Cover East of Gravel Parking Area (11/18/05)
