**Re: GE Pittsfield/Housatonic River Site
Upper ½-Mile Reach Removal Action (GECD800)
2002 Annual Monitoring Report**

***2002 Annual Monitoring Report
Upper 1/2-Mile Reach of the
Housatonic River***

**General Electric Company
Pittsfield, Massachusetts**

December 2002

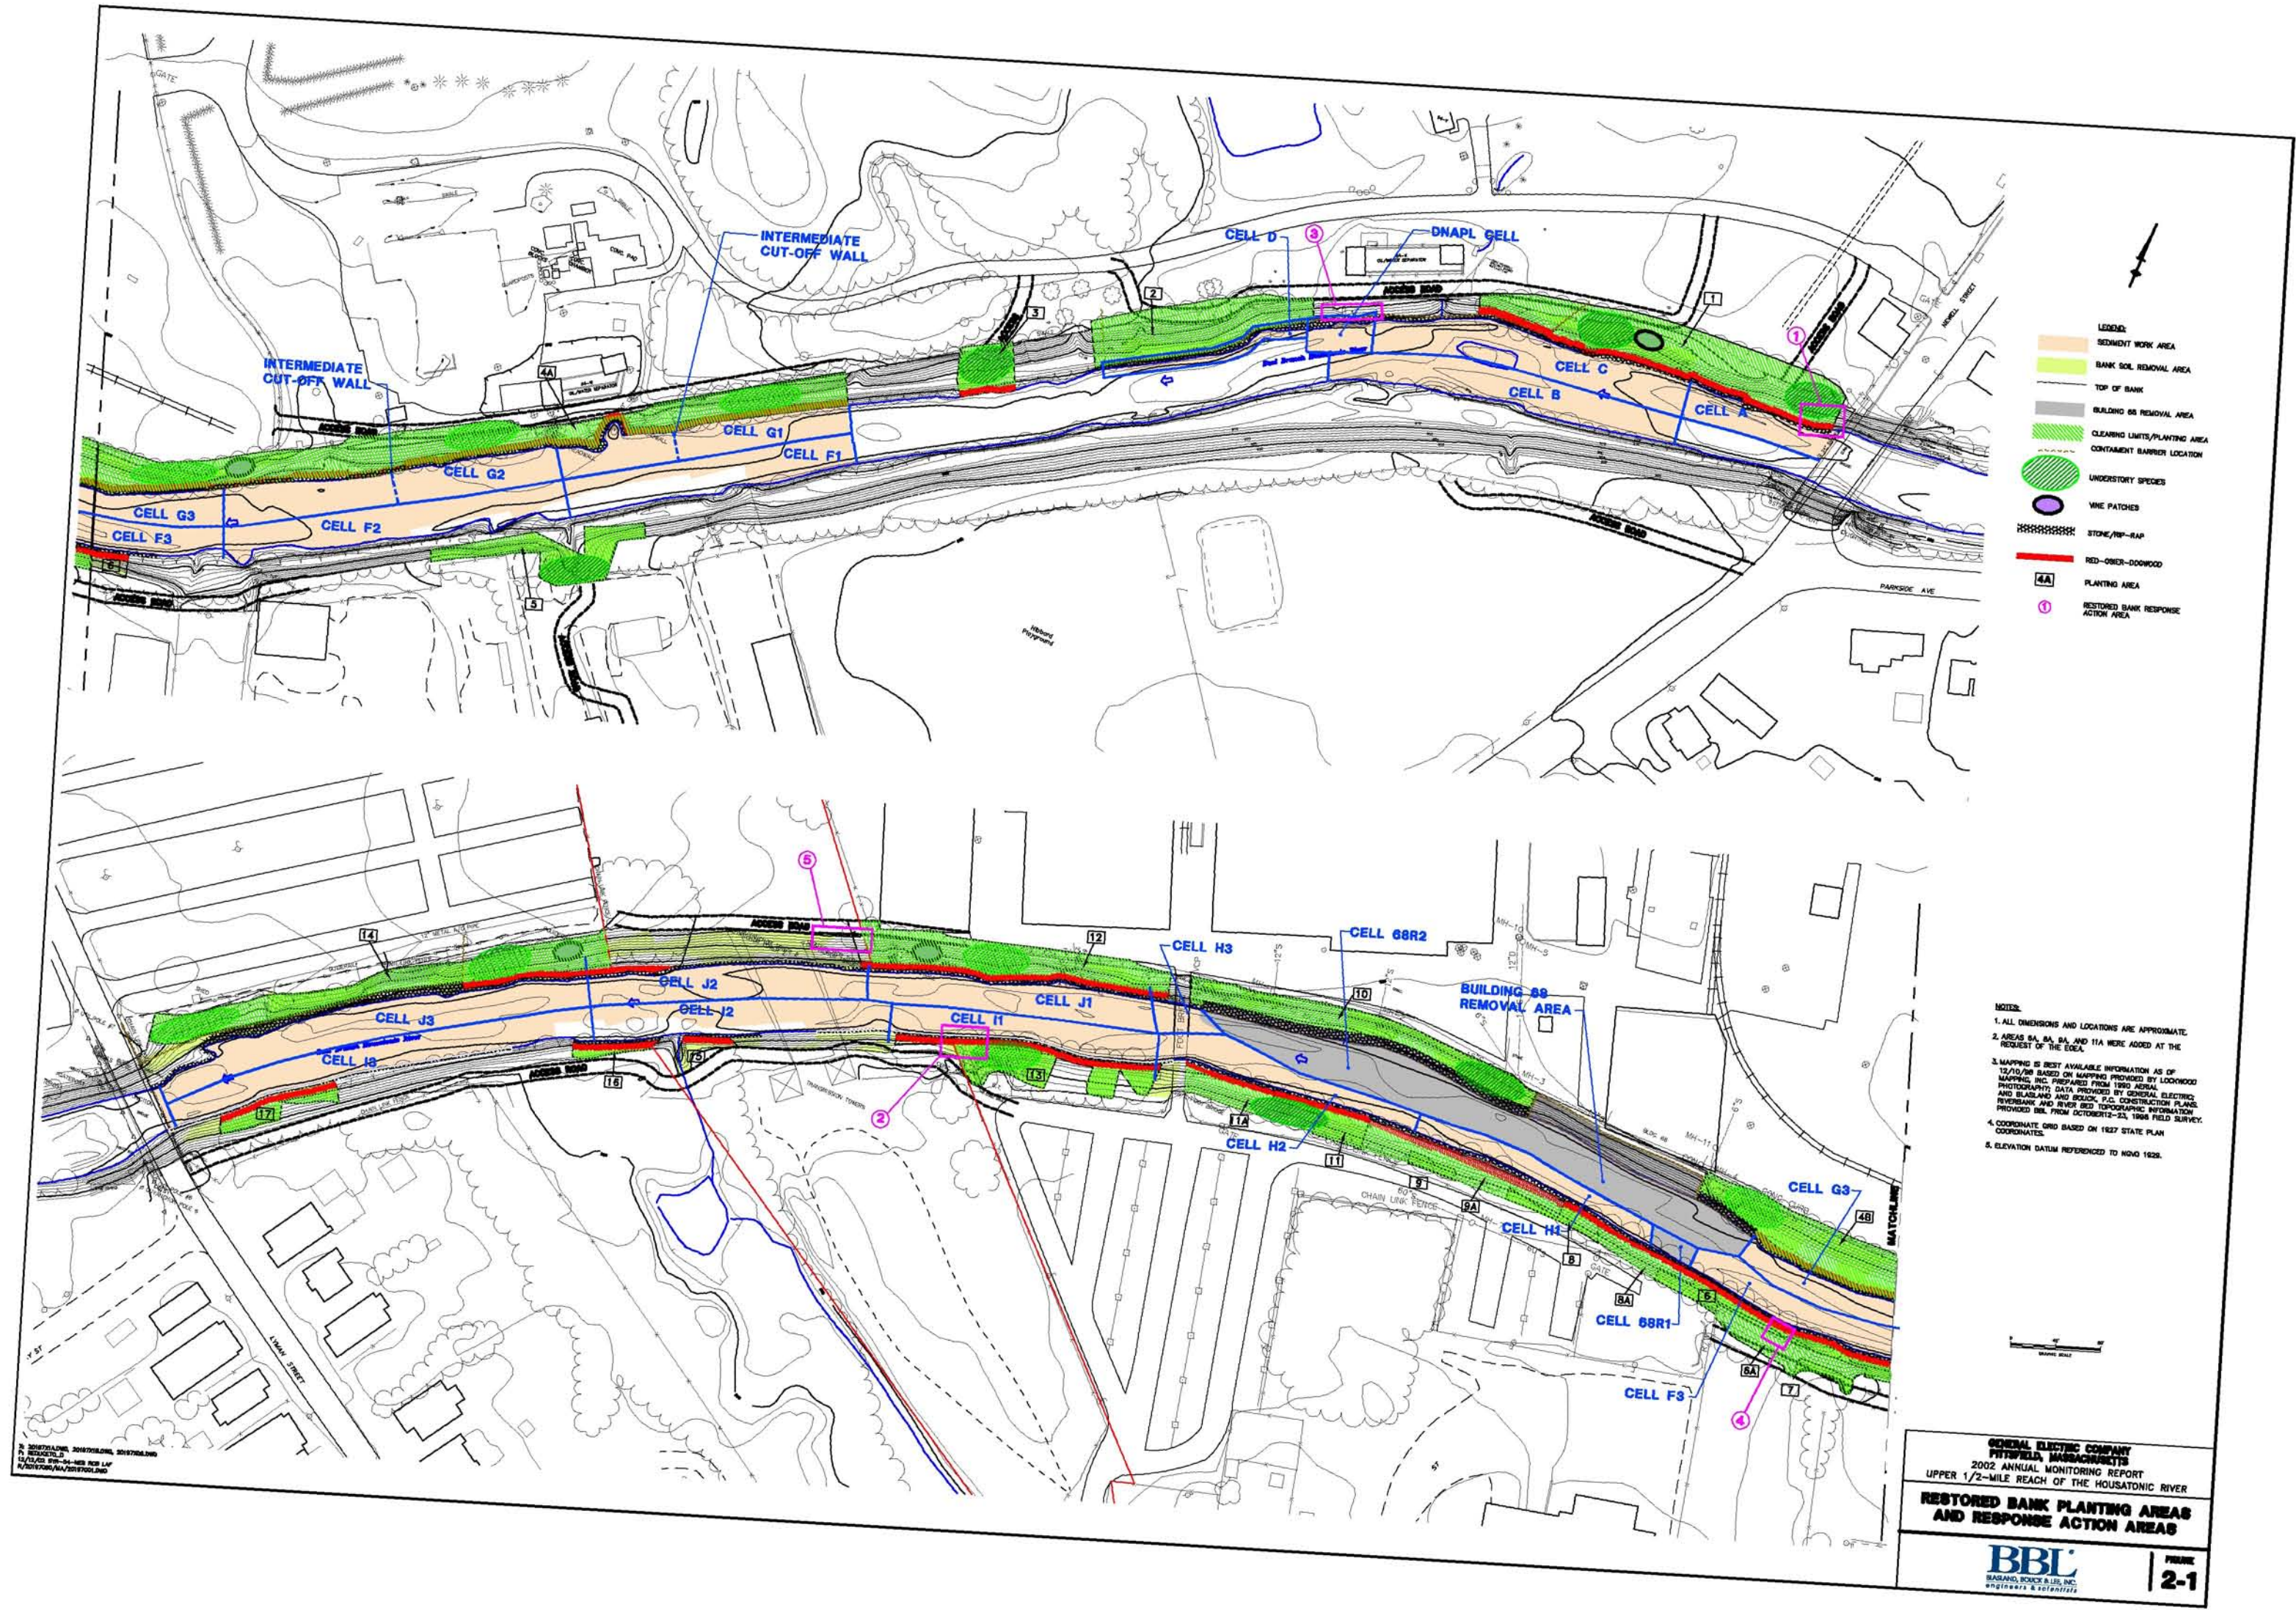
FIGURE
2-1

The restored banks were monitored during a spring 2002 monitoring event and the results were presented in a trip report included in this Monitoring Report as Attachment A. In addition, observations were made at various times throughout the year during implementation of the Upper ½-Mile Reach Removal Action. Results of additional monitoring and maintenance activities performed as a result of observations made during the Removal Action were presented in various monthly reports on activities at the GE-Pittsfield/Housatonic River Site. Response actions associated with these monitoring and maintenance activities are summarized below, and the locations where such activities were performed are identified on Figure 2-1.
