**Re: GE Pittsfield/Housatonic River Site
Upper ½-Mile Reach Removal Action (GEC800)
2006 Annual Monitoring Report**

2006 Annual Monitoring Report

**Upper 1/2-Mile Reach of the
Housatonic River**

Prepared by:
ARCADIS of New York, Inc.
6723 Towpath Road
Syracuse
New York 13214-0066
Tel 315.446.9120
Fax 315.449.0017

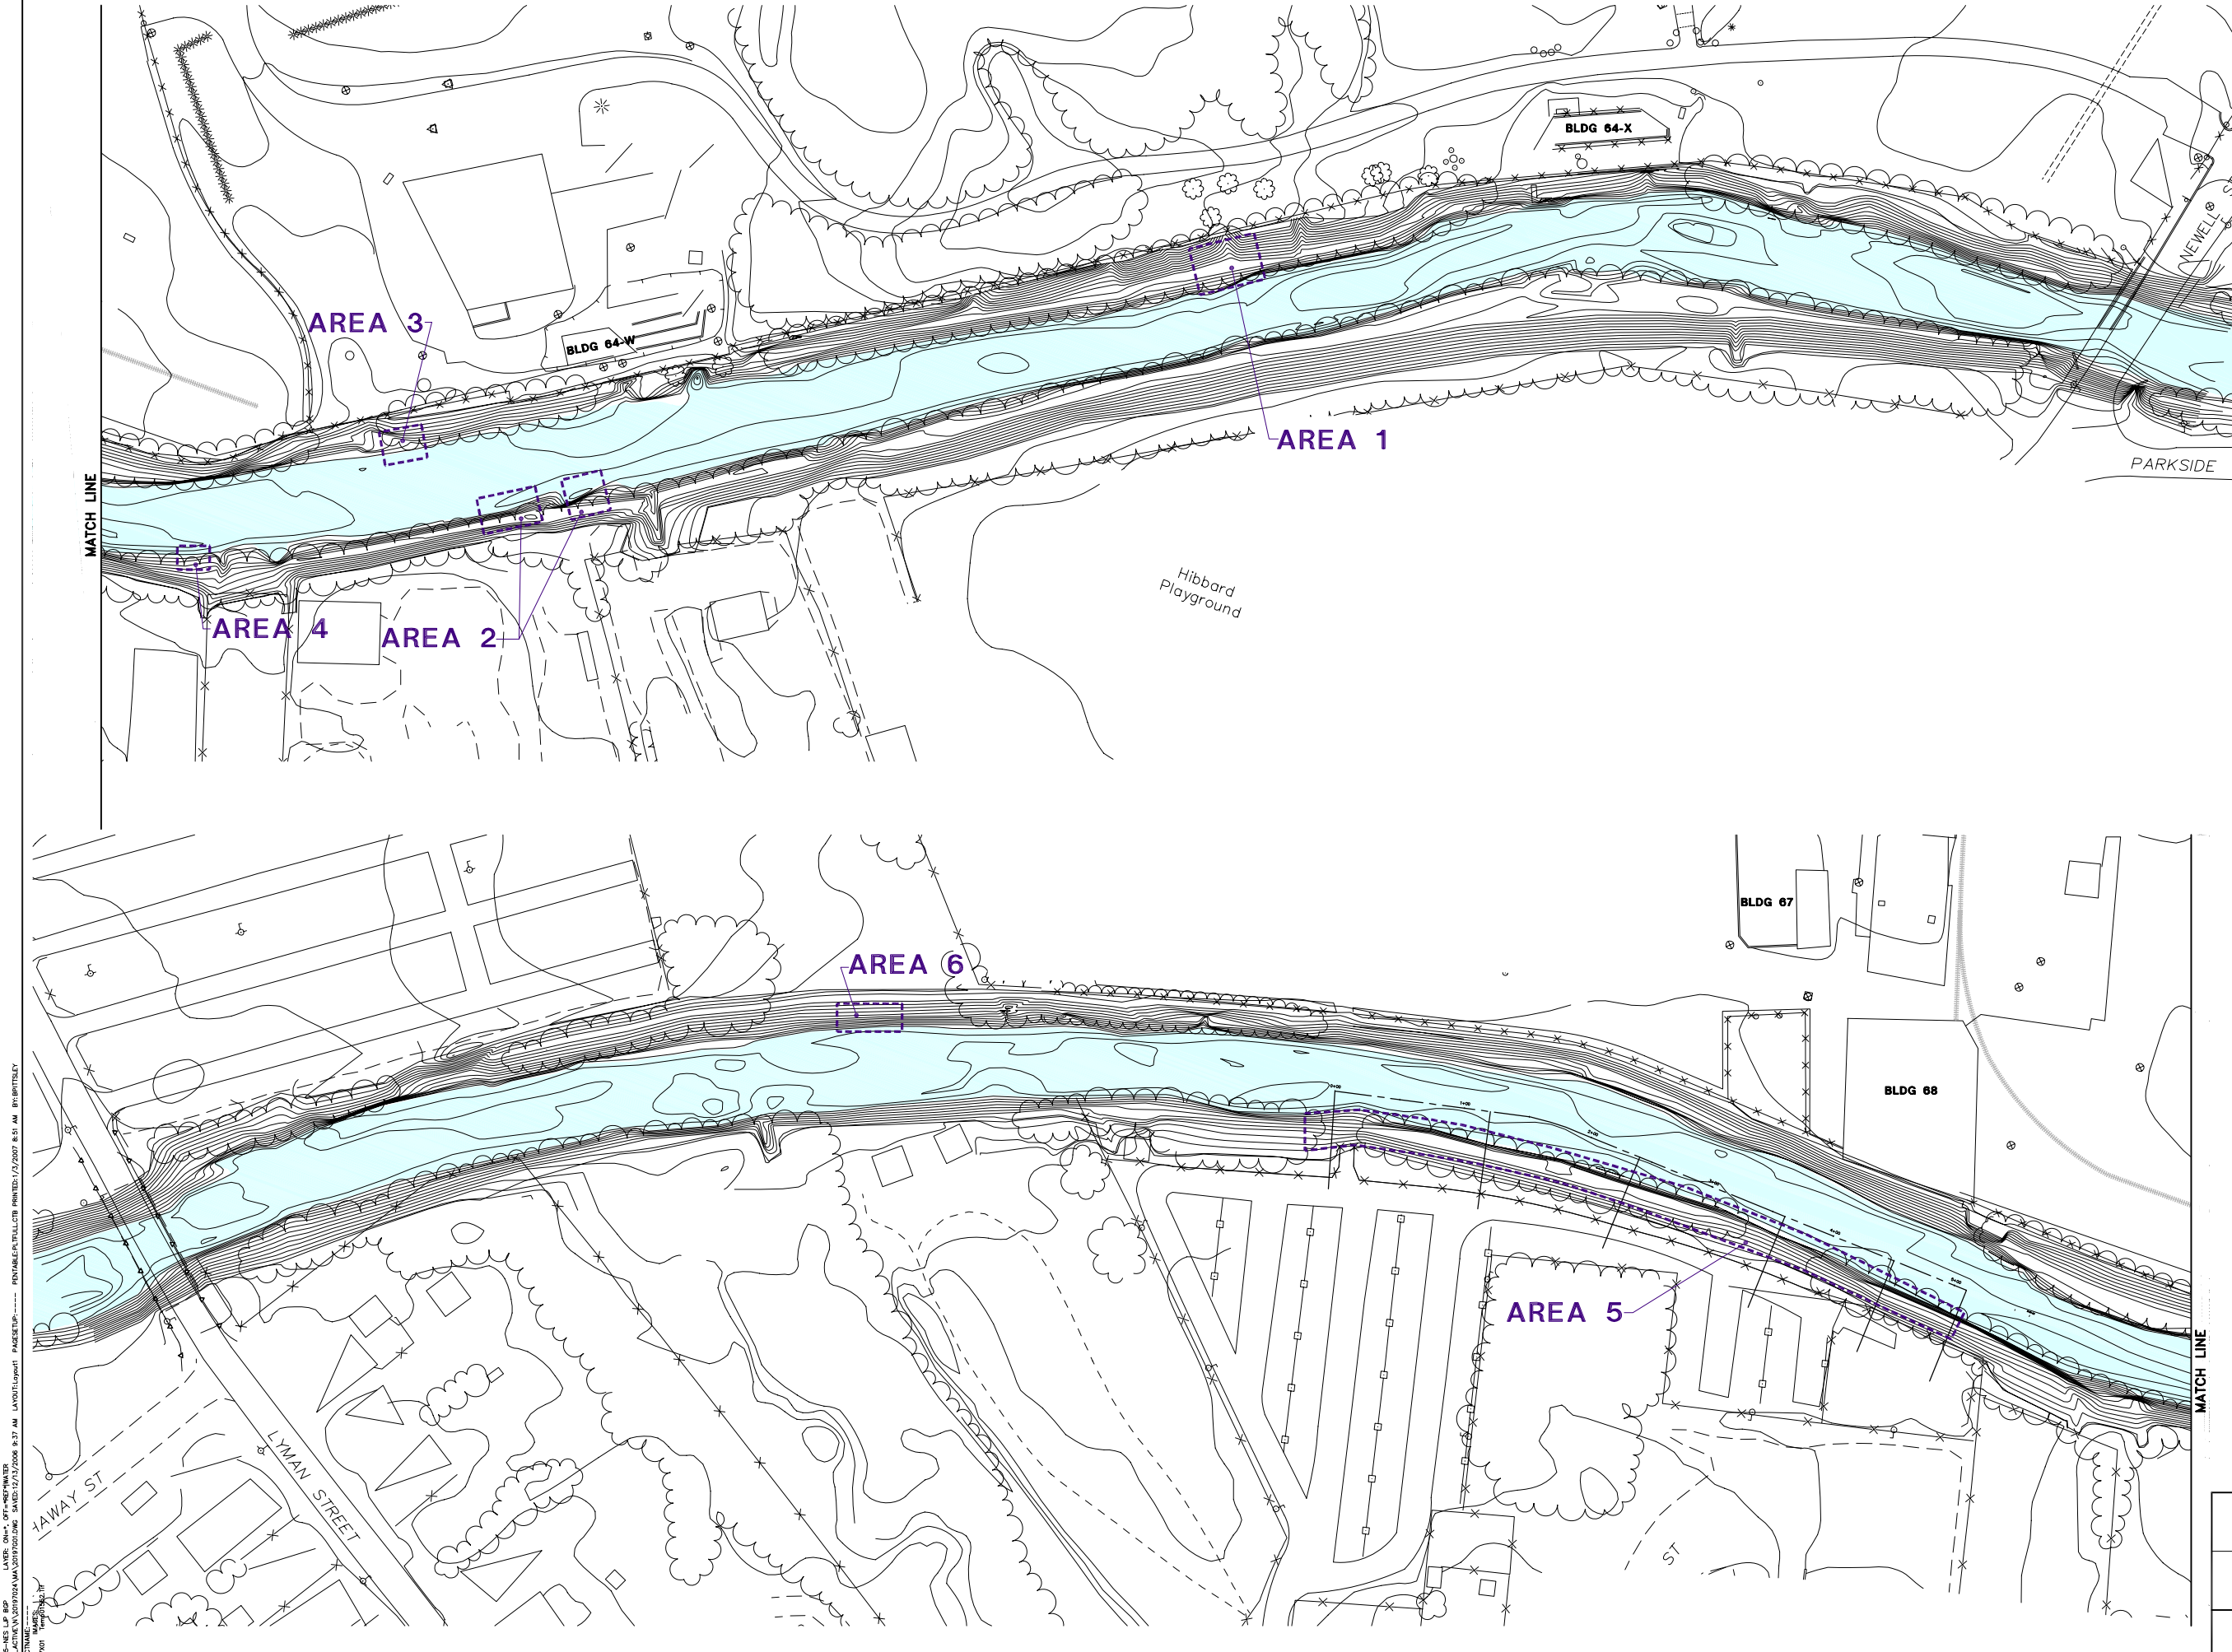
FIGURE
1

At the time of the inspection, several areas were noted with either a visually observable loss of bank soil or movement of bank armoring. These areas are identified on Figure 1. Where appropriate, certain areas may require protection from further erosion through the placement of armor stone. Armor stone placed as part of these activities will be similar to that used during the implementation of the Upper ½ Mile Reach Removal Action (i.e., graded riprap, $D_{100}=12$ -inch), as fully described in the Work Plan. GE plans to complete the remedial activities discussed below during the 2007 construction season, and will coordinate scheduling with EPA as the construction season approaches.

Area 1 – This area consists of approximately 25 feet of undercut bank, located on the northern bank of the river approximately 200 feet downstream of Building 64X in an area where no remedial activities were performed either in the river or on the riverbank (see Figure 1 and Photo 1). This area of observed erosion is located downstream of rip-rap placed adjacent to sheetpiles installed during past remedial activities, where the bank transitions from riprap to bank soil. In this area, less than 10 cubic yards (cy) of bank soil appear to have eroded from the bank. The source of the eroded material appears to be native material from the low- and mid-bank area directly down-slope from established grassy vegetation. The cause of erosion appears to be a combination of the transition from riprap to unprotected bank soils and the high velocity flows associated with the extreme flood event discussed above. No eroded soil was observed in the adjacent portion of the river and, therefore, no removal activities are planned at this location.

Area 2 – Area 2 includes two areas (see Figure 1). The first area consists of approximately 40 feet of undercut bank, located on the southern bank directly across the river from Building 64W in a non-remediated bank area (see Photo 2). In this area, less than 5 cy of bank soil appears to have eroded from the bank. The source of the eroded material appears to be native material from the low- and mid-bank area directly upstream of a riprap swale. The cause of erosion appears to be high velocity water flow, likely associated with the extreme flood event discussed above. No evidence of eroded soil was observed in the adjacent portion of the river and, therefore, no removal activities are planned at this location. As discussed during the inspection, the proposed response action in this area will consist of placement of armor stone to replace eroded materials and protect against further such erosion. In this area, an approximate 1-ft thick layer of $D_{100}=12$ -inch graded riprap will be placed along the lower portion of the bank in this area, extending approximately 4-feet up the bank from the riverbed. To the extent practicable, the installed armor layer will be keyed into the bank such that the eroded areas will be restored to previous grades.

Area 3 – This area is located on the northern bank, in a non-remediated bank area, approximately 200 feet downstream of Building 64W (see Figure 1). In this area, less than 1 cy of bank soil appears to have eroded from within a 5-foot long slight undercut just above the existing riverbed armor layer (see Photo 4). The source of the eroded material appears to be native material from the mid-bank area. The cause of erosion appears to be high velocity water flow, likely associated with the extreme flood event discussed above. No evidence of eroded soil was observed in the adjacent portion of the river and, therefore, no removal activities are planned at this location. As discussed during the inspection, armor stone will be placed in this area to replace eroded materials and protect against further such erosion. In this area, armor stone (i.e., $D_{100}=12$ -inch graded riprap) will be keyed into the bank to fill the undercut such that the lower bank above the existing riverbed armor layer will be restored to previous grades.

Area 4 – This area consists of a slightly undercut bank, extending over approximately 30 feet of the southern riverbank just upstream of riprap-protected banks, in a non-remediated bank area approximately 200 feet upstream of the eastern edge of the Newell Street Area II Parking Lot (see Figure 1 and Photo 5). In this area, less than 1 cy of bank soil appears to have eroded from the bank. The source of the eroded material appears to be native material from the low-bank area above the existing riverbed armor layer. The cause of erosion appears to be high velocity water flow, likely associated with the extreme flood event discussed above. No evidence of eroded soil was observed in the adjacent portion of the river and, therefore, no removal activities are planned at this location. As discussed during the inspection, armor stone will be placed in this area to replace eroded materials and protect against further such erosion. In this area, armor stone (i.e., $D_{100}=12$ -inch graded riprap) will be keyed into the bank to fill the undercut such that the lower bank above the existing riverbed armor layer will be restored to previous grades.

Area 5 – Area 5 is located on the southern bank adjacent to the Newell Street Area II Parking Lot, and extends from a point approximately 15 feet downstream of the former pedestrian bridge to approximately 500 feet upstream of the bridge (see Figure 1). Within Area 5 there are several intermittent areas of undercut bank, from which soils have been eroded from bank areas above the adjacent existing riverbed armor layer (see Photo 6), and steep, near-vertical slopes are present that potentially could further erode or fail (Photo 7). The observed erosion is likely a result of the high velocity flow associated with the extreme flood event discussed above, but may also be related, to some extent, to settling of the riprap in this area. The sources of eroded materials in this area appear to be native materials or clean backfill, as portions of Area 5 proposed for removal intersect areas that have been previously remediated. No evidence of eroded soil was observed in the adjacent portion of the river and, therefore, no removal activities are planned at this location. During the inspection, it was discussed that this area would likely require excavation of the remaining steep slopes to tie into post-construction Newell Street Area II grades, as well as armor stone placement (tied into the existing riverbed armor layer at the toe of the slope) to restore this area to grade and reduce the potential for further erosion. Any such armor stone will be installed in this area such that it is to provide a continuous line of protection against further erosion.

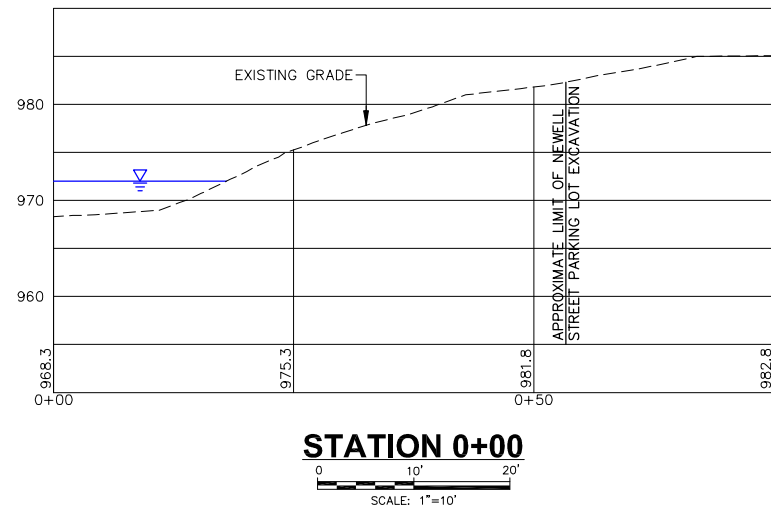
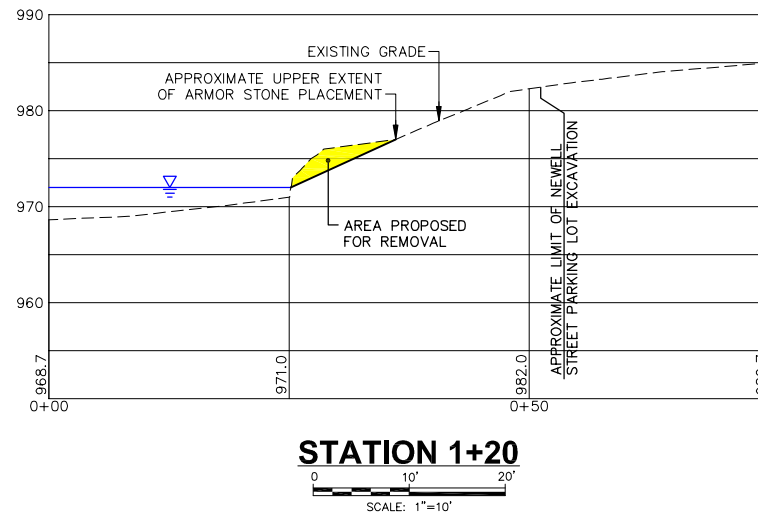
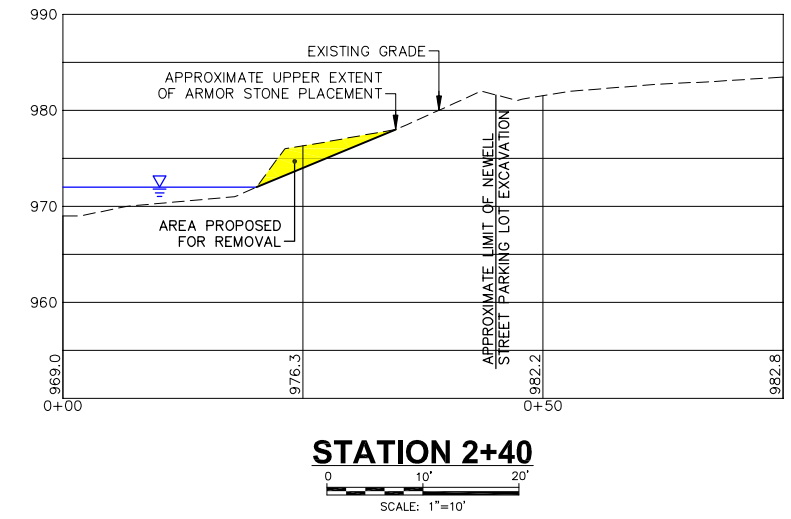
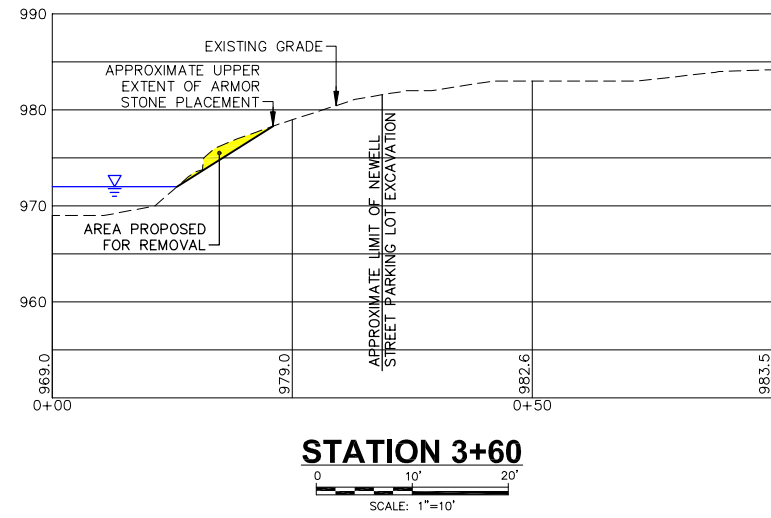
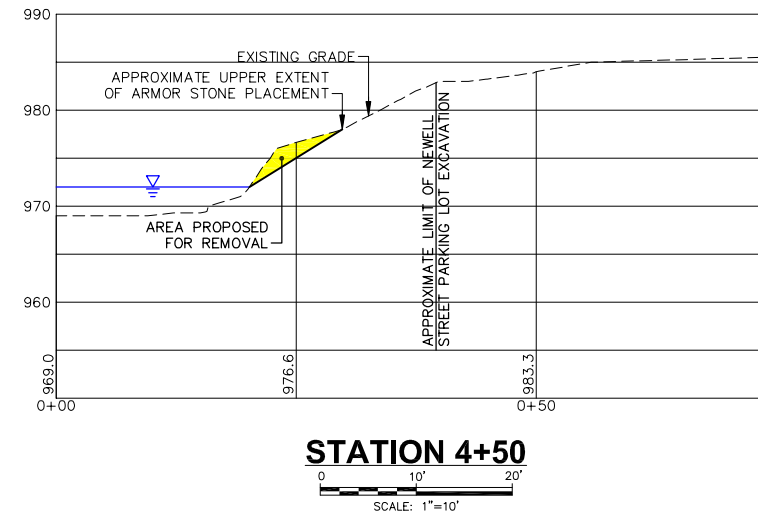
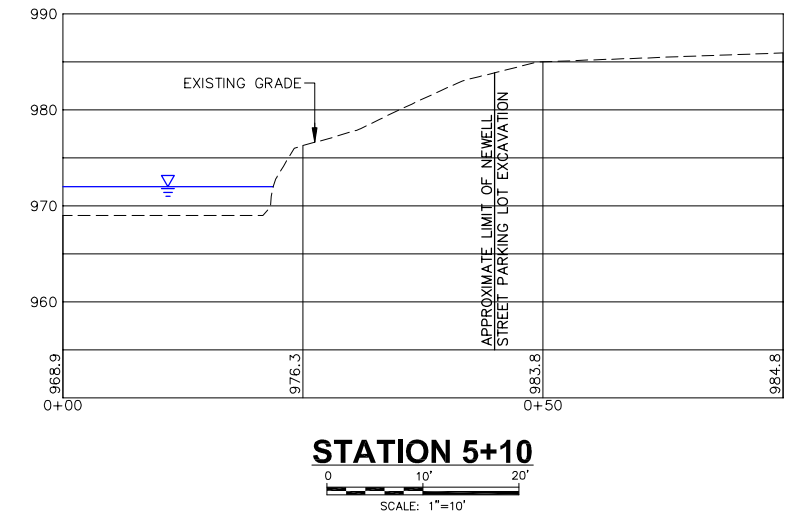
of bank materials would be performed to reduce the slope in those areas where undercutting has left near-vertical banks. Figure 2 shows the locations of six representative cross sections drawn through Area 5, as well as the extent of Area 5 where GE proposes to remove bank materials. In addition, Figure 2 shows those areas that have previously been remediated, and the concentrations of polychlorinated biphenyls (PCBs) in remaining bank soils. Figure 3 shows the six cross sections of the Area 5 bank, and provides an illustration of those portions of bank materials that GE proposes to remove.

As shown on Figures 2 and 3, removal is proposed to be conducted between Station 1+20 and Station 4+50, and is anticipated to proceed up the bank such that approximate 2:1 (horizontal to vertical) bank slopes will extend from the upper extent of the removal area to the edge of armoring around the perimeter of the engineered barrier placed over the Newell Street Area II Parking Lot. Total removal of in-situ bank material in this area is estimated to be approximately 220 cy. Removal is anticipated to be performed with conventional equipment from the top-of-bank (with appropriate safeguards to protect the engineered barrier in that area).

ARMOR STONE IS ANTICIPATED TO BE INSTALLED AND KEYED INTO BANK MATERIALS TO RESTORE ERODED AREAS TO PRE-EROSION GRADES SUCH THAT NO CHANGE IN EXISTING FLOOD STORAGE OR CONVEYANCE CAPACITY IS ANTICIPATED.
