**SECOND FIVE-YEAR REVIEW REPORT**

**DUTCHTOWN TREATMENT PLANT SUPERFUND SITE  
DUTCHTOWN, ASCENSION PARISH, LOUISIANA**

**SEPTEMBER 2007**

**United States Environmental Protection Agency  
Region 6  
Dallas, Texas**

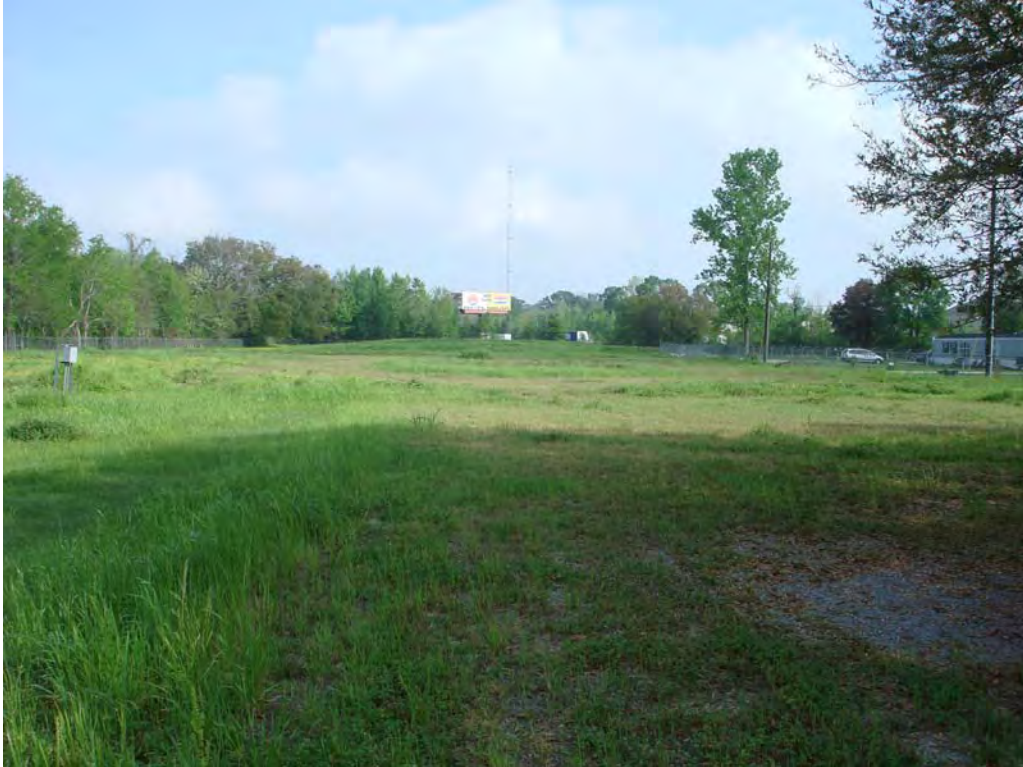
Photograph No. 2 Site: Dutchtown Treatment Plant Superfund Site  
Description: View north of the western portion of the site Date: March 29, 2007

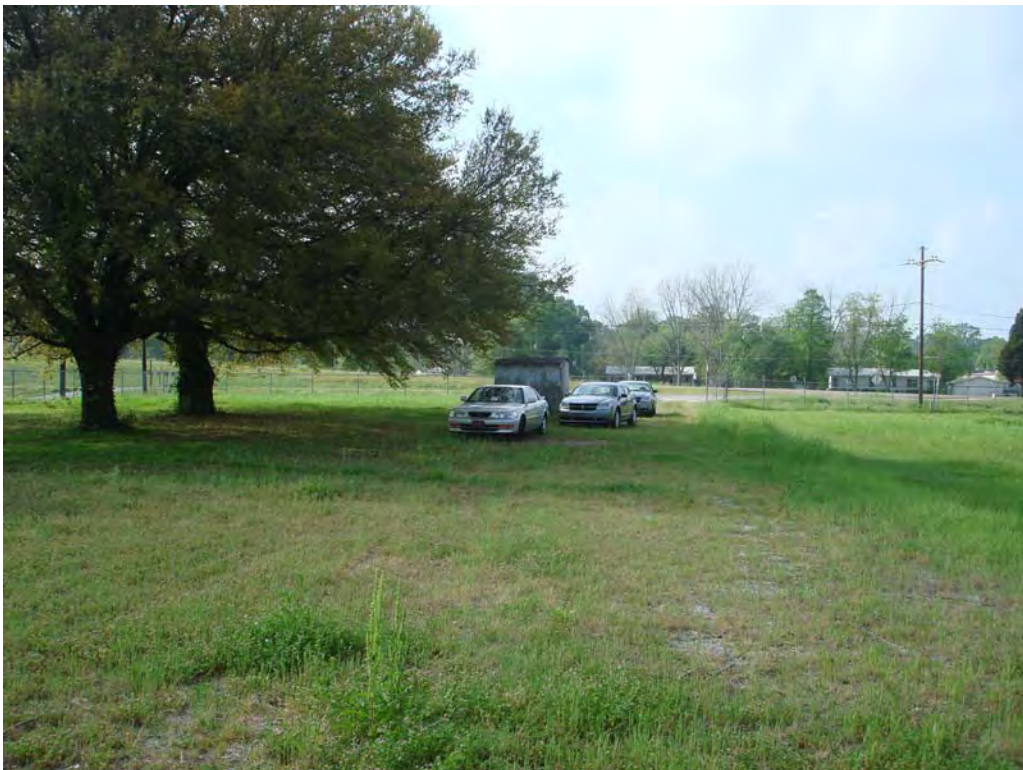
Photograph No. 3 Site: Dutchtown Treatment Plant Superfund Site  
Description: View north of the eastern portion of the site Date: March 29, 2007
