FIVE-YEAR REVIEW

**Jacksonville Municipal Landfill Superfund Site
EPA ID# ARD980809941
Lonoke County, Arkansas**

FIRST FIVE-YEAR REVIEW REPORT
for
Jacksonville Municipal Landfill Superfund Site
Lonoke County, Arkansas
EPA ID# ARD980809941

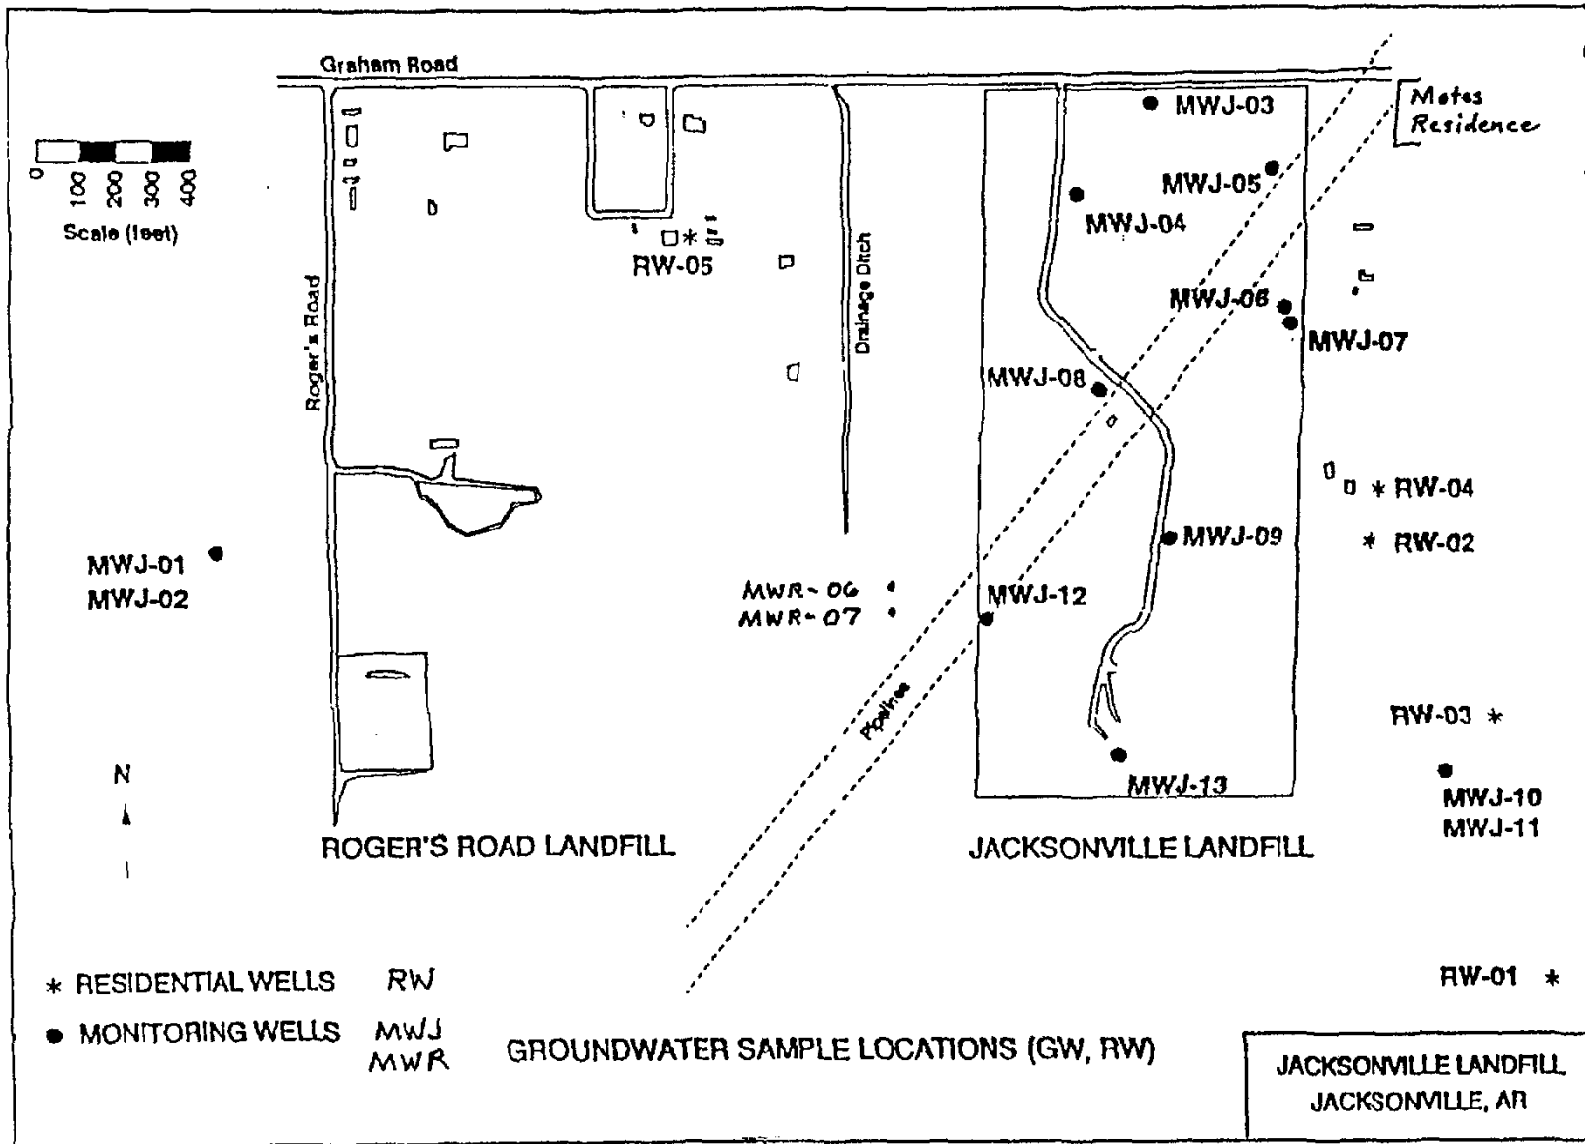
Figure 1: Site Map and Monitoring Well Network
 Rogers Road and Jacksonville Municipal Landfills

The only community concern regarding the site since prior to the initiation of the remedial action in 1994 was one complaint by a nearby resident that water was draining from the site to his property. This was not a result of the actions taken at the site; however, the City of Jacksonville responded to the complaint by dredging the drainage ditch. There is a gas pipeline owned by Teppco that runs diagonally across the site (Figure 1) that is maintained by the gas company.

Monitor wells MWJ-07, MWJ-08, MWJ-10, MWJ-11, MWJ-13 and an unused residential well were located during the site inspection and photographed (Photos 6, 7, 10, 16, 17, 18, and 19; see also Figure1). Surface completions appeared to be in good condition with the exception of MWJ-10, where a cracked pad was noted (Photo 17, Attachment 4). Not all wells were located during the site inspection due to the presence of dense vegetation, including poison oak and ivy, and the abundance of ticks observed in the area. The wells are visited by city personnel during the periodic inspections several times per year.
