FIVE-YEAR REVIEW

Rogers Road Municipal Landfill Superfund Site

Pulaski County, Arkansas

FIRST FIVE-YEAR REVIEW REPORT
for
Rogers Road Municipal Landfill Superfund Site
Pulaski County, Arkansas
EPA ID#ARD981055809

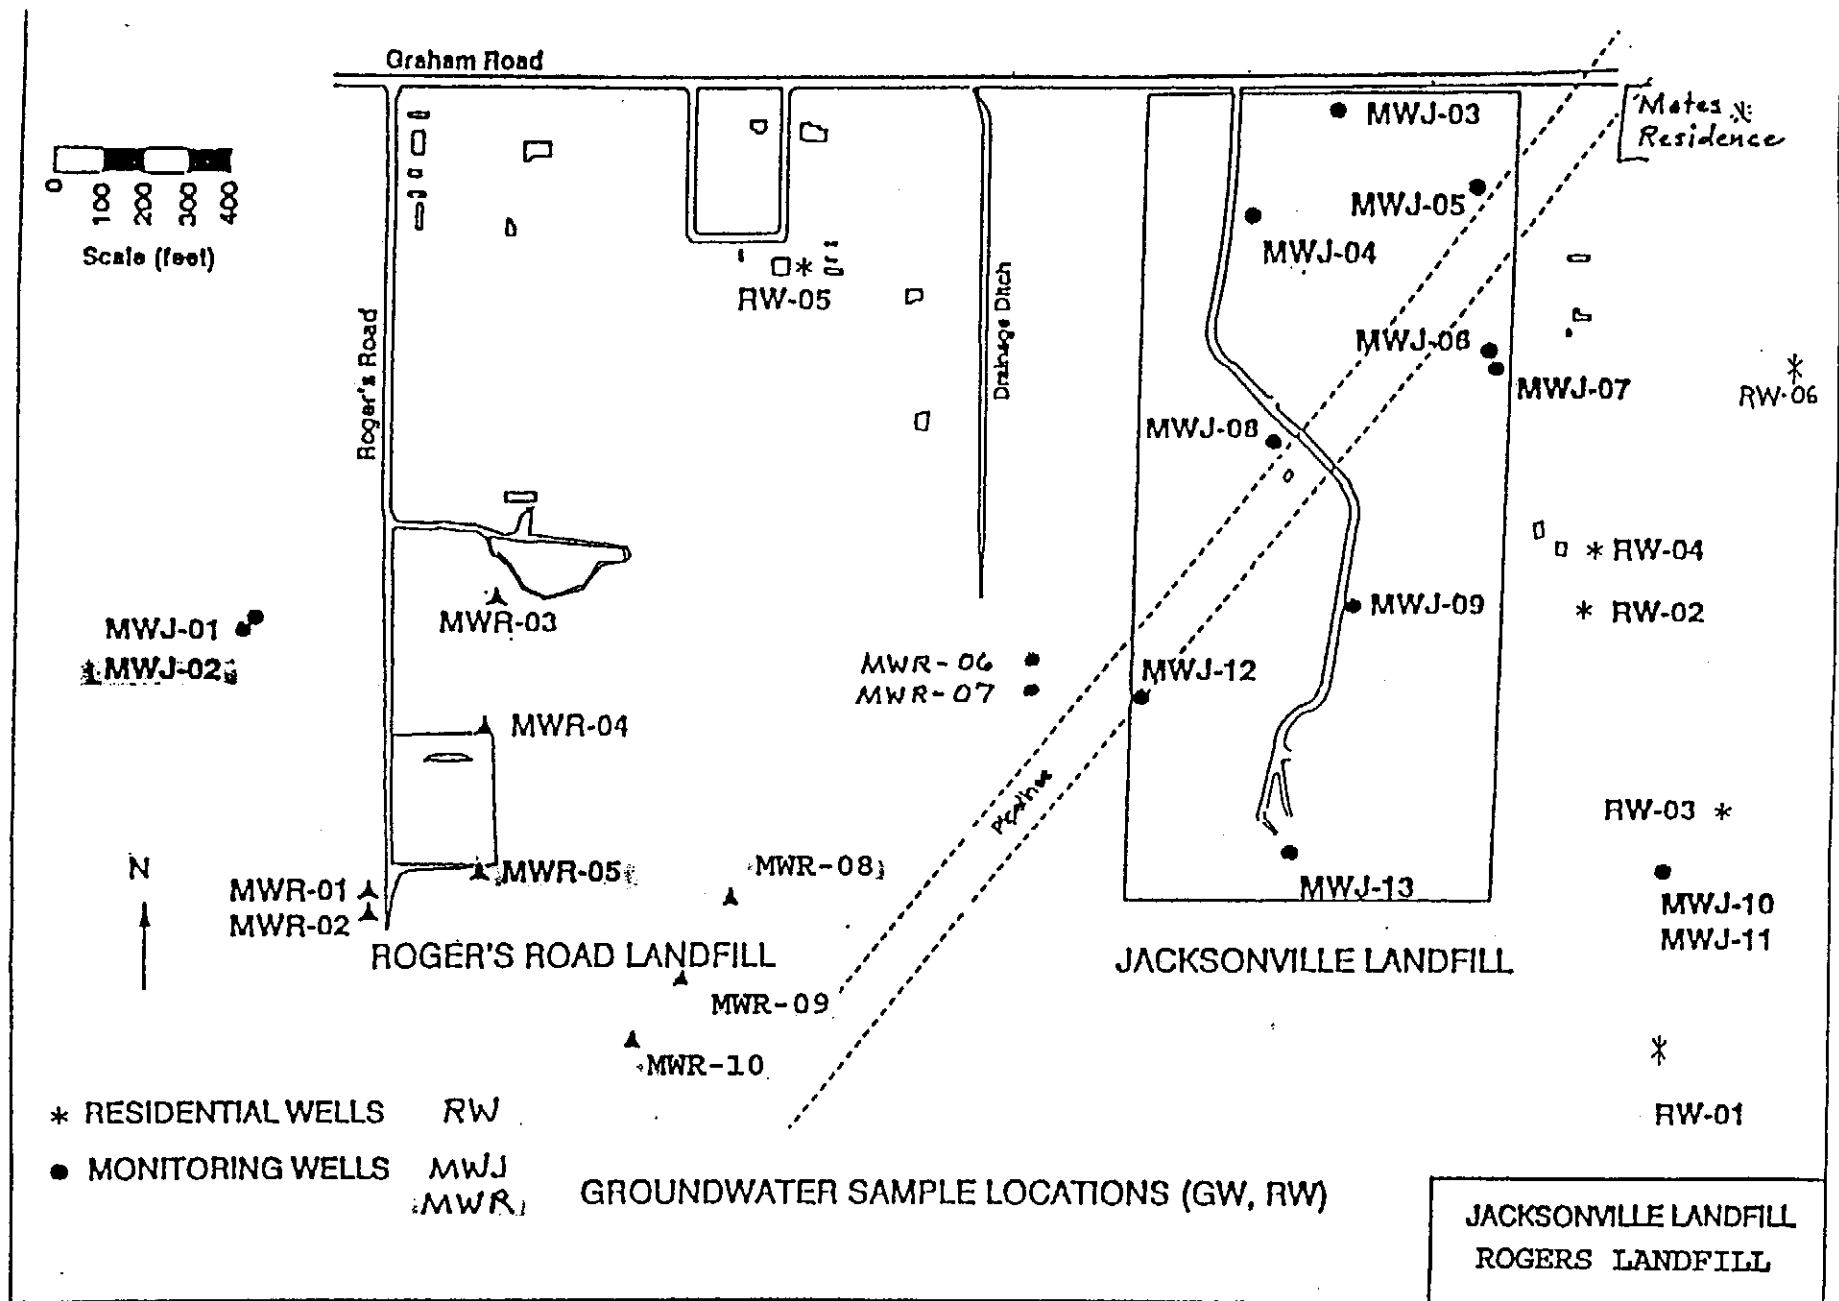
Figure 1: Site Map and Monitoring Well Network
 Rogers Road and Jacksonville Municipal Landfills

However, the site is situated in a natural low area, and standing water in the area surrounding Rogers Road Landfill has been noted by the City of Jacksonville staff following rain events. Monitor wells MWR-01 and MWR-02 were located and photographed (Photo 8, Attachment 4; locations noted on Figure 1). Surface completions appeared to be in good condition. Not all wells were located during the site inspection due to the presence of dense vegetation, including poison oak and ivy, and the abundance of ticks observed in the area. The wells are visited by City personnel during the periodic inspections several times per year.

Groundwater monitoring at the site was conducted concurrently with the groundwater monitoring of the Jacksonville Municipal Landfill Superfund Site between 1994 and 1997. Five wells were sampled annually (MWR-01, MWR-05, MWR-08, MWR-09, and MWR-10 - see Figure 1) and submitted for analysis for dioxins, metals, volatiles, semivolatiles, and pesticides. None of the compounds of concern listed in the ROD (Equivalents of 2,3,7,8-TCDD, chlorophenols, herbicides, and pesticides) were observed during the four sampling events (ADEQ, 1999).

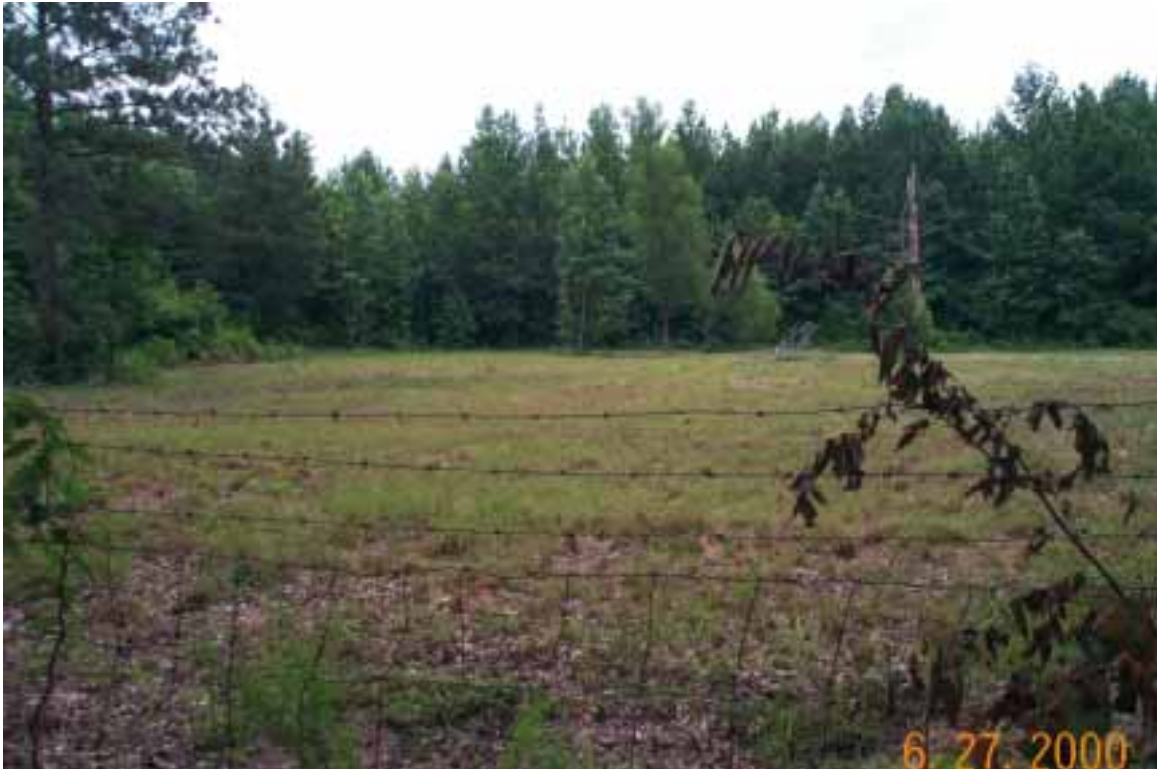
Photograph 2.

The area around the site along Rogers Road is densely wooded (Photo 1, Attachment 4). The fencing around the site appeared intact and secure, although no signs were posted on the fence or the gate (Photos 2 -5, Attachment 4). No vandalism was evident, and the roads were adequate

(Photos 1 and 9, Attachment 4). Unauthorized dumping reportedly took place prior to the remedial action, and debris was noted outside the perimeter of the site. The soil cover appeared to be in good condition; no settlement, cracks, or erosion was evident (Photos 2-4, and 6, Attachment 4). The site was dry on the day of the site inspection and appeared well-graded. The presence of poison oak, poison ivy, and numerous ticks were observed.

Facing east-northeast from outside perimeter fence just north of main access gate. View is of north end of excavated/covered area of site.

Perimeter fence visible in foreground.

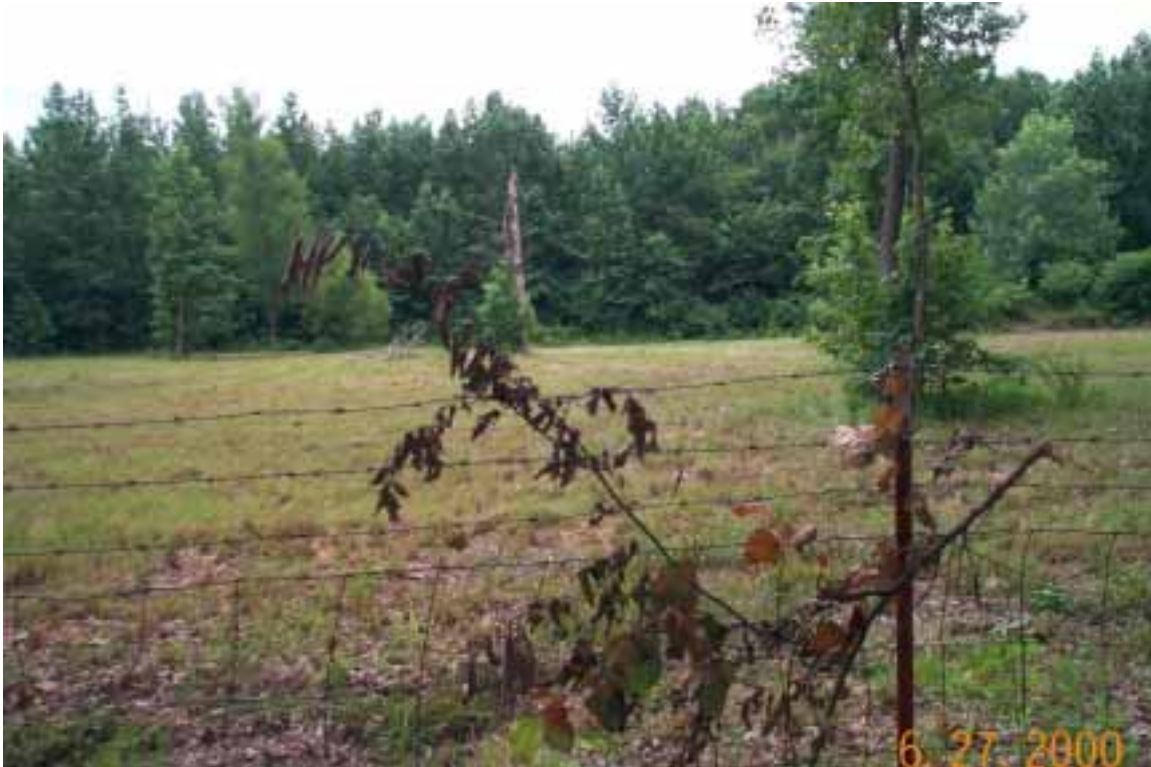
Photograph 3.

Facing east, from outside perimeter fence, on Rogers Road just north of main access gate.

Perimeter fence visible in foreground.

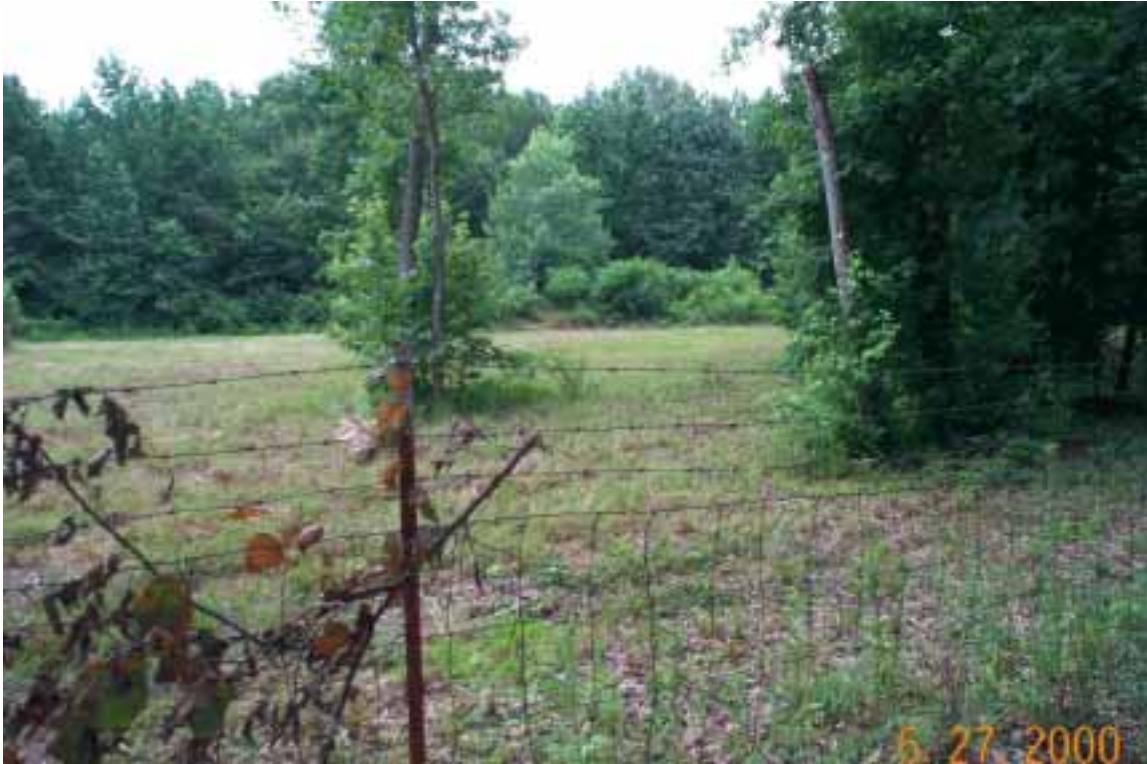
Photograph 4.

Facing east-southeast, from outside perimeter fence, on Rogers Road just north of main access gate.

Perimeter fence visible in foreground.

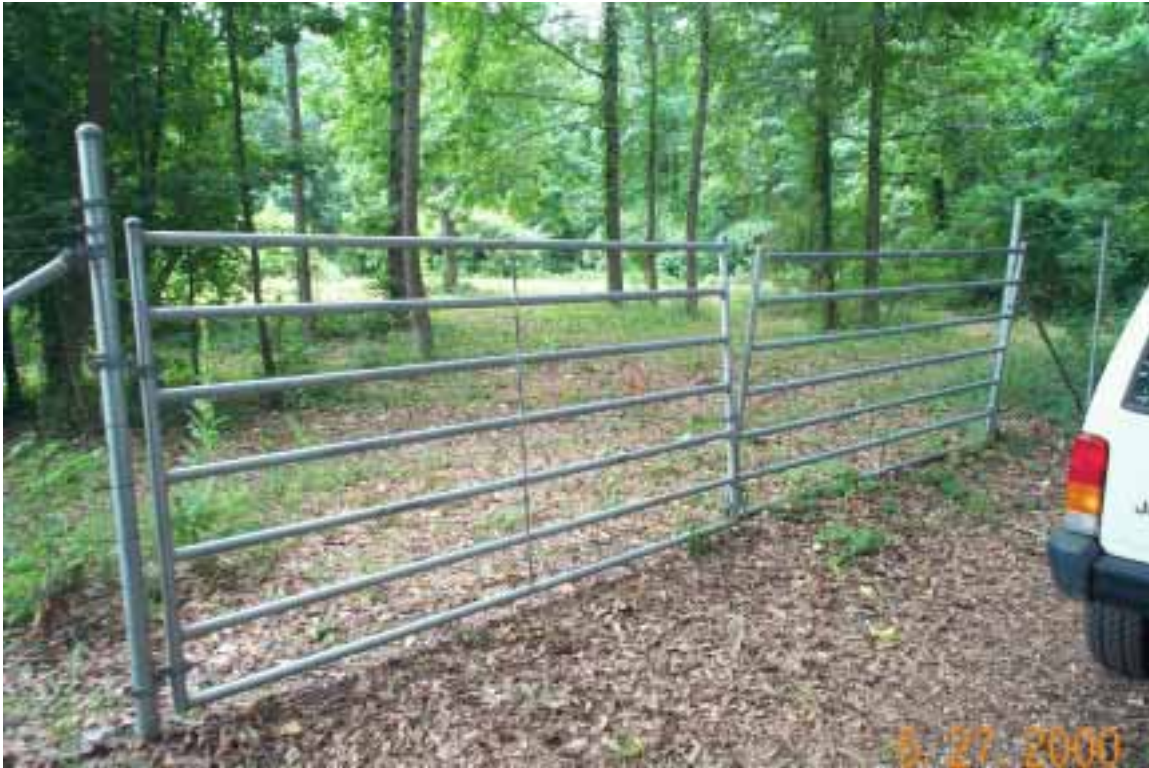
Photograph 5.

Facing east-southeast into site through main access gate, from Rogers Road.

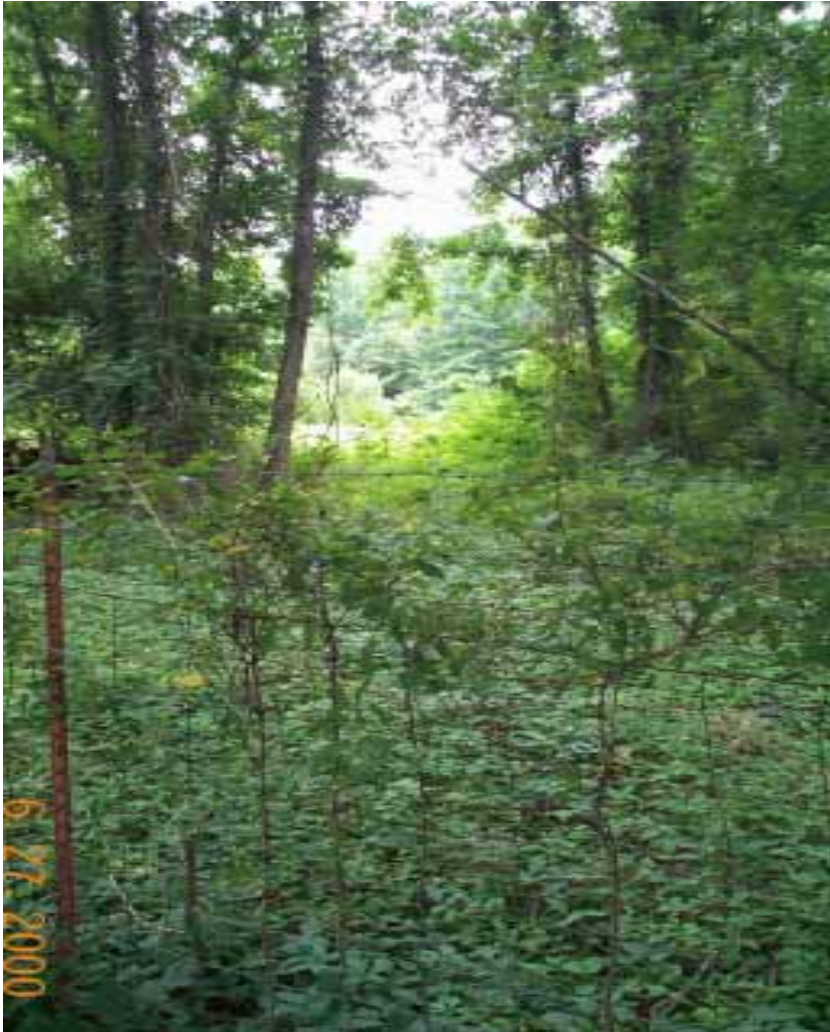
Photograph 7.

Facing northeast, from just north of southwest corner of perimeter fence. Clearing in background is the excavated/covered area of the landfill.
