**Five-Year Review
South Cavalcade Street Superfund Site
Houston, Harris County, Texas**

September 2007

**FIVE_YEAR REVIEW
South Cavalcade Street Site
EPA ID# TXD980810386
Houston, Harris County, Texas**

**Second Five-Year Review Report for
South Cavalcade Street Superfund Site
Houston
Harris County, Texas**

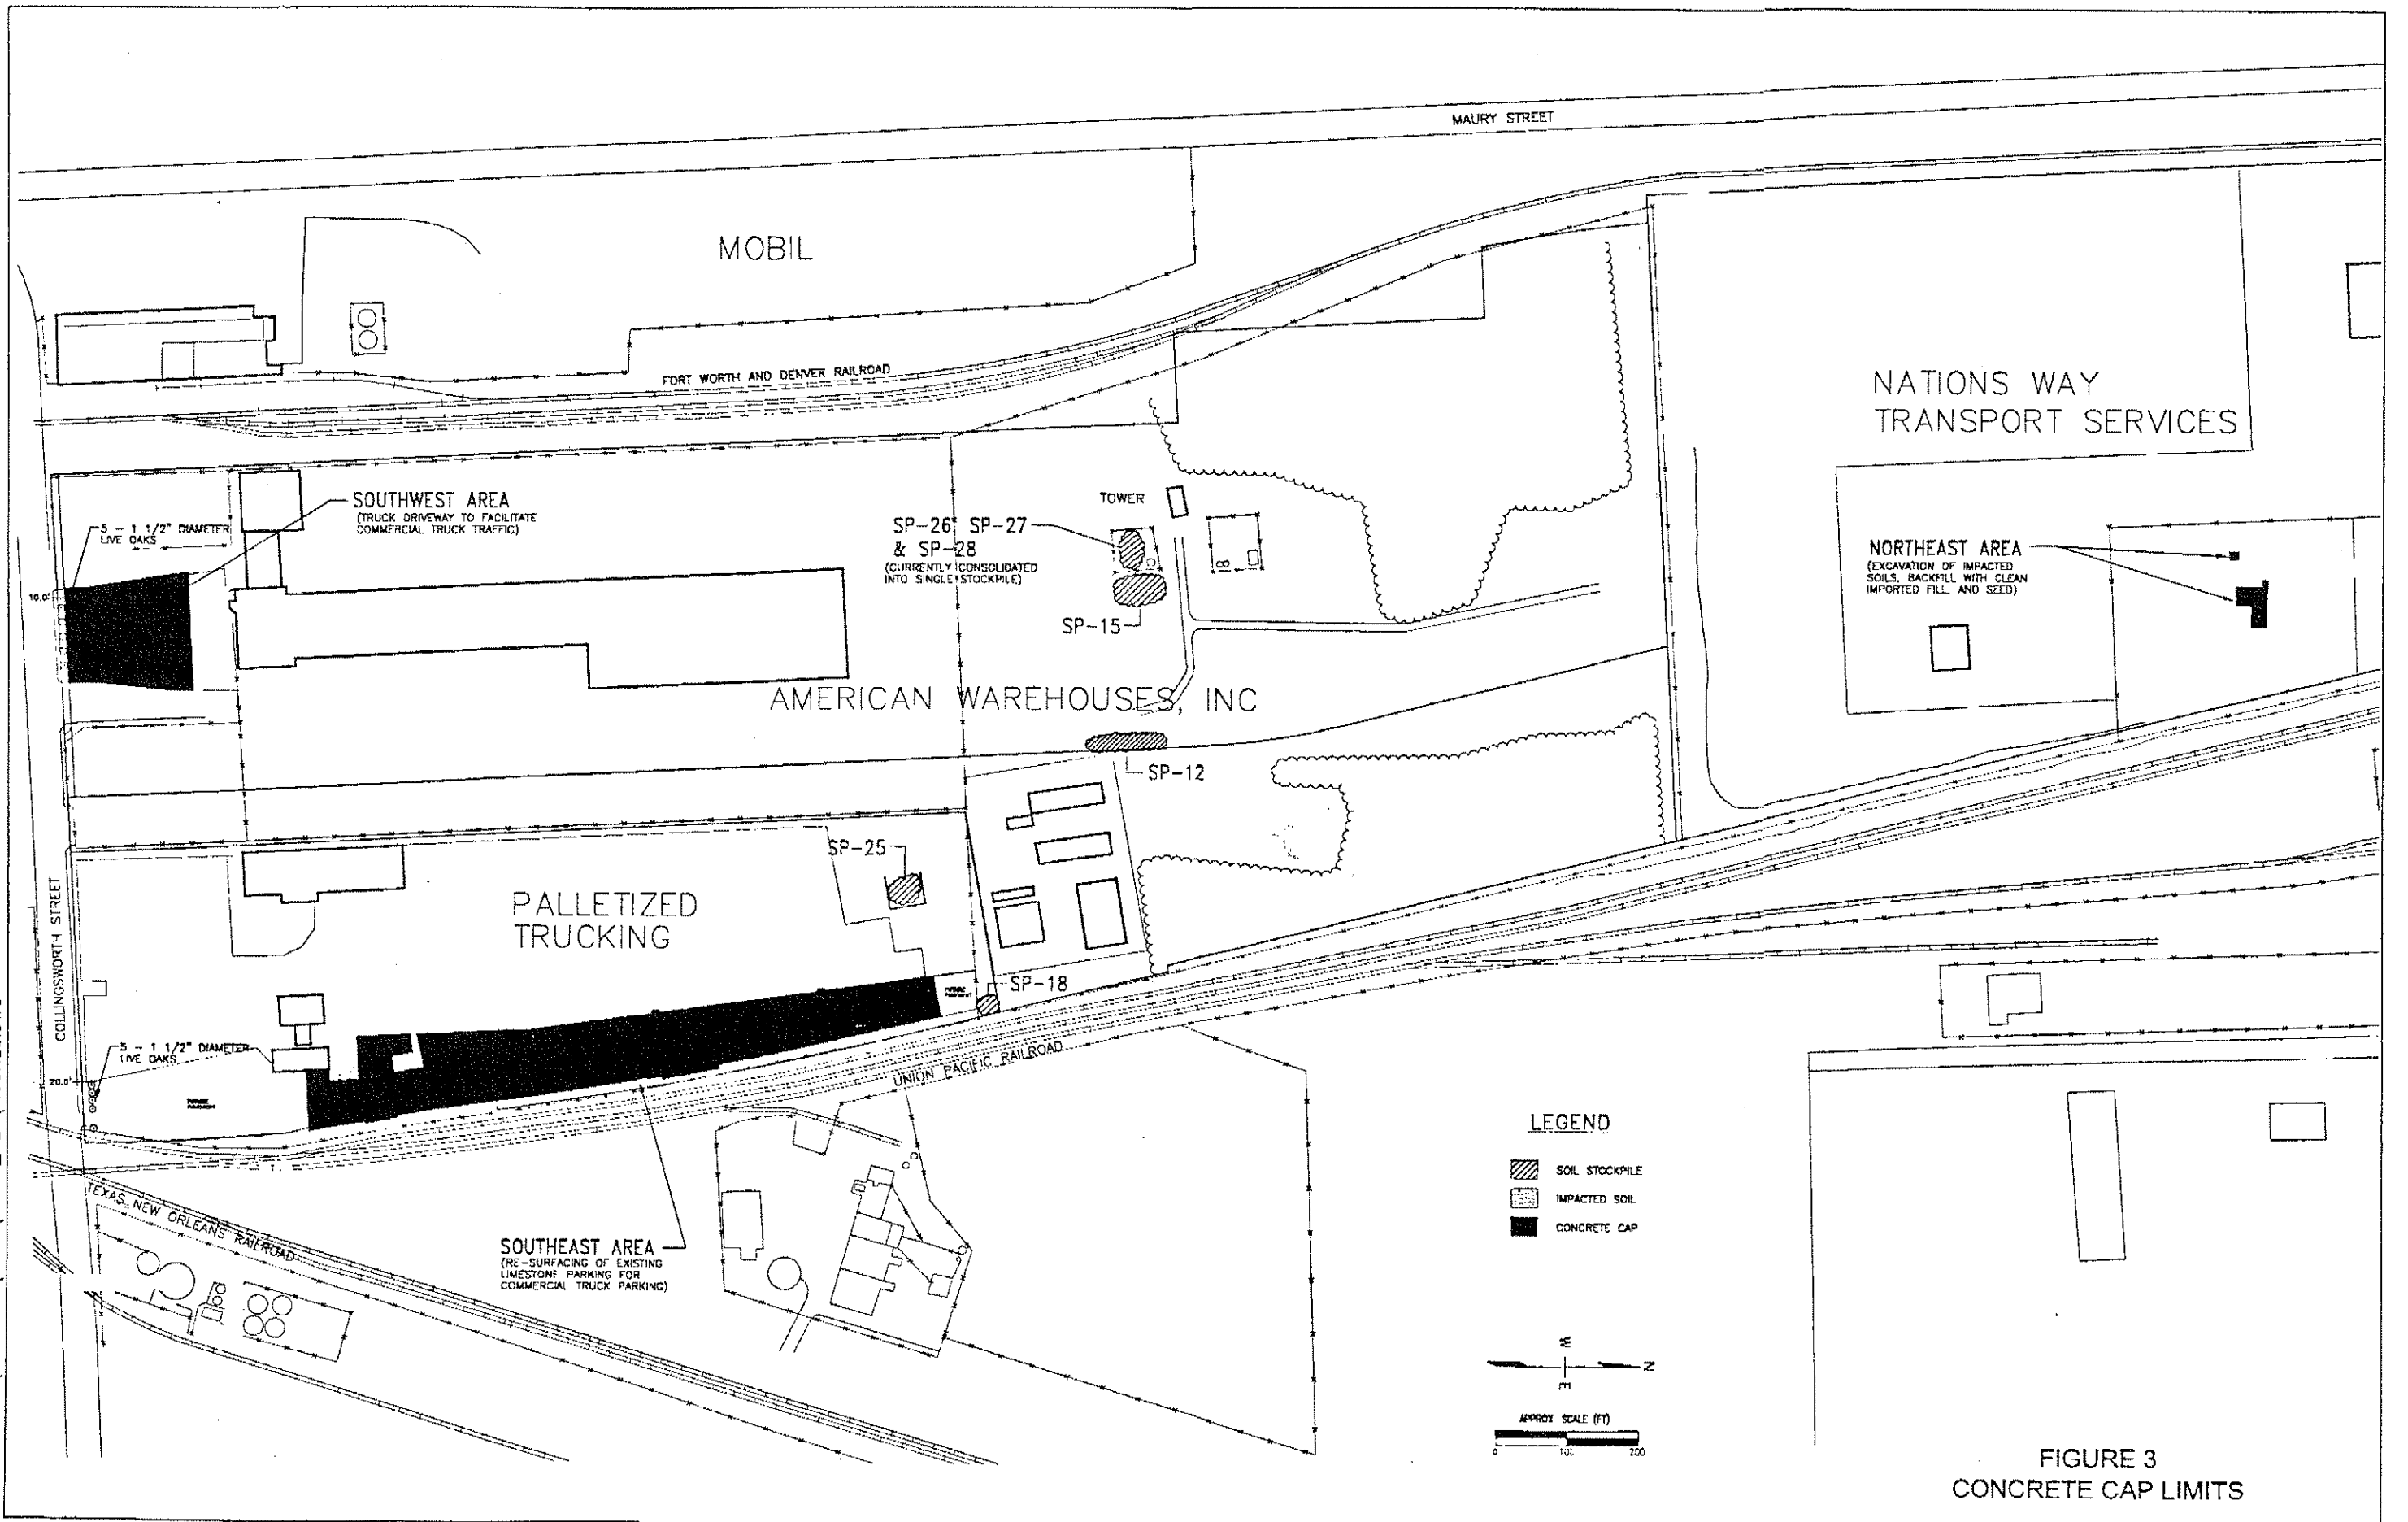
FIGURE 3
CONCRETE CAP LIMITS

The soil remedial action concrete cap system was to cover impacted as well as non-impacted areas in the Southeast and the Southwest areas, therein providing usable parking and driveway systems for the current property owners. The extent of the concrete cap is shown in Figure 3. The concrete cap is eight inches thick in the Southwest area and 10 inches thick in the Southeast area. Soils in the Northeast area were not capped in place, but were excavated and used, along with existing on-site stockpiled materials, as fill under the concrete cap structures in the Southeast and Southwest areas. The Northeast area was then backfilled with clean imported fill from an off-site source.
