Third Five-Year Review Report

FMC YAKIMA

Superfund Site

SEPTEMBER 2008

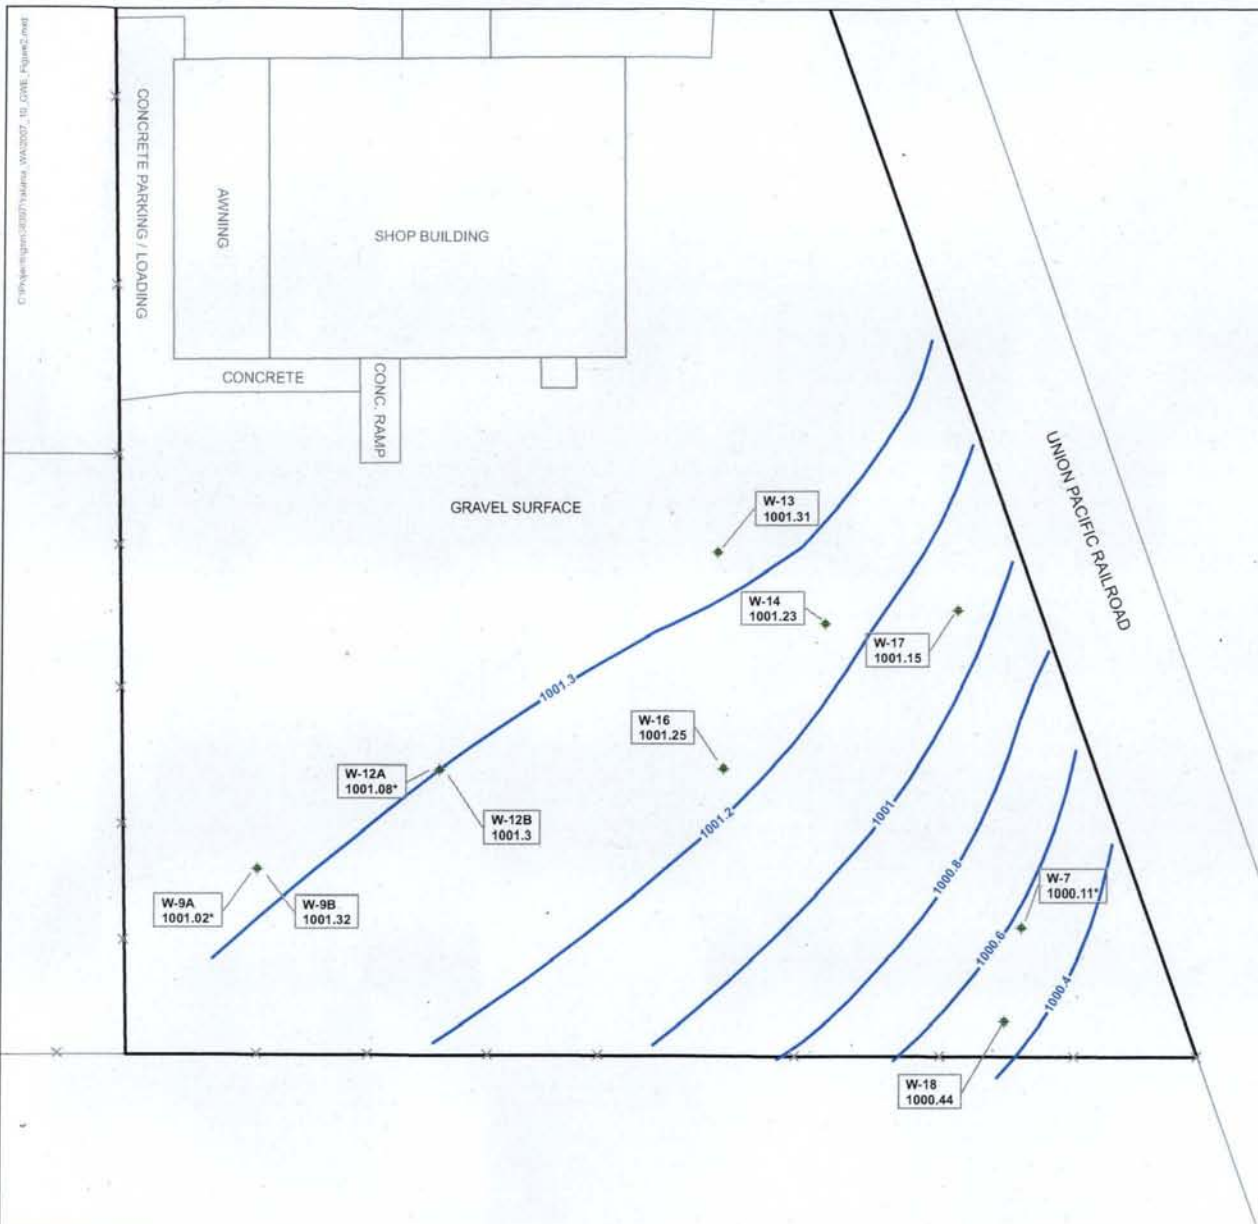
- 210.06 Groundwater Elevation: Feet Above Mean Sea Level
- Groundwater Elevation Contour
- 1001.25 Groundwater Elevation: Feet Above Mean Sea Level
- *Values with asterisks not used in contouring.
W-7, W-9A, & W-12A represent the deeper groundwater zone.
- Monitoring Well
- Property Boundary

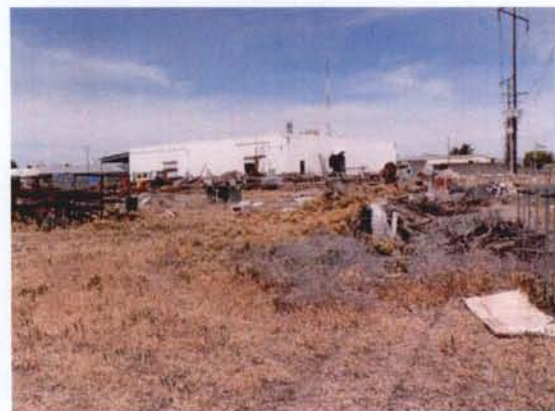
B. Other Site Conditions			
Remarks <u>There is a lot of debris piled here and there, but that is expected for a laydown yard. Flush well heads should be safe and allow use as a laydown yard. Like this year's site visit, future visits should be preceded by a request to make sure there is proper access to all monitoring wells.</u>			
VII. LANDFILL COVERS		Applicable	<u>N/A</u>

Looking north from the southeast corner of the Stephens Metal Products laydown yard
