**Second Five-Year Review Report for
Priority One and Two Sites,
Fairchild Air Force Base, Washington**

Air Force Center for Engineering and the Environment (AFCEE/ICM)
Brooks City-Base, Texas 78235-5328

CH2M HILL
9 South Washington, Suite 400
Spokane, WA 99201

June 2008

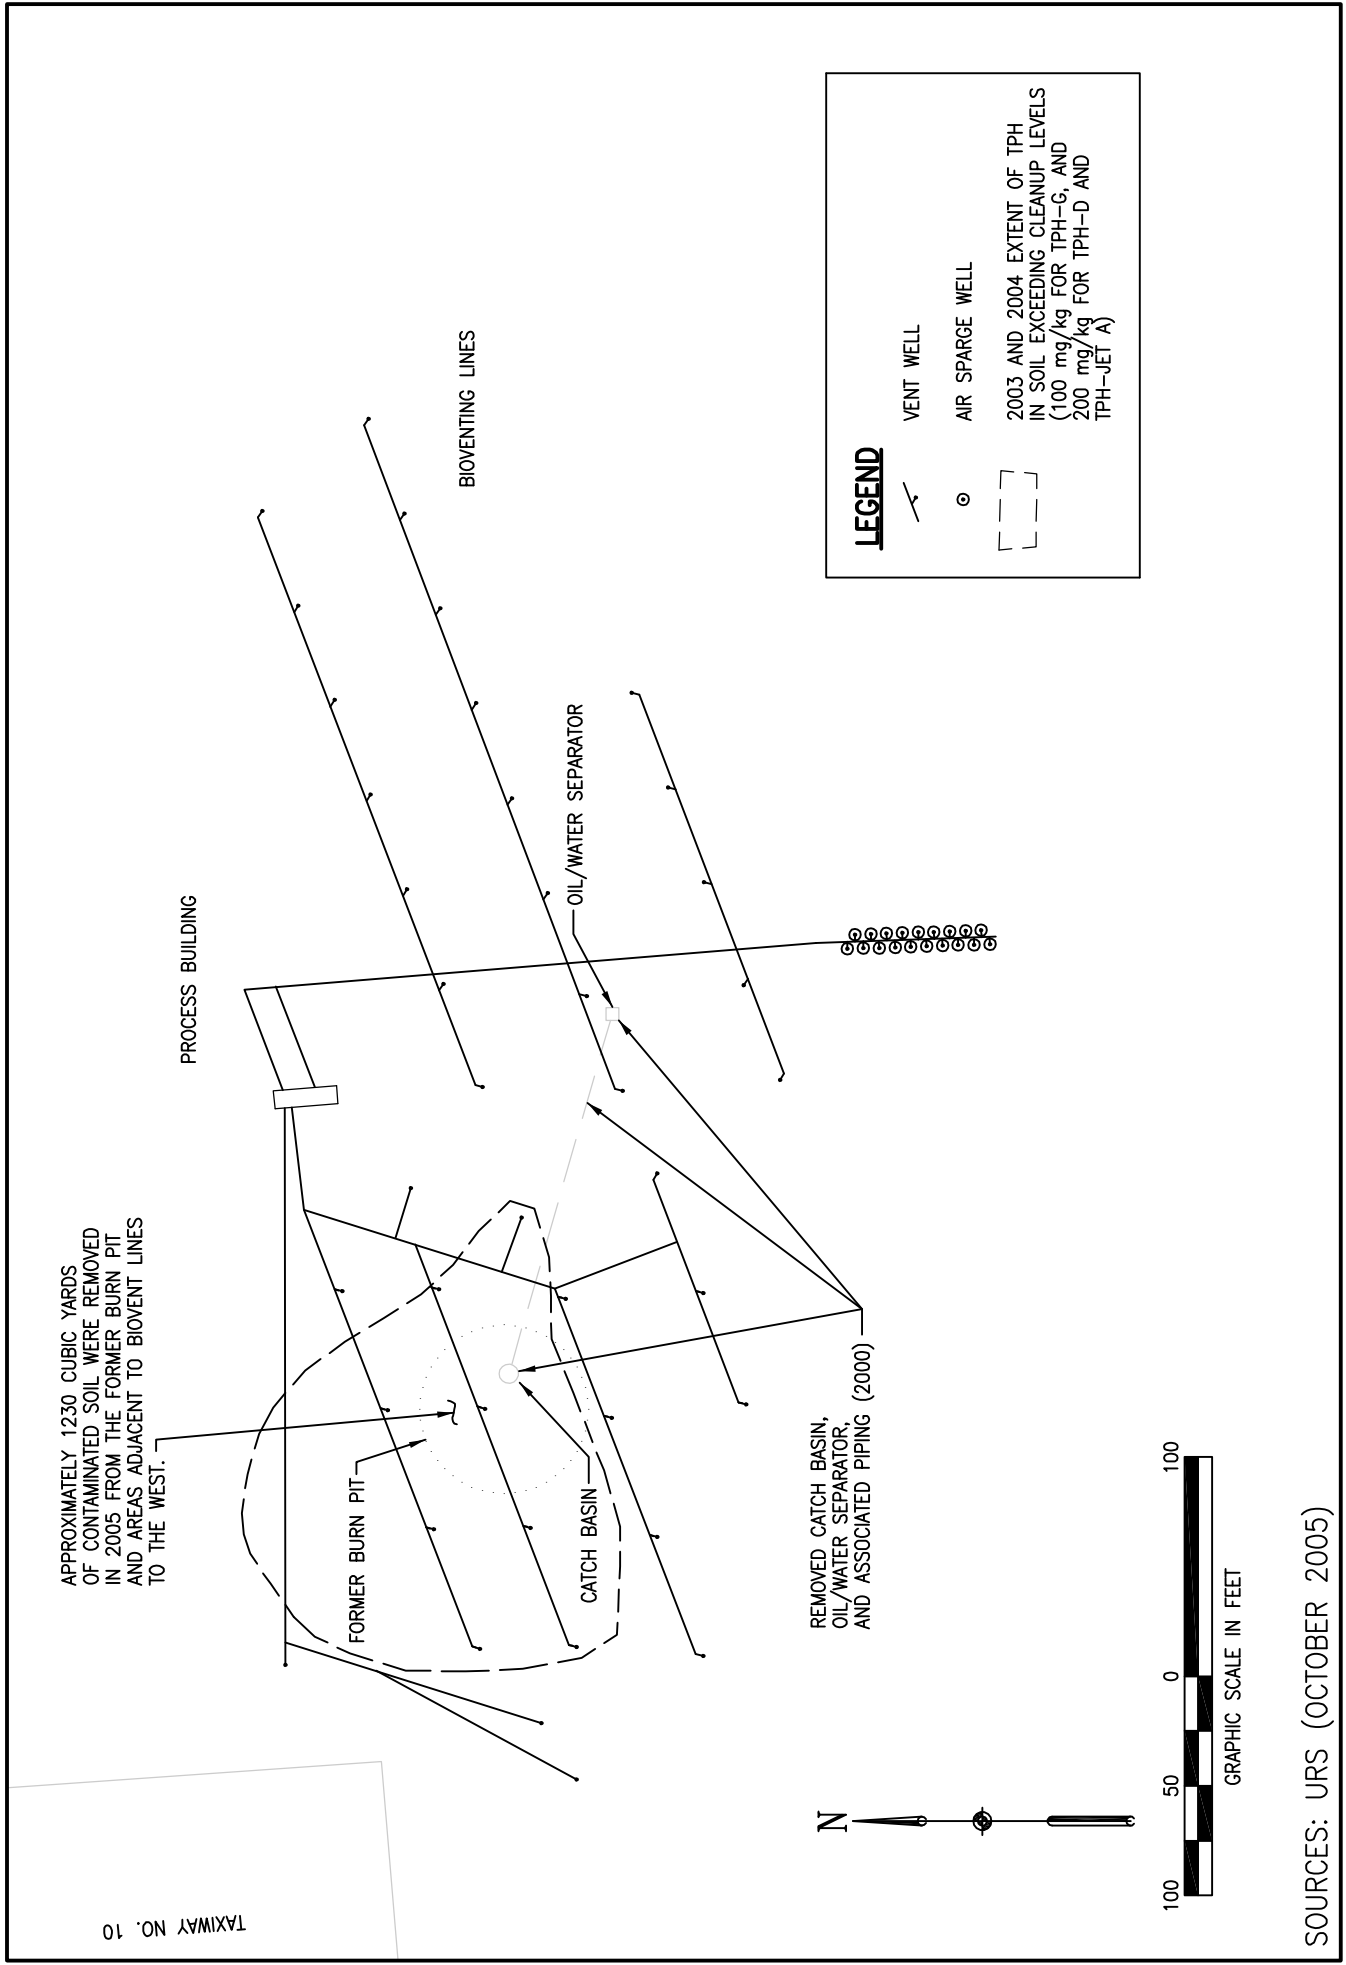
FIGURE 4.4-2: FT-1 SOIL RA-0

Soil monitoring was initiated in 1997 as a part of bioventing systems operation to monitor soil remediation progress. In recent years, annual sampling events have consisted of collecting 25 soil samples from 25 soil borings, at depths ranging from 2 to 4, 4 to 6, or 6 to 8 feet bgs. For the 1999 to 2004 review period, a total of 125 soil samples were submitted for laboratory analyses. Benzene was detected in only six of these samples, five of which were above the cleanup level of 0.5 mg/kg. These cleanup level exceedances ranged in concentration from 0.57 mg/kg to 4.8 mg/kg and were from borings primarily located in the former burn pit area, or north and west of this same area. Benzene was not detected above the cleanup level in any 2004 samples. Toluene and ethylbenzene detections also decreased during the review period. However, xylene, TPH-D, and TPH, gasoline-range organics (TPH-G) detections and concentrations have not shown significant reductions. The highest annual xylene detections during this review period ranged from 57 mg/kg to 2,080 mg/kg. The highest annual TPH-G concentrations ranged from 6,100 mg/kg to 24,000 mg/kg, and the highest annual TPH-D detections ranged from 8,700 mg/kg to 23,000 mg/kg. The soil bioventing system and lateral extent of soils where TPH cleanup levels were exceeded based on 2003 and 2004 data (that is, 100 mg/kg for TPH-G and/or 200 mg/kg for TPH-D or TPH-Jet A) are shown in Figure 4.4-2.

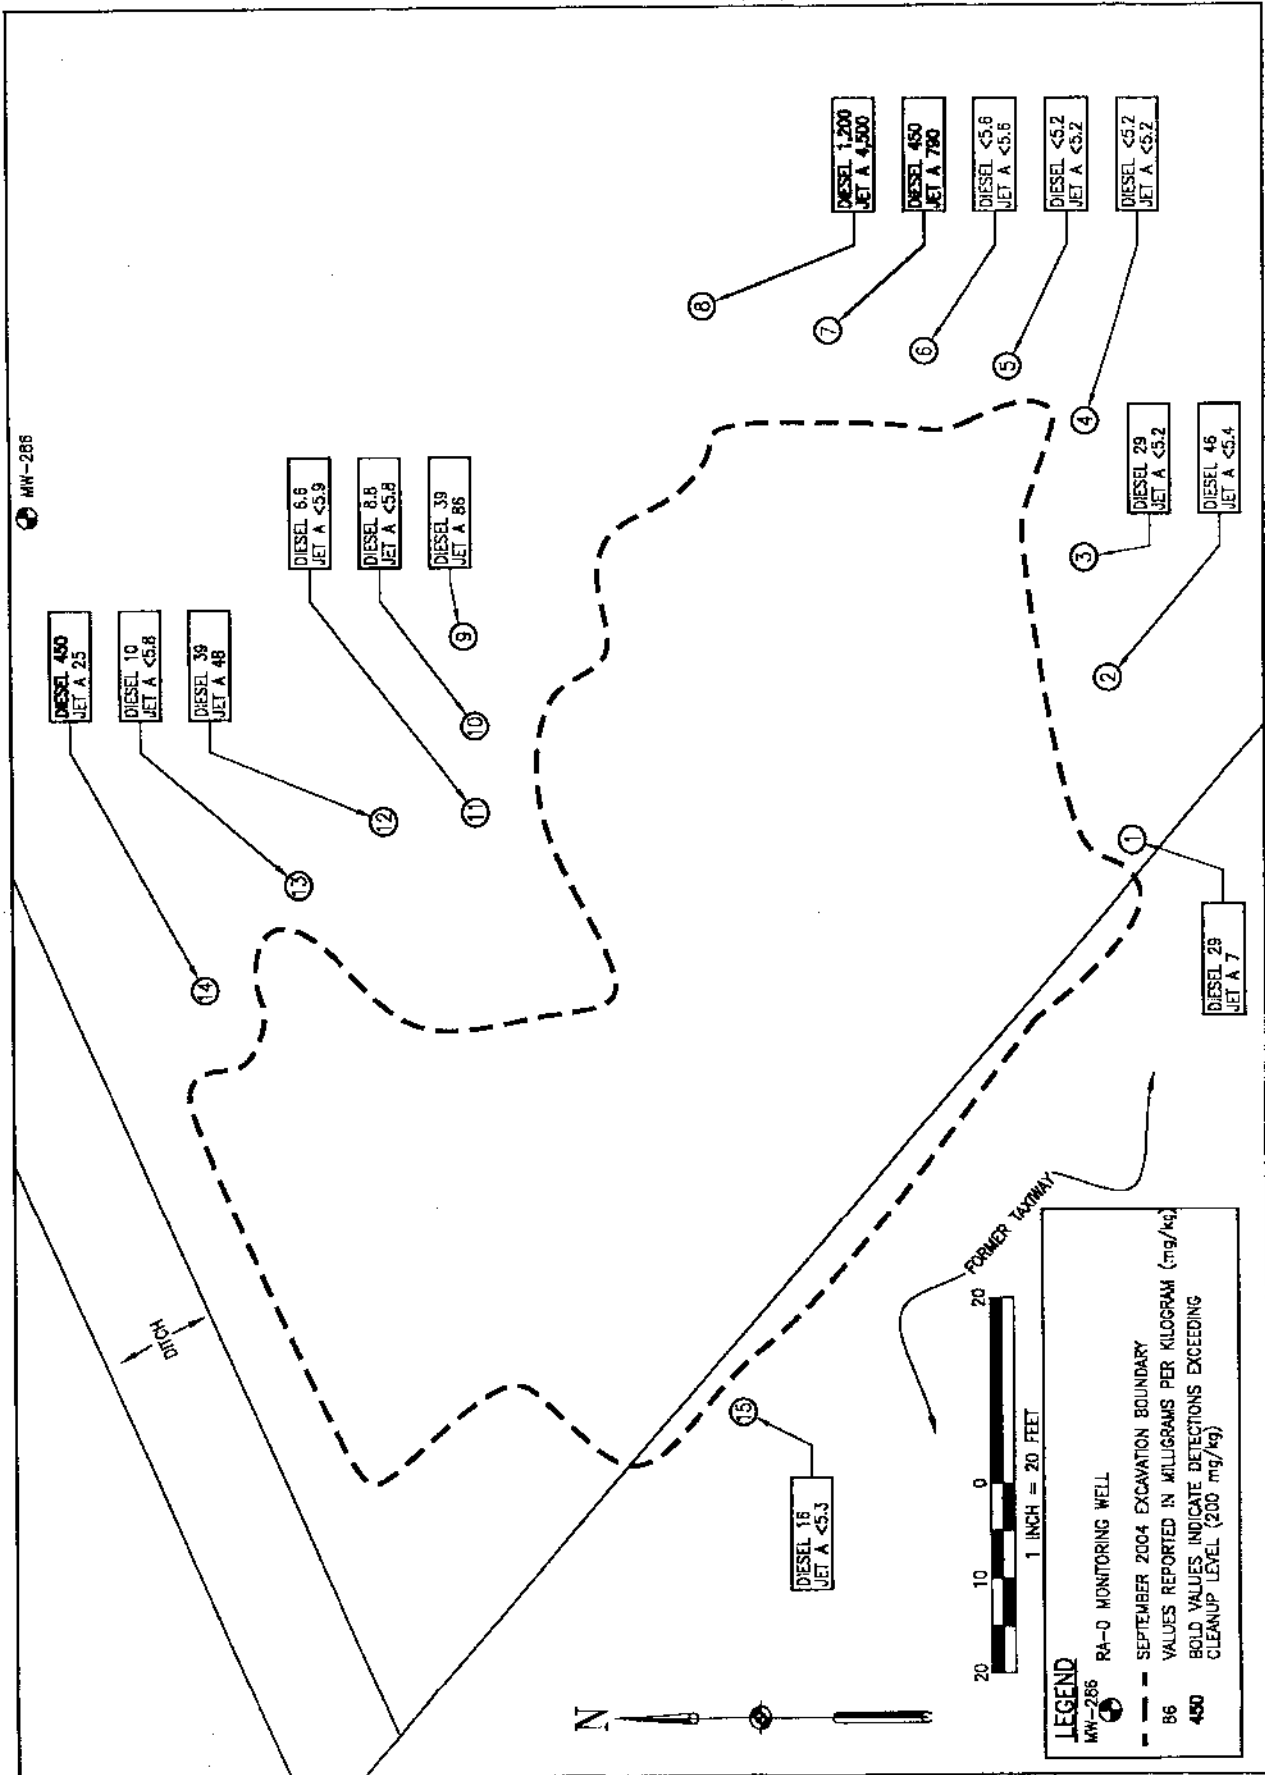
Figure 7-2: Site IS-4 Soil Sample Locations and TPH-D Concentrations - October 2004

Diesel and jet fuel as Jet A were detected above the ROD soil cleanup level in soil samples collected from 3 of the 15 boreholes. Two samples southeast and one sample northeast of the land farm excavation created in September 2004 exceeded the ROD soil cleanup level. Sample locations and analytical results are presented in Figure 7-2 and summarized in Table 7-2.
