U.S. Fire Administration/Technical Report Series

Apartment Complex Fire, 66 Units Destroyed

Seattle, Washington

USFA-TR-059/September 1991

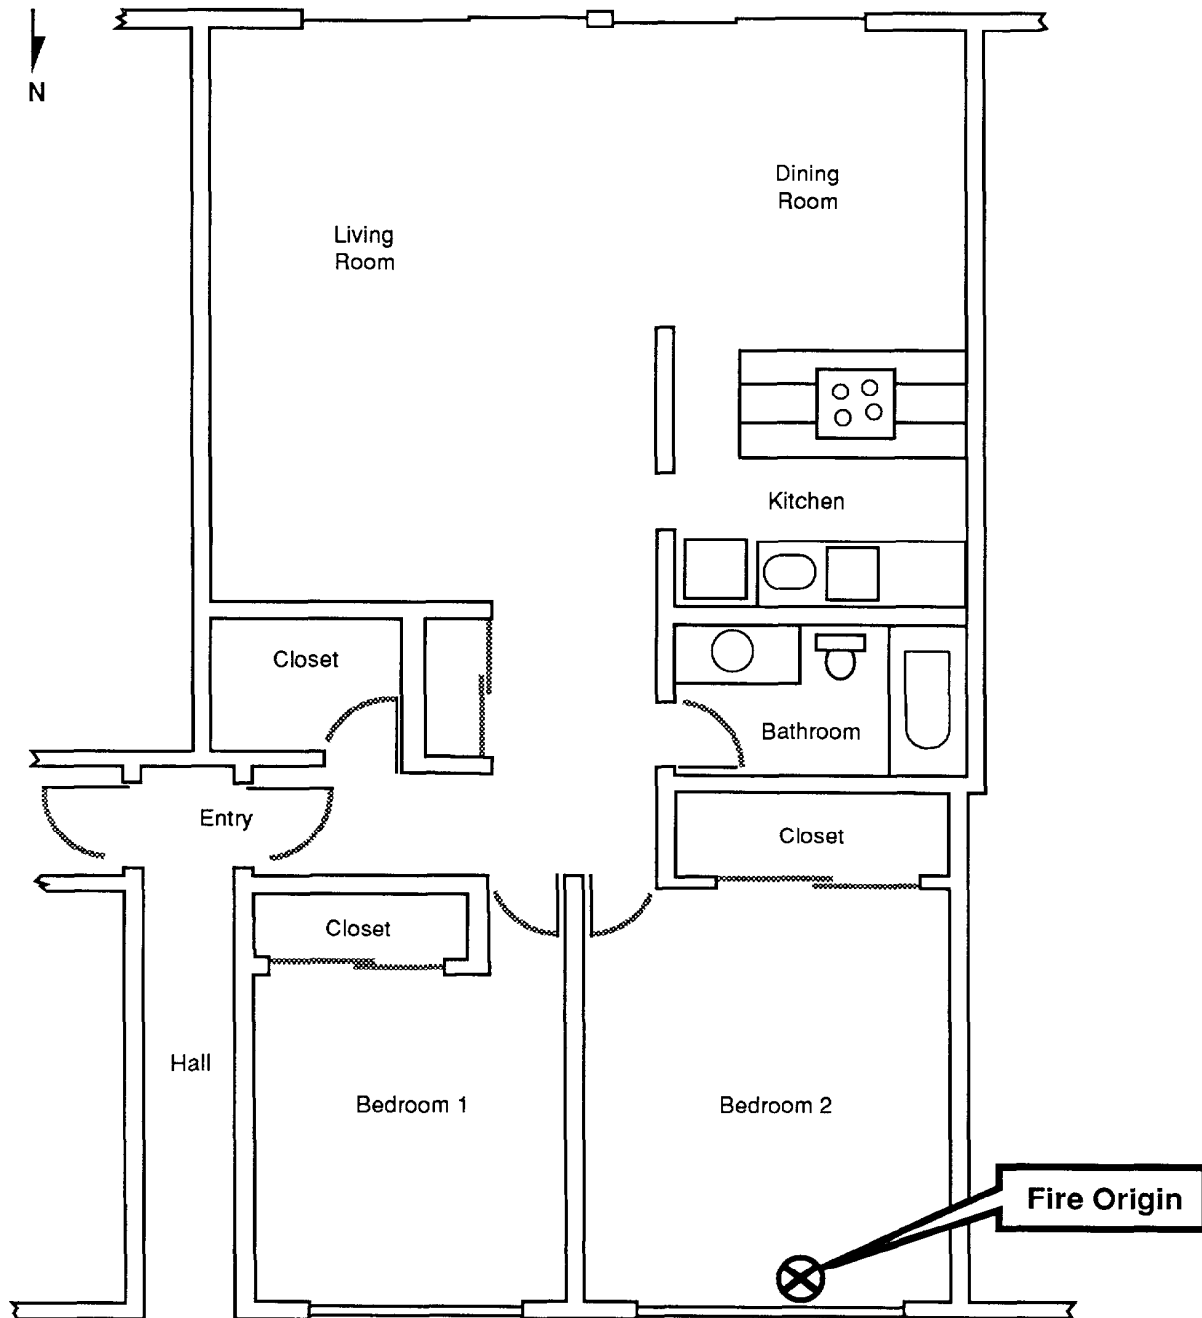
Floor Plan of Apartment of Fire Origin and Building Elevation Drawings

Based on the facts and observations noted in the body of this report, it is the opinion of the investigators that this is an accidental fire. It originated in apartment #115 in the east bedroom. The fire was a result of a tenants attempt to light the room with use of a candle due to disconnected electrical service to the apt. Paper was placed on dwindling candle in an attempt to provide a better light. This flame exceeded it's intended purpose and an attempt was made to blow it out. This attempt resulted in blowing burning paper debris onto the floor and behind the dresser igniting available combustible items.
