Oregon State Hospital

Framework Master Plan Phase I Report

KMD Architects

May 16, 2005

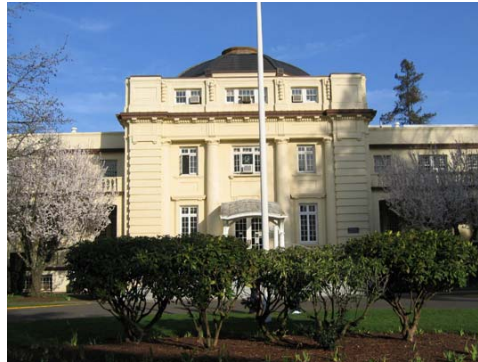
Dome Building (Building 36)

- The two buildings have been placed on the list of local historic buildings for their architectural, human and environmental significance, per Section 120A.040 of the Salem Revised Code (SRC).
- Any remodel to or change to the buildings' exterior facade must be approved by the Salem Historic Commission and by the Salem Department of Development (Planning Bureau).
- Demolition of the structures is possible only after complying with SRC Section 120A.050. This section requires verification that the building cannot be reasonably repaired or restored, that there is no viable beneficial use of the building, and that there is no serious interest by outside parties in relocating the building.

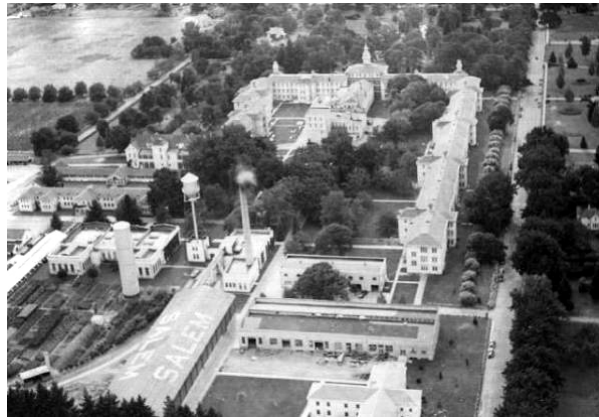
An aerial photograph of the south of center buildings taken in August 1940 shows several major structures located directly south of the "J" Complex buildings. These buildings are no longer present but there are existing signs of their previous existence. Any development in this area would require investigation of the site. As an historic reconnaissance of the facility is recommended to determine the historic issues pertaining to the buildings, an archaeological investigation of the site also is recommended prior to any redevelopment in the area.

1940 Photo of Oregon State Hospital
Ben Maxwell Collection
Salem (Oregon) Public Library
