U.S.S. IOWA
EXPLOSION

Sandia National
Laboratories' Final
Technical Report

**SANDIA NATIONAL LABORATORIES
REVIEW OF THE USS IOWA INCIDENT**

AUGUST 1991

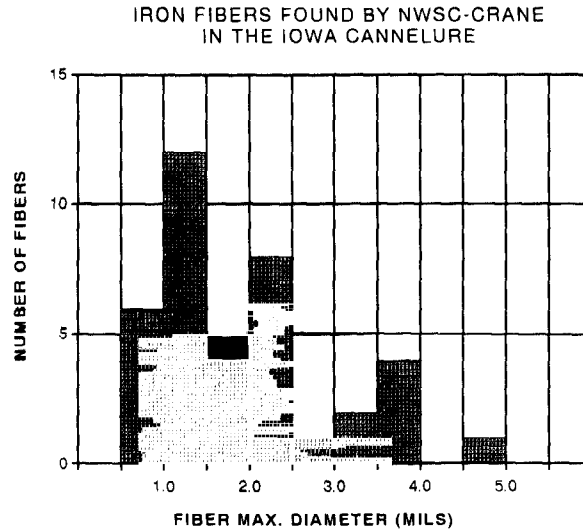
compared to the distribution of fiber sizes found in the IG-1 cannellure (Figure 3a). Within experimental uncertainty, these distributions are identical. Our conclusions from the fiber size data are that there is no difference in the sizes of the various fibers found in the cannellure and in the forward grooves of the IG-1 projectile.

Figure 3a. Size distribution of iron fibers found in the USS IOWA cannellure by NWSC-Crane.

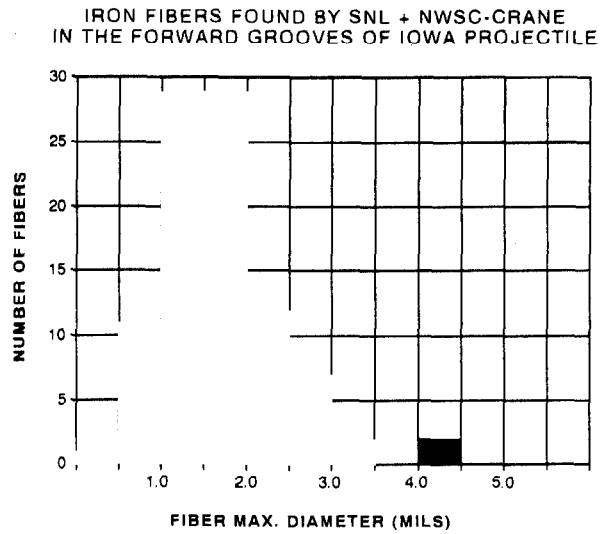
Figure 3b. Size distribution of iron fibers found in the forward grooves of USS IOWA projectile (SNL + NWSC-Crane).

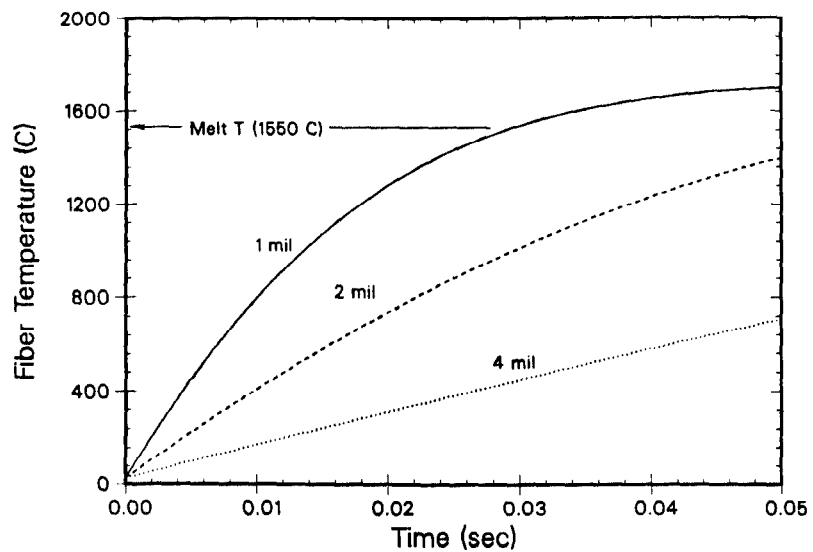
Figure 9. The temperature history of iron fibers with various diameters.

In summary, the propellant combustion environment produced sufficient heat transfer to partially melt small fibers and thus would have modified fibers originating within the powder charge. No recovered fiber exhibits a surface morphology indicative of intense heat transfer. It is concluded that the surface morphology of the iron "foreign material" fibers is not indicative of their having come from a hypothetical chemical ignition device in the propellant powder bags.

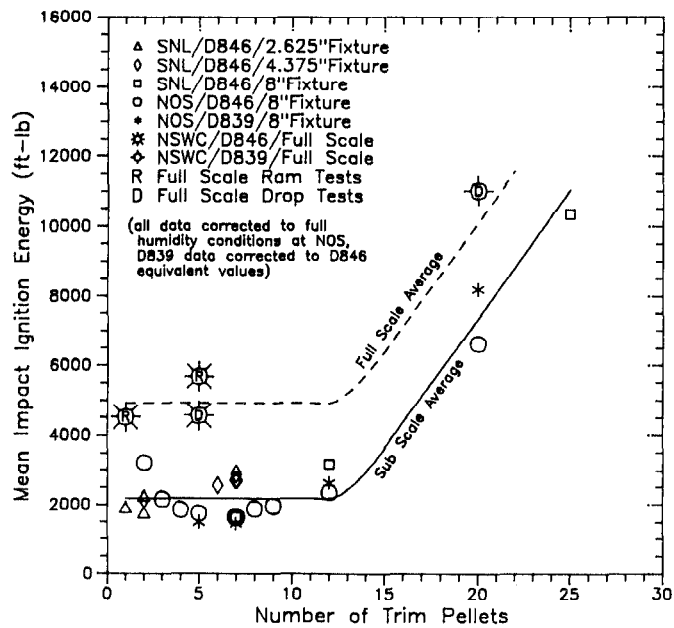
When the data in Figure 11 are analyzed, they show an approximately constant offset between the subscale and full-scale data. This offset is the energy that is lost in powder bag compression and swelling and subsequent mass pellet motion.

Figure 11. Full-scale ramming and drop test result compared to subscale test results.

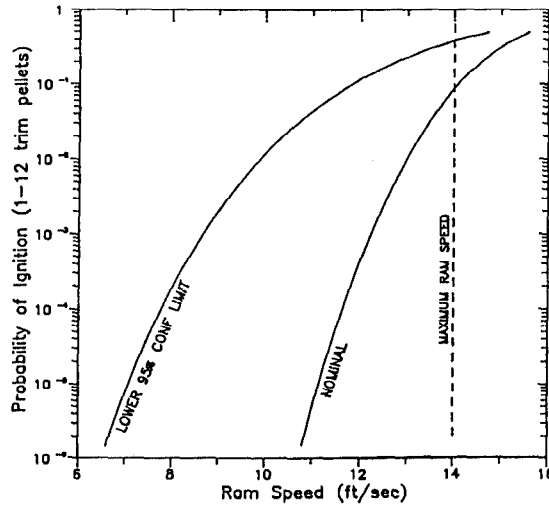
In either case, it is seen that there is a significant probability of ignition when a load of five bags with a small number of trim pellets in one of the bags is overrammed at high speed (but within the operating limits of the gun) into the base of a seated projectile. As the ram speed is reduced, so is the probability of ignition. Although the probability of ignition becomes extremely low at mid-range ramming speeds, it is not zero. It should be noted that in subscale tests (test Series No. 23, Table 1) ignition was obtained at 6.5 ft./sec. impact speeds.

Figure 12. Probability of ignition versus speed of ram (for five-bag load of D846 with one to twelve trim pellets in at least one bag).

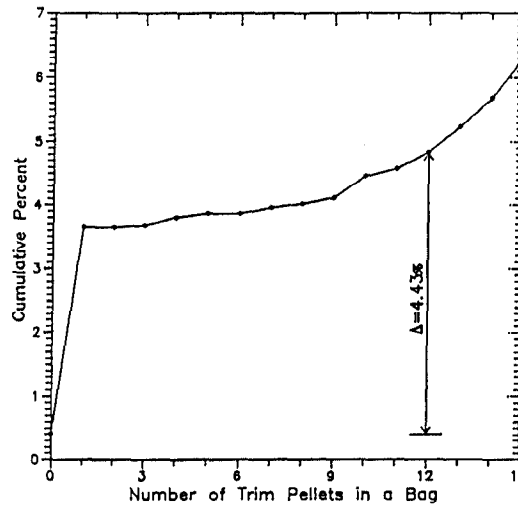
Figure 17 shows that the fraction of powder bags containing from one to twelve trim pellets is 0.0443 (or 4.43 percent). This means that if one powder bag were selected at random from the lot of D846 bags, there is a 4.43 percent chance that it would contain between one and twelve trim pellets.

Figure 17. Cumulative distribution of trim pellets in D846 powder bags.

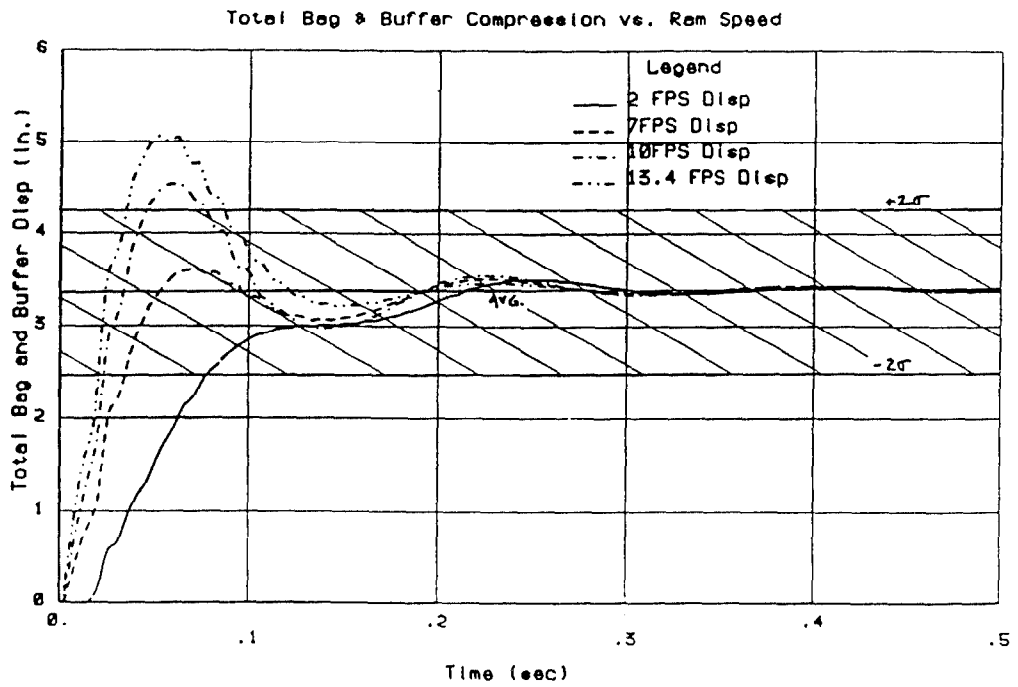
As indicated above, the buffer and bags must compress 3.33 in. in order for the rammerhead to be in the position that matches the gouges in the spanning tray. Figure 18 is a plot of the sum of the buffer and bag compression at four different rammer speeds as predicted by the model. For times greater than 0.3 sec., all four of the compression curves approach the static compression of the rammer, 3.33 in.

At times < 0.3 sec., the rammerhead is in the required compression position at different instances, depending on the rammer speed. The variability in bag length and the uncertainty in the measurements of seating distance contribute to a large band of uncertainty in the compression. To illustrate this uncertainty, the cross-hatched band centered about the 3.33 in. compression represents the range of ± 0.88 in. caused by a two-sigma variation in bag length. Additional uncertainty bands could be plotted to account for the ± 0.2 in. and ± 0.1 in. uncertainty in the measurements of seating distance and rammerhead position, respectively.

Figure 18. Predicted total powder bag and buffer compression for various ram speeds.

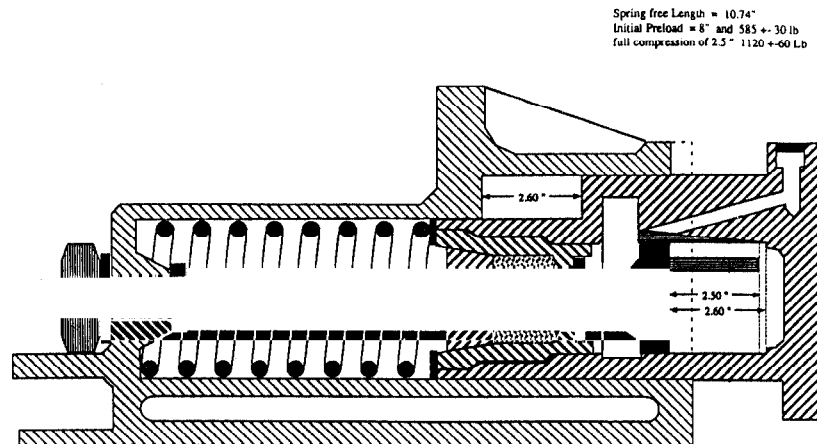
The rammerhead, shown in Figure 19, incorporates a spring-loaded, fluid-filled buffer assembly that acts as a shock absorber during projectile seating. When the force exceeds the preload in the spring, the head moves into the body, compresses the spring, and forces fluid around the piston. The fluid is forced through three decreasing area slots and the annular gap between the piston and the cylinder and into an expansion chamber above the piston. The spring reaches maximum compression at 2 1/2 in. and stops the head motion. The force of approximately 1100 lb., required to fully compress the buffer, is readily supplied by the rammer hydraulic drive. Tests by the USN have shown that the head takes about 0.4 sec. to fully compress at a rammer speed of 2 ft./sec., and about 0.2 sec. to fully compress at a rammer speed of 14 ft./sec.

In the USN's dynamic overram tests that caused ignition, it was observed that ignition occurred before the rammerhead buffer was completely compressed. In contrast, most of the open-breech burn tests that involve a statically held ram show no loss of load on the rammer chain, implying that the buffer was fully compressed at the time of the blast. The only exception to this observation was Test #23, in which the chain moved into the chamber prior to the blast, implying that the buffer could have been moving out or extending.

Figure 19. Cross-section through rammerhead buffer assembly.

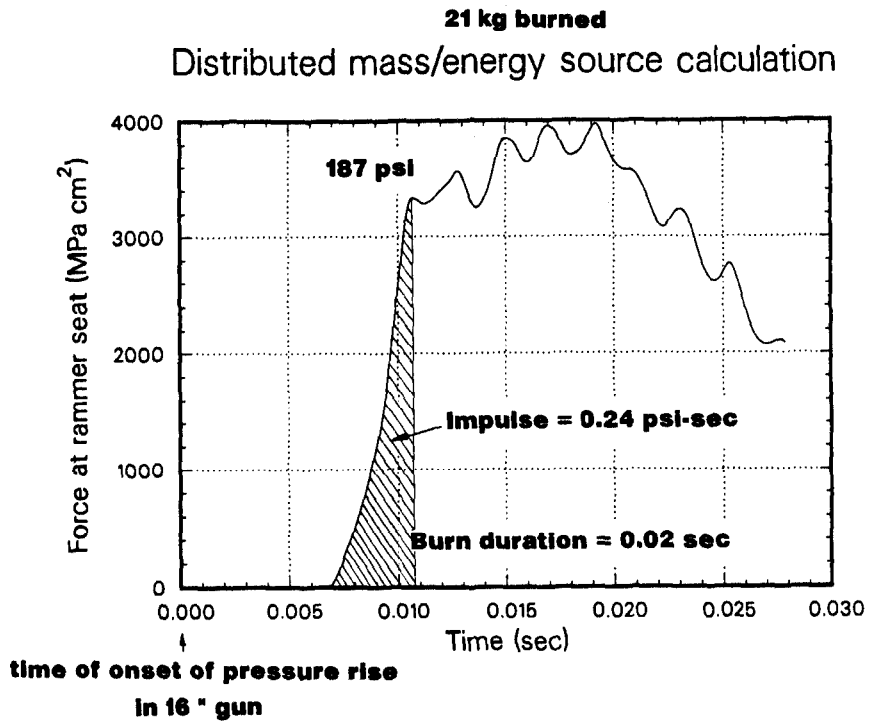
A plot of the pressure/history on the rammerman's seat is given in Figure 28. The peak pressure was estimated to be 187 psi, which occurred over 4 msec. of time. Because the pressure loading is due to gas flow impinging on the rammerman's seat, a loss of differential pressure occurs when the flow has arrived on the other side of the seat. It is thus assumed that no additional loading exists on the seat after this initial peak pressure of 187 psi.

Figure 28. Pressure at rammerman's seat predicted by distributed mass/energy source calculation. Note the absence of a pressure spike at the leading edge of the pulse.

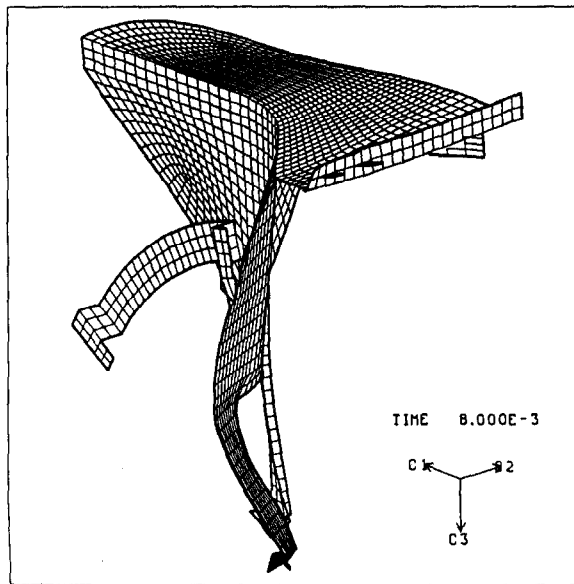
The results from the analysis show that the seat has translated and deformed over to the point of first contact with the quadrant at approximately 8.0 msec. after the initial loading. The seat plastically deforms and moves such that the first contact occurs at the lower aft mounting point of the quadrant. This is shown in Figure 32, which shows the deformed plot of the structure at this time from behind and to the side of the rammerman's seat (the bulkhead has been removed for clarity). The seat has deformed and extends over to the quadrant. Also, forward and outward motion of the seat is evident by the deformation of the bolts attaching the seat to the rear bulkhead.

It is seen that the seat has contacted the quadrant at the aft rear portion of the mounting pad. This is important because it corresponds with damage to the quadrant from the incident, where a bolt head was apparently removed and a flat surface was evident at this same position.

Figure 32. Predicted contact between rammerman's seat and aft end of quadrant 8 msec. after start of pressure loading.

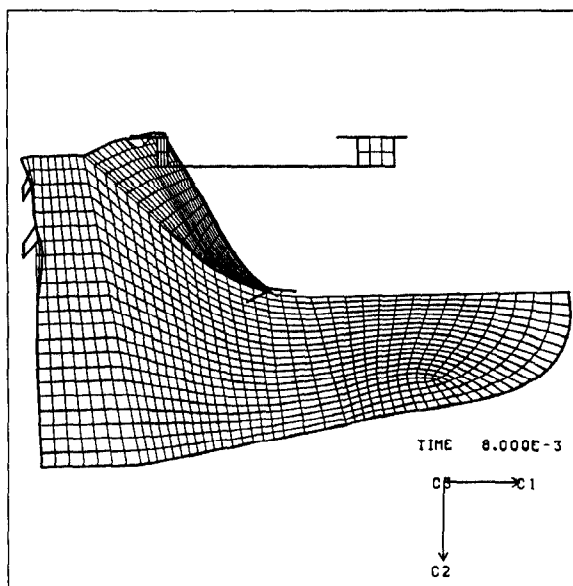
Of particular interest is the direction that the seat impacts the quadrant. Figure 33 shows the view of the seat from above. It is clear from this plot that significant forward directed forces exist on impact. The stresses shown in the plot are the VonMises stresses in these parts, and show that some yielding of the quadrant material has been caused by the impact. Because of these similarities with the physical evidence, it is concluded that these physical phenomena discovered from the analyses resemble the event and can be used to form the basis for a reasonable seat motion scenario.

Figure 33. Top view of seat when contract is first made with quadrant.
