**HURRICANE KATRINA:  
WHY DID THE LEVEES FAIL?**

COMMITTEE ON  
HOMELAND SECURITY AND  
GOVERNMENTAL AFFAIRS  
UNITED STATES SENATE

\_\_\_\_\_  
NOVEMBER 2, 2005  
\_\_\_\_\_

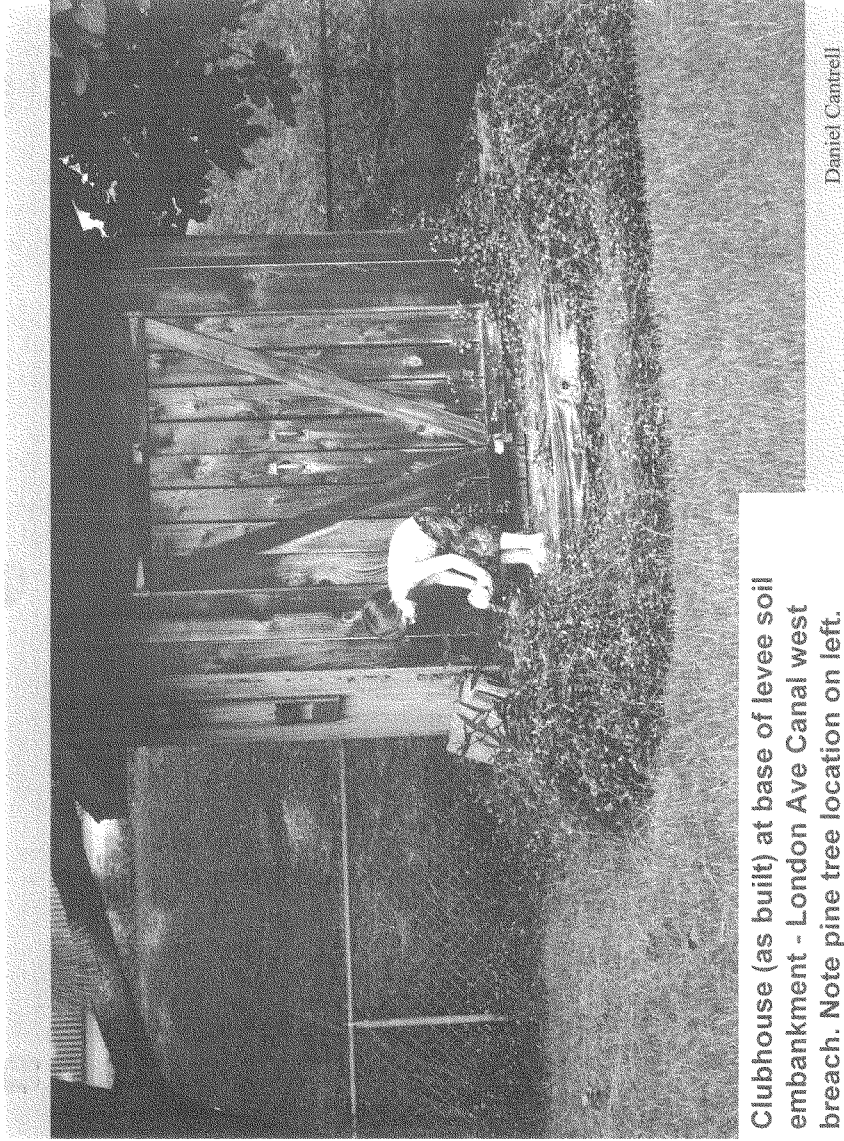
Clubhouse (as built) at base of levee soil embankment - London Ave Canal west breach. Note pine tree location on left.

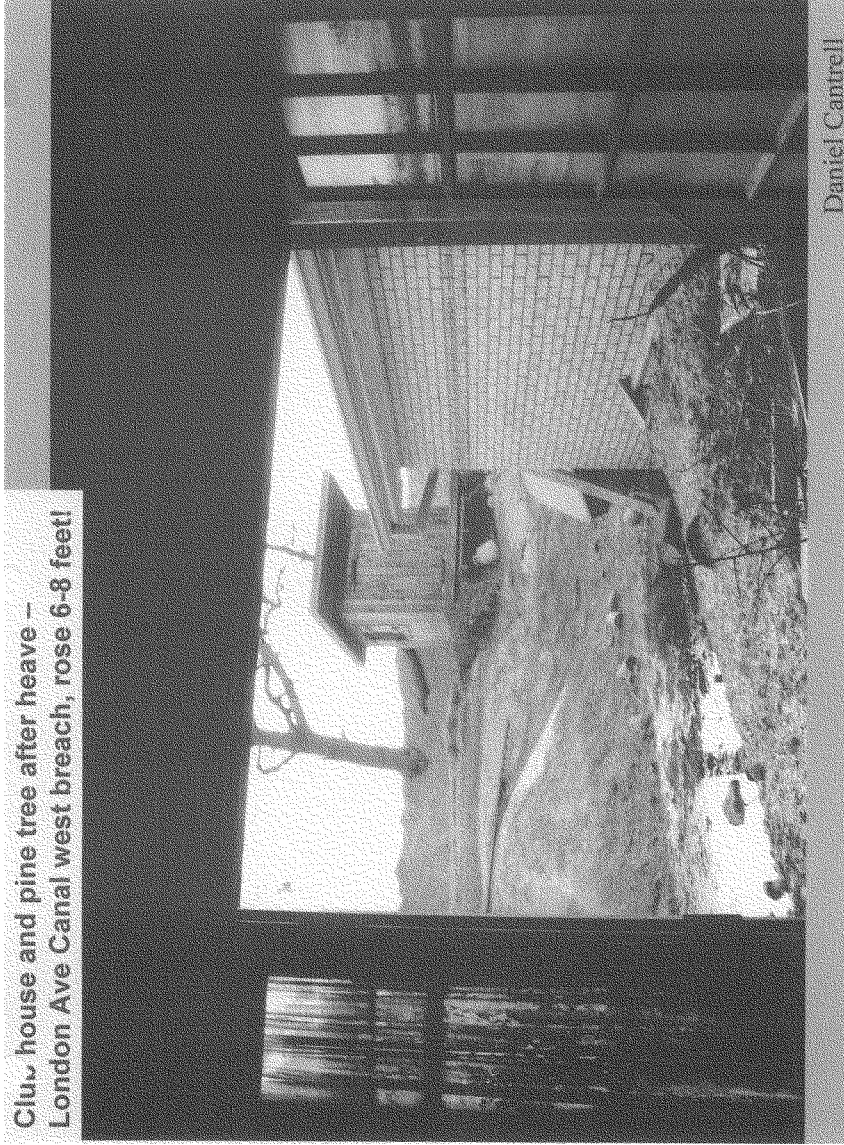
Clu, house and pine tree after heave –  
London Ave Canal west breach, rose 6-8 feet!

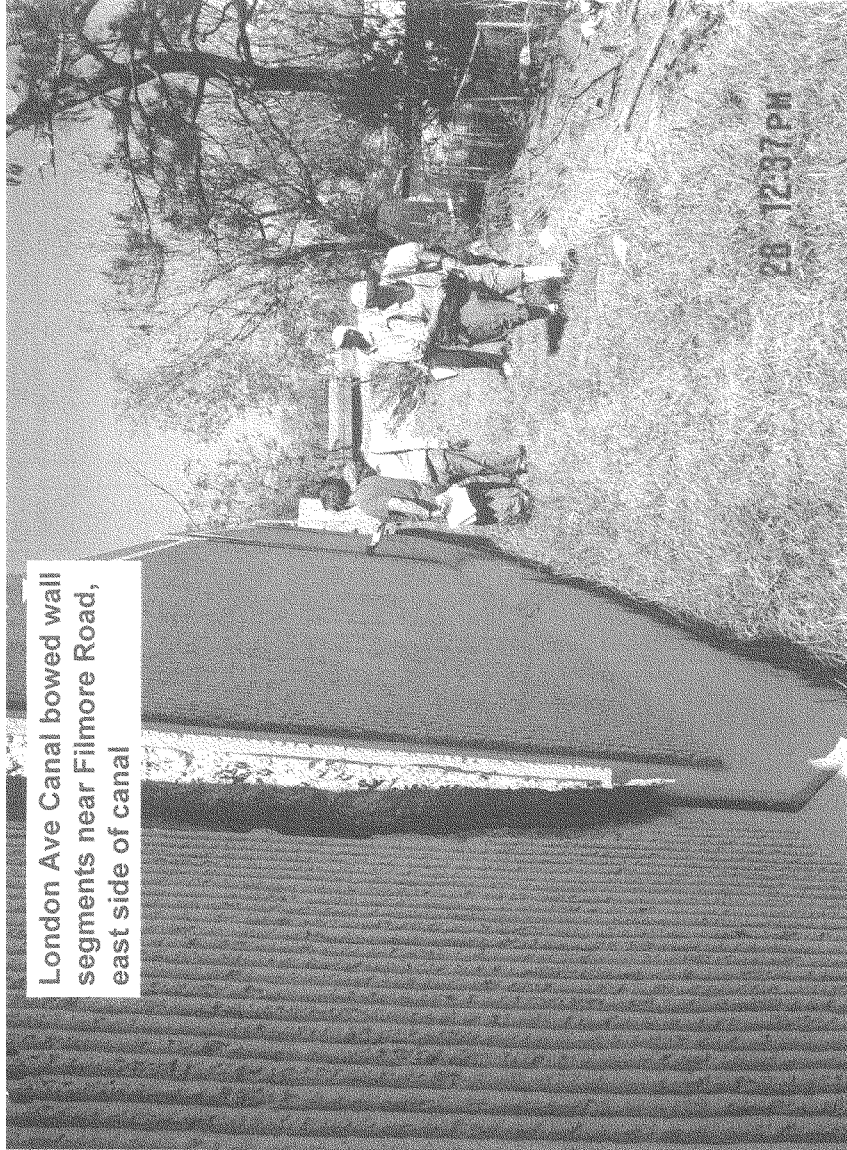
London Ave Canal bowled wall segments near Filmore Road, east side of canal

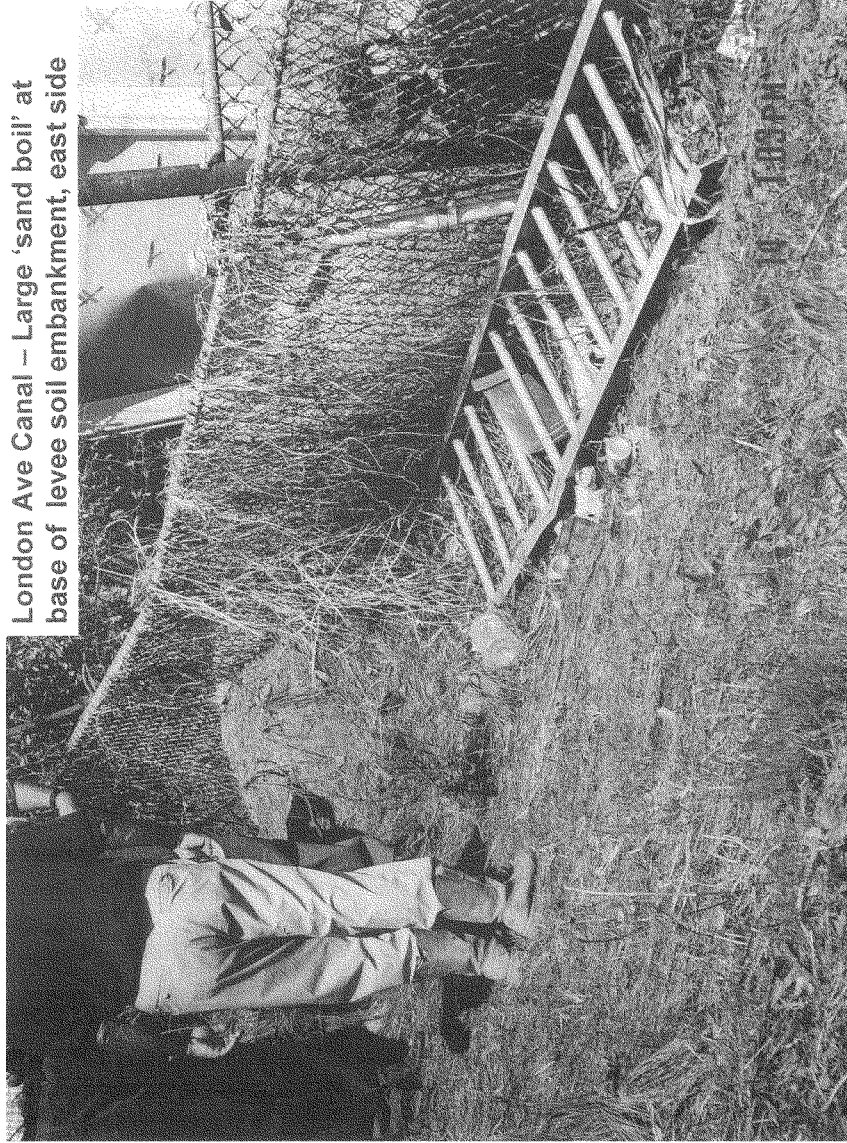
London Ave Canal – Large 'sand boil' at base of levee soil embankment, east side

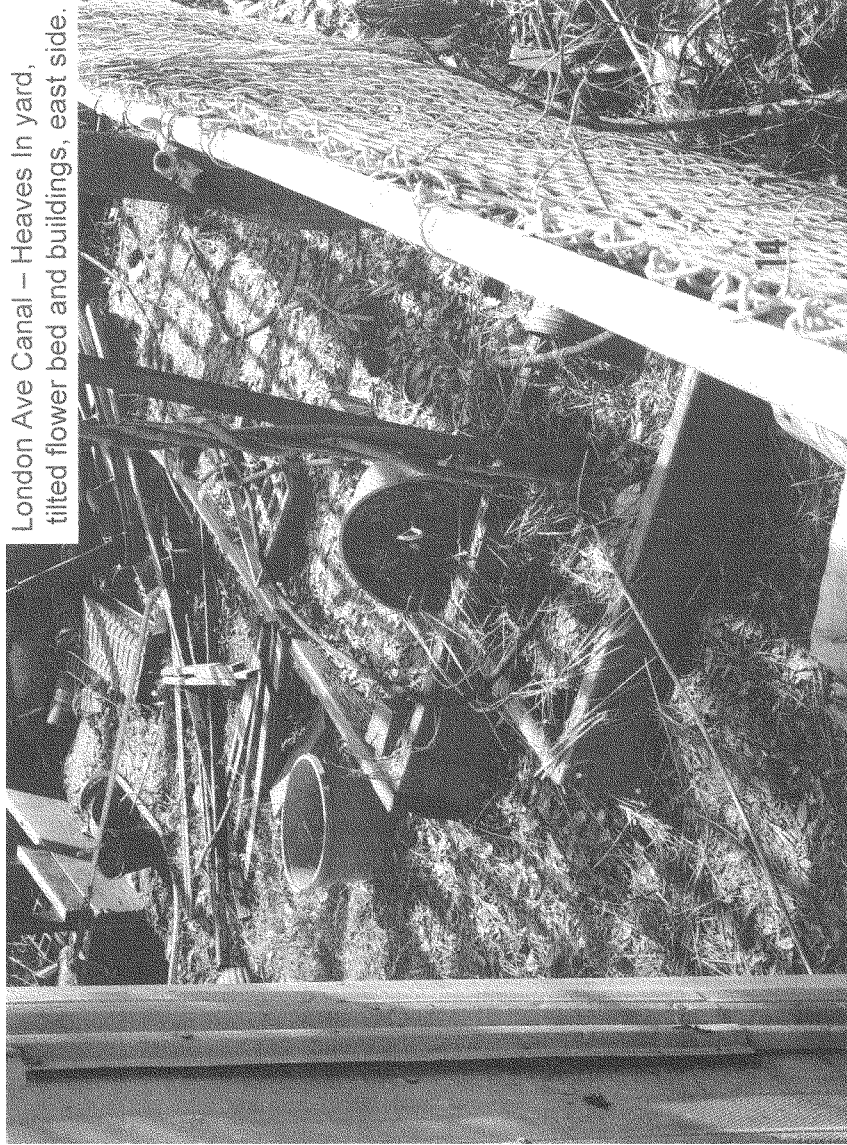
London Ave Canal – Heaves In yard,  
tilted flower bed and buildings, east side.

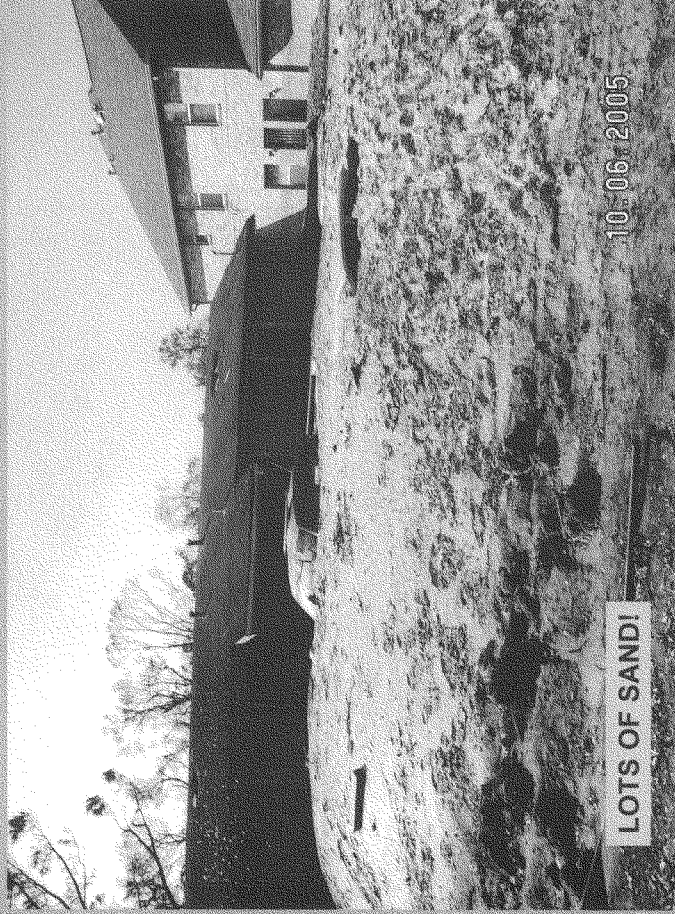
Mirabeau Break on London Ave.

LOTS OF SAND!

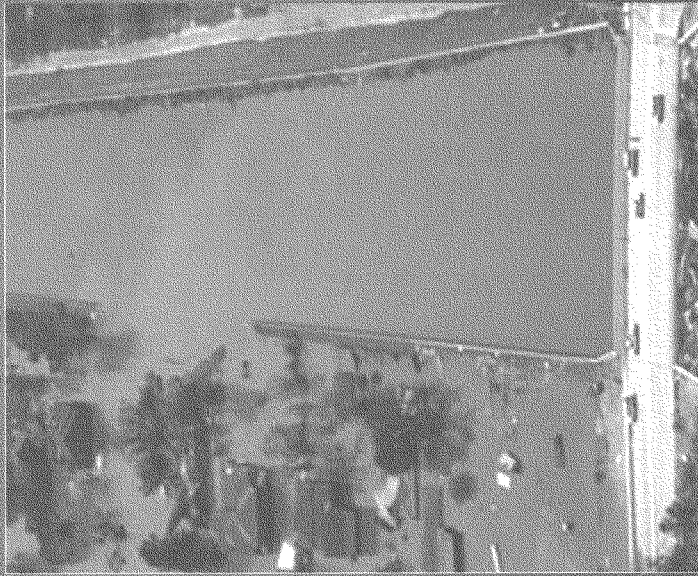
17<sup>th</sup> Street Canal

At the 17th Street Canal breach, we observed intact soil blocks that had experienced large translation and heave. This movement would be consistent with a failure either of

the soil embankment or the foundation soils beneath. There was no evidence of overtopping at this site. While we cannot yet determine conclusively the cause of the breach itself, this type of soil failure may well have been a significant contributing factor. Further investigation, together with analyses and review of the design and construction documents, should be of tremendous assistance in ultimately making these kinds of determinations.

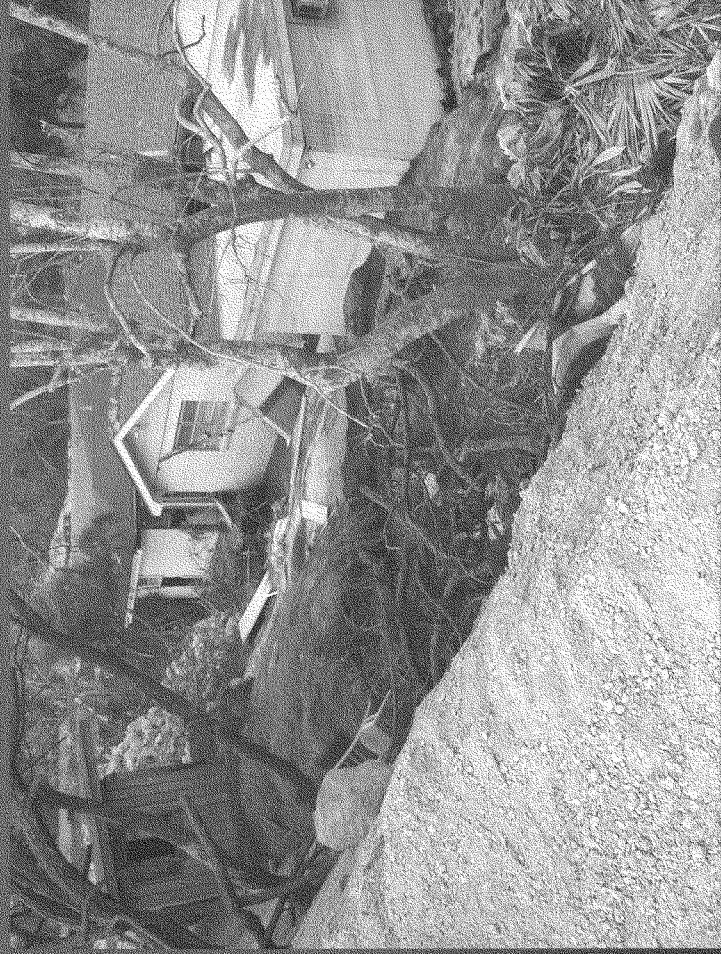
London Avenue Canal, North Breach

At the north breach on the London Avenue Canal, we observed a large displaced soil mass, which had been heaved nearly vertically over six feet, apparently indicating the toe of a rotational-type soil failure. Again, there was no evidence of overtopping at this site. Field inspection also showed a large amount of sandy soil deposited in the neighborhood landward of the breach, which is believed to be material from the foundation beneath the embankment together with material scoured from the canal bottom. This is consistent with the soil profiles provided to us which showed sand in the subsurface near this location. Under high water pressure, the flow through this type of material can be significant, which is known to cause internal stability problems.

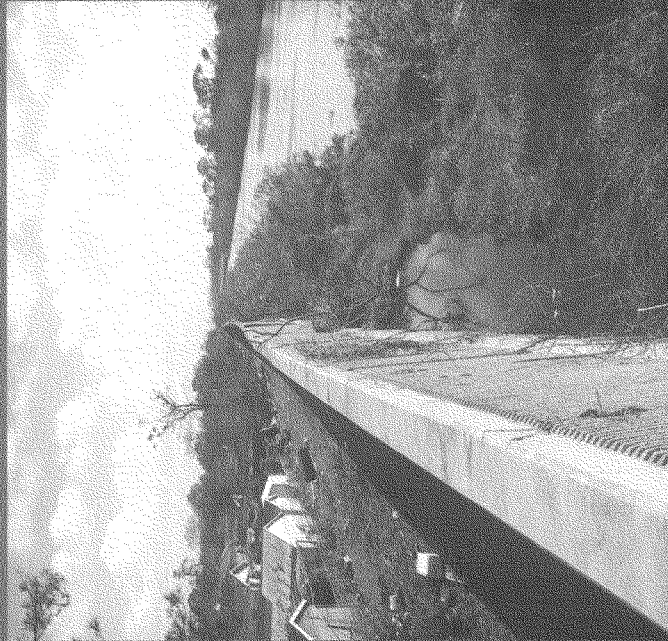
London Avenue Canal, North  
Across from Breach

Of particular interest was the levee section almost directly across from the north breach on the London Avenue Canal, where we observed a floodwall and underlying embankment that was in severe distress.

This site provided an excellent case study demonstrating multiple, concurrent failure mechanisms. It was observed that this section of floodwall was distressed to the point that it appeared that it might have been approaching failure when the water loading was relieved as the other breaches occurred. The wall was badly out of alignment and tilting landward; as a result of the tilt, there were gaps between the wall and the supporting soil on the canal or waterside. Also observed were evidence of soil movement, seepage and piping, as indicated by a series of sinkholes near the crest, together with "boils"<sup>3</sup> and heave at or near the inboard toe<sup>4</sup> of the embankment.

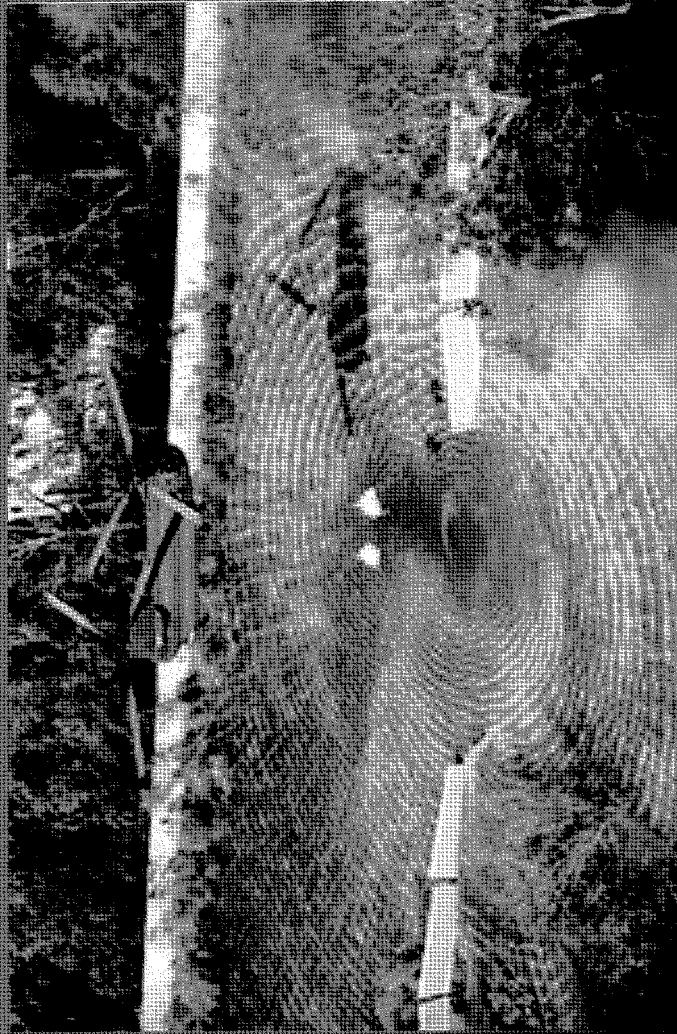
London Avenue Canal, South Breach

To the south was another breach on the London Avenue Canal. That breach had apparently cut so deeply that huge volumes of sandy material had been scoured from the canal bottom and then deposited up to five feet deep extending hundreds of feet into the neighborhood. Very little evidence remained to be gathered at this site and the causes and mechanisms of the breach may never be known. It was, however, again

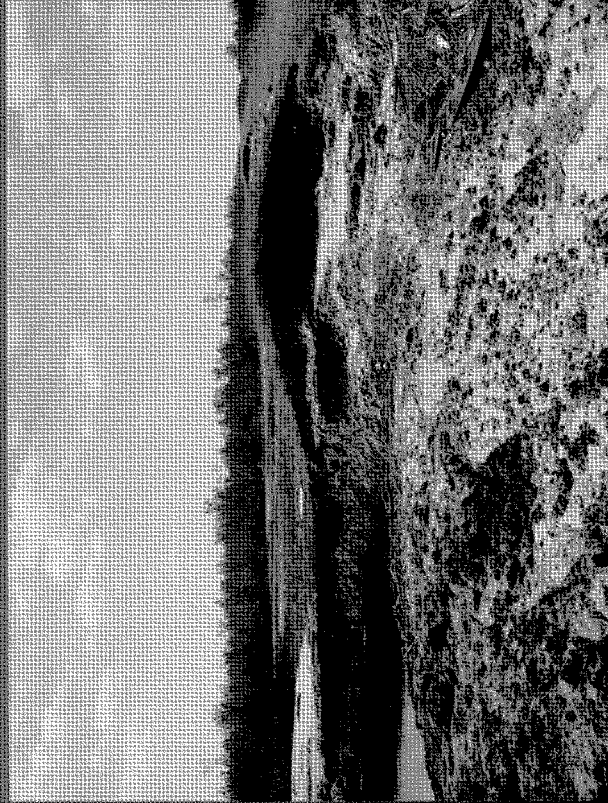
Overtopped Embankment (Sand Core)

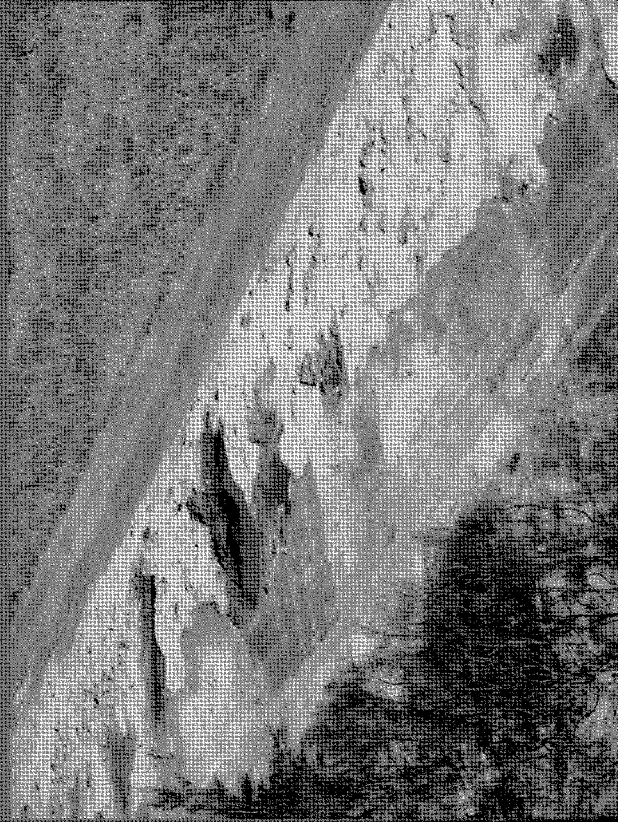
Overtopped Embankment (Sand Core)

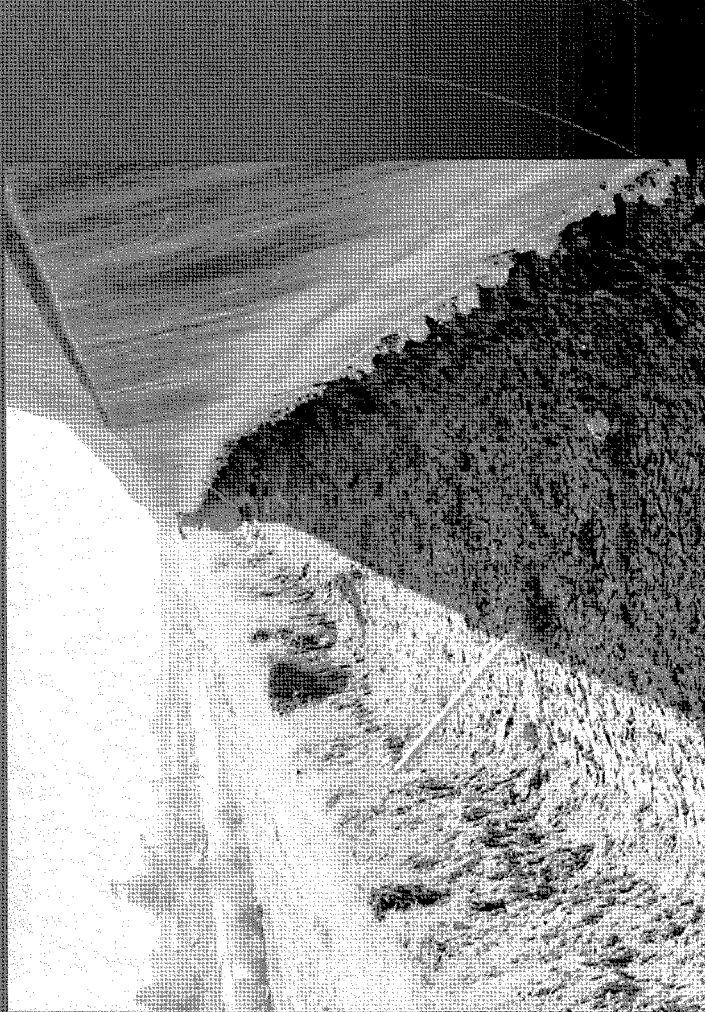
Inner Harbor Navigation Channel  
Back Scour at Lower 9th Ward

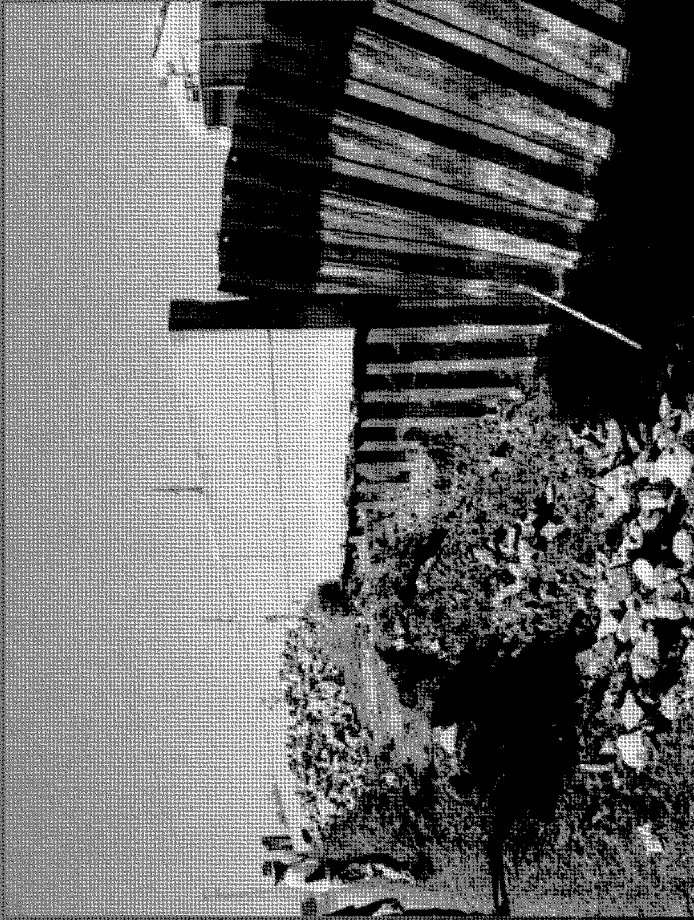
Common Transition Failures

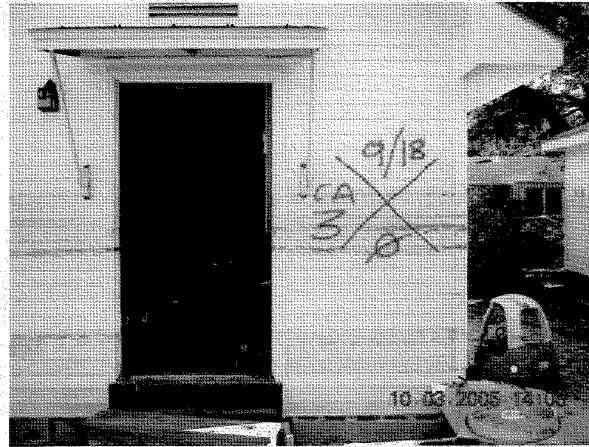
Figure 1.8: High water marks remain on structures after temporary levee repairs have been completed and flood waters have been pumped out.

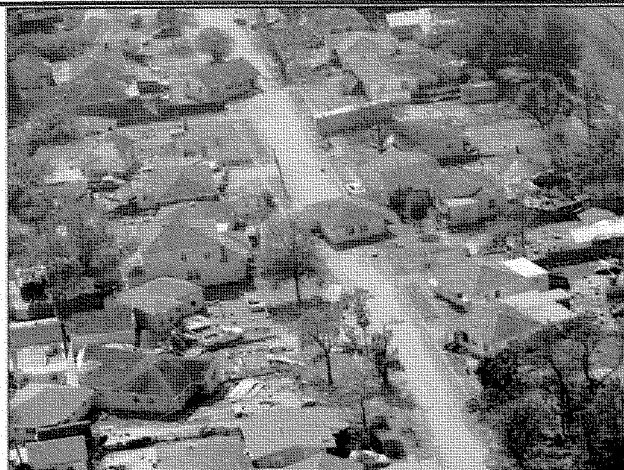
Figure 1.10: Flooded neighborhood in St. Bernard Parish, showing homes floated off their foundations and transported by floodwaters.

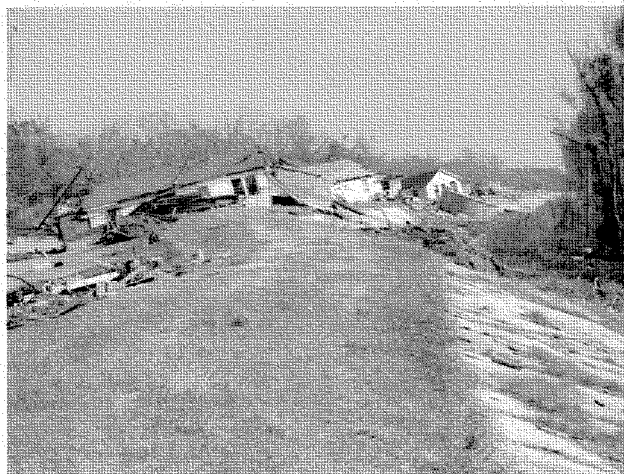
Figure 1.11: Homes in Plaquemines Parish carried from left to right in photo and strewn across the crown of the Mississippi Riverfront levee.

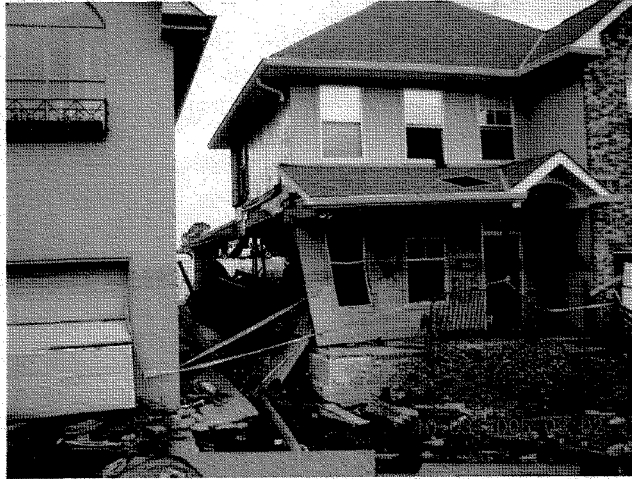
Figure 1.12: Damage to a residential neighborhood in the 17<sup>th</sup> Street Canal area due to flooding.

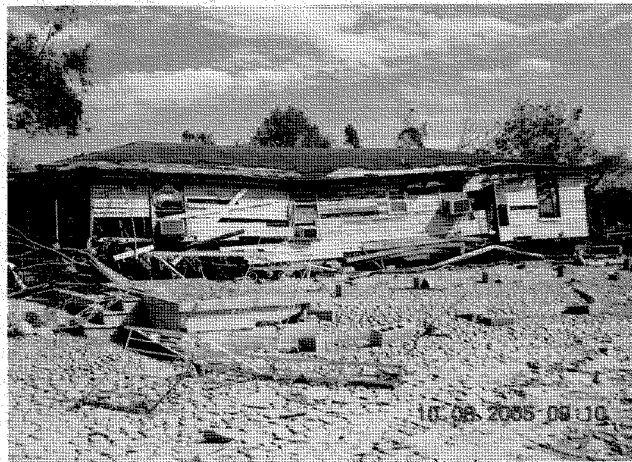
Figure 1.13: Another view of flooding damage, this time in the lower Ninth Ward.

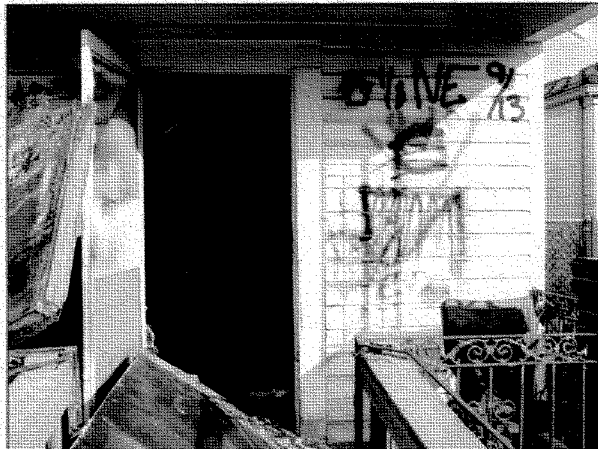
Figure 1.14: Search and rescue team markings on a building in the Ninth Ward where three inhabitants died.

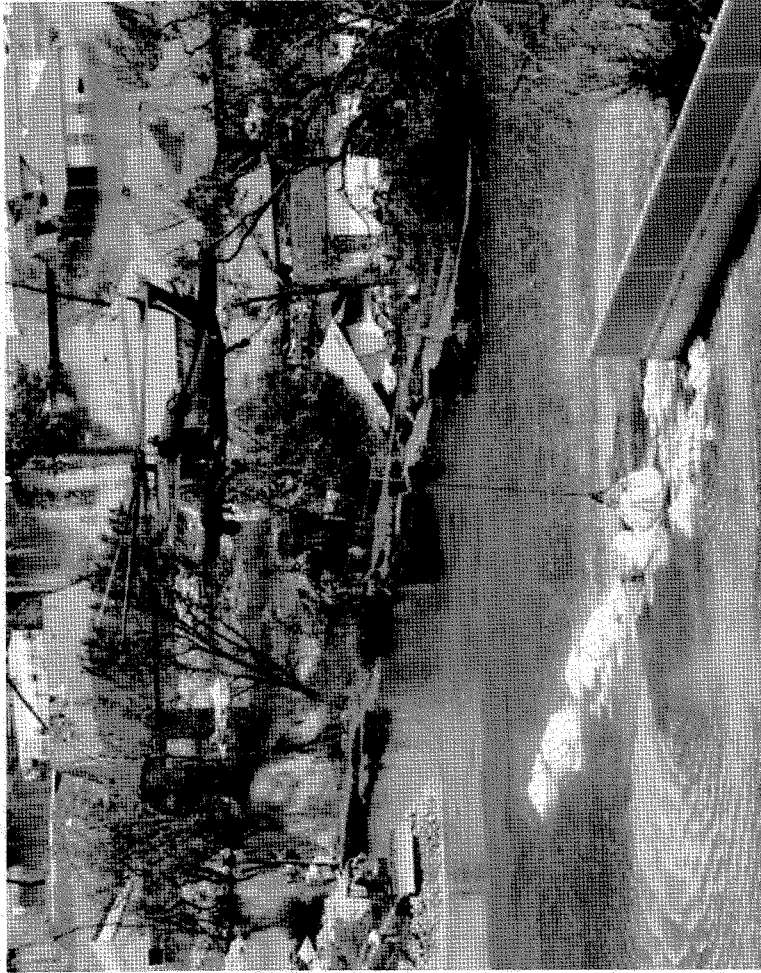
Figure 2.3(a) shows the major breach at the east side of the 17<sup>th</sup> Street Canal as it is being “plugged” with large sandbags being delivered by military helicopters in the wake of Hurricane Katrina. This photo is taken looking to the northeast. Figure 2.3(b) shows the same figure, but this time highlighting key features for discussion. The line of grassy soil units in the center of the photo are the inboard half of the southern end of the original levee embankment, and the chain link fence is remnants of the fence that passed along the inboard lip of the crest road, separating the crest from adjacent homeowner’s back yards. The southern end of the embankment has translated to the east, traveling laterally up to about 45 feet away from its original position. The northern end of the breached embankment section was largely eroded by scour after the breach opened.

Figure 2.3(a): The 17<sup>th</sup> Street Canal breach during initial breach closure.

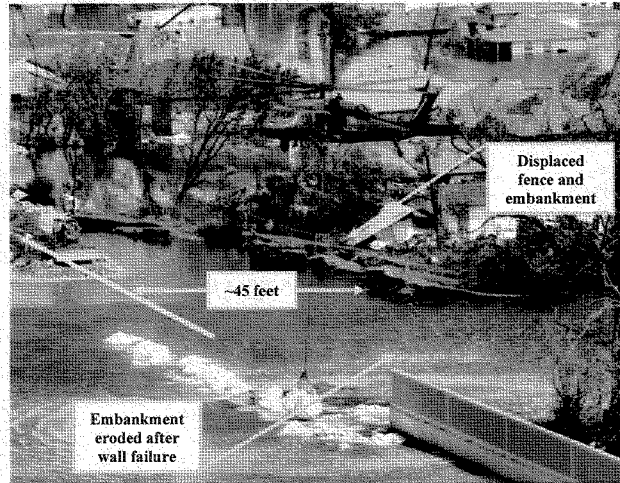
Figure 2.3(b): The 17<sup>th</sup> Street breach, highlighting key points for discussion

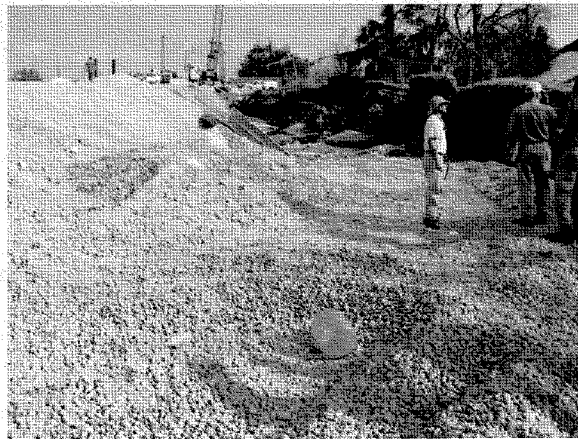
Figure 2.4 shows a second view of some of the details at this site. The relatively intact southern embankment sections translated laterally approximately 45 feet, and without significant rotation, as the trees and chain link fence remained vertical throughout this displacement. The laterally translating wedge of embankment (and possibly also some foundation) soil “plowed” into soft soils at the inboard toe, causing them to bulge upwards, heaving the largely collapsed shed and pushing it into the house.

Figure 2.4: View of the 17<sup>th</sup> Street breach section from the south.

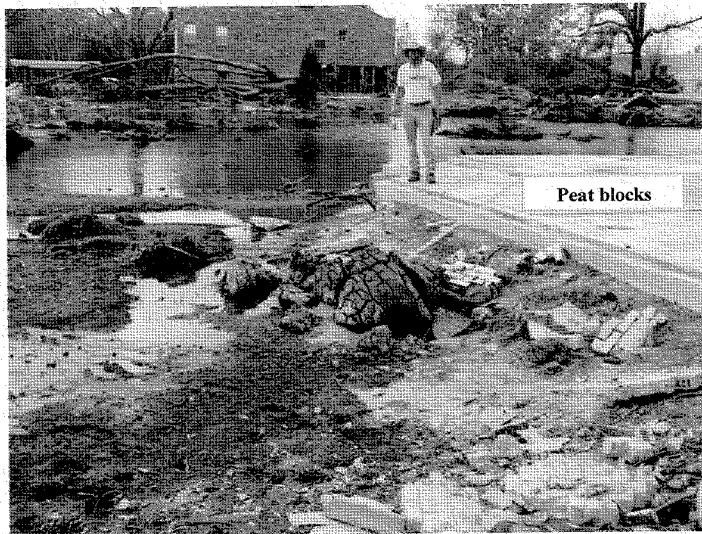
Figure 2.5 shows a view looking east across the zone through which the principal floodwaters flowed. Clearly evident in this photo are large blocks of peat scoured from the eroding foundation by the floodwaters.

Figure 2.5: View from crest of emergency embankment closure section at the 17<sup>th</sup> Street Canal breach, looking south across the floodwater scoured zone.

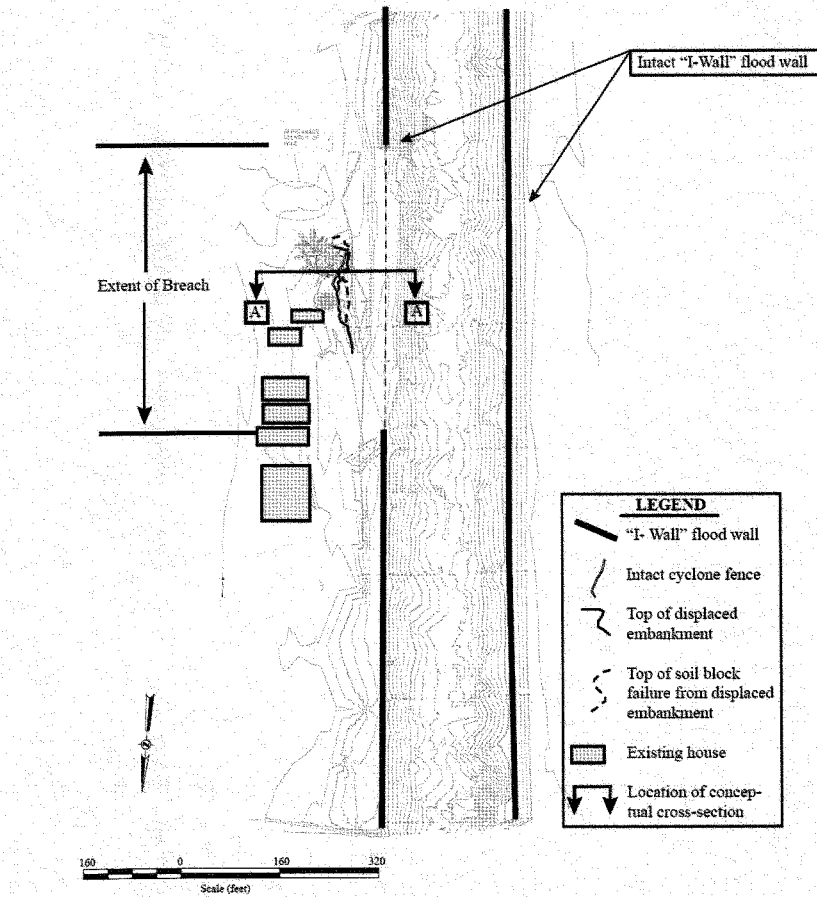
Figure 2.6 shows an approximate plan view of this site, highlighting key locations and objects of interest. The overall breach was 465 feet in width at the end of the flooding and scour, and the intact embankments and floodwalls immediately to the north and south of the breached section were largely undamaged.

Figure 2.6: Schematic plan view of the 17<sup>th</sup> Street Canal breach site. Results of LIDAR scan superimposed on base survey.

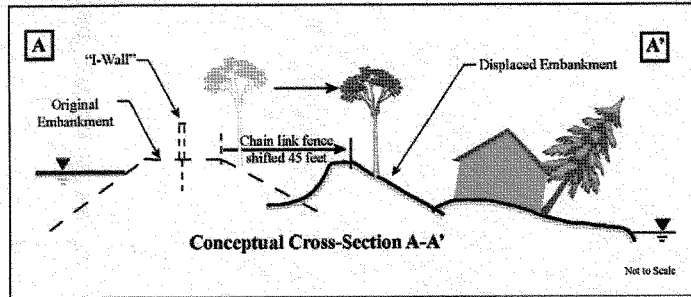
Figure 2.7 shows a simplified schematic cross-section through the site, roughly along Section A-A' in Figure 2.6. This shows the lateral translation of the inboard portion of the embankment, and the compression and heaving produced at the inboard toe by these movements.

The mechanism of failure at this site appears to have been a stability failure of the foundation soils beneath the earthen embankment. The embankment was pushed sideways, by about 45 feet, by storm surge induced water pressures acting against the front face of the sheetpile/l-wall vertical barrier. The actual depth at which foundation soil shear failure occurred is not yet known, and this remains to be investigated. Also still to be determined is the actual soil unit or strata that provided the weak sliding plane, and the precise mechanism of weakness that was most critical.

Figure 2.7: Schematic cross section at the 17<sup>th</sup> Street breach section.

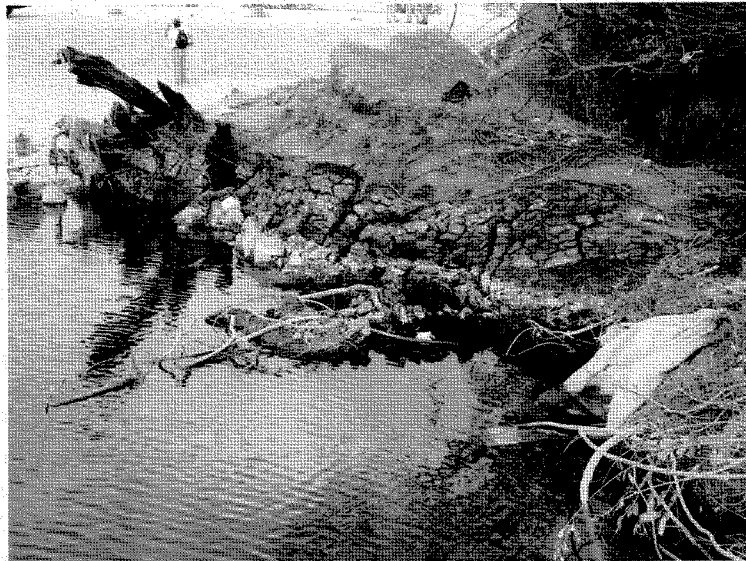
Foundation soils at this site were known to consist of a layer of organic, peaty material. The peats were interbedded with occasional thin, soft clayey layers, probably periodic overbank flood deposits, and one such clay layer within the peat unit was exposed at the southern end of the breach opening, as shown in Figures 2.8 and 2.9. A torvane performed in the field during our visit indicated an undrained shear strength of approximately 200 lb/ft<sup>2</sup> for this weak material, which varied in thickness from about 1 to 4 inches over several feet laterally at this location.

Figure 2.8: Location at which clay seam interbedded within the peat at the toe of the translated levee embankment was sampled.

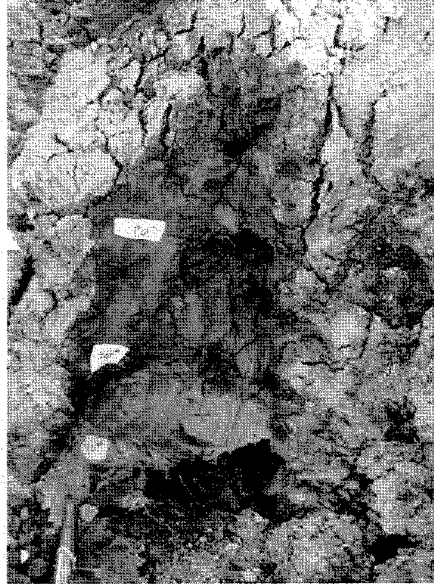
Figure 2.9: Clay seam (light gray layer) underlain by darker lean clay, and overlain by fibrous peat.

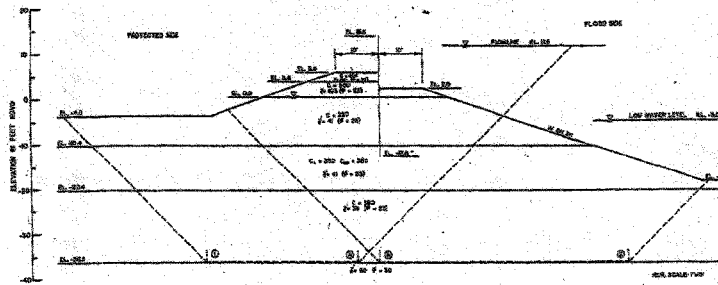
Figure 2.10 shows the approximate configuration of the levee, and its sheetpile curtain and concrete floodwall. As shown in Figure 2.10, the sheetpiles do not penetrate very deeply into the poor foundation soils, and they do not provide a full cut-off for underseepage through the pervious foundation soils.

Figure 2.10: Design cross-section at the 17<sup>th</sup> Street breach.

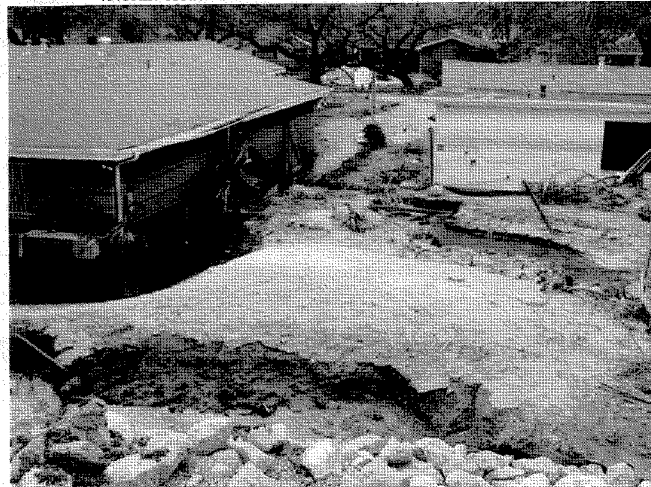
Significant deposits of sediment occurred inboard of this breach, and these appeared to represent a mix of soils scoured out from the breached embankment section and its foundation soils, as well as sediments from the canal outboard of the failed section (see Figure 2.18.)

Figure 2.18: Sediment from the London Avenue Canal was deposited inboard of the levee break. High water marks (from long-term ponding) are visible on the exteriors of the residential homes.

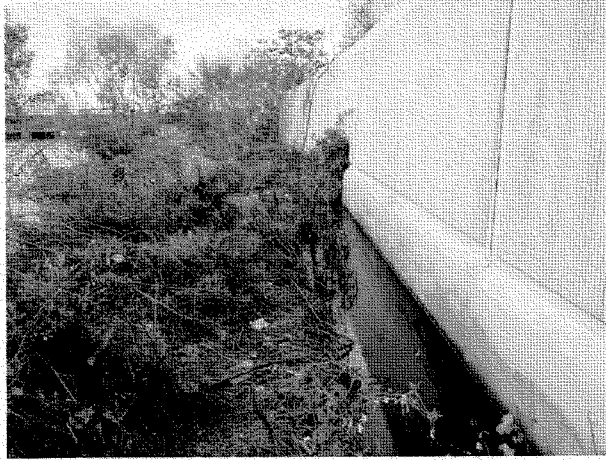
Figure 2.19 shows the floodwall of the “distressed” section directly across the canal, on the east bank. This photo shows the outboard side of the floodwall, which has been pushed laterally, opening an extensional crack as wide as approximately 18 to 28 inches at its original outboard side base contact with soil at the levee embankment crest.

Figure 2.19: Gap at the base of the floodwall on the canal side of the East Bank "distressed" section.

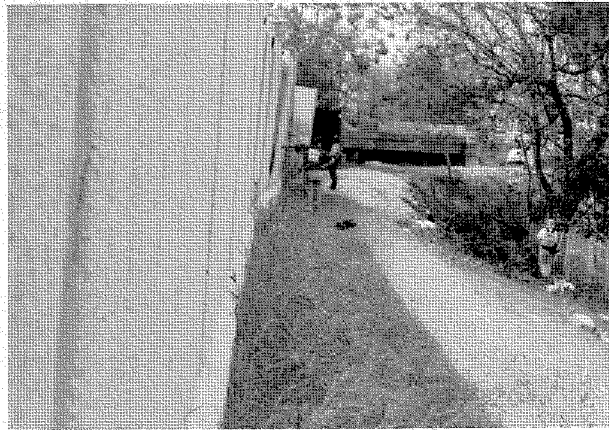
Figure 2.20 shows conditions on the inboard side of the east bank distressed section, directly on the other side of the wall shown in Figure 2.19. The wall has been pushed towards the inboard side, and now leans inwards (to the right) by about 5° off vertical in this photo. Figure 2.21 shows a closeup view of part of a line of sinkholes noted at the inboard toe of the wall, along the section shown in Figure 2.20. These appear to have been related to underseepage and resulting erosion and piping. Figure 2.23 shows the “boil” outlet of one erosional “pipe” at the inboard toe of the embankment at this location.

Figure 2.20: View of the inboard side of the floodwall and earthen levee embankment.

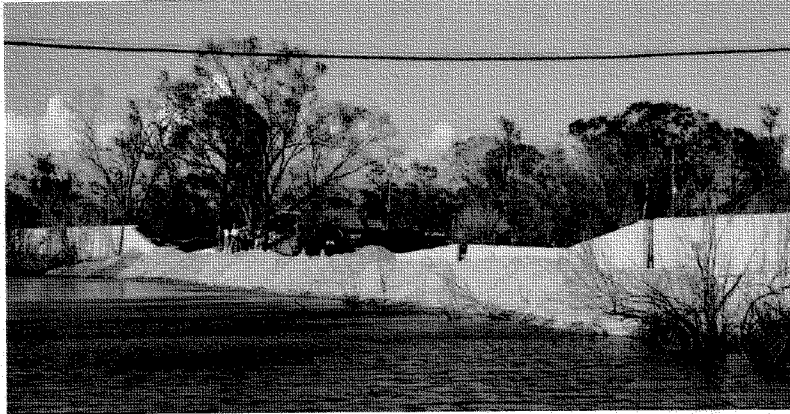
Figure 2.25: View of the crest of the temporary embankment closure section at the London Avenue Canal (South) breach.

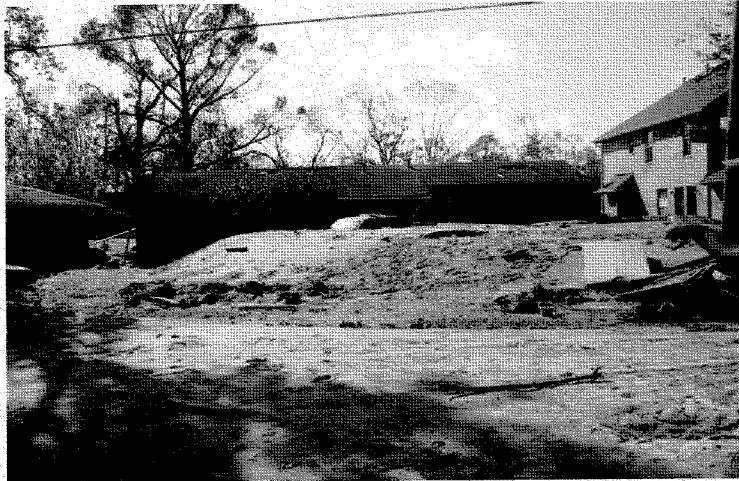
Figure 2.26: Significant quantities of sediment were deposited in the residential neighborhoods on the east side of the London Avenue Canal. More than five feet of sediment was deposited around this home.

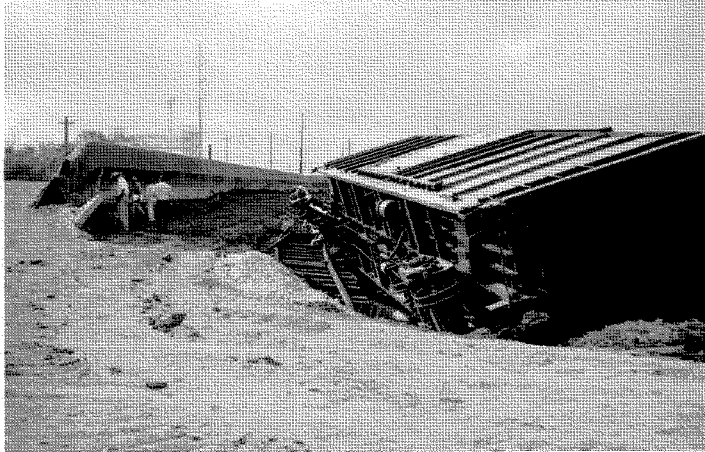
Figure 2.27: Breached levee floodwall section at Location "A" along the west side of the INHC.

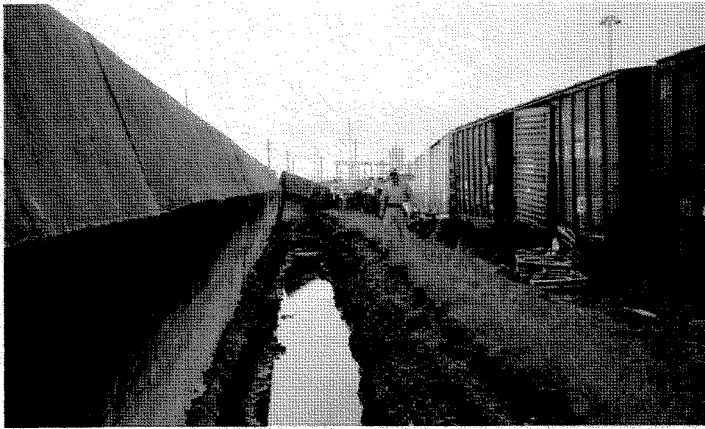
Figure 2.28: Erosion at the inboard toe of concrete floodwalls at Location "A" along the west side of the INHC, adjacent to the breached section shown previously in Figure 2.27.

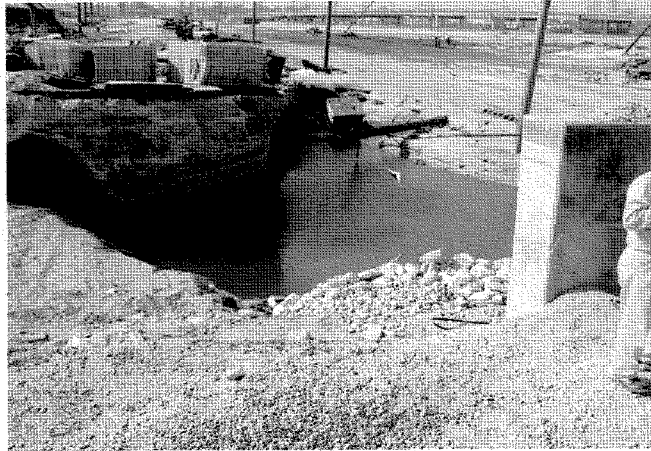
Figure 2.29: Erosion at a “transition” between a concrete floodgate wall and the adjacent earthen embankment section.

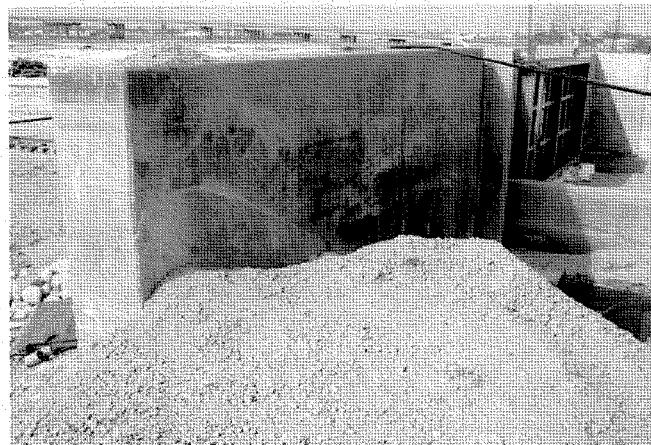
Figure 2.30: View of the structural wall and floodgate structure from Figure 2.29.

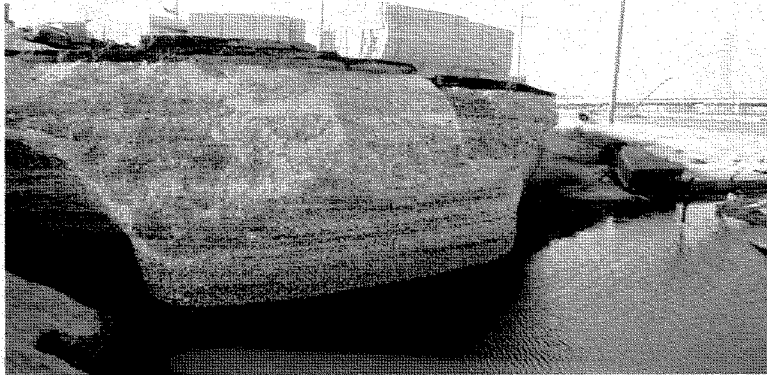
Figure 2.31: Close-up view of sandy "shell" fill at the scoured edge of the breach shown previously in Figure 2.29.

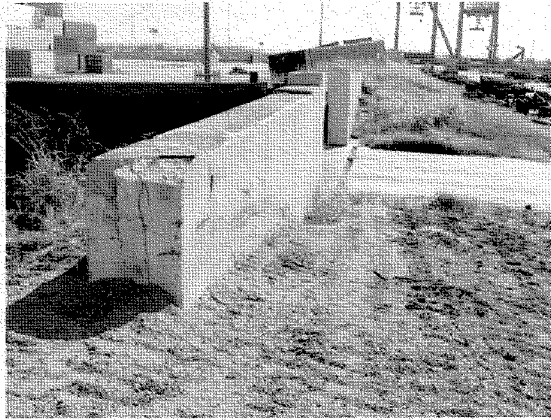
Figure 2.32: Common structural wall (with flood gate) and earthen levee transition problem with erosion at the contact between the earth and concrete sections.

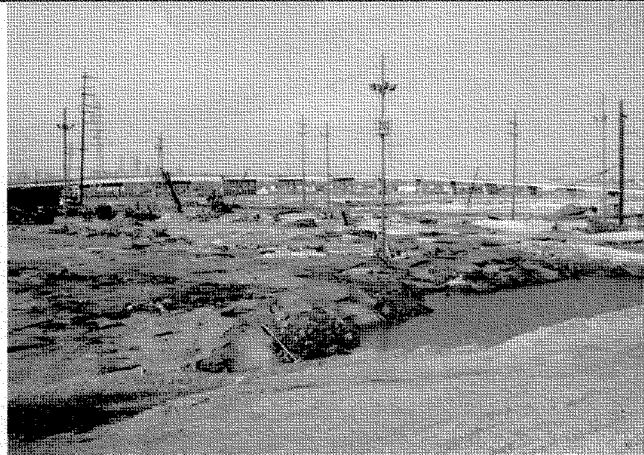
Figure 2.33: Scour hole and deposits of sediment and shells, inboard of the breach shown previously in Figure 2.32.

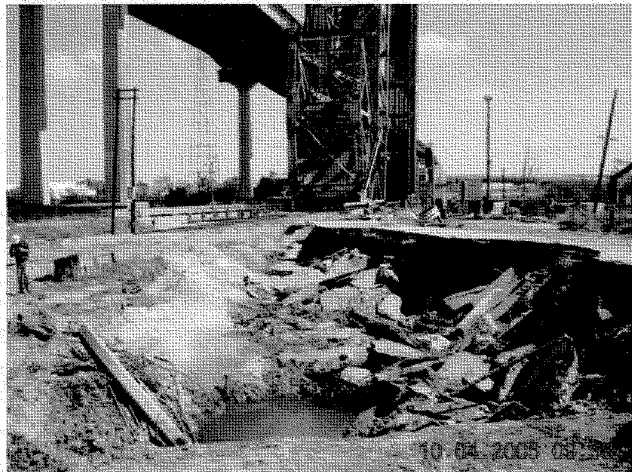
Figure 2.34: A complex “transition” involving several overlapping operations and penetrations through the flood protection levees immediately south of the I-10 bridge across the IHNC.

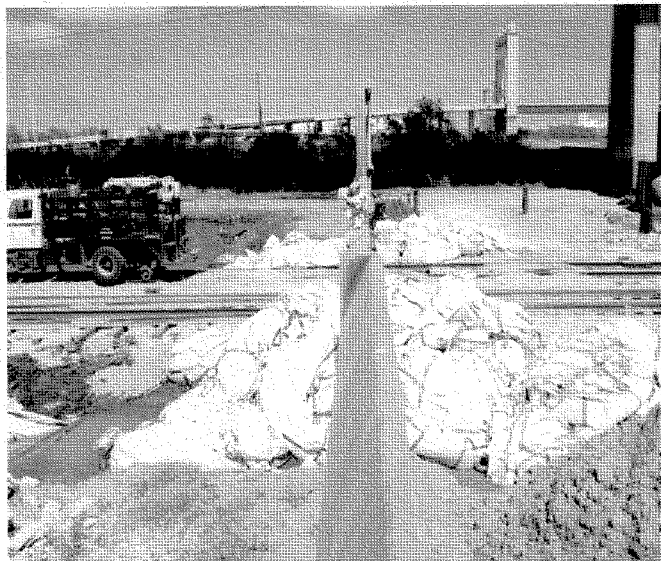
Figure 2.35: Rail line crossing through floodgate structure at the west side of the INHC at the complex transition shown in Figure 2.34.
