**HURRICANE KATRINA:  
WHY DID THE LEVEES FAIL?**

COMMITTEE ON  
HOMELAND SECURITY AND  
GOVERNMENTAL AFFAIRS  
UNITED STATES SENATE

\_\_\_\_\_  
NOVEMBER 2, 2005  
\_\_\_\_\_

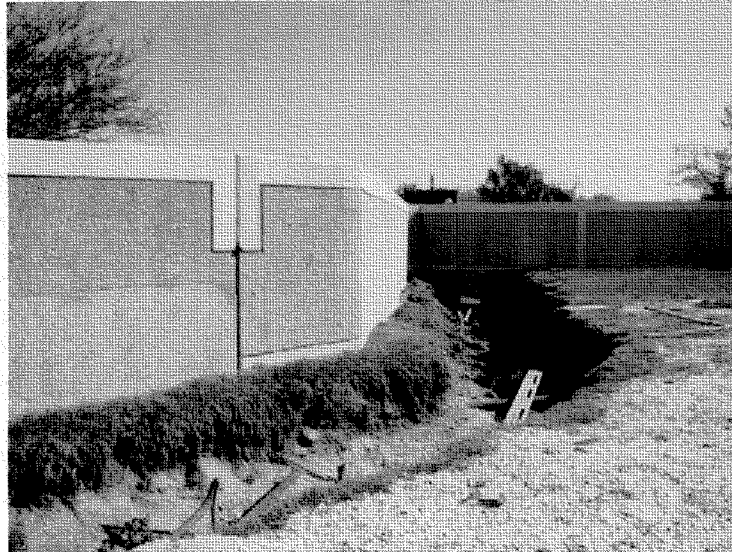
Figure 3.3: I-wall adjacent to the Lakefront Airport showing deep back-scour but no evidence of distress to the wall.

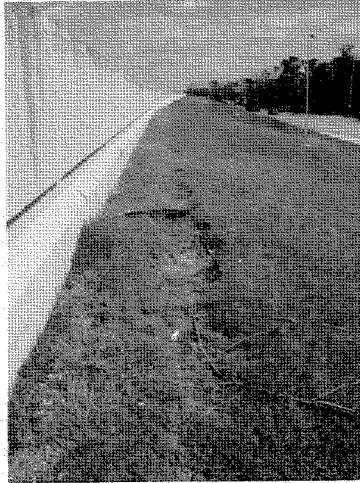
Figure 3.4: Beginning of overtopping scour along lakefront flood wall suggests moderate overtopping at this location.

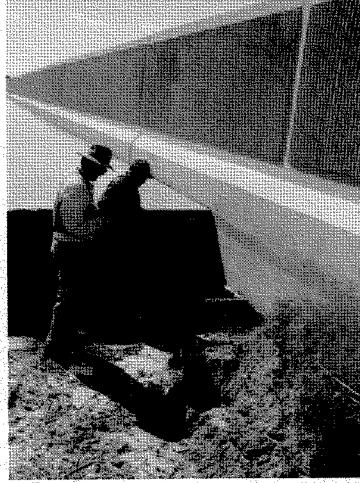
Figure 3.5: Concentrated scour due to presence of concrete apron. Area in the background is a good example of the benefits of armoring the base of the flood walls.

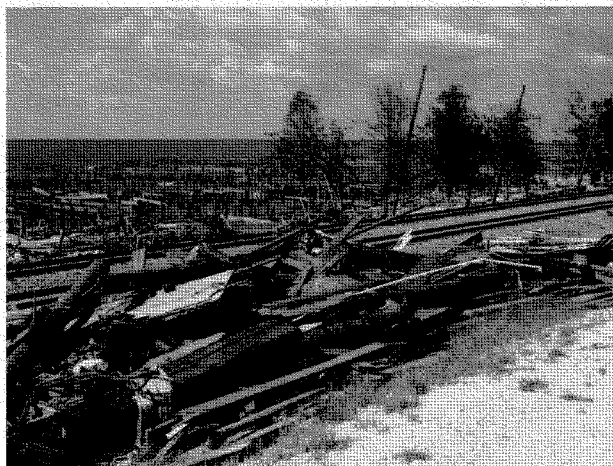
Figure 3.7: The lakefront community of Little Woods destroyed by wind and water (N 30° 04' 70.5", W 89° 56' 44.0")

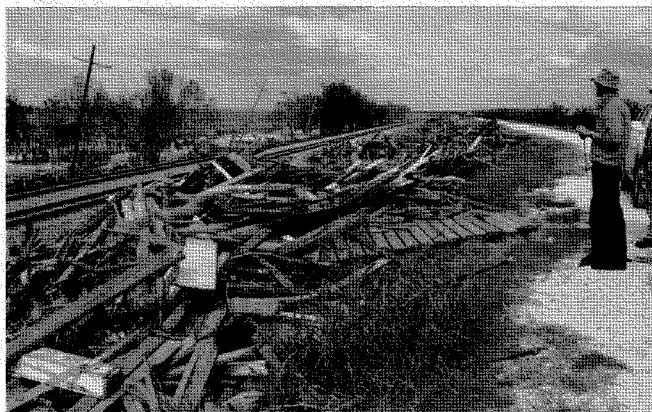
Figure 3.8: Debris from the Little Woods houses accumulated near the crest of the earth levee indicates the level of the lake waters during the storm. (N 30° 04' 70.5", W 89° 56' 44.0")

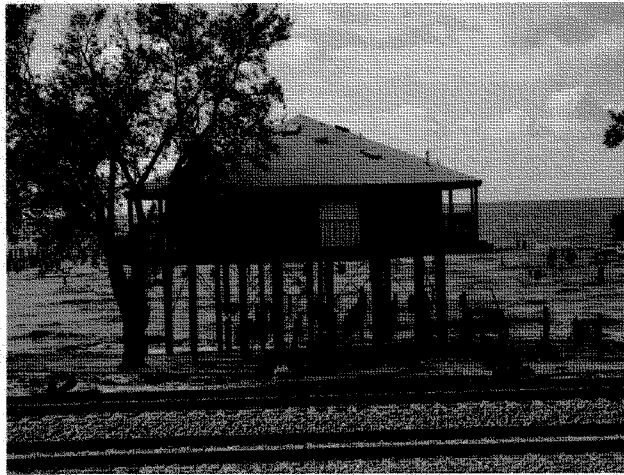
Figure 3.9: The lone surviving structure at Little Woods appears unscathed, except for the lack of stairs.

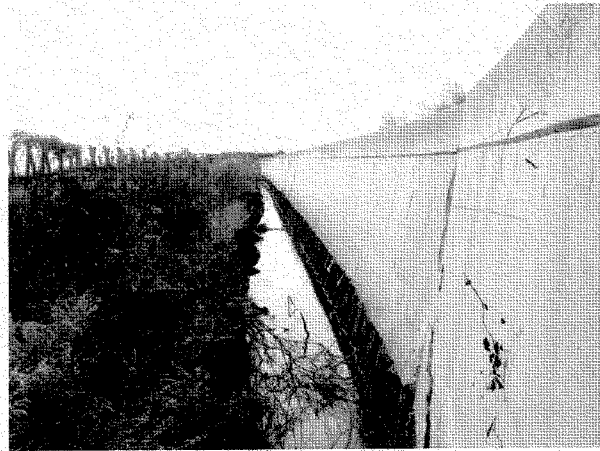
Figure 3.12: "Gapping" between soil and wall as distressed wall was displaced landward from the IWW/MRGO.

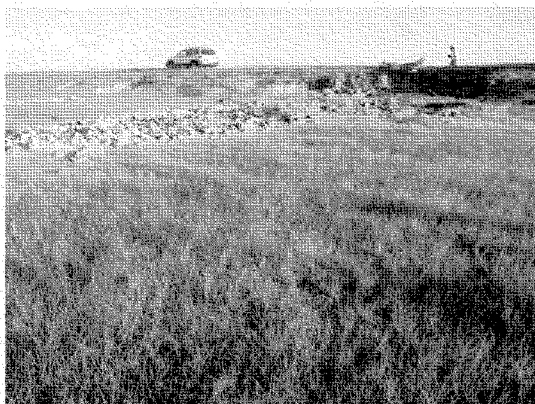
Figure 3.15: Embankment along the IWW/MRGO that survived although somewhat scoured.

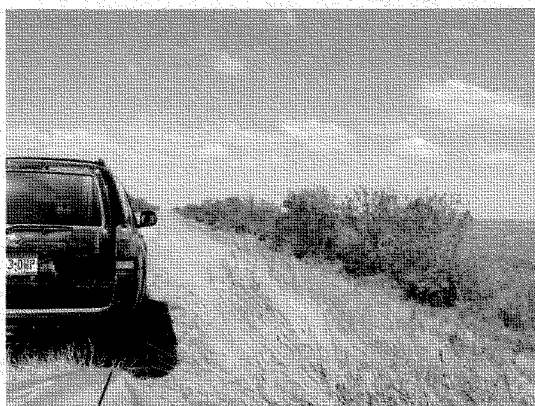
Figure 3.16: Virtually unscathed earth embankment levee on the eastern edge of the protected area of New Orleans East

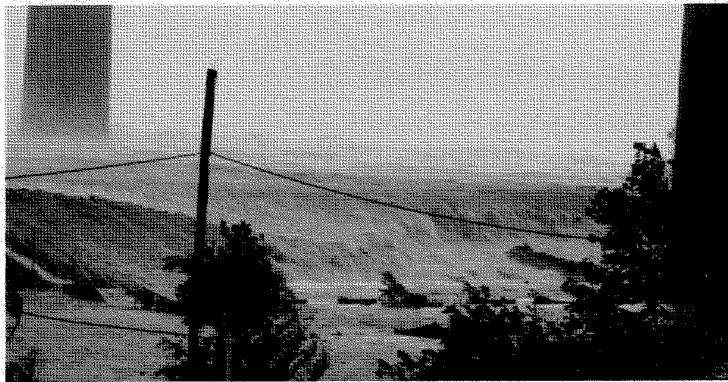
The earth levee along the north bank of the Intracoastal Waterway under the Route 47 Bridge stands as an example of satisfactory performance despite hydraulic conditions that far exceeded the design criteria. Figure 3.17 shows the erosion damage on the landside slope of the levee due to the overtopping. Figure 3.18, taken from the Entergy Michoud Generating Plant, shows the area in Figure 3.17 under storm conditions. Given the ferocity of the storm as evidenced in Figure 3.18, the relatively modest damage to the earth levee represents satisfactory performance.

Figure 3.18: Same view of the overtopped earth embankment as seen in Figure 3.17 taken during the storm surge.

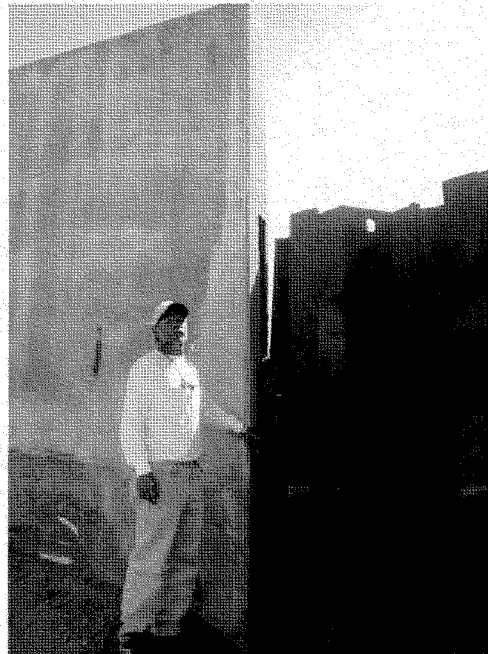
Figure 3.19: Transition between concrete and sheetpile walls at uneven wall height elevations

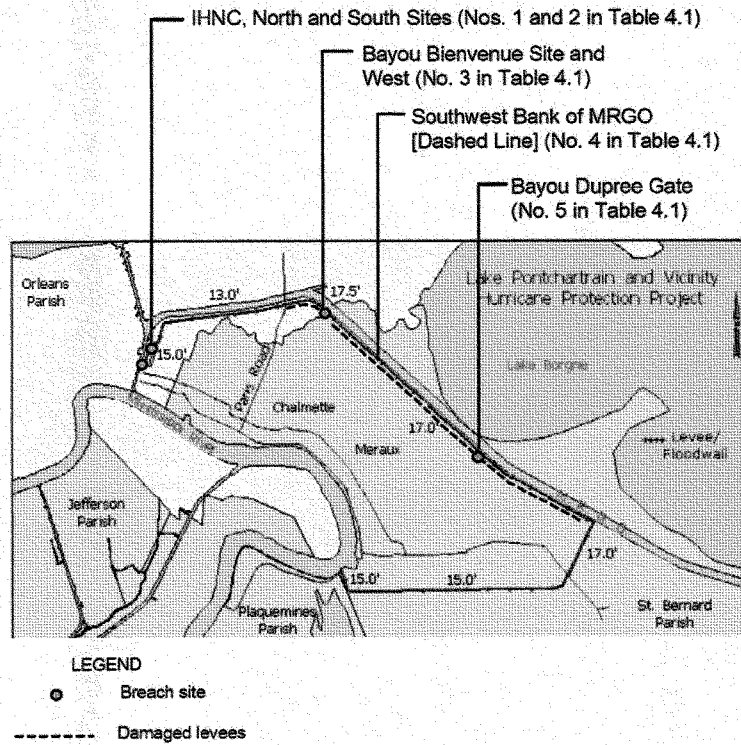
Figure 4.1: Overview map of the Lower Ninth Ward/St. Bernard Parish Polder showing the locations of damage to the primary levee system. Sites nos. 1 through 4 are summarized in Table 4.1. The elevations shown correspond to the top of the levee system at each location (after USACE).

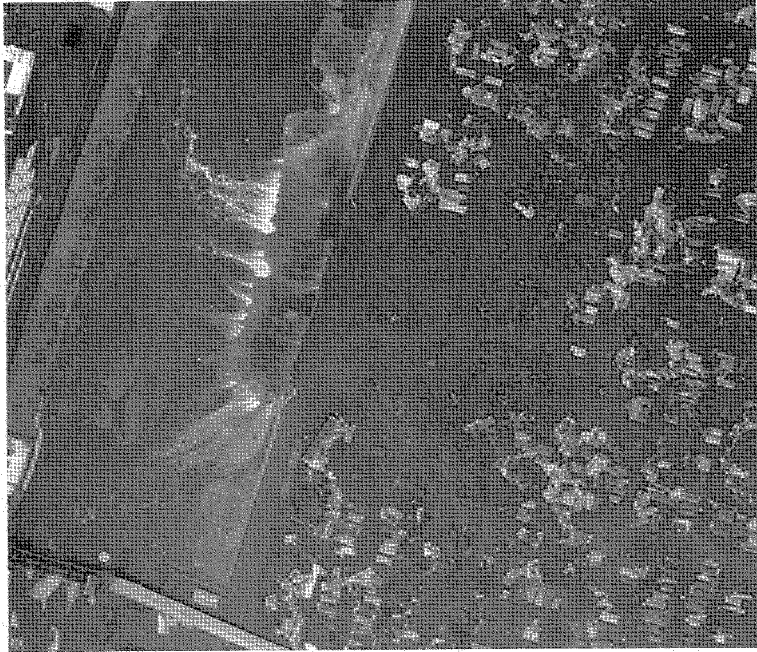
Figures 4.2 and 4.3 show aerial views of an approximately 900 feet long levee breach located 850 feet north of the Claiborne Avenue Bridge. The breach initially resulted from the Hurricane Katrina storm surge in the IHNC. An emergency repair was made shortly after the breach occurred. This repaired portion of the breach was later re-breached on September 24 by a storm surge caused by Hurricane Rita, which flooded the Lower Ninth Ward for a second time. This second flooding incident was reportedly much less severe than that caused by Hurricane Katrina (floodwaters reached a depth of about 3 feet), and as such, it is likely that it caused relatively little, if any, additional damage to the levee system at this location.

It is likely that the breach resulted from overtopping of the levee system along the IHNC, leading to scour and subsequent loss of passive resistance at the base of the wall, which then overturned in response to the high water levels in the canal. This hypothesis is supported by the extensive scour found at the base of the protected side of the levee. As the

Figure 4.3: Airborne digital imagery of the south breach at the Lower Ninth Ward. Water is shown flowing back into the IHNC (courtesy NOAA, August 31, 2005).

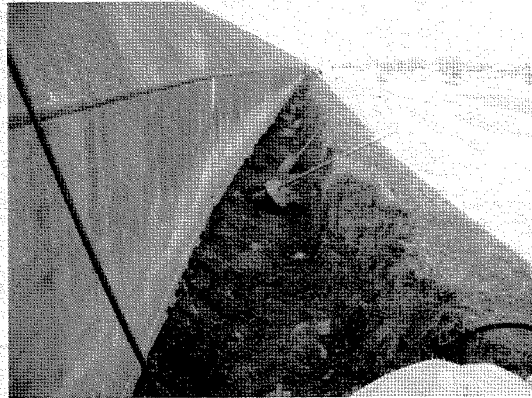
In this area, the earthen portion of the levee was almost completely destroyed and the I-wall was overturned toward the landside and dragged inland by as much as 190 feet. As shown in Figure 4.2, the displaced I-wall assumed a sinuous shape that reached its maximum distance along the northern extent of the breach. It is worth noting that the sheet pile remained interlocked, hence the displacement resulted from elongation of the sheet pile portion of the I-wall structure. The unbreached portions of the I-wall system located immediately north and south of the failure were tilted landward, reaching their maximum inclination of approximately 3 degrees near the breach and gradually tapered to close to vertical at further distances from the breach. Scour trenches at the landside toe of the floodwall (protected side) were found along the entire length of the intact I-wall section. The scour trenches were typically about 5 feet wide at the top and extended to depths of approximately 4 feet. The scour trenches were generally wide and U-shaped near the breach and gradually became narrower, V-shaped and incised with at further distances from the breach (Figure 4.4).

Figure 4.4: North view from the end of the south breach of Lower Ninth Ward. Note how the scour trench becomes progressively wider as it approaches the breach (J. Wartman, October 4, 2005).

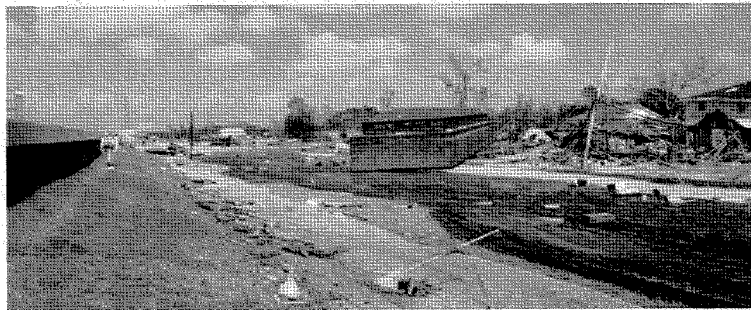
Figure 4.5 shows a unique feature of the failure site: a large barge that was drawn through the breach and came to rest on the landside of the levee as floodwaters receded. The barge was reportedly docked in the IHNC and became unmoored during Hurricane Katrina. Note the crushed school bus under the right side of the barge. Review of press photographs indicate that the barge initially came to rest further inland as floodwaters from Hurricane Katrina receded. The barge was later refloated as the Ninth Ward flooded a second time during Hurricane Rita. The barge drifted back toward the breach and came to rest upon the school bus as the Lower Ninth Ward was later unwatered.

Figure 4.5: A barge was drawn through the south breach of the Lower Ninth Ward (J. Wartman, October 4, 2005).

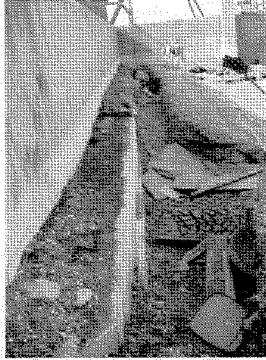
The unbreached portions of the I-wall system located immediately south of the failure were tilted inward (landward). The tilted I-walls reached their maximum inclination of approximately 3 degrees near the breach and gradually tapered to close to vertical at further distances to the south. Scour trenches at the landside toe of the floodwall (protected side) were found along the entire length of the intact I-wall section. The scour trenches were typically about 5 feet wide at the top and extended to depths of approximately 3 to 4 feet. As with the south breach, the scour trenches were wide and u-shaped near the breached area and gradually became narrower, v-shaped and incised at greater distances. Scour was also noted along the landside of the T-wall levee sections (Figure 4.8).

Figure 4.8: A scoured, but nevertheless well-performing "T-wall" levee section located near the north breach of the Lower Ninth Ward (J. Wartman, October 4, 2005).

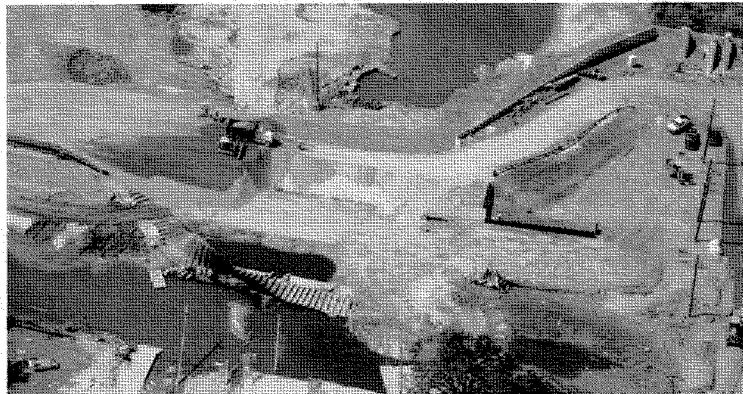
Figure 4.9 shows an aerial view of a 210 foot long levee breach located approximately 500 feet south of Florida Avenue. The breach initially resulted from the Hurricane Katrina storm surge in the IHNC. An emergency repair was made soon after. It is reported that unlike the south breach location, the north breach emergency repair was not overtopped in Hurricane Rita. The earthen portion of the I-wall levee system was almost completely destroyed and the I-wall was overturned and dragged inland by as much as 70 feet while remaining fully interlocked. In the most extreme case, the I-wall came to rest upside down, with the concrete portion at the bottom, and the toe of the sheeting pointing upward (Figure 4.10). The sheet pile separated from the concrete wall at the north end of the site by splitting the webbed section rather than tearing the interlock.

Figure 4.9: Aerial view of the north breach of the Lower Ninth Ward (L. Harder, October 14, 2005).

Figures 4.9 and 4.11 show the emergency repair, consisting of a core of large sandbags overlain by embankment fill. The sandbags were airlifted into place, while the stone was placed from land. Owing to the presence of standing water on the landside during a visit on October 4, it was not possible to determine if seepage was occurring through the repaired section.

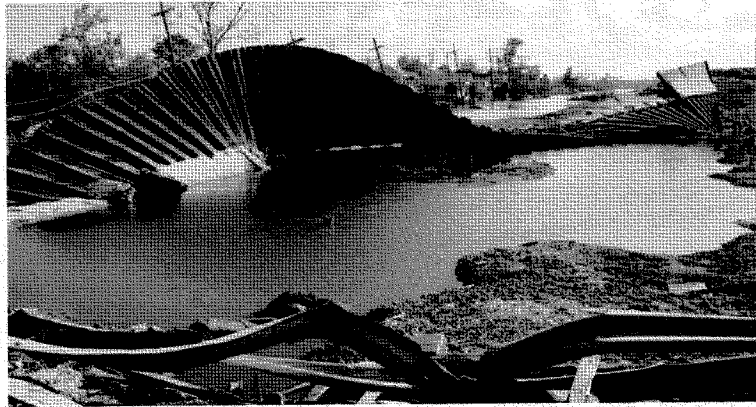
It is likely that the breach occurred in a manner similar to that described for the south breach location (i.e. overtopping of the levee, leading to scour and loss of passive resistance at the base of the wall, resulting in overturning). The scour-related failure hypothesis is again supported by extensive erosion found at the base of the protected side of the levee. While it is thought that overtopping may be the principal cause of the levee failure, it is not yet known why the failure occurred at this location along the IHNC levee system.

Figure 4.10: Overturned I-wall system at north breach of Lower Ninth Ward (J. Wartman, October 4, 2005).

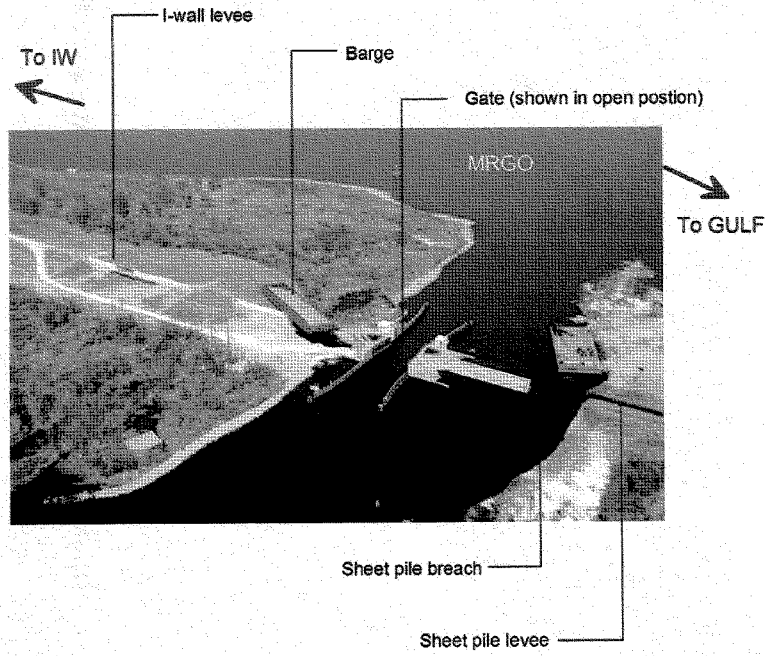
The flood protection system at the Bayou Bienvenue gate site is a complex levee-gate transition involving several different levee sections located as shown in Figure 4.12. These include (from northwest to southeast) an earthen levee, transitioning to an I-wall, transitioning to a gate structure, transition to a sheet pile section, which finally transitions again to an earthen levee along the MRGO.

Visible in Figure 4.12 is a large barge that struck and then overran the I-wall section northwest of the gate. The barge eventually came to rest directly upon the I-wall, which was locally damaged by the impact of the barge. Scour was found immediately adjacent to the I-wall damage as a result of concentrated water flow at this location (Figure 4.14). Despite the combined effects of the scour, impact damage, and the vertical load imposed by the barge, the I-wall at this location survived relatively intact and performed remarkably well. As shown in Figure 4.15, minor scour was also noted at the transition between the earthen levee and I-wall section located northwest of the barge.

Figure 4.12: Northwest facing aerial view of the Bayou Bienvenue Gate structure (L. Harder, October 14, 2005).

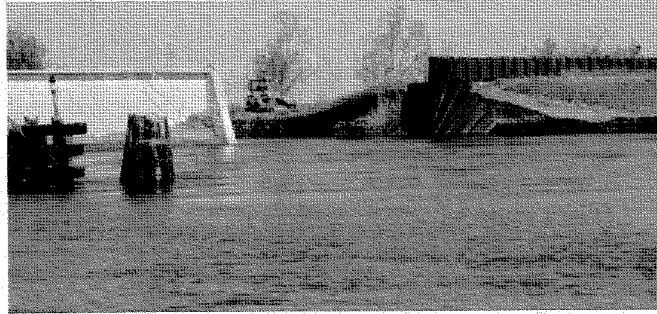
Figure 4.13 shows an approximately 80 feet long levee breach in the sheet pile section located immediately southeast of the gate structure. The earthen portion of the levee was completely obliterated and the sheet pile wall appears to have been torn from its connection southeast to the Bayou Bienvenue gate structure, and overturned. Representatives of the Orleans Levee District indicated that the gates were closed during Hurricane Katrina, and later reopened manually, due to the lack of electric power, after the storm had passed. Many of the sheet pile breach features were obscured by water at the site, and hence it was not apparent if the breach occurred due to a structural failure at the sheet pile gate connection, a result of overtopping, leading to scour and subsequent loss of passive resistance, or some combination of these factors. At the time of the last visit to the site on October 5, no repairs had been made to the breach.

Figure 4.13: Sheet pile breach at the Bayou Bienvenue Gate (J. Wartman, October 5, 2005).

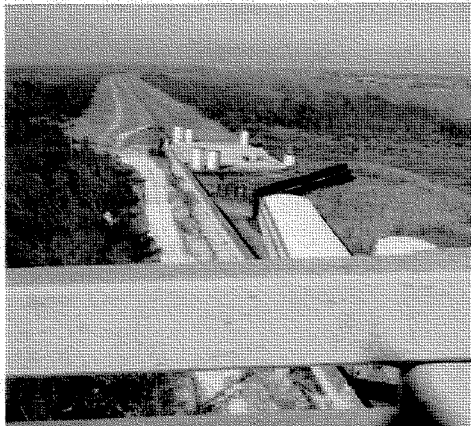
Figure 4.16: View of levee along the south bank of the Intracoastal Waterway from the Rt. 47 Bridge (Lee Wooten, October 6, 2005).

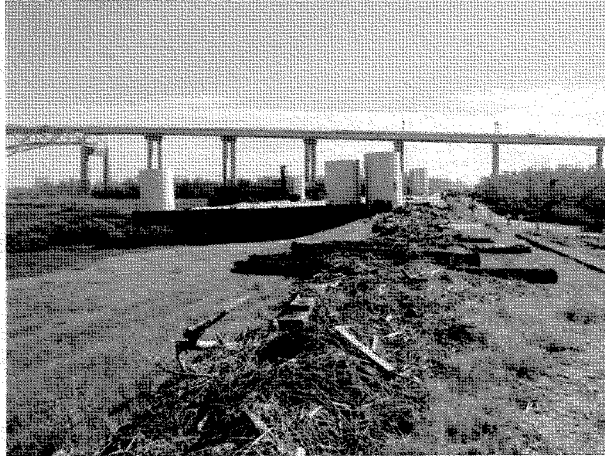
Figure 4.17: Debris line near levee crest just west of the Rt. 47 Bridge south abutment (L. Wooten, October 5, 2005).

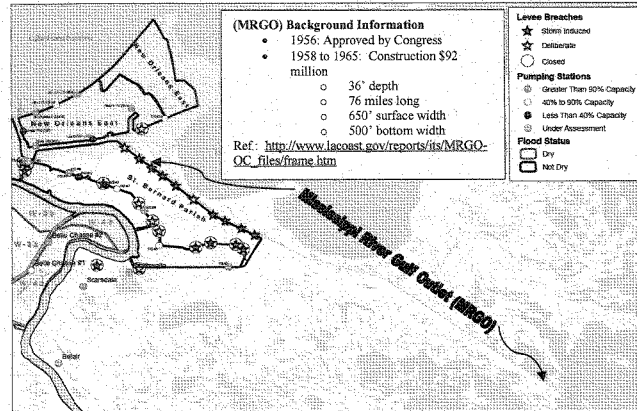
Figure 4.19: Mississippi River Gulf Outlet [MRGO] (USACE). The two yellow stars (i.e., deliberate breaches) along MRGO seem to correspond to locations of gate structures where storm-induced breaches occurred. These yellow star markers are likely errors in the original map that should have been designated using blue star markers.

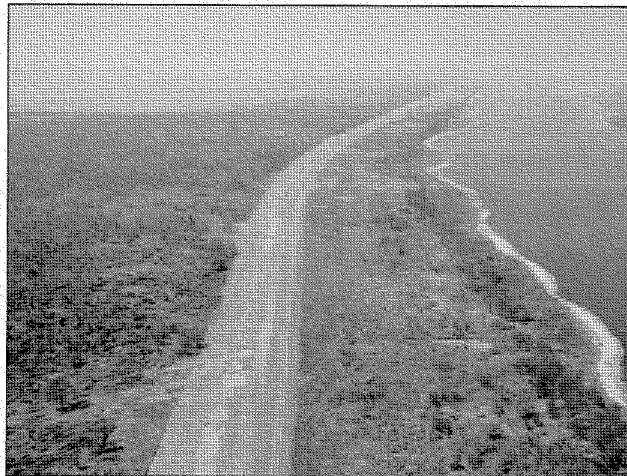
Figure 4.26: Aerial view of MRGO looking towards the city of New Orleans (L. Harder, October 14, 2005).

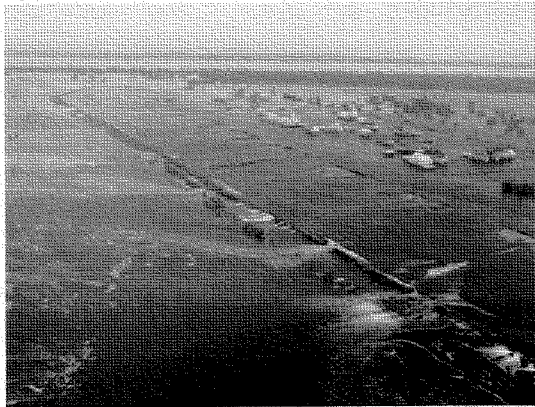
Figure 5.1: Aerial photograph of inundated portion of Myrtle Grove along western side of the Mississippi River (September 25, 2005)

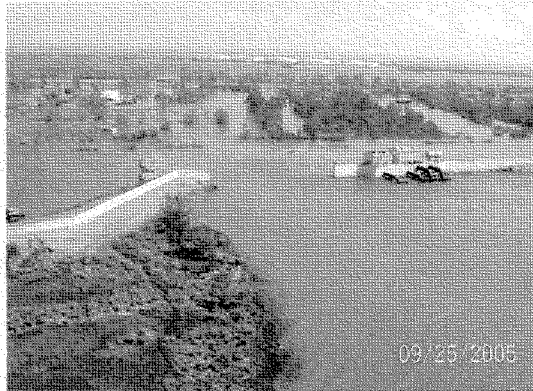
Figure 5.2: Aerial photograph of levee breach of hurricane (back) levee along western side of the Mississippi River near the community of Sunrise (September 25, 2005)

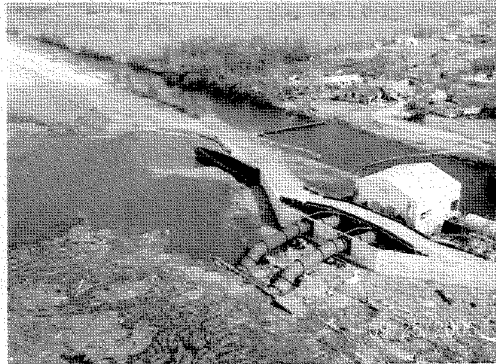
Figure 5.3: Aerial photograph of levee breach of hurricane (back) levee at levee transition near Hayes Pump Station (September 25, 2005)

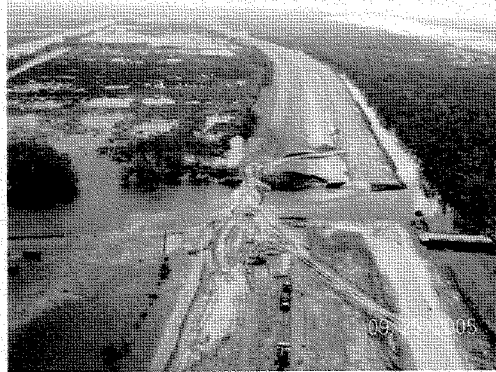
Figure 5.4: Aerial photograph of levee breach of hurricane (back) levee east of Pointe a la Hache (September 25, 2005)

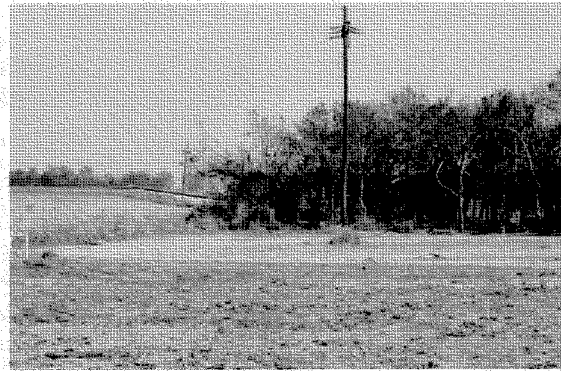
Figure 5.6: Photograph of flood elevation on trees landward of hurricane levee east of Pointe a la Hache – illustrating that flood water remained to large depths for extended periods (October 12, 2005)

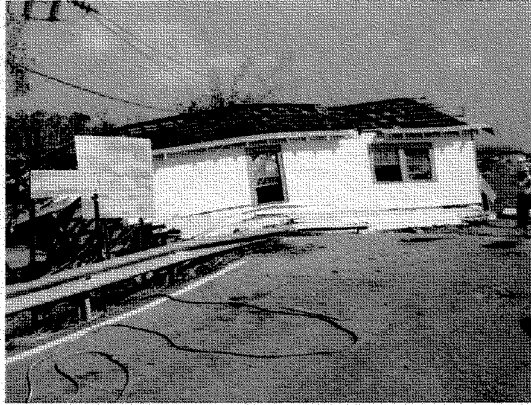
Like many New Orleans residences, the small wooden homes in Pointe a la Hache were commonly founded on cinderblock piers. As a result of the deep flooding and the flow towards the Mississippi River, homes in Pointe a la Hache were commonly picked up and floated away from their foundations. Many ended up being deposited on or across the Mississippi River Levee as a result of flood waters flowing into the Mississippi River (see Figures 5.7 through 5.9).

Figure 5.7: Photograph of Pointe a la Hache home deposited on Mississippi River levee crown after storm surges overtopped this levee from the east (left) towards the river – which is to the right in this photograph (October 12, 2005)

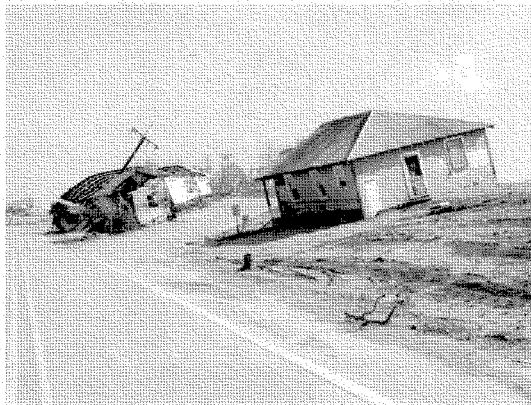
Figure 5.8: Photograph of Pointe a la Hache homes deposited on Mississippi River levee after storm surges overtopped the levee from the east (left) towards the river (right) (October 12, 2005)

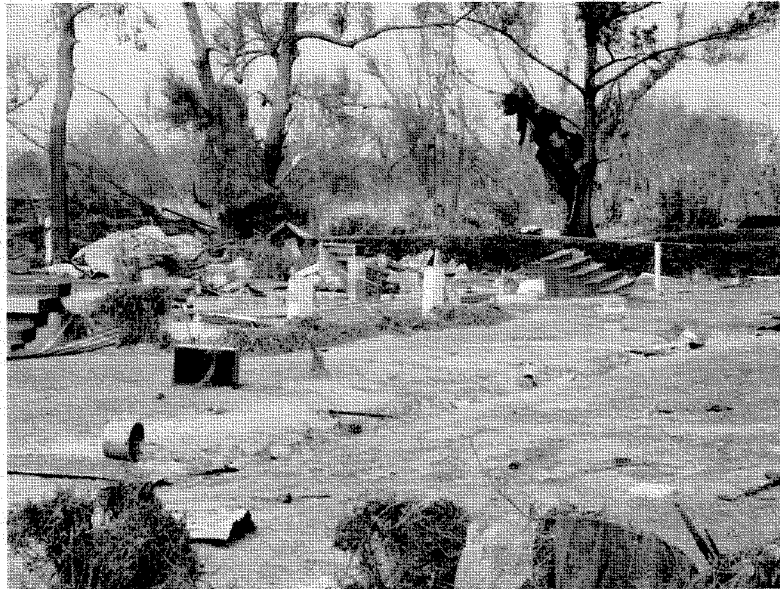
Figure 5.9: Photograph of Pointe a la Hache home site where wooden home was floated off of its cinderblock piers – note concrete stairs and black plastic sheet in tree illustrating the depth of flooding (October 12, 2005)

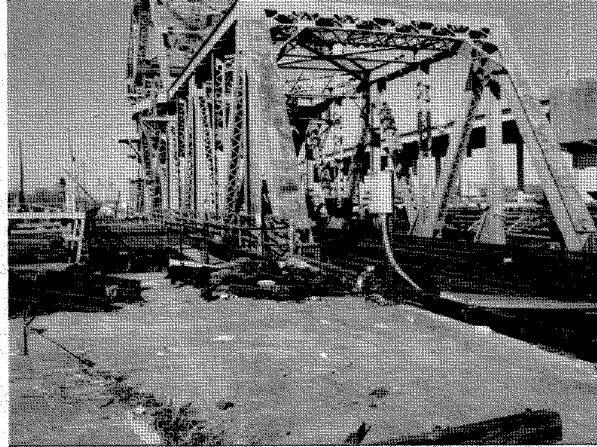
Figure 6.1: A railroad bridge adjacent to the Lake Pontchartrain frontage road.

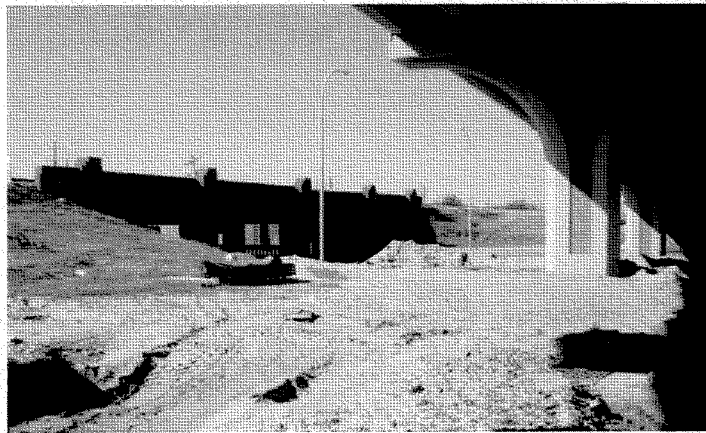
Figure 6.3: Lack of a flood gate beneath the railroad over-crossing facilitated the flooding of residential neighborhoods.

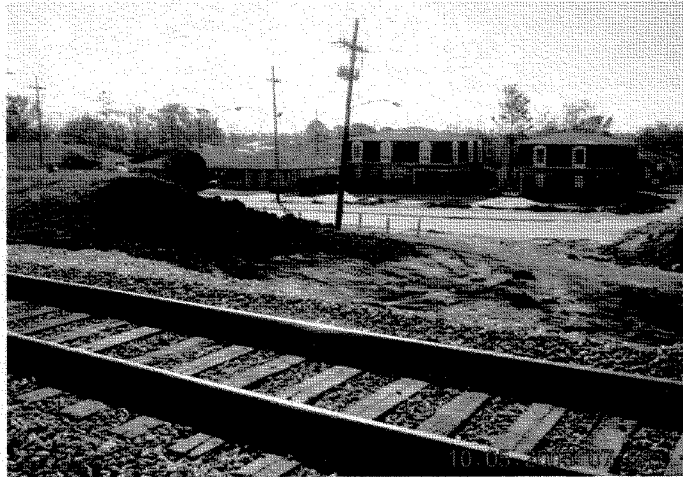
Figure 6.4: This flood protection levee was overtopped and scoured, resulting in flooding of this lakefront residential area.

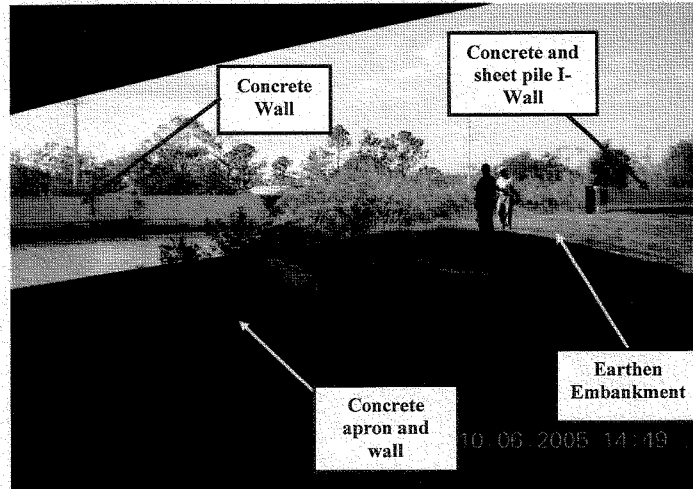
Figure 6.8: Area outside (to the north of) the Orleans pump station.

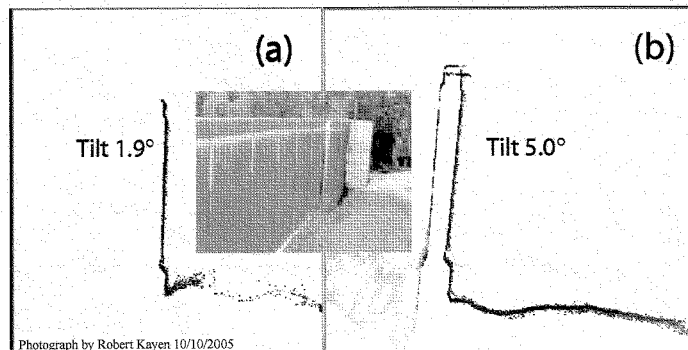
Considerable vegetation grows along the banks of the canal side of the levee that are less maintained for growth than the landside neighborhood-side of the levee wall. Thin slices of the point-cloud data orthogonal to the alignment of the levee wall (Figure 7.14) display highly accurate cross sections of the distressed I-wall at London Canal. Segment (a) is toward the south (left) of Figure 7.13 and has a modest 1.9 degree rotational deformation. Near a position of maximum distress, the I-wall has 5.0 degrees of rotational deformation toward the landside of the levee.

Figure 7.14: Cross sections through two segments of distressed I-wall at London Avenue Canal. Segment (a) is toward the south (left) of Figure 7.13 and has a modest 1.9 degree rotational deformation toward the landside of the levee. Near a position of maximum distress, the I-wall has 5.0 degrees of rotational deformation.

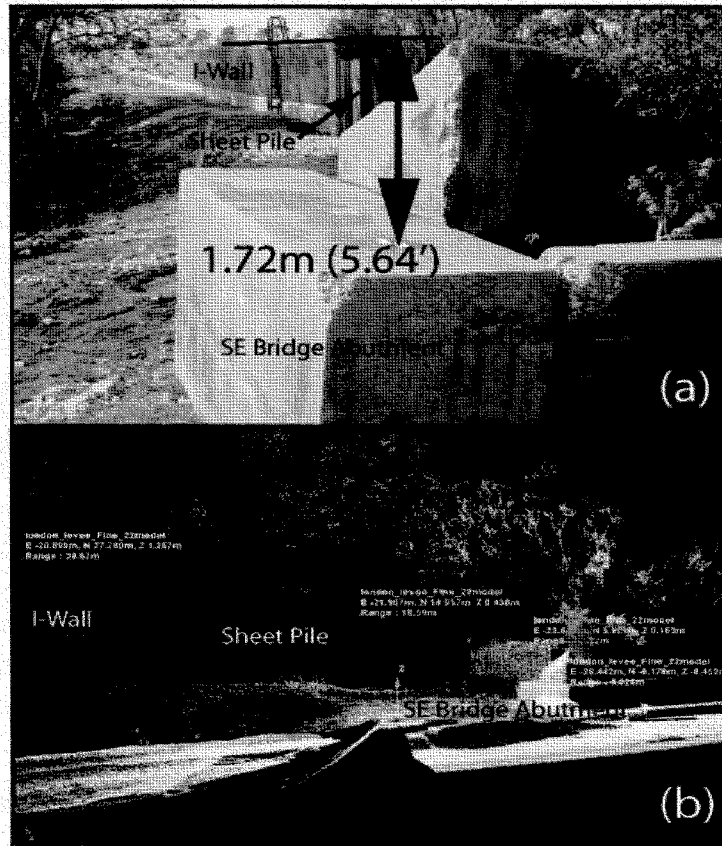
The London Canal levee failure (west side) and distressed wall (east side) are both immediately south of the bridge crossing at Robert E. Lee Boulevard. A significant gap in height between the lower un-walled bridge abutment and I-wall prevents water from overtopping these levees. The height gap differs slightly between the walls located north and south of the bridge, due either to differing design heights or differential settlement following construction. At the distressed I-wall section on the southeast corner of the bridge, LIDAR surveys and visual inspection indicated the gap at this location was approximately 1.7 meters (5.6 feet). Therefore, water rising in the canal would overtop the bridge abutment and begin to flood the surrounding community when the water level was 1.7 meters (5.6 feet) below the top of the I-wall. Figure 7.15 shows this considerable wall gap, as well as moderate scour at the southeast edge of the bridge abutment (Figure 7.15a). On the northeast corner of the bridge abutment near the north levee wall, LIDAR surveys indicate the gap at this location to be approximately 1.51 meters (5.0 feet). Figure 7.16 and 7.17 show this gap, as well as a scour trench at the base of the northeast abutment (Figure 7.17a).

Figure 7.15: Photograph of the southeast abutment of the London Avenue Canal bridge at Robert E. Lee Blvd (a), and LIDAR scan of the same location (b). New soil and rock apparently fills scour and sink hole erosion beneath the abutment. The relative height gap between the bridge abutment and the flood wall is 1.72 meters (5.6 feet).

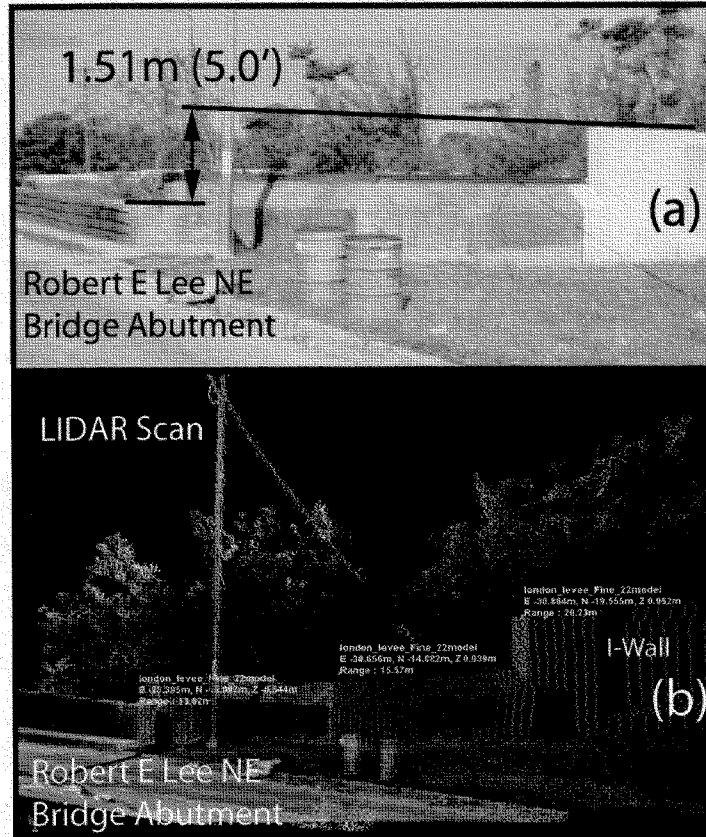
Figure 7.16: The northeast abutment of the London Avenue Canal bridge on Robert E. Lee Blvd. in photograph taken from the lower portion of the bridge approach-fill embankment (a), and corresponding LIDAR scan (b). The wall gap here is 1.51 meters (5.0 feet).

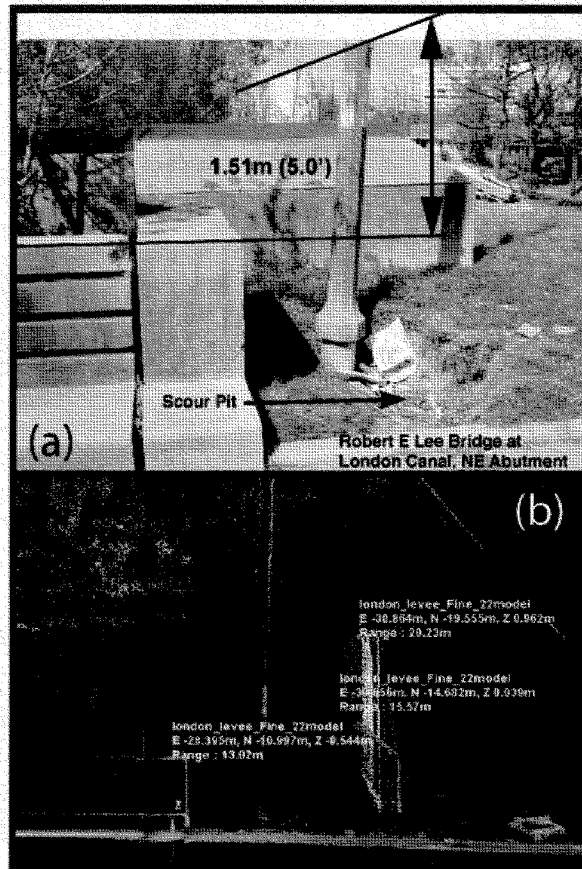
There was no evidence of overtopping of the levee walls or erosion scour anywhere along this section of the canal except at the gap at the bridge. The LIDAR and scour evidence therefore indicate that the floodwalls along the London Canal section, south of the Robert E. Lee Boulevard Bridge were not overtopped prior to failure of the levee wall.

Figure 7.17: Photograph taken directly south and adjacent to the northeast abutment of the Robert E. Lee Bridge (a), and corresponding LIDAR scan of the same location (b). A scour trench is clearly visible beneath the abutment. The wall gap here is 1.51 meters (5.0 feet).

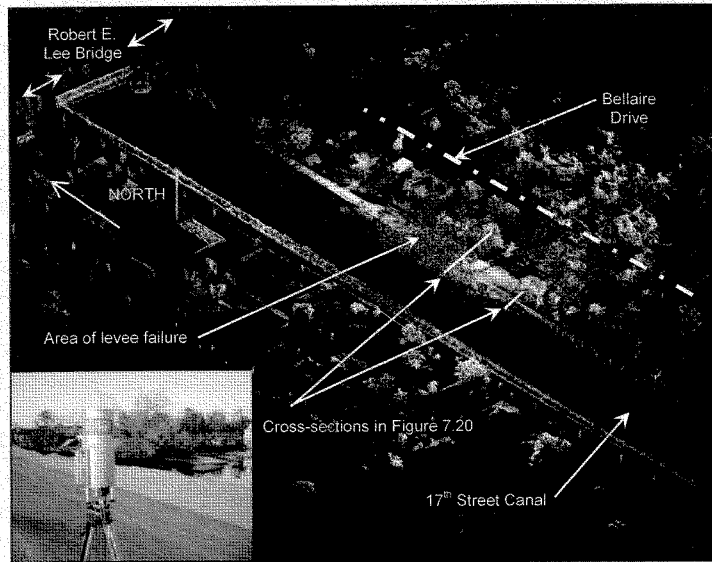
Measurement of displacement along the 17<sup>th</sup> Street Canal breach can be made by identifying the blocks of ground formerly within the intact levee that slid eastward toward the landside of the levee. Figure 7.18 is an overview image of a portion of the 17<sup>th</sup> Street point cloud data set consisting of 11 individual scans. In this image, the bridge crossing over the canal at Robert E. Lee Blvd. (also called the Hammond Highway.) is toward the upper left (north). A dense cluster of points is visible at the levee breach in the center of the image as are the houses in the affected area. Close in to the levee breach in Figure 7.19, the remaining I-wall can be seen in alignment with the crest of the replacement structure. Here, a total breach repair width of 142 meters (466 feet) as measured between intact I-wall sections has been calculated directly from the LIDAR data set. A cross section taken through this area is shown in Figure 7.20. A multi-section view is shown, consisting of a section of the intact southern I-wall overlain over the failed section of the levee. The geometry of the emergency repair embankment is clearly visible. The sections also show the magnitude of the

Figure 7.18: Overview oblique image of the 17<sup>th</sup> Street Canal area in the vicinity of the breach. The Robert E. Lee Blvd. Bridge is to the north (upper left) and the breach area is to the upper right (east). Houses within the neighborhood breach area and the scour pond were imaged from the new levee and Bellaire Drive.

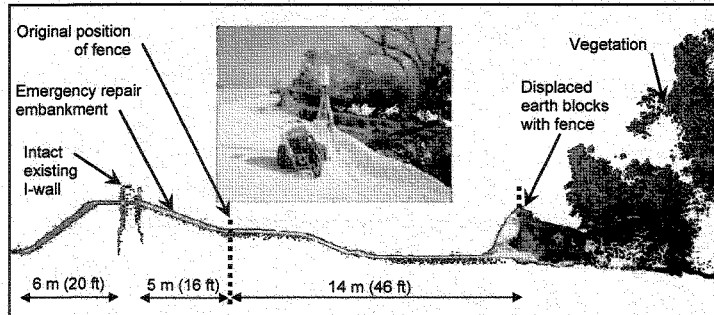
displacement of several earth blocks that moved away from the levee break during failure. While forensic work on the original positions of the earth blocks is still ongoing, the LIDAR data shows that blocks translated approximately 14 meters (46 feet) as measured from the existing alignment of the cyclone fence line to its new position within the displaced blocks. From the perspective shown in Figure 7.20, it can also be seen that the width of the 17<sup>th</sup> St. Canal has been reduced about 6 meters (20 feet) by the placement of the earthen embankment.

Figure 7.20 Cross-section of the 17<sup>th</sup> Street Canal breach looking northward. Measurement of the lateral translation of the landside soil levee from its original position is approximately 14 meters (46 ft). The I-wall in this image is offset (out of the page) from the slide block.

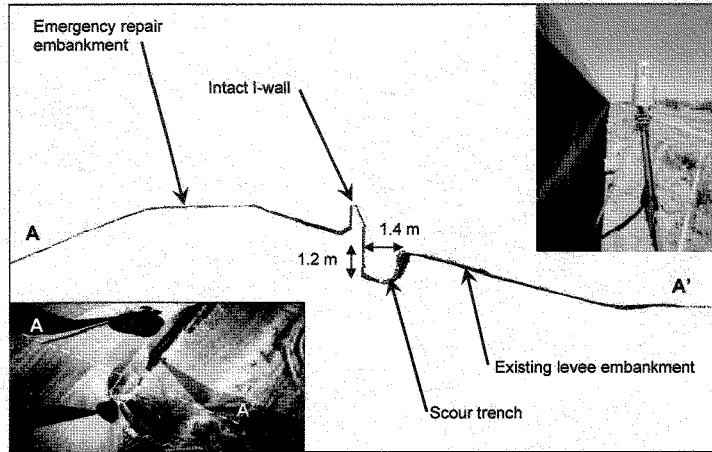
Figure 7.21: Measurement of scour trench dimensions at the IHNC – South site.
