1966 BEECH BARON

CASE 1-1

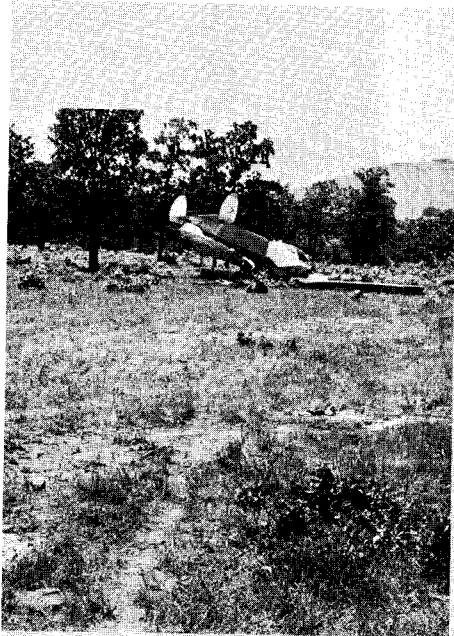
A. Distant view of resting aircraft & part of its 114-foot skid mark.

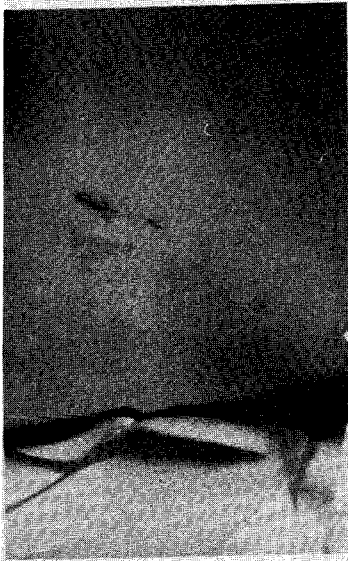
C & D Minor abrasions in the pelvic area are proof that this pilot was wearing a seat belt.
