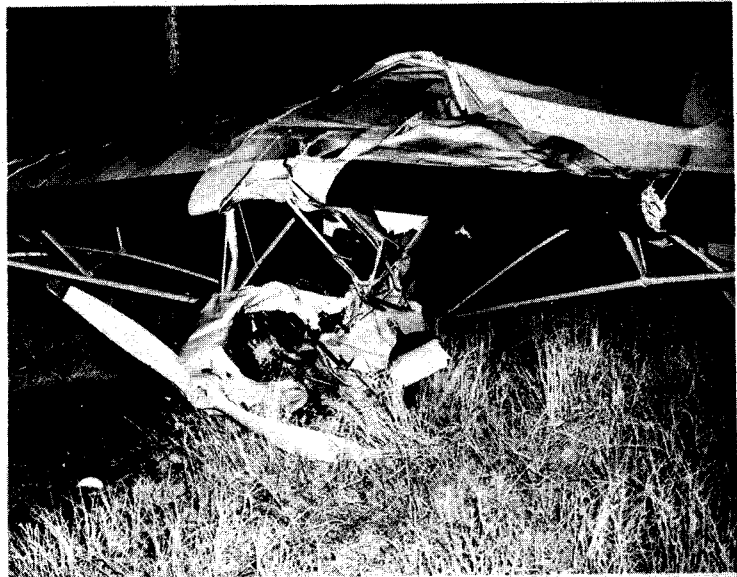
B. Front view showing tubular framework of this aircraft prevented cabin collapse.

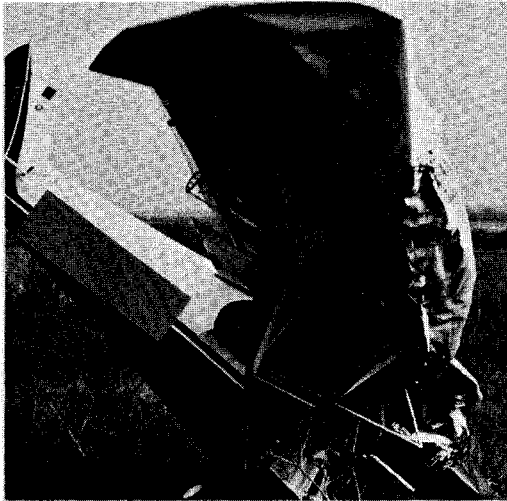
A. Photograph of wreckage from side showing cabin space not compromised.

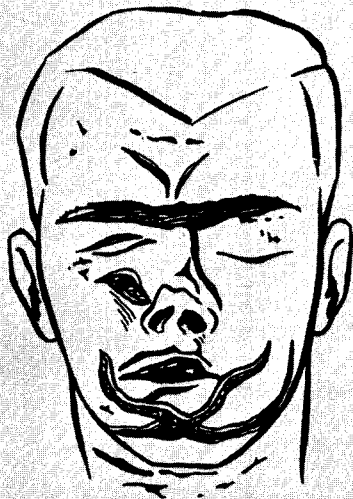
C. Artist sketch of severe lacerations & facial crushing resulting from impact with the instrument panel.

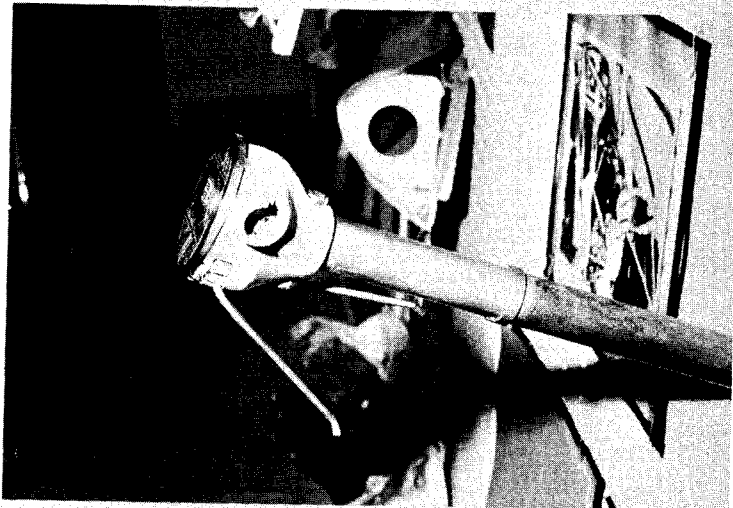
G. Control wheel was removed from chest cavity with difficulty since wire spokes opened up like an umbrella.

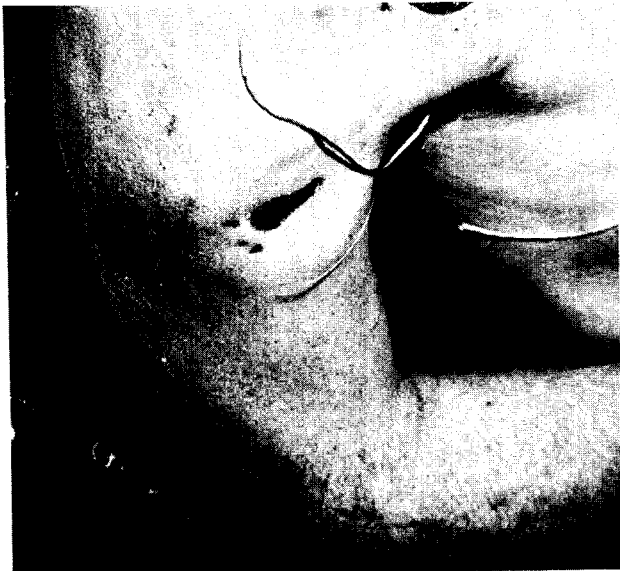
H. Puncture wounds in the right shoulder from hub & spokes of right control wheel.

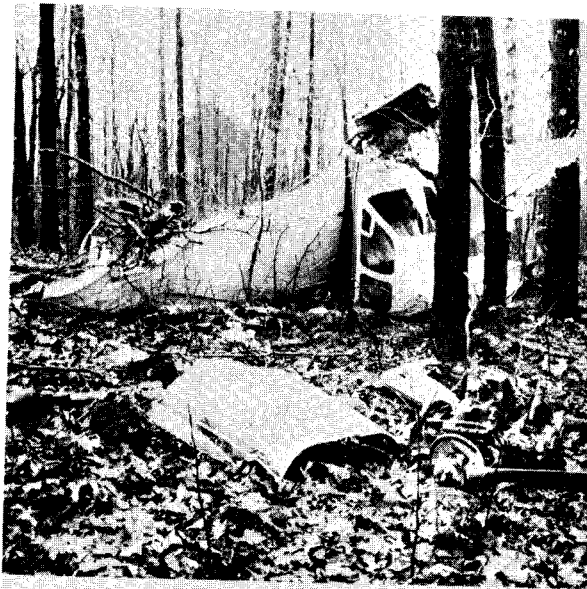
A. Wreckage of Beech Bonanza. Note that the tail, wings, & motor are torn away, but the cabin is intact.
