1968 CESSNA 150

ACCIDENT INVESTIGATED BY:
GALE BRADEN AND DON ROWLAN
CAMI

CASE 20-1

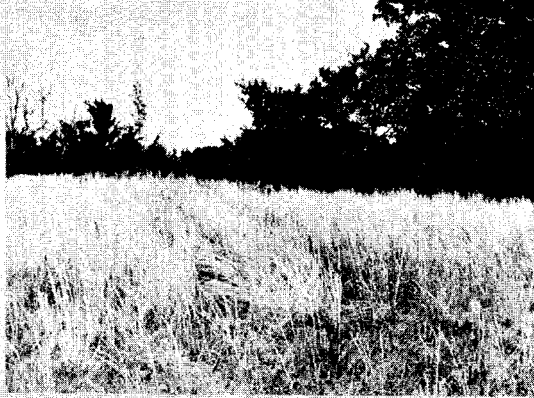
A. Distant view of crash site. Tracks in wheat field were made by rescue personnel as aircraft did not touch the ground before striking the tree.

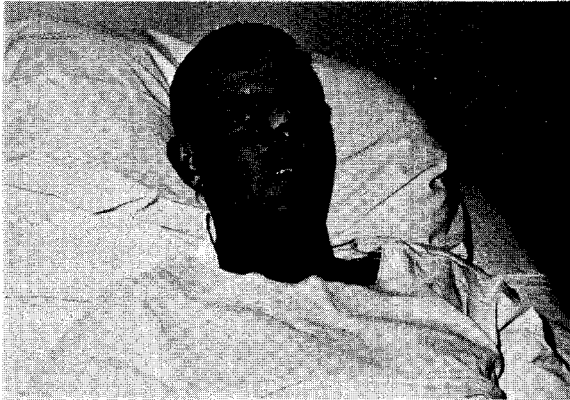
E. Copilot received only minor nose injury as he was thrown sideways away from the instrument panel.
