# NASA Technical Memorandum 87636

EARTH RADIATION BUDGET EXPERIMENT (ERBE) SCANNER INSTRUMENT ANOMALY INVESTIGATION

N. D. WATSON, J. B. MILLER, L. V. TAYLOR, J. B. LOVELL, J. W. Cox, J. C. Fedors, L. P. Kopia, R. M. Holloway, and O. H. Bradley

OCTOBER 1985

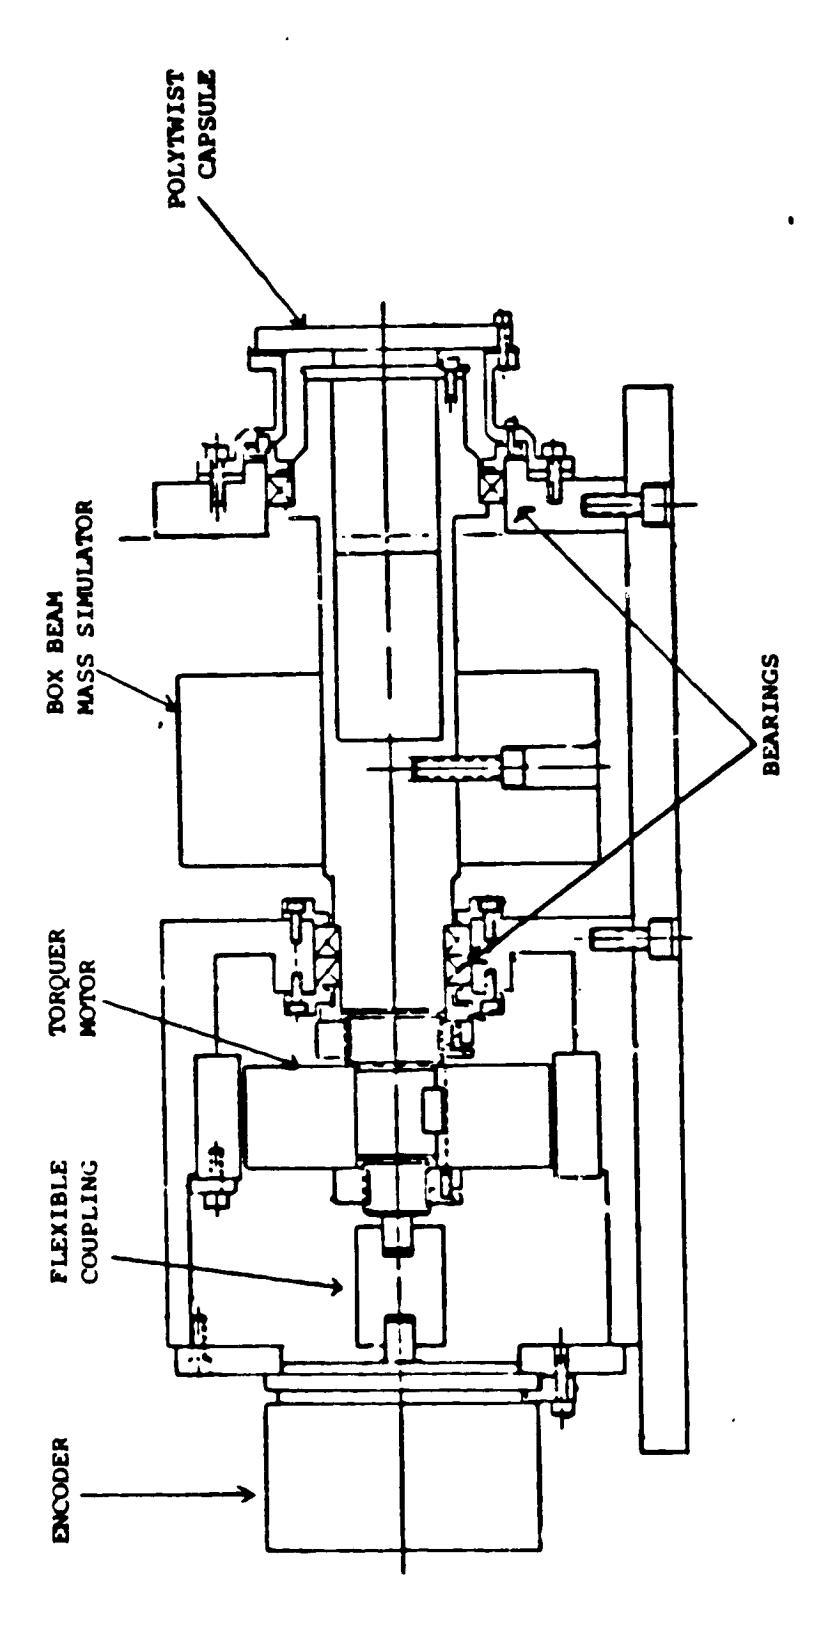
Figure 1

A two part analysis was performed; compound identification of the material on the phenolic retainer and the balls, and a surface elemental analysis of the outer race. A schematic of the Scanner assembly of the life test model is shown in figure 1.

The evidence indicates ineffective transfer of the liquid lubricant from the phenolic retainer to the ball bearings. This lack of lubrication between the ball bearings and the races may be due to the TCP treatment. In the high vacuum conditions of outer space, once the lotal oxide or phosphate film wears away, there is no oxygen or water varor to react with the nascent metal surfaces to reform a protective film.

In light of the low vacuum  $(10^{-3}$  Torr) used in the scanner life tests, it is possible that the deposit found on the outer race could have resulted from an oxygen reaction at the wearing surfaces.

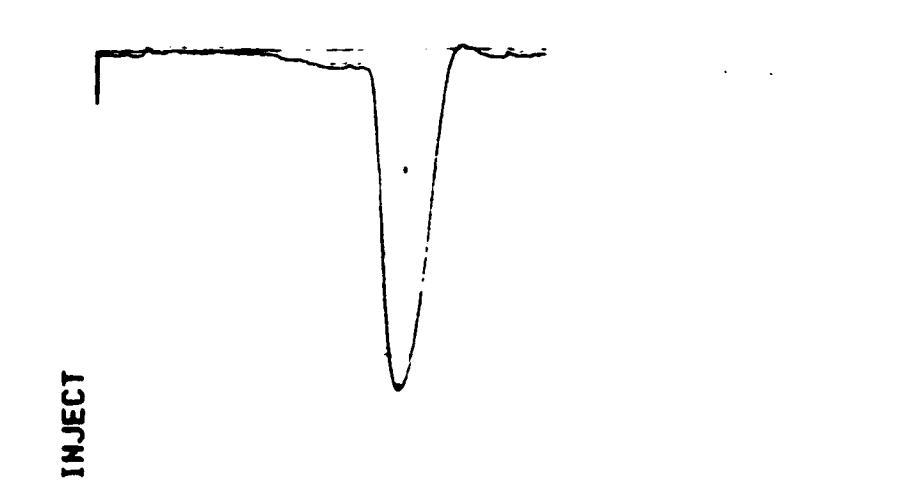
Fig. 1- HPLC chromatogram of the unused fluorocarbon liquid lubricant

The compound identification analysis was accomplished by first obtaining a high pressure liquid chromatography (HPLC) chromatogram of the unused fluorinated polyether liquid lubricant. This was done by dissolving 30 ul of the lubricant in 4 ml of 1,1,2 trichlorotrifluoroethane (a "Freon" solvent) and injecting 30 ul into the HPLC unit. Figure 1 is the HPLC chromatogram of the unused lubricant. All HPLC separations were conducted in the size exclusion mode using an E-125  $\mu$ -Bondagel column and a 60Å  $\mu$ -Porasil column. The mobile phase (the 1,1,2 trichlorotrifluoroethane solvent) flow rate was maintained at 0.5 ml/min and compound detection made by a refractive index detector.
