# 737 GRAPHITE COMPOSITE FLIGHT SPOILER FLIGHT SERVICE EVALUATION

**EIGHTH REPORT  
MAY 1981 THROUGH DECEMBER 1984**

**Prepared under Contract NAS 1-11668 by  
BOEING COMMERCIAL AIRPLANE COMPANY  
July 1985**

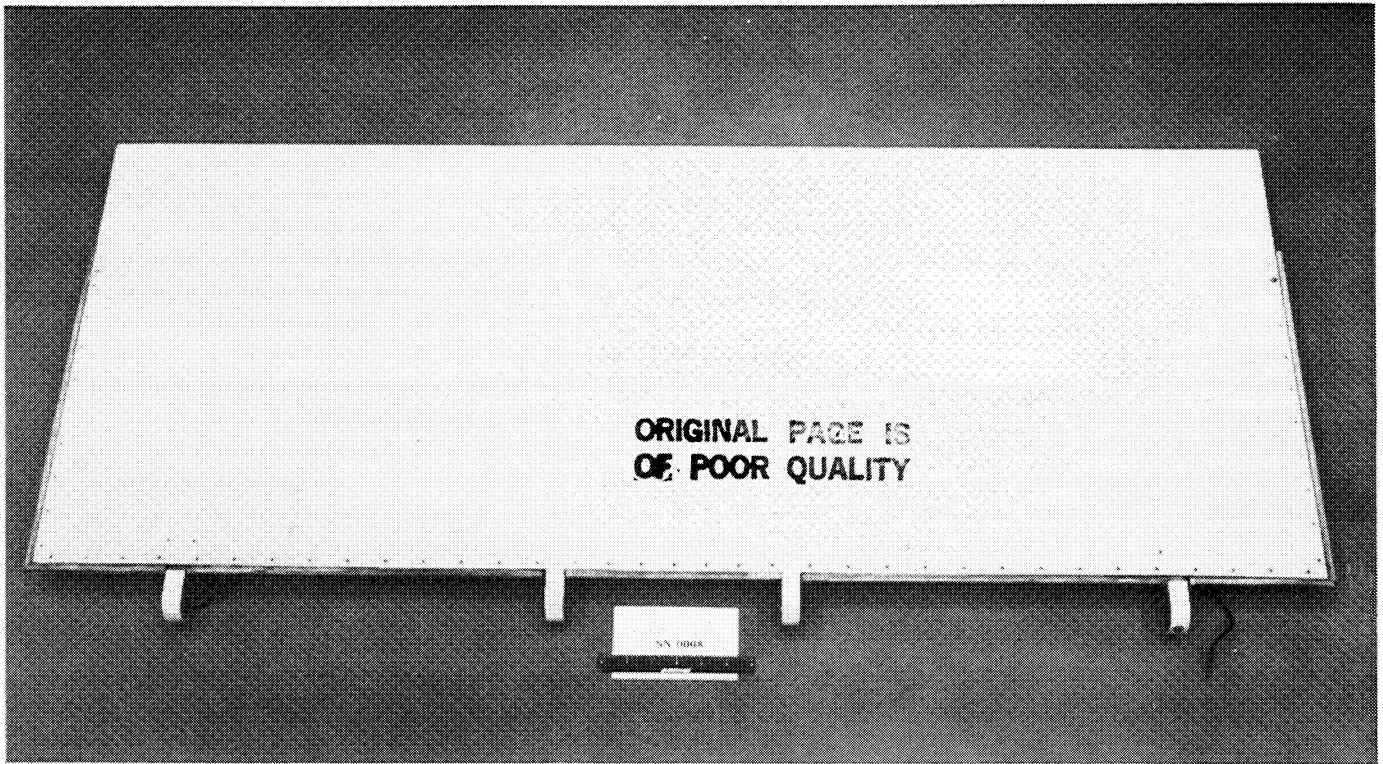
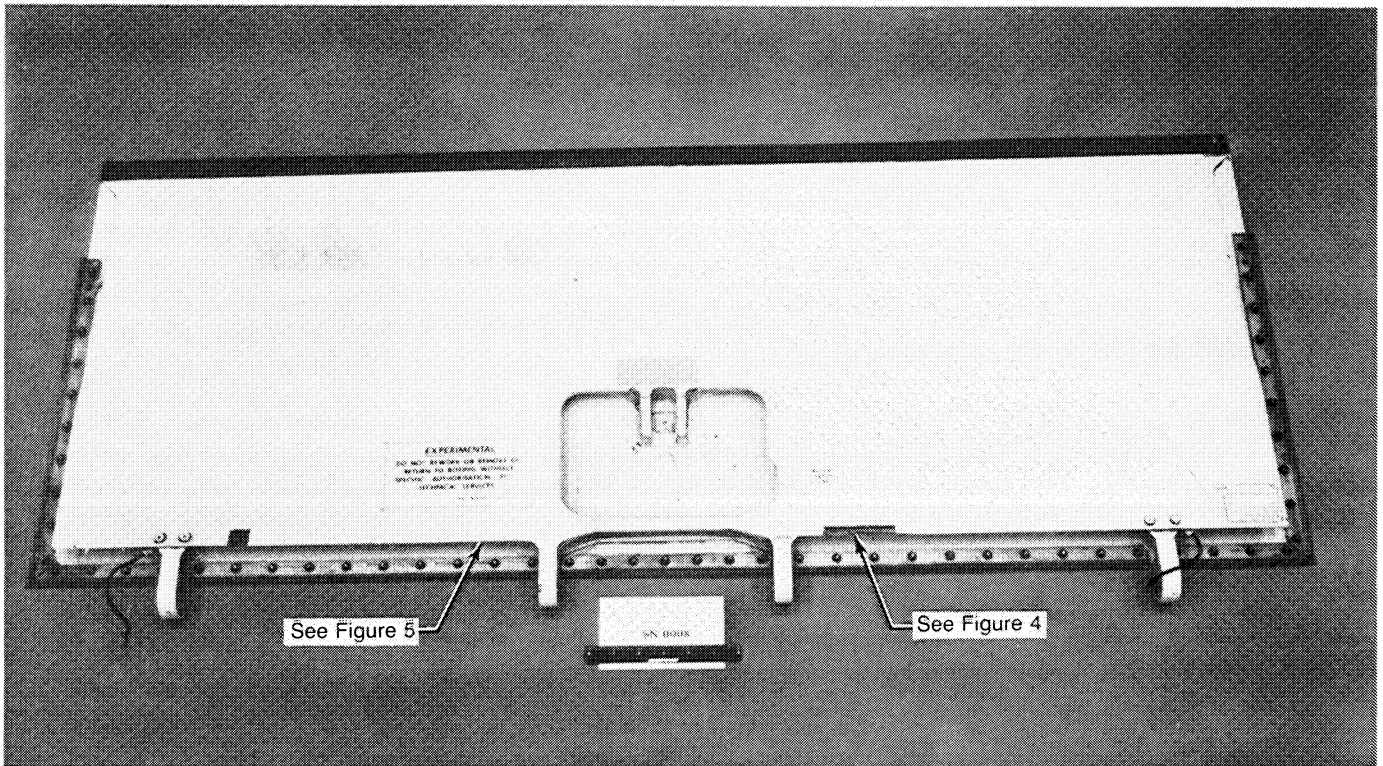
Figure 2. Upper Surface of Spoiler S/N 0008 After 7 Years of Service

Following selection for test, the units were photographed. Figures 2 and 3 show the upper and lower surfaces of spoiler S/N 0008 after 7 years of service, respectively. The damage on this unit is shown in Figures 4 and 5. Figure 4 shows an exfoliation corrosion blister at one spar to center hinge fitting splice, and Figure 5 shows a similar but less severe exfoliation corrosion blister at the opposite side.

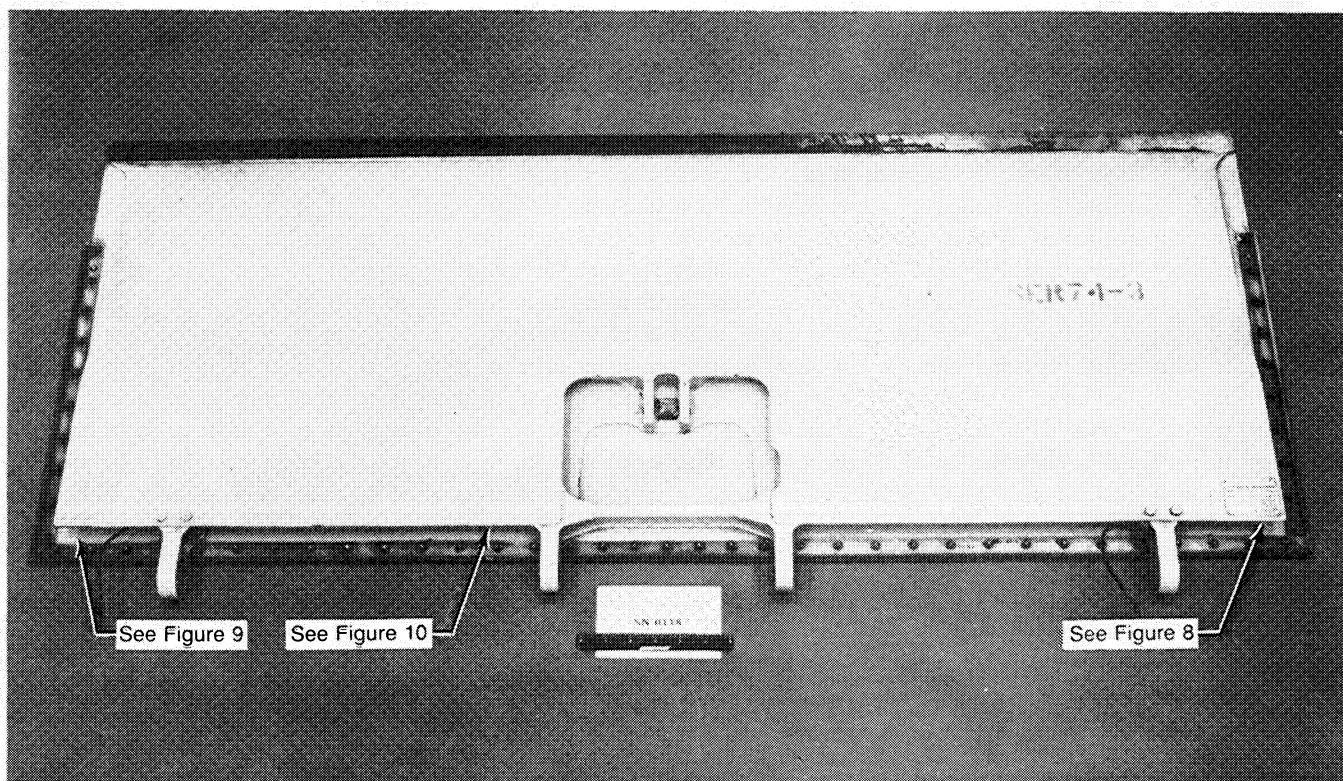
Figure 7. Lower Surface of Spoiler S/N 0118 After 7 Years of Service

Figures 6 and 7 are photographs of the upper and lower surfaces, respectively, of spoiler S/N 0118 after 7 years of service. The upper surface shows evidence of paint erosion although no damage to the graphite skin was apparent. Figures 8 through 10 show the damage found on this unit. Figure 8 shows earlier minor doubler corrosion that had been dressed down and repainted by the airline. This condition was also found on the opposite side. An edge delamination on the corner of the panel is also shown. These two defects are shown on Figure 9. The initial stages of exfoliation corrosion at one spar to center hinge fitting splice are shown on Figure 10.

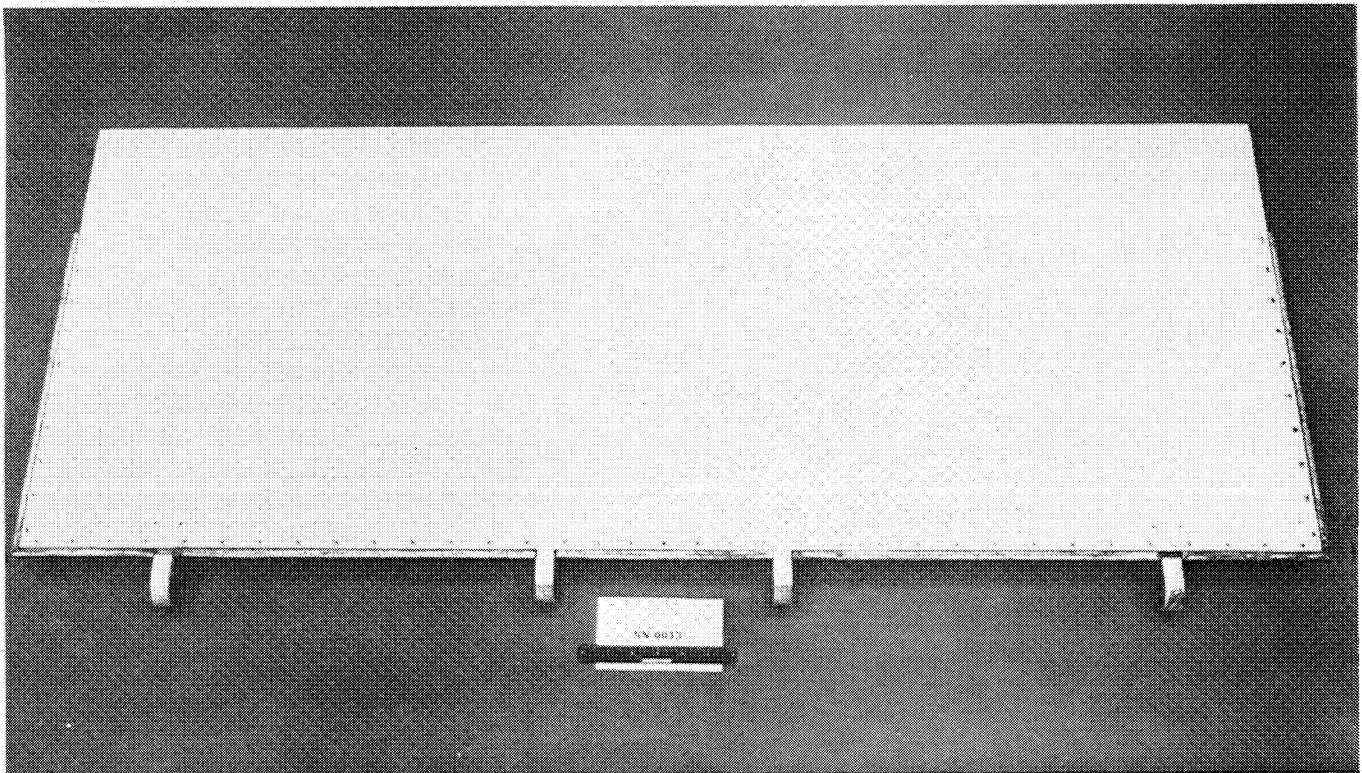
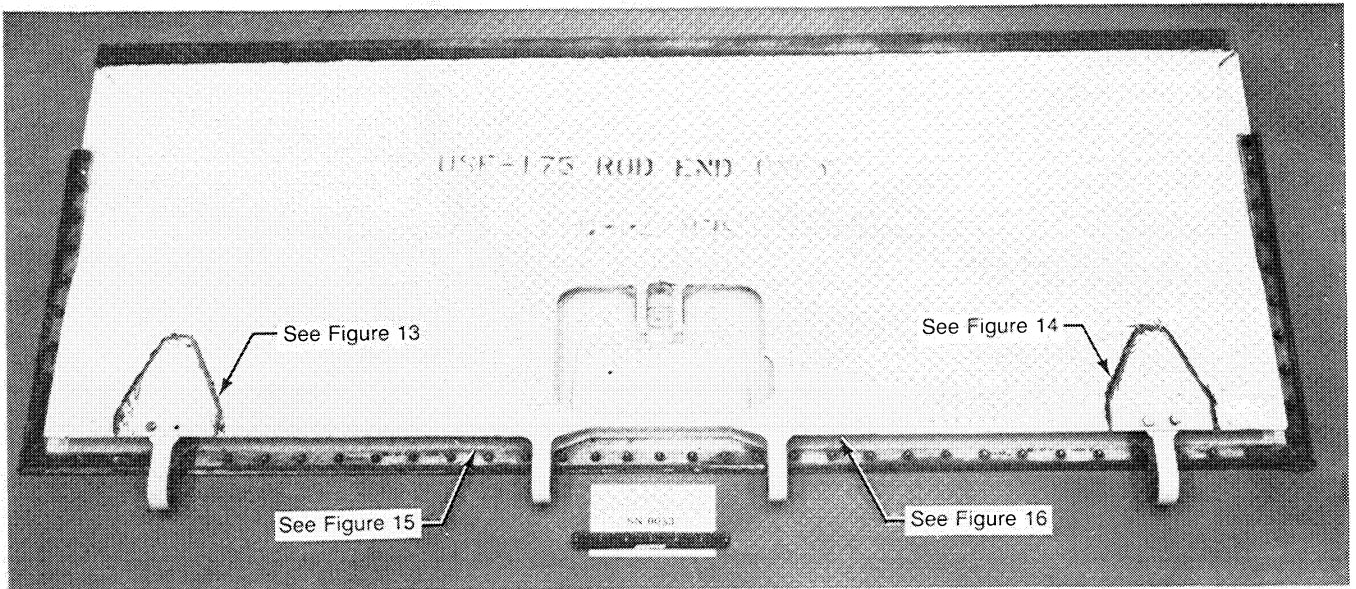
Figure 11. Upper Surface of Spoiler S/N 0033 After 8 Years of Service

The upper and lower surfaces of spoiler S/N 0033 after 8 years of service are shown, respectively, on Figures 11 and 12. Each doubler had been dressed down and sealed after minor corrosion. The panel was removed prior to repainting. These defects are shown on Figures 13 and 14. Figures 15 and 16 show exfoliation corrosion located at both spar to center hinge fitting splices.

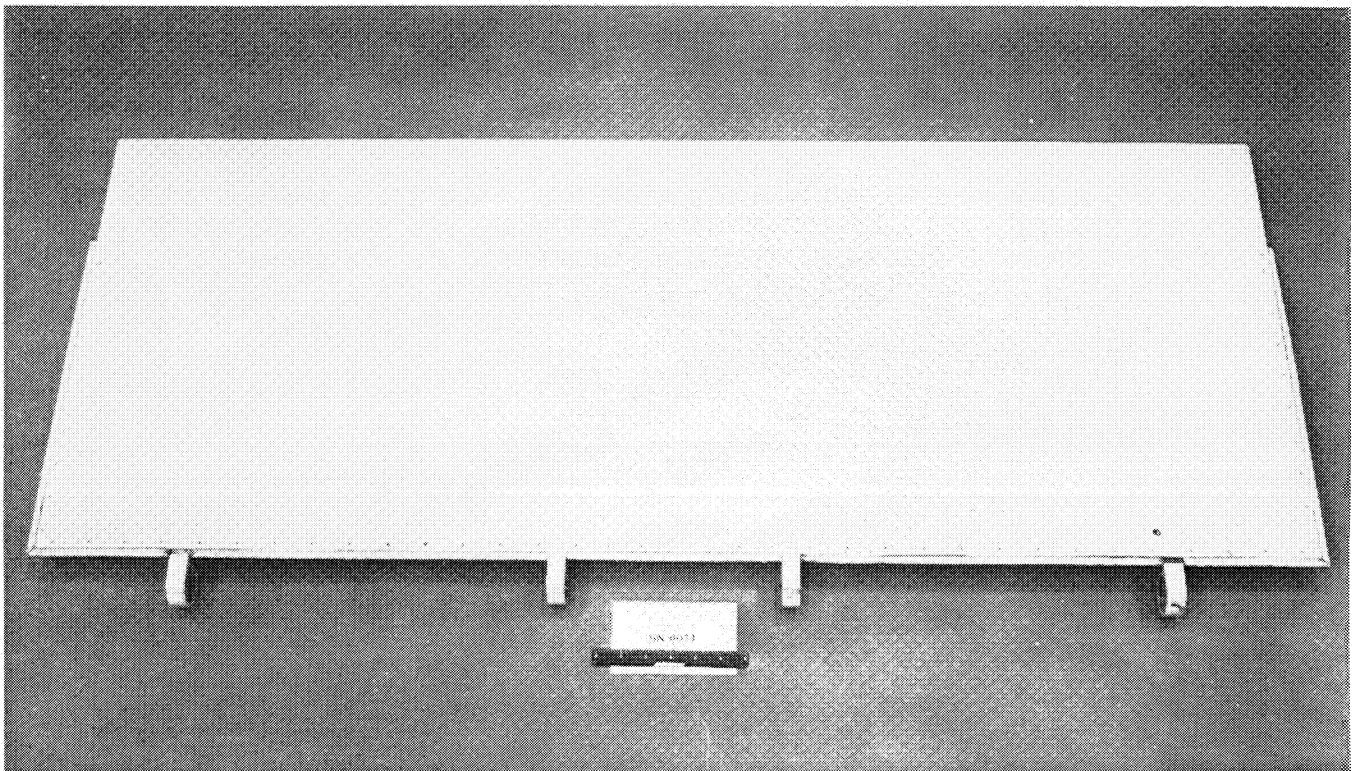
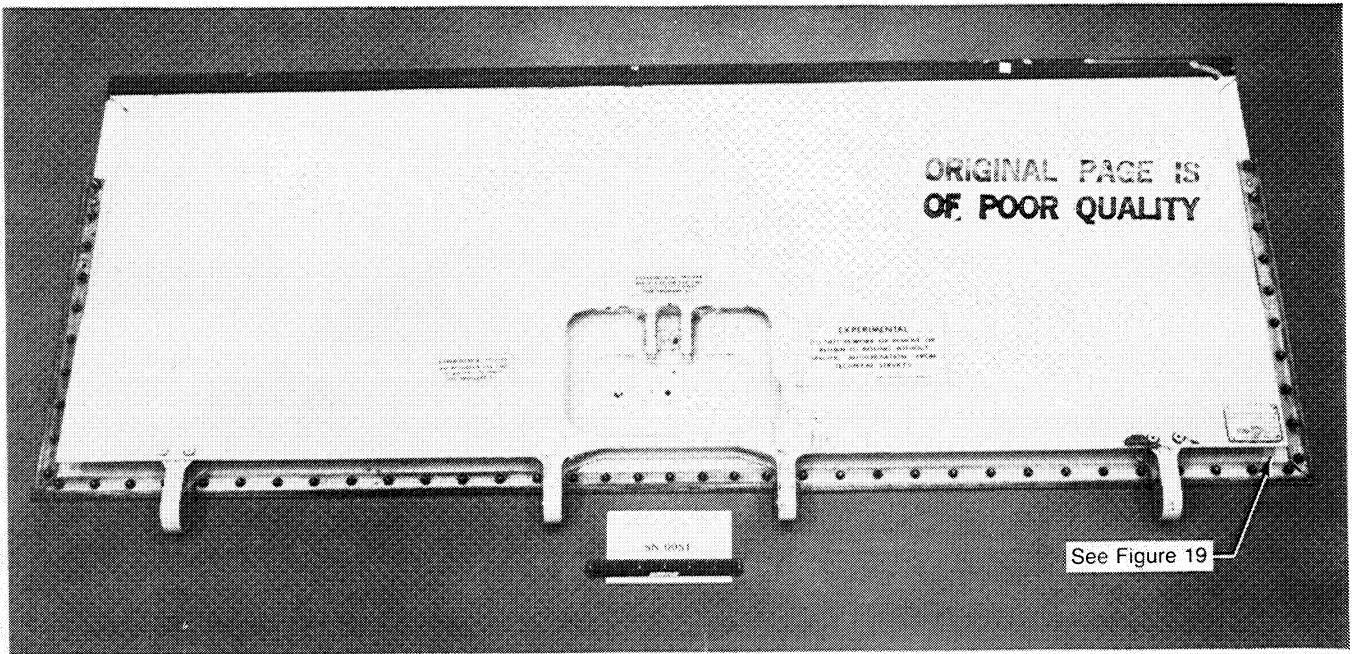
Figure 17. Upper Surface of Spoiler S/N 0051 After 8 Years of Service

Figures 17 and 18 show the upper and lower surfaces of spoiler S/N 0051 after 8 years of service. This unit was relatively clear of damage. The only detectable damage was some minor doubler corrosion as shown in Figure 19.

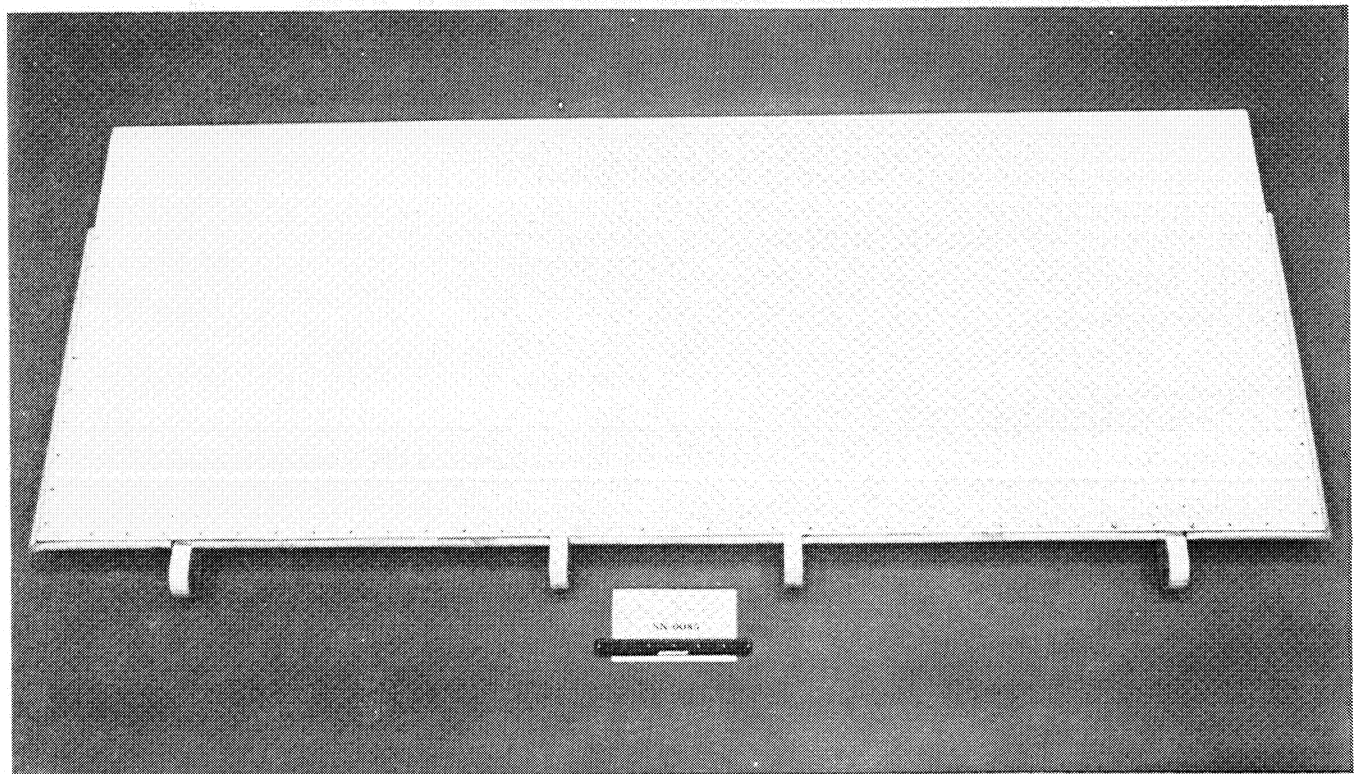
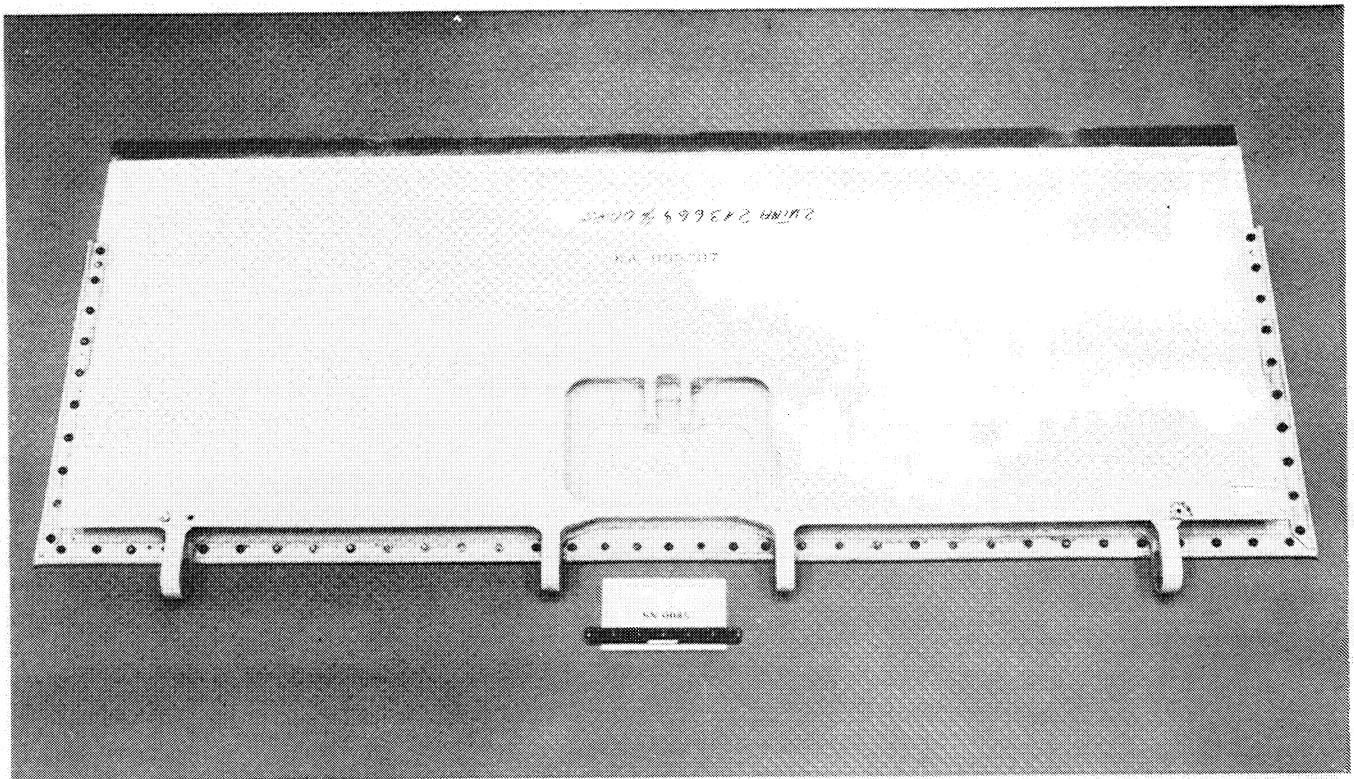
Figure 23. Upper Surface of Spoiler S/N 0085 After 8 Years of Service

The upper and lower surfaces of spoiler S/N 0085 after 8 years of service are shown on Figures 23 and 24, respectively. There was no noted damage on this spoiler.

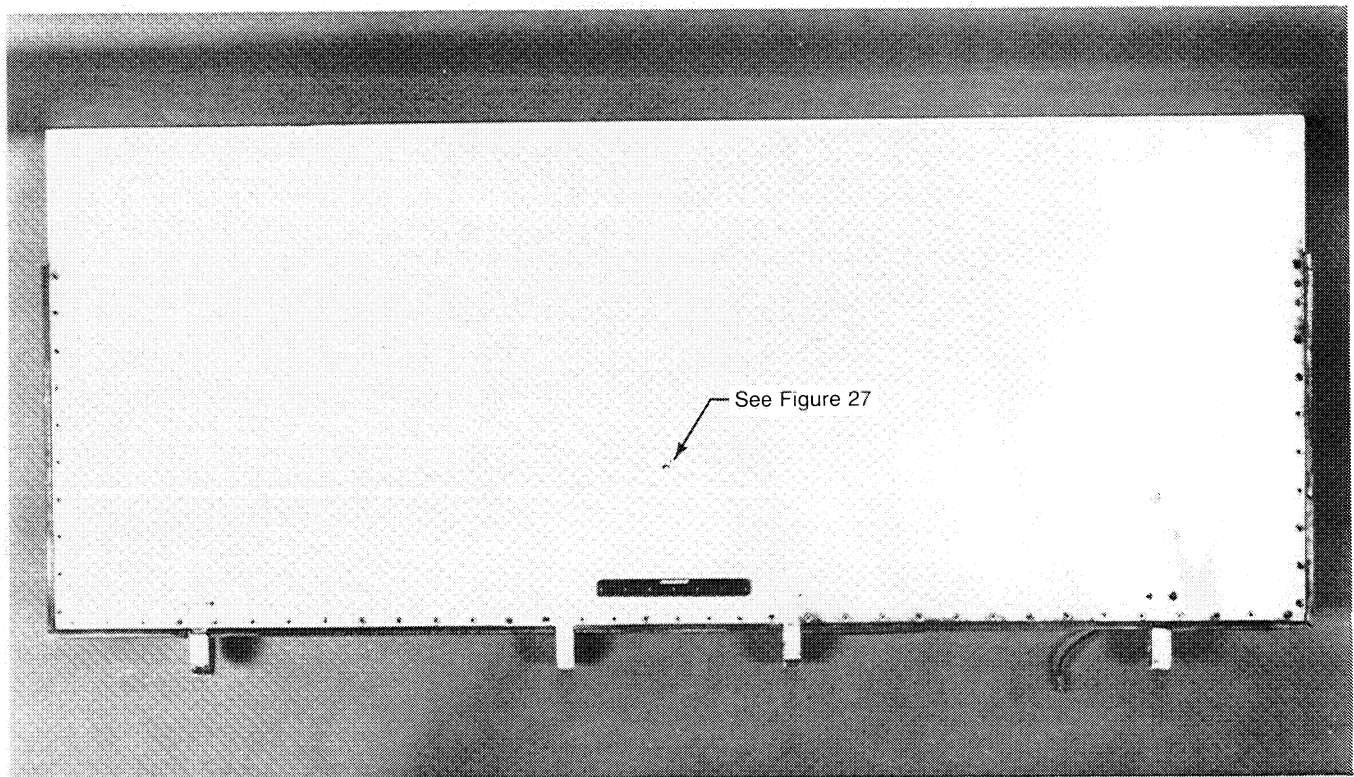
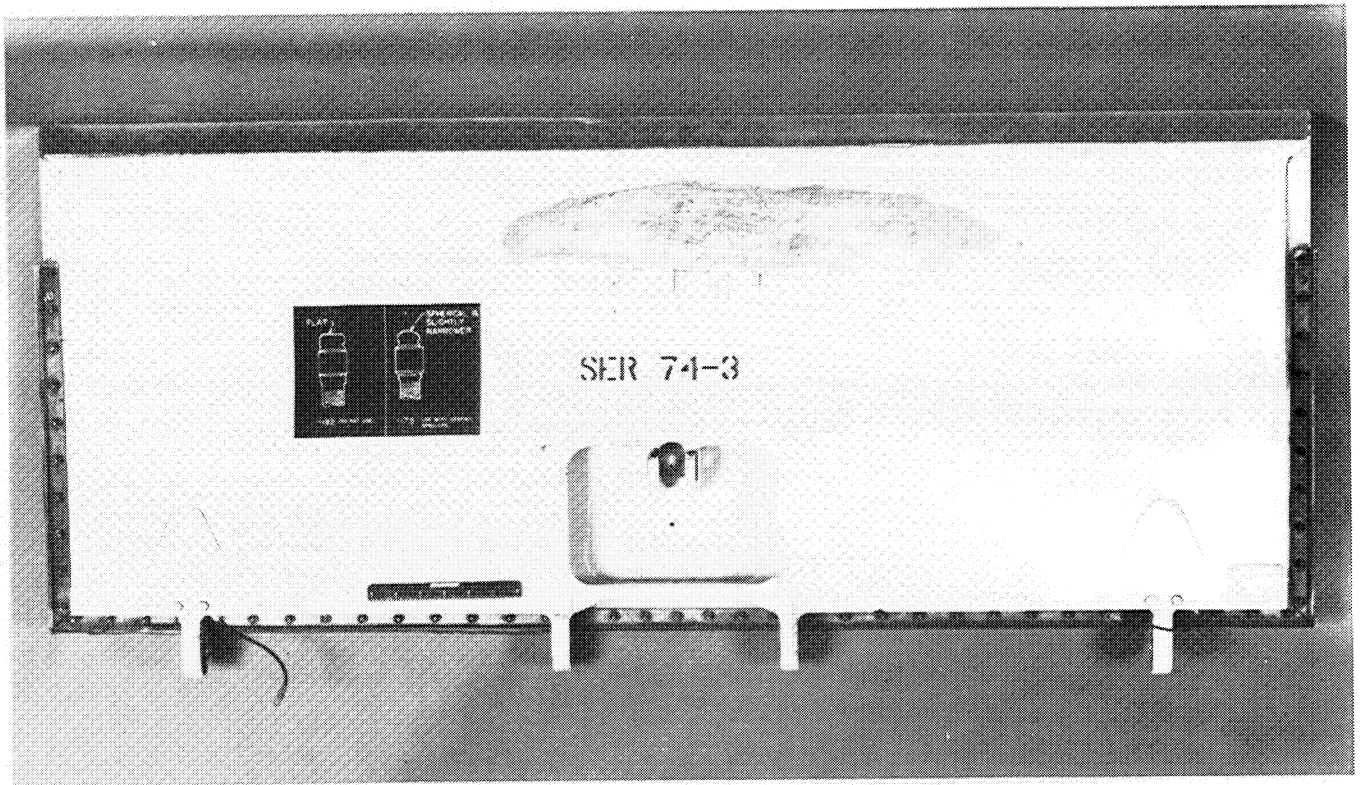
Figure 25. Upper Surface of Spoiler S/N 0029 After 9 Years of Service

The upper and lower surfaces of spoiler S/N 0029 after 8 years of service are shown on Figures 25 and 26, respectively. Flap track rubbing on the lower surface was covered with a thick application of teflon paint. The only major damage is a blister over the center hinge fitting. A closeup of this is shown on Figure 27. This was the second blister at this location. The first blister was repaired previously.

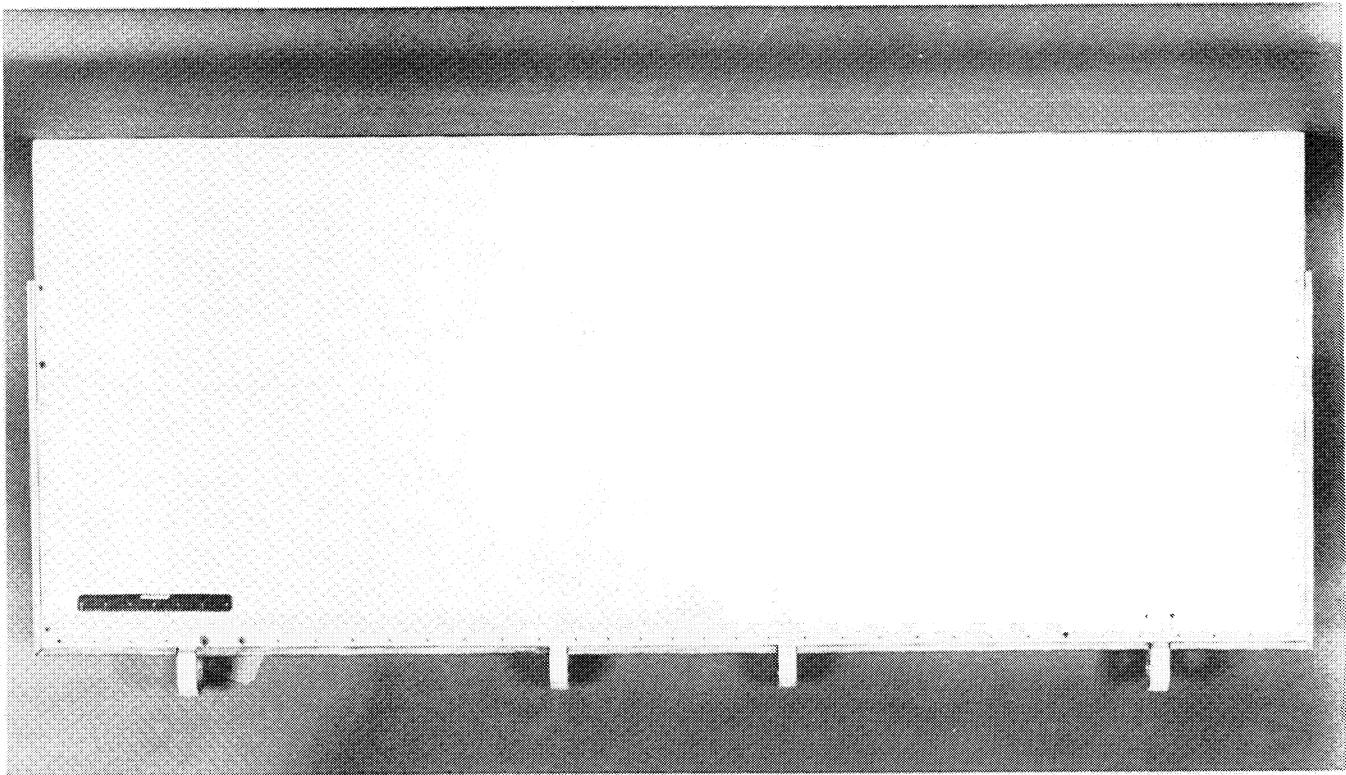
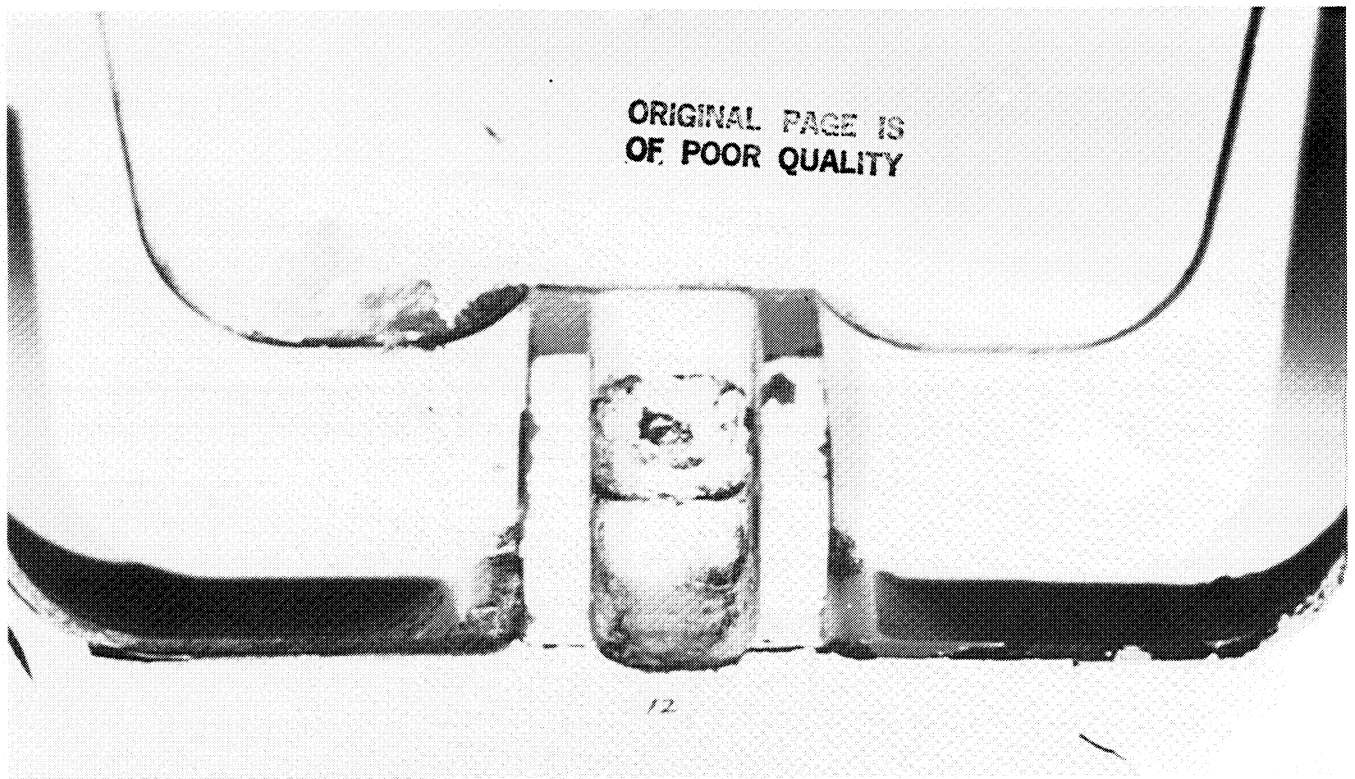
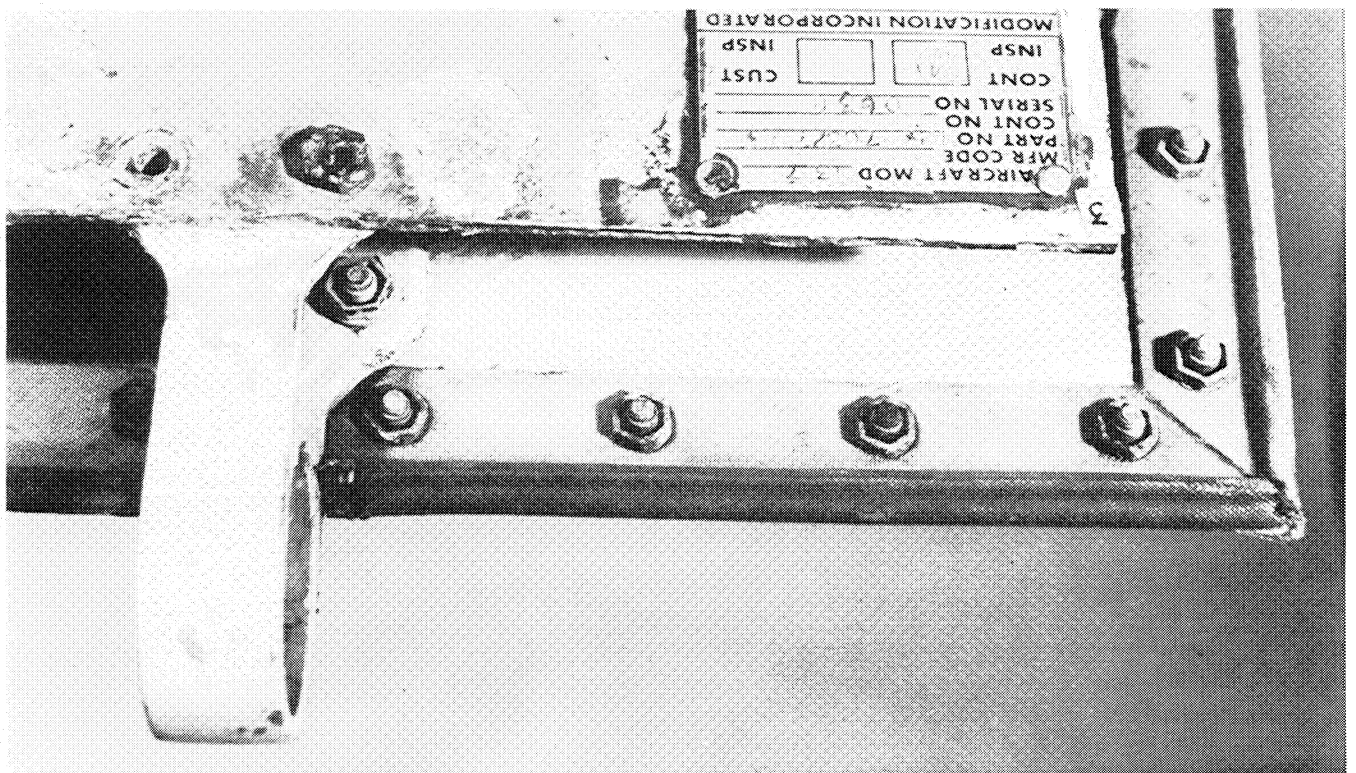
*Figure 28. Upper Surface of Spoiler S/N 0038 After 9 Years of Service*

Spoiler S/N 0038 after 9 years of service is shown on Figures 28 through 31. Corrosion was evident on both lower skin aluminum doublers and on the doubler in the center hinge fitting. One doubler had delaminated as shown on Figure 29. This photograph was taken after the spoiler had been tested to failure.

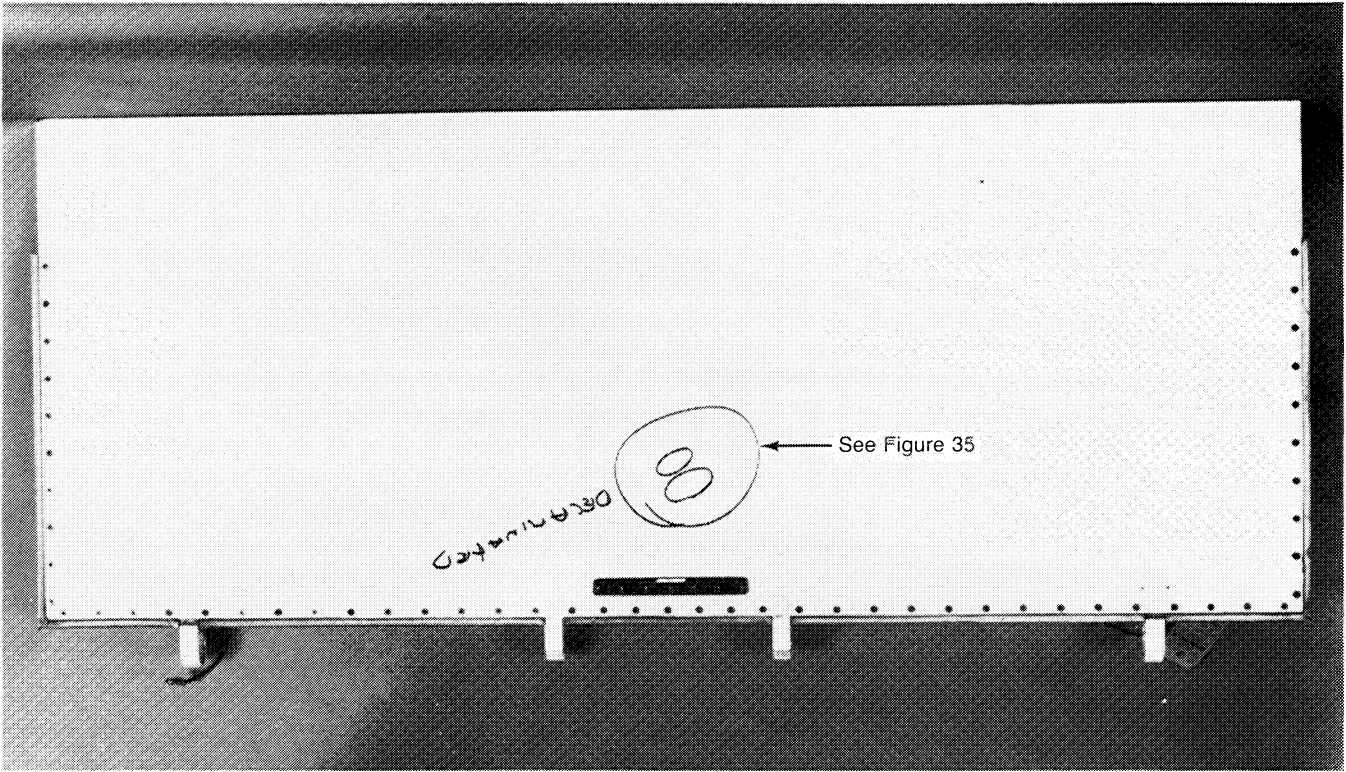
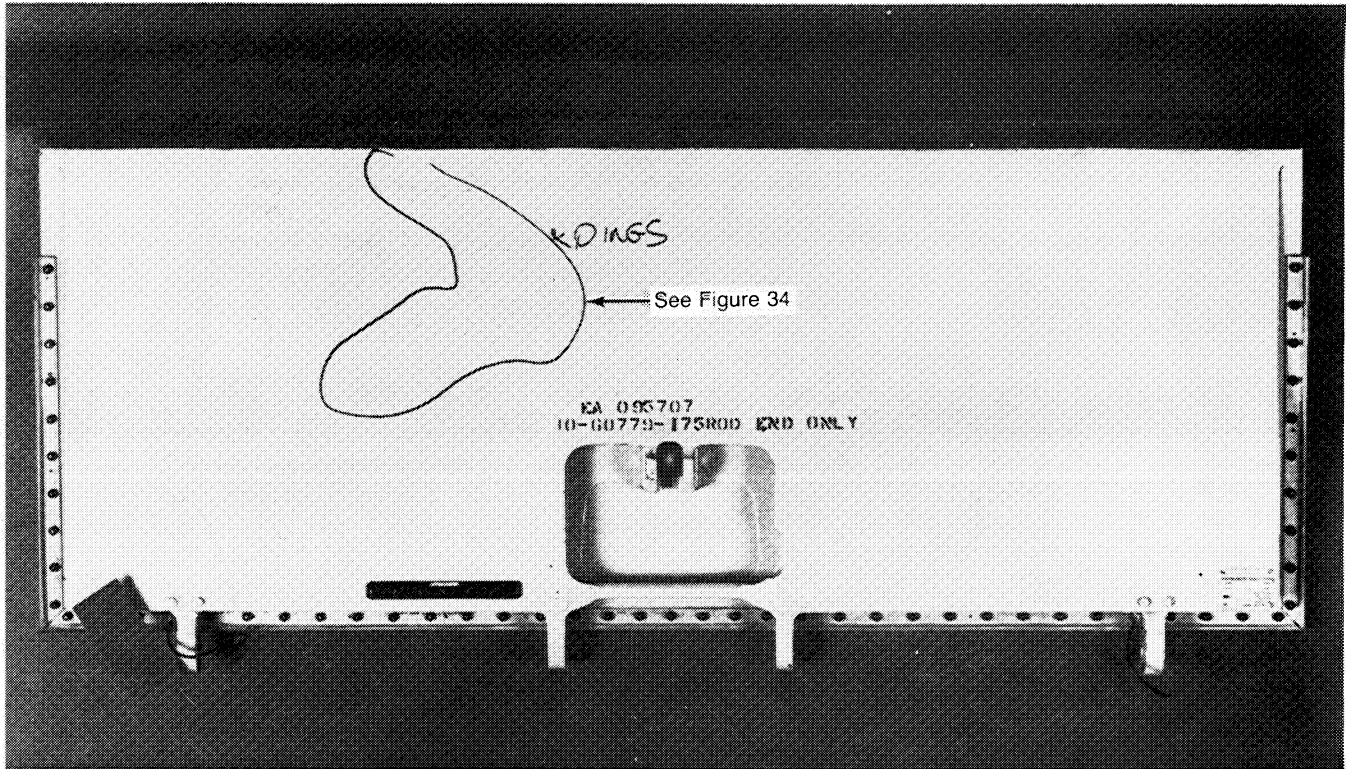
Figure 32. Upper Surface of Spoiler S/N 0064 After 9 Years of Service

Photographs of spoiler S/N 0064 after 9 years of service are shown on Figures 32 through 35. This spoiler had evidence of mechanical impact damage on the lower surface as shown on Figure 34. A blister was evident over the center hinge fitting as shown on Figure 35.

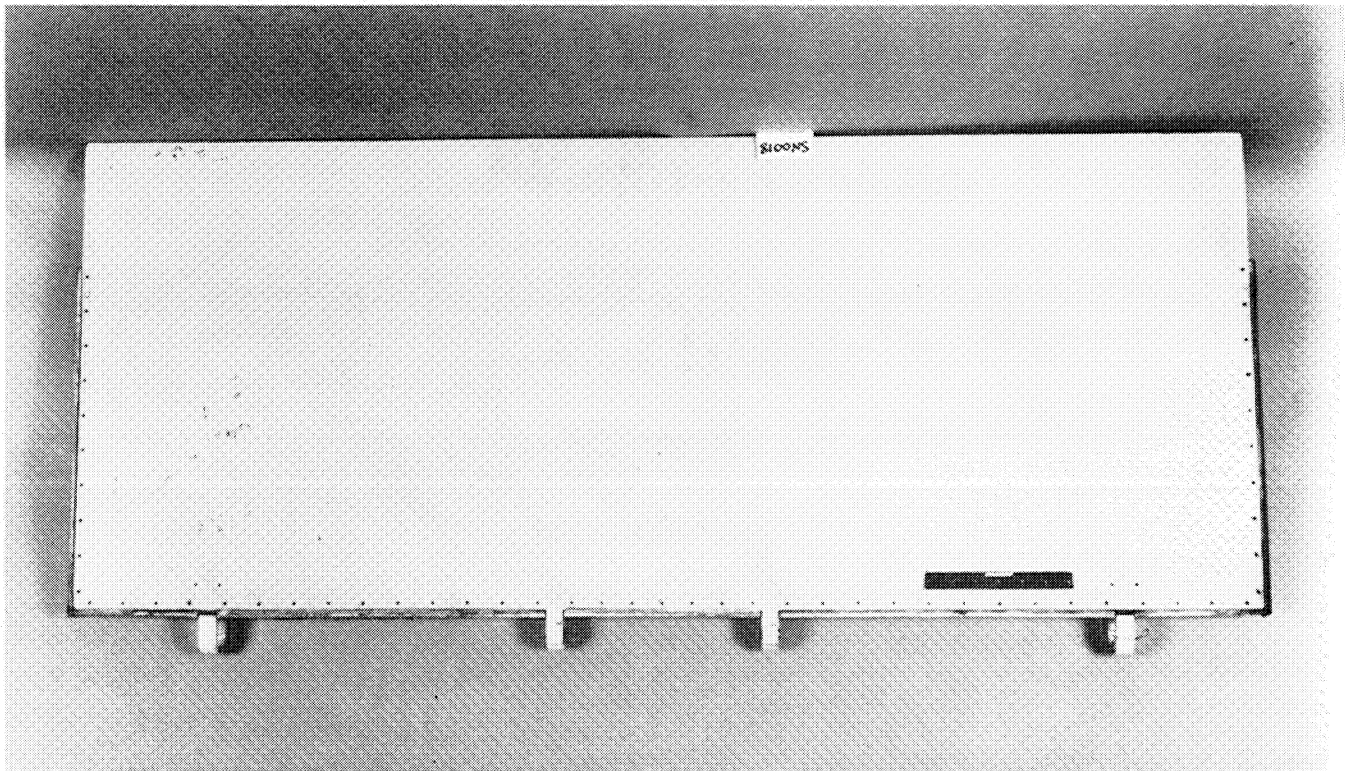
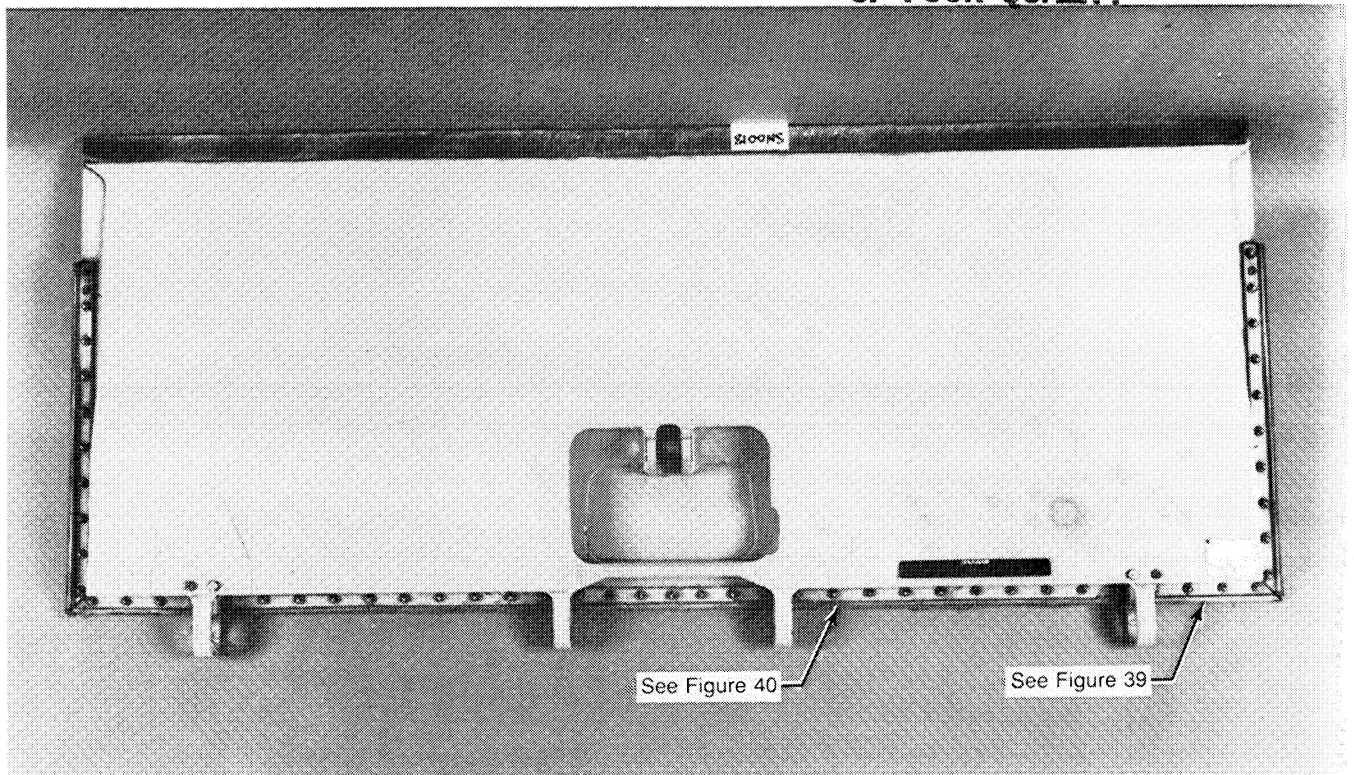
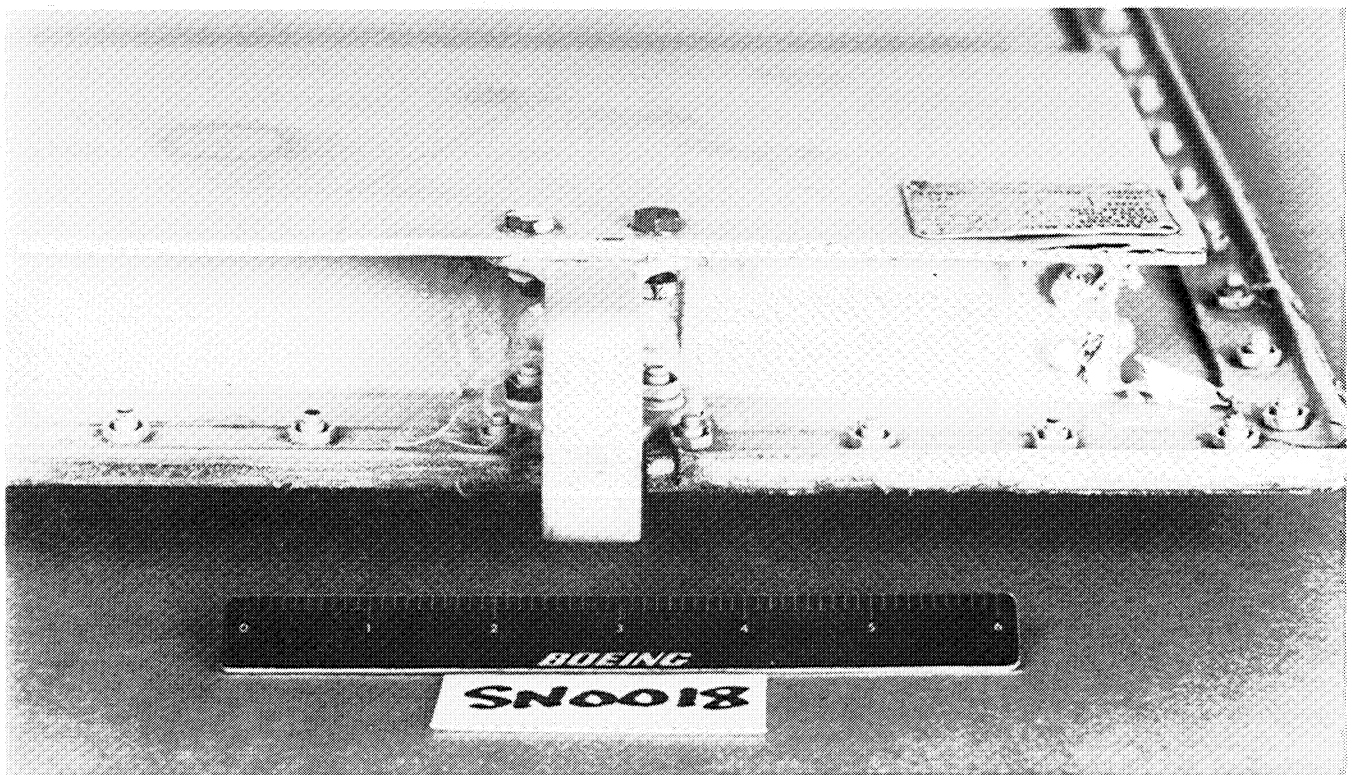
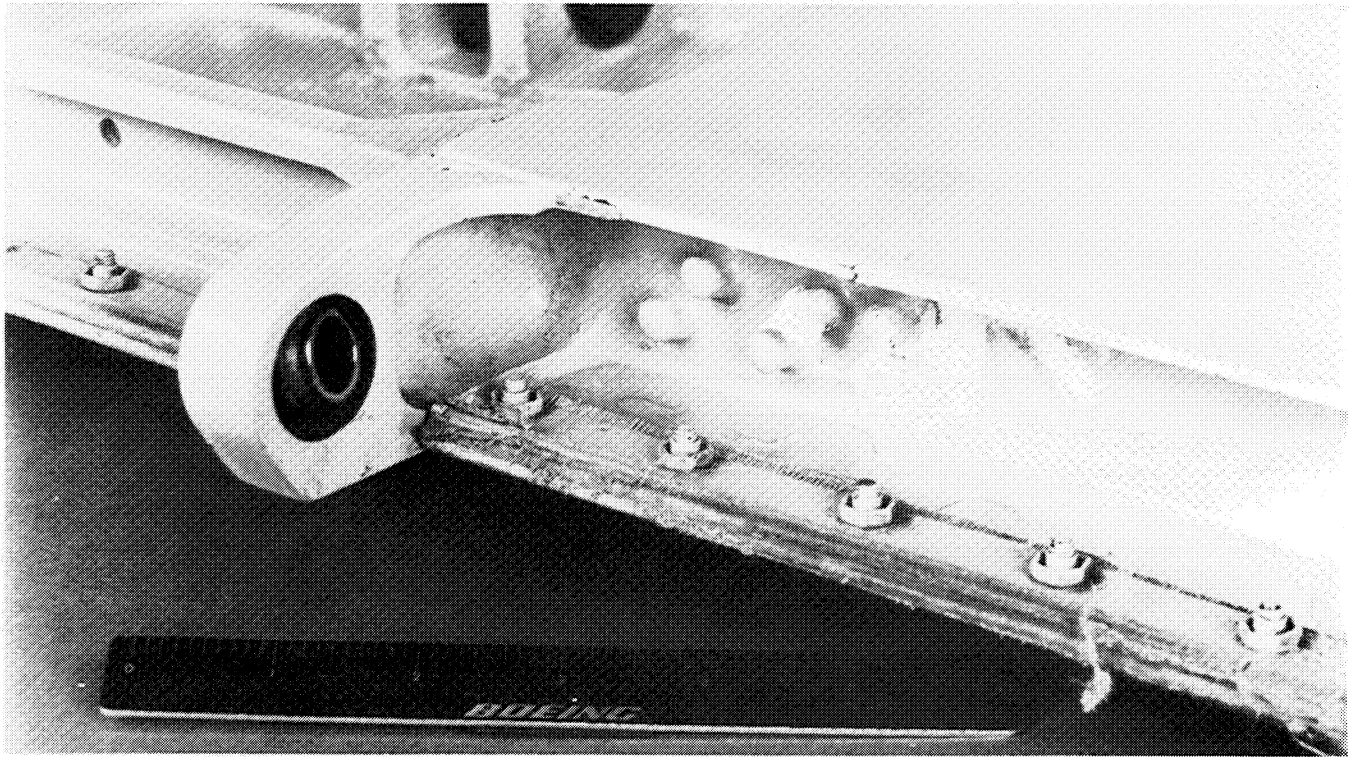
*Figure 37. Upper Surface of Spoiler S/N 0018 After 10 Years of Service*

The overall view and detailed photographs of spoiler S/N 0018 after 10 years of service are shown on Figures 37 through 40. The general condition of this unit was good with the exception of a small delamination on a lower surface corner. A minor edge delamination has started at one spar to center hinge fitting location.
