# 737 GRAPHITE COMPOSITE FLIGHT SPOILER FLIGHT SERVICE EVALUATION

**EIGHTH REPORT  
MAY 1981 THROUGH DECEMBER 1984**

**Prepared under Contract NAS 1-11668 by  
BOEING COMMERCIAL AIRPLANE COMPANY  
July 1985**

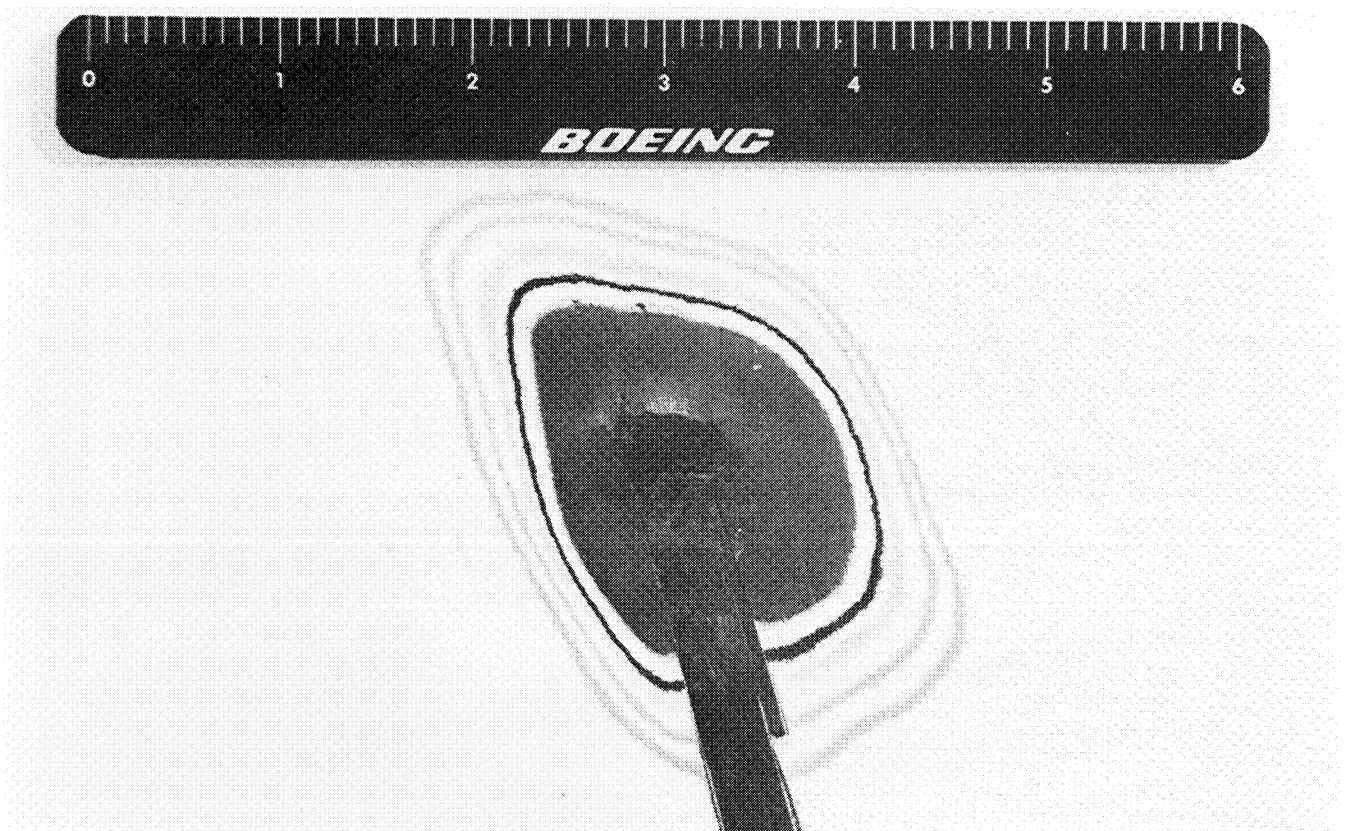
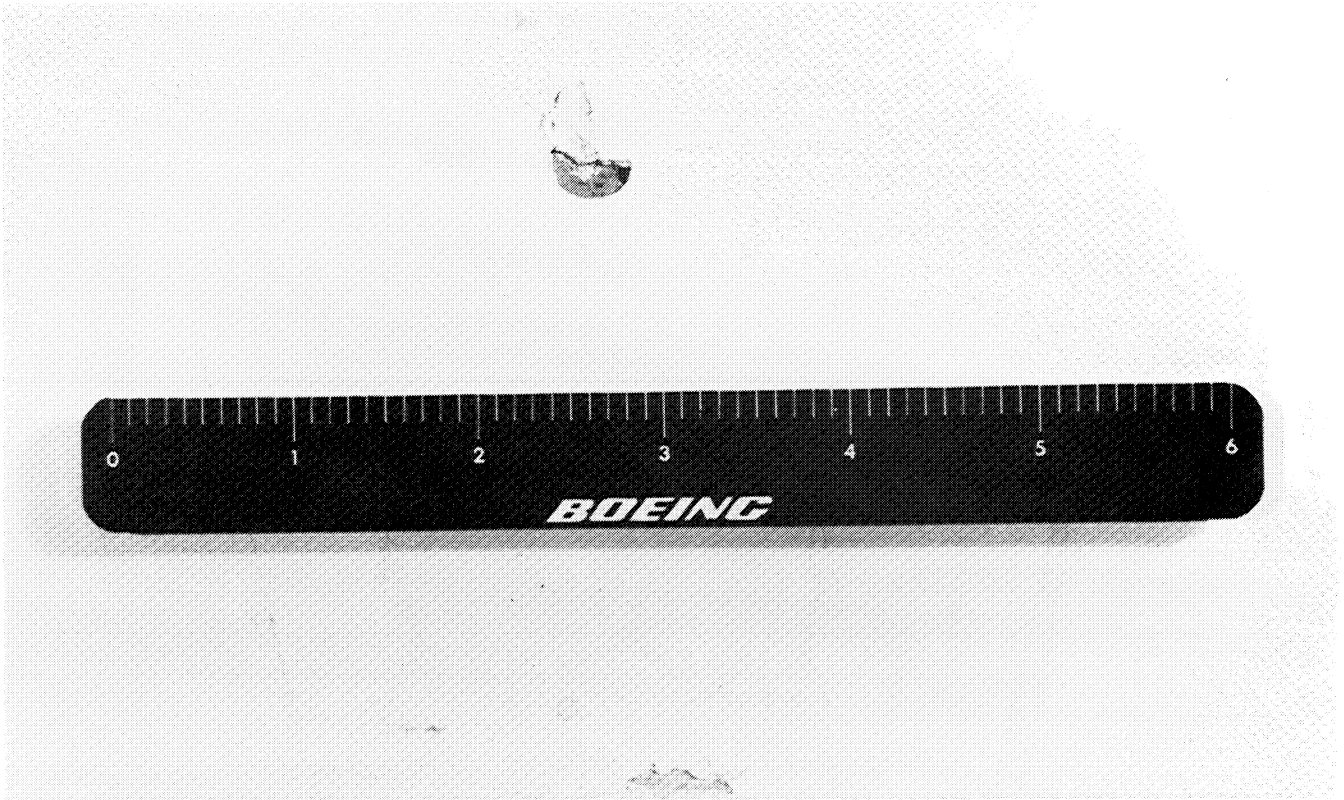
Figure 43. Blister Detail of Spoiler S/N 0044 After 10 Years of Service

Spoiler S/N 0044 with 10 years of service was returned with a delamination over the center hinge fitting. This is shown in an overall view on Figure 41 and in detail on Figure 42. The outer ply has been removed in a strip in the chordwise direction. The delamination area has been sanded down, removing the paint for better clarity. The lower surface overall view is shown on Figure 43. A small mechanical impact in the upper surface is shown on Figure 44. This impact was most likely caused after the panel was removed from the aircraft.

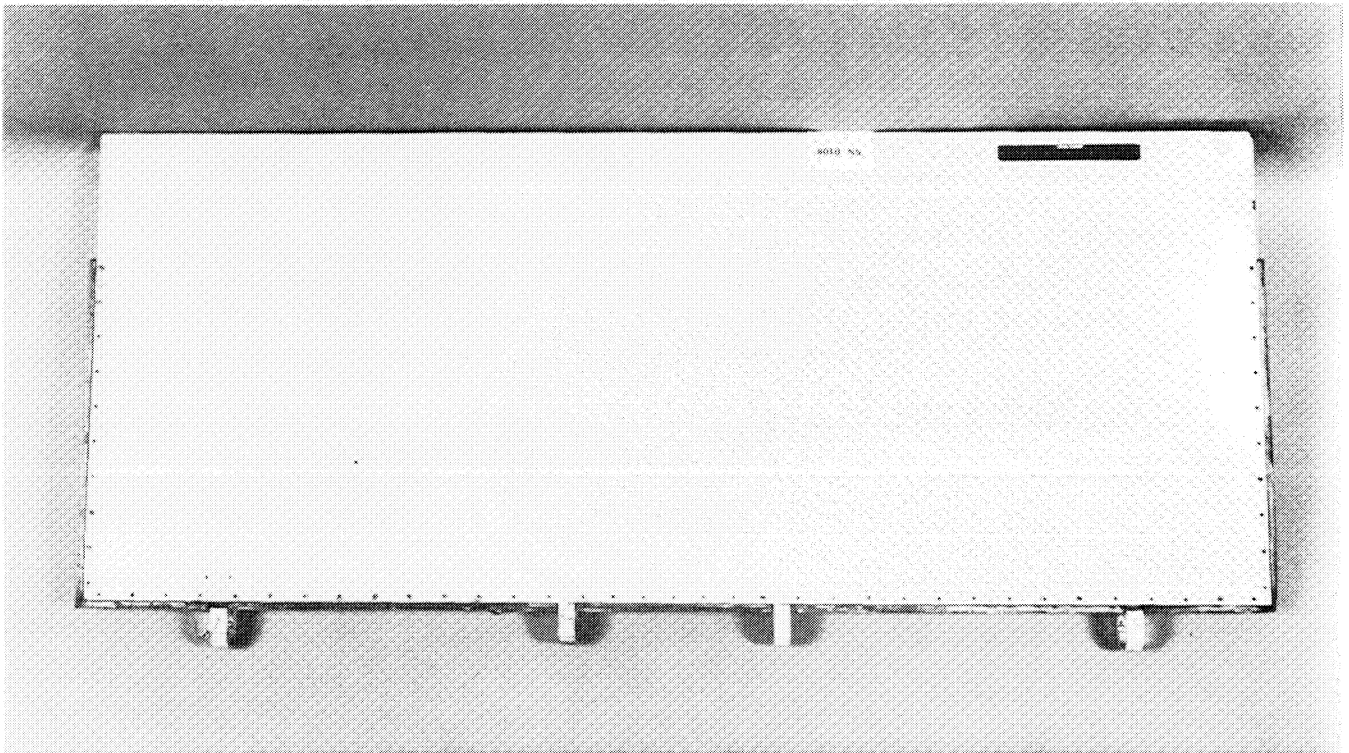
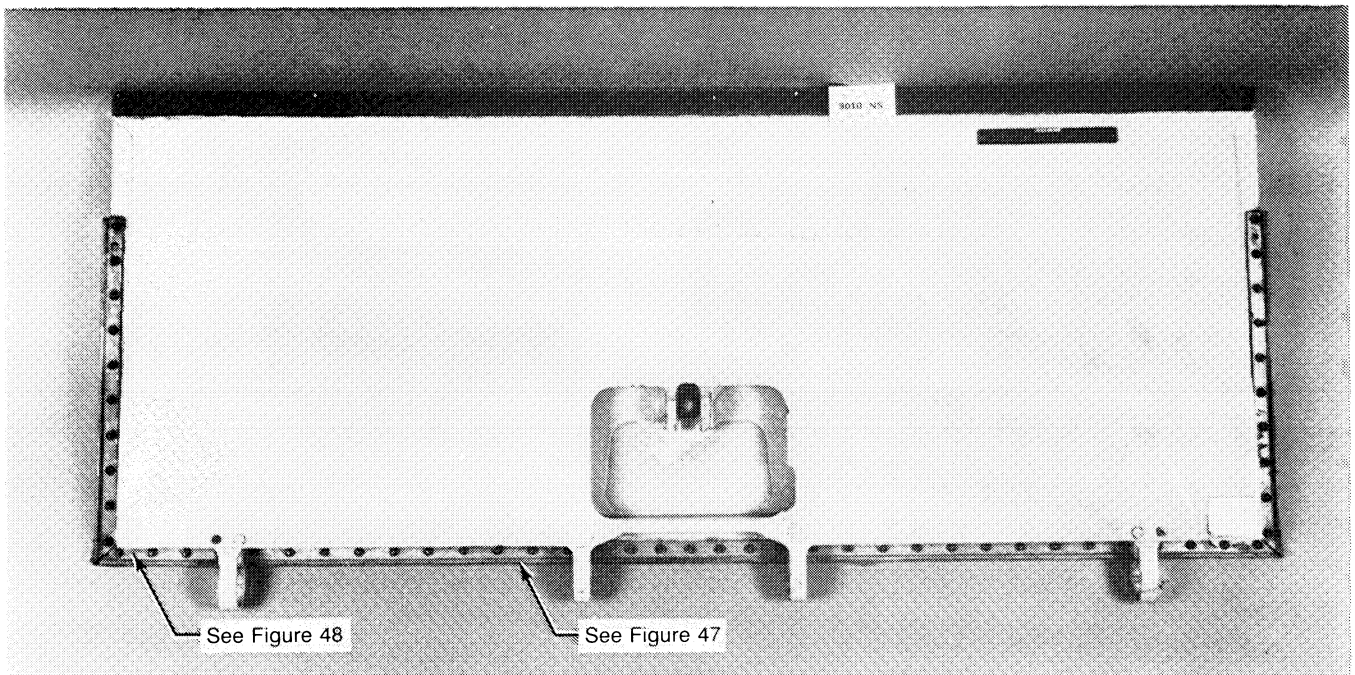
Figure 45. Upper Surface of Spoiler S/N 0108 After 10 Years of Service

The overall views of spoiler S/N 0108 after 10 years of service are shown on Figures 45 and 46. Some interference rubbing with the flaps on the lower surface has been treated. A substantial blister on one spar to center hinge fitting location is shown on Figure 47. This blister has progressed to the point where corrosion products are visible. This blister is one of the most severe found in the program. A minor corner delamination was also found on the forward lower surface. This delamination is shown on Figure 48.

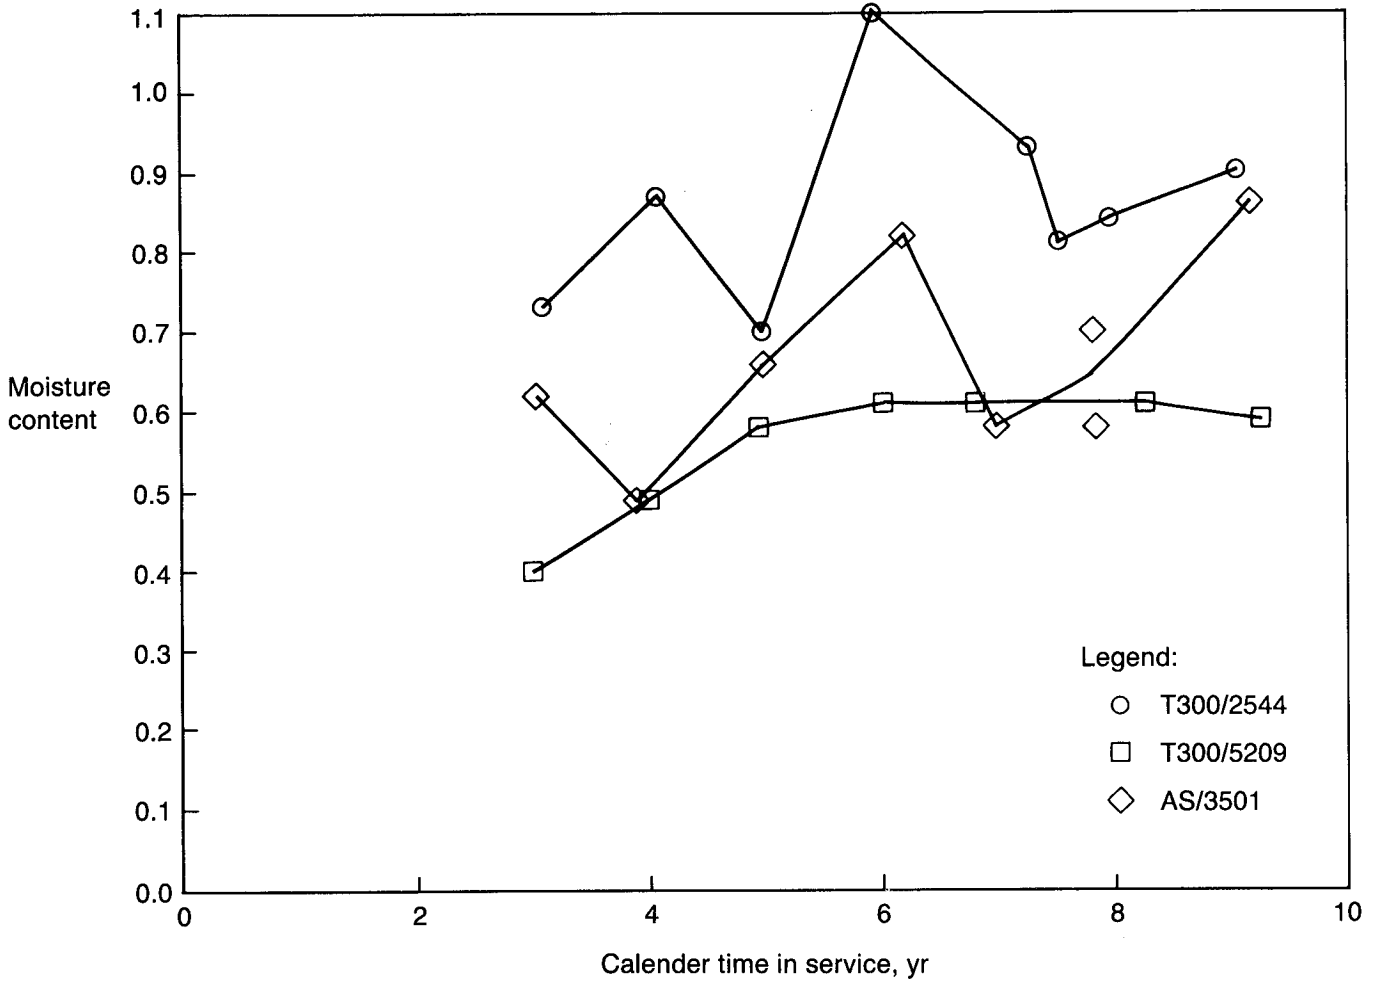
Figure 67. Moisture Weight Loss of Spoiler Core Samples

All core specimens were subjected to a drying environment at 160°F. The samples were weighed in order to construct a final observed graphite-epoxy moisture content. This moisture content data is shown plotted against time on Figure 67.

Use of this procedure to determine graphite-epoxy moisture content should result in a calculated value slightly higher than actual. Both the paint and the adhesive should have moisture contents higher than the epoxy matrix. This error should be relatively small.

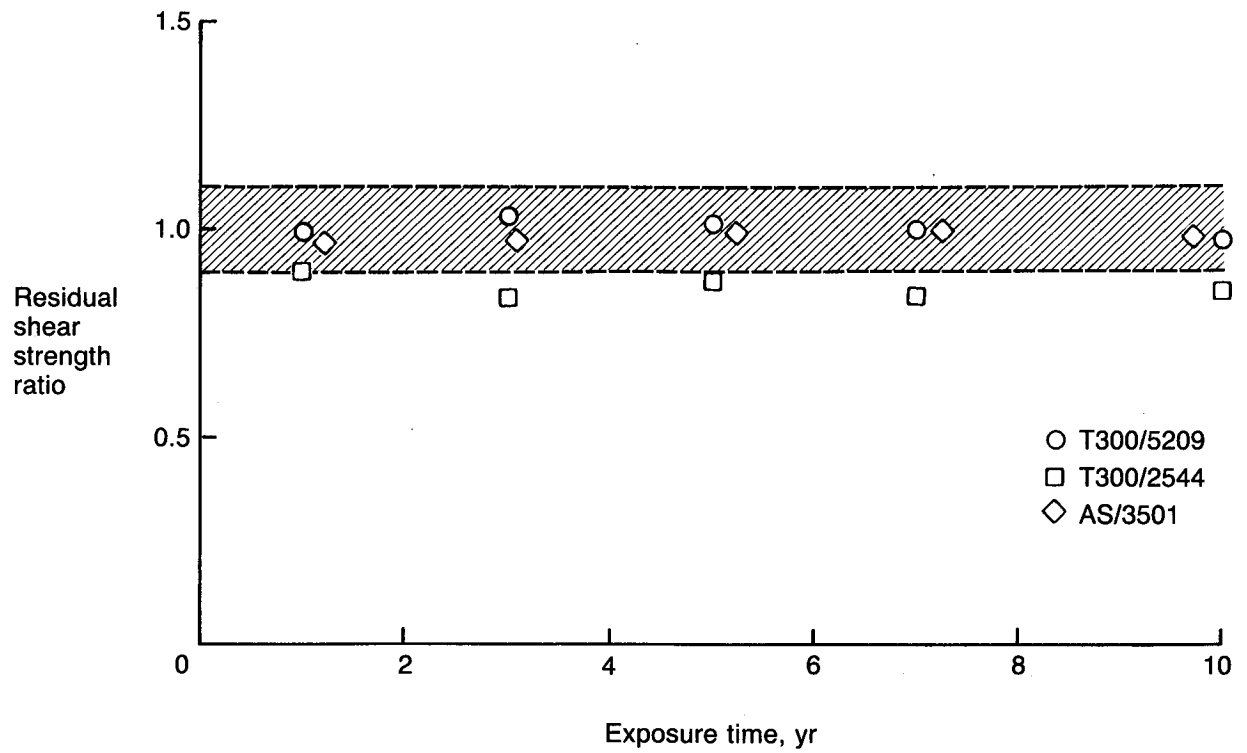
The average residual strength ratios for the shear, flexure, and compression specimens are plotted in figures 70, 71, and 72, respectively. These values represent a comparison of the average strength values for all six exposure sites with the average baseline strength value for that material system. A  $\pm 10\%$  bandwidth, which represents the strength scatter in the baseline specimens, is shown on each figure. The shear strength ratios are within the scatterband except for T300-2544, which has continued to be slightly below the baseline value. For the flexure specimens, figure 71, the strength of the T300/2544 material was slightly below the scatterband after 10 years of exposure. The flexure strength for the AS/3501 material has been consistently above the baseline strength since the first year tests. These results indicate that the baseline strength may be low. To investigate this possibility, eight spare AS/3501 flexure specimens that had been stored in an office for 10 years at NASA Langley were tested. The average failure stress for these specimens was 18 percent higher than the failure stress for the baseline specimens. These results confirm that a larger number of specimens should have been tested to establish the baseline strength. For the compression specimens, figure 72, the strengths for all materials are within the scatterband or slightly below the scatterband.

Figure 70. Average Residual Shear Strength After Outdoor Exposure at Six Worldwide Locations

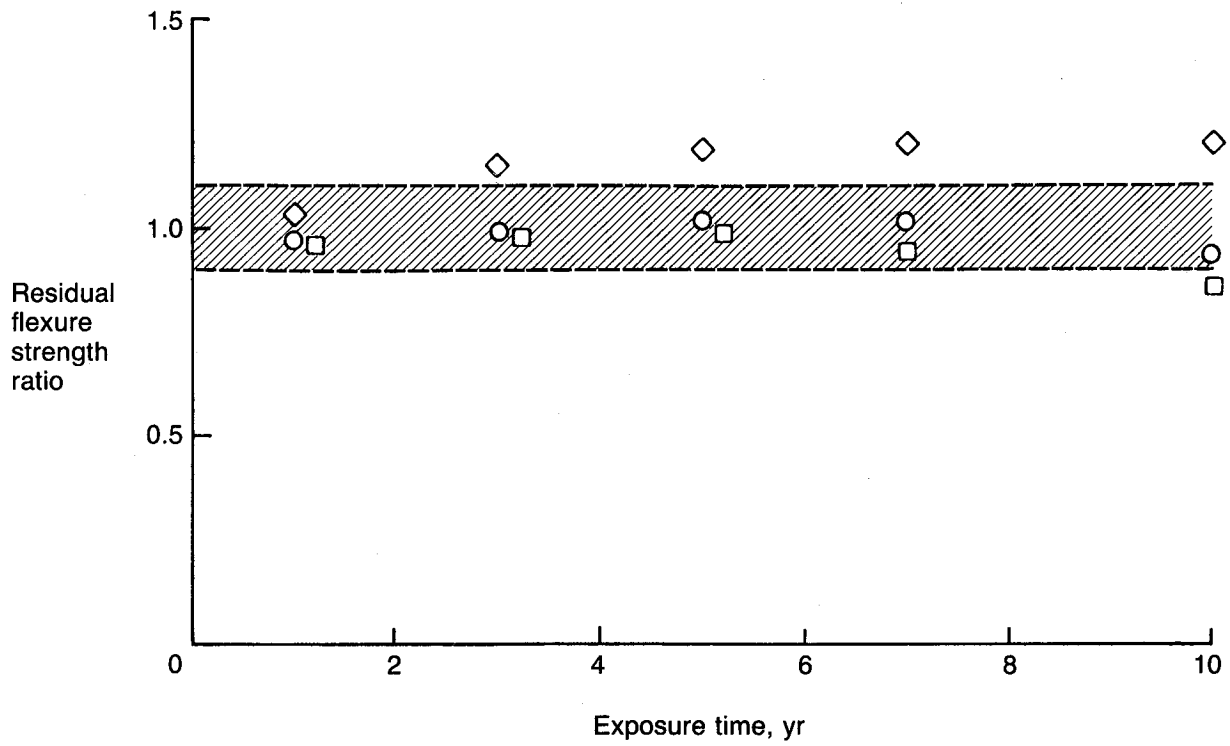
Figure 71. Average Residual Flexure Strength After Outdoor Exposure at Six Worldwide Locations

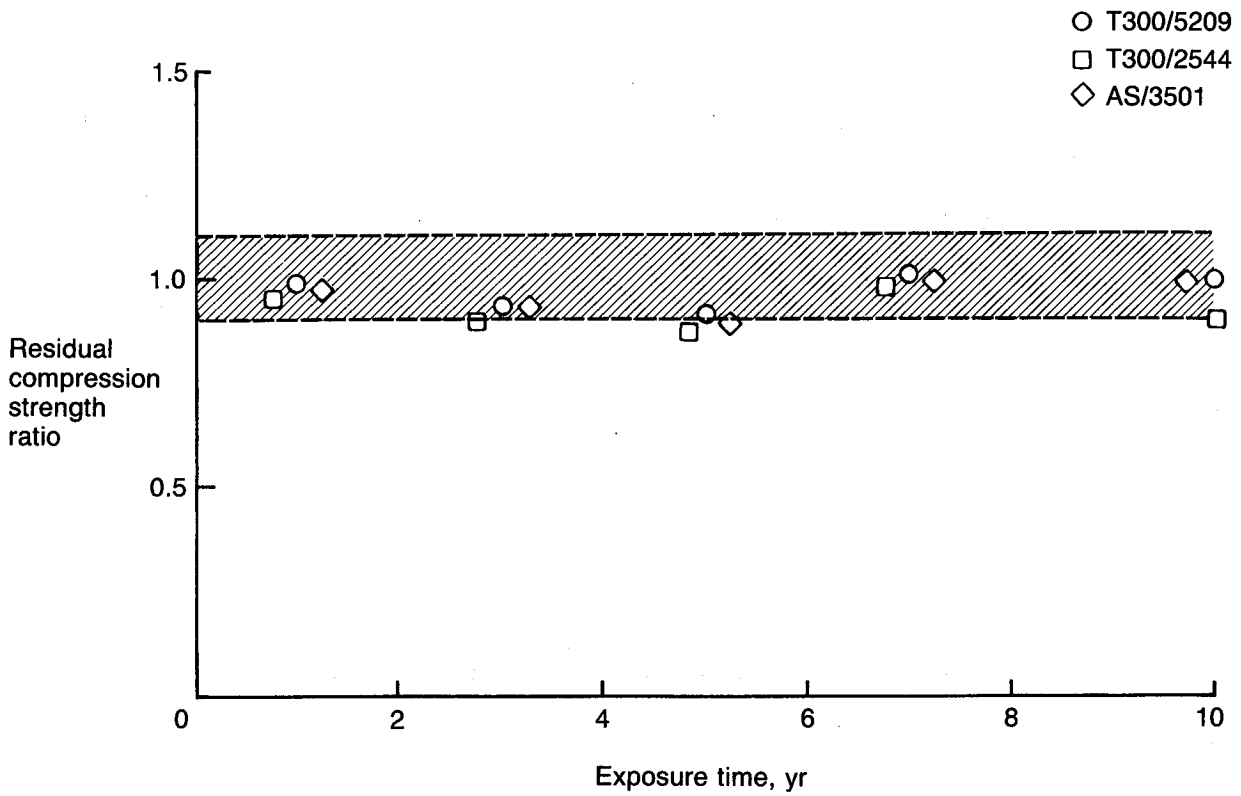
Figure 72. Average Residual Compression Strength After Outdoor Exposure at Six Worldwide Locations
