AC NO: AC 20-64

ADVISORY CIRCULAR

SUBJECT: MAINTENANCE INSPECTION NOTES FOR LOCKHEED L-188
SERIES AIRCRAFT

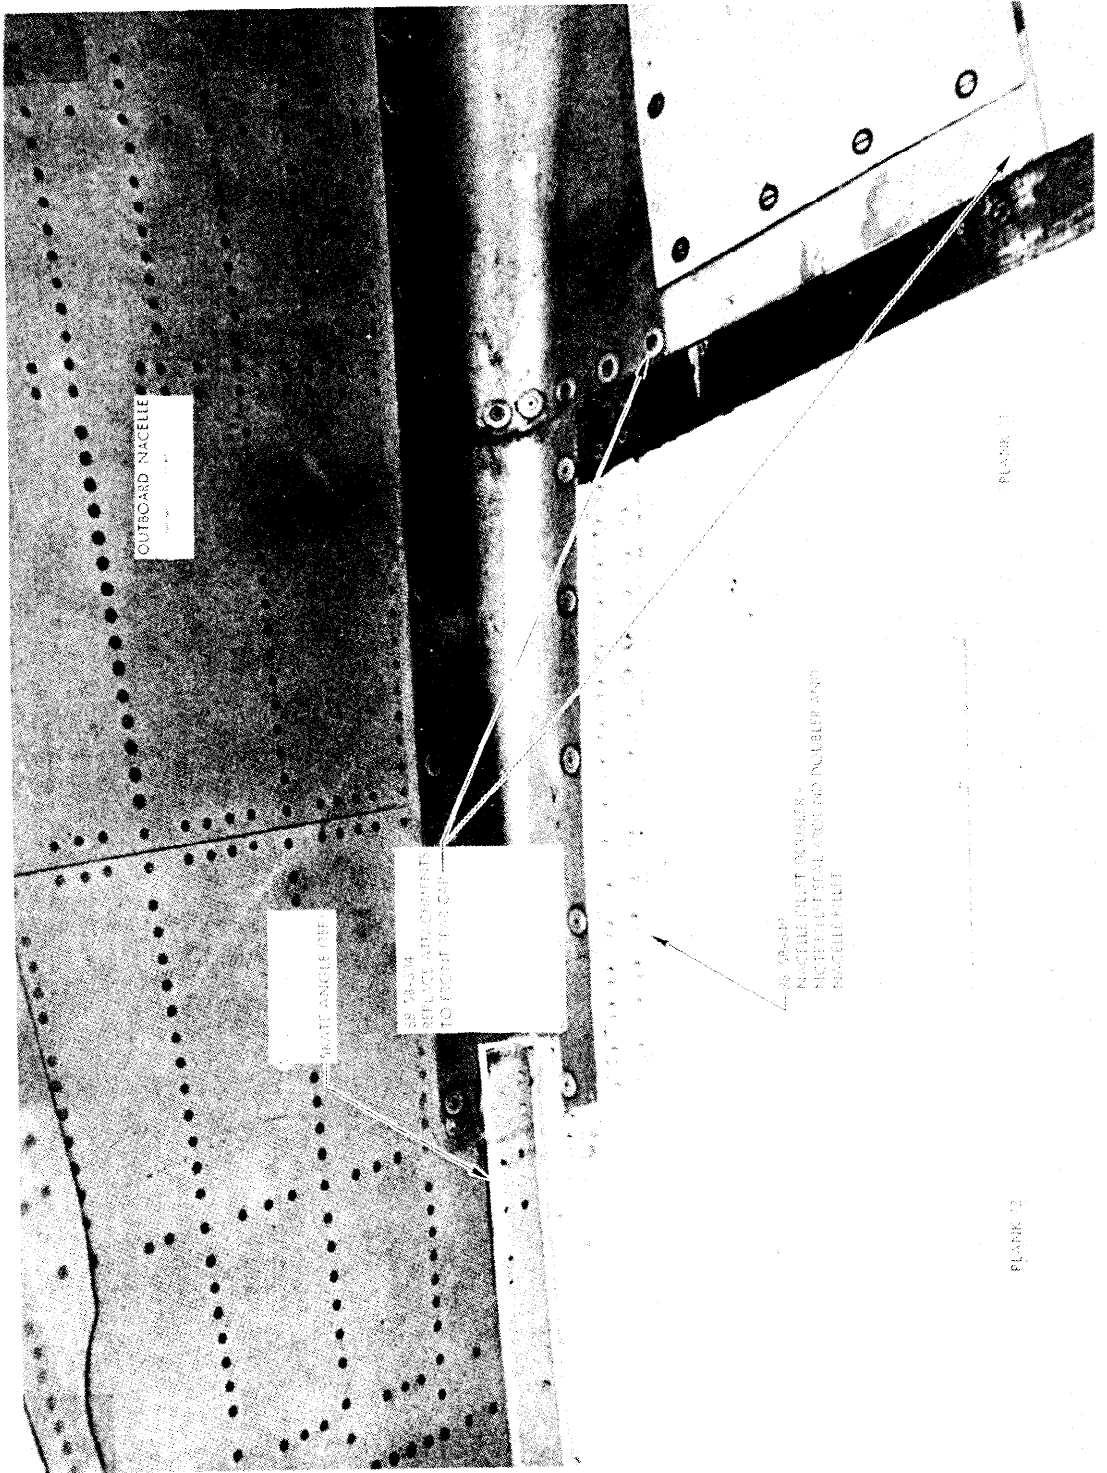
FIGURE F-4. WING UPPER SURFACE
Reference W-1, page 8
W-20, page 20

1	2	3	4	5	6
NO.	MAJOR ASSEMBLY	ITEM	SERVICE HISTORY	PAGE REF. FOR ILLUSTR.	S/N CODE
W-1	Outer Wing Leading Edge Inboard, Middle, & Outboard Sections	A t t a c h S c r e w s Upper and Lower	Loosening has occurred of the screws attaching the leading edge skins to the front spar caps.	29 30	⚠
W-2	Outer Wing Lower Surface	No. 1 and 3 Planks	Surface depressions have been reported in planks between Wing Stations 478 and 528.	31	⚠
W-3	Outer Wing Lower Surface, W.S. 159.6	No. 4 Plank	Cracks have occurred at the lower No. 4 wing plank drain hole adjacent to Wing Station 159.6.	32	⚠
W-4	Outer Wing Lower Surface	Rear Spar	Loose and failed flap track attachment bolts have been found.	33	⚠

7	8		9	10
RECOMMENDATIONS				
METHOD OF INSP.	FREQUENCY OF INSPECTION	TYPE OR METHOD OF REPAIR		PREVENTIVE ACTION
Visual	Inspect at 50 flight hours intervals and retighten all screws each 300 hours until LAC 88/SB-334 is incorporated.	Remove existing screws and replace with new type fasteners per 88/SB-334.		Accomplish 88/SB-334.
Visual	Inspect within next 300 hour interval. If depressions exceed limits reinspect each 100 hours until corrective action is taken.	Replace H-clips per instructions of LAC Service Bulletin 88/SB-564.		Same as Column 9.
External Visual	Repeat inspections at 1000 hour intervals until permanent repair is incorporated. Interim repairs have special inspection requirements.	<p>(1) Preventive/temporary repair may be effected by installing 5/16 Hi-Lok fasteners in drain holes per 88/SB-587C with continued 1000 hr. repeat inspections.</p> <p>(2) Permanent repair/reinforcement can be made by incorporating either SED/63-9015-101 or SED/63-9015-135 shown on Dwg. SED/63-9015B.</p>		Same as Column 9, Item (2).

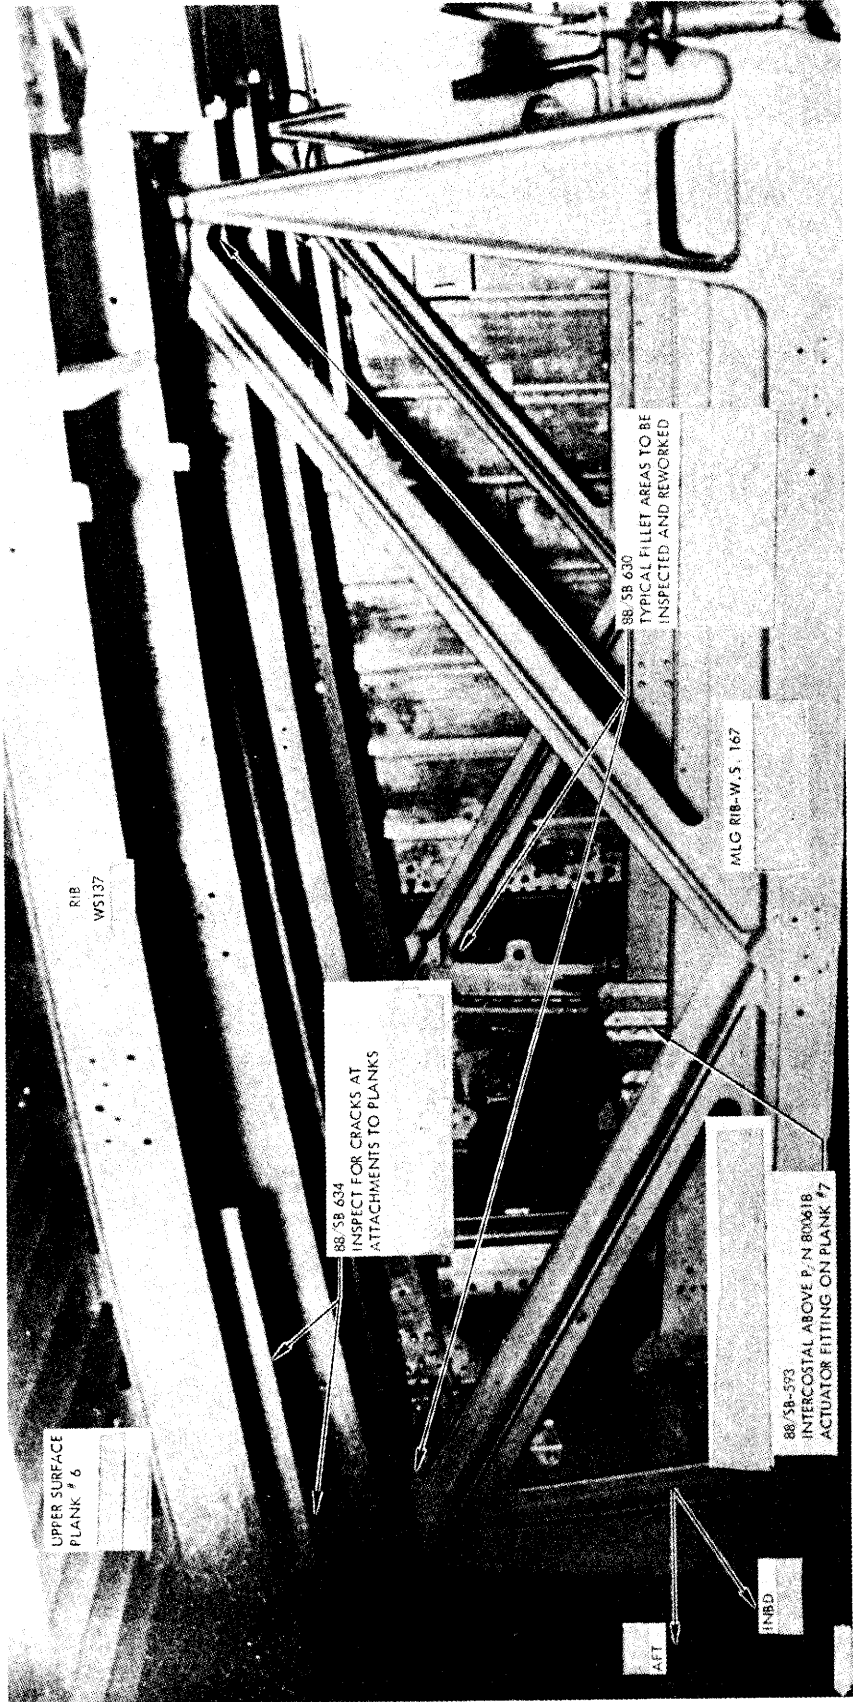
FIGURE F-9. WING INTERNAL STRUCTURE
Reference W-5, page 10
W-13, page 16
W-17, page 18

1	2	3	4	5	6
NO.	MAJOR ASSEMBLY	ITEM	SERVICE HISTORY	PAGE REF. FOR ILLUSTR.	S/N CODE
W-5	Outer Wing Lower Surface, W.S. 179-197	Wing Plank No. 7	Cracks have occurred in the wing plank surface and plank riser located under the main landing gear actuating cylinder attach fitting angles, P/N 802699.	34 35	⚠
W-6	Outer Wing Lower Surface, W.S. 187	Support Fitting, MLG Actuator P/N 800618-1 P/N 800618-2 P/N 800618-3 P/N 800618-4	Fatigue cracks have occurred at the aft end of the MLG actuator support fittings in the radius of the vertical legs.	35 36	⚠

7	8		9	10
RECOMMENDATIONS				
METHOD OF INSP.	FREQUENCY OF INSPECTION	TYPE OR METHOD OF REPAIR	PREVENTIVE ACTION	
<p>Visual Requires removal of 801266-1 door (Dry Bay A/C) & 800917 Door (Wet Bay A/C)</p>	<p>Within next 2500 flight hours on A/C which have 88/SB-538 incorporated. Otherwise, inspect at 88/SB-538 incorporation, or within next 2500 ft. hours, whichever occurs first.</p> <p>Repeat inspections at 2500 ft. hour intervals are recommended.</p>	<p>Repair wing plank skin and riser cracks per Electra Structural Repair Manual, Section 57-2-1, Fig. 3, Sheets 41 thru 44, LAC Dwg. 841880, and LAC 88/SB-593C. Repair out-of-round holes per LAC Service Bulletin 88/SB-593C.</p>	<p>Same as Column 9.</p>	
<p>Visual, Dye Penetrant</p>	<p>Dye penetrant inspect original 800618-3 & -4 fittings within 215 flight hours. Repeat at 425 ft. hrs. Visual dye penetrant inspect aft 4 in. of fittings at each 850 ft. hrs.</p> <p>Visual inspect reworked fittings (radius on aft edge) at each 850 ft. hrs. and dye penetrant inspect at each 1700 ft. hrs.</p> <p>No repeat inspections for new 841275-101, -102 fittings.</p>	<p>Install new 800618-3 or 841275-101 (LH) and 800618-4 or 841275-102 (RH) support fittings to replace damaged parts per LAC 88/SB-599A.</p>	<p>Install new fittings, P/N 841275.</p>

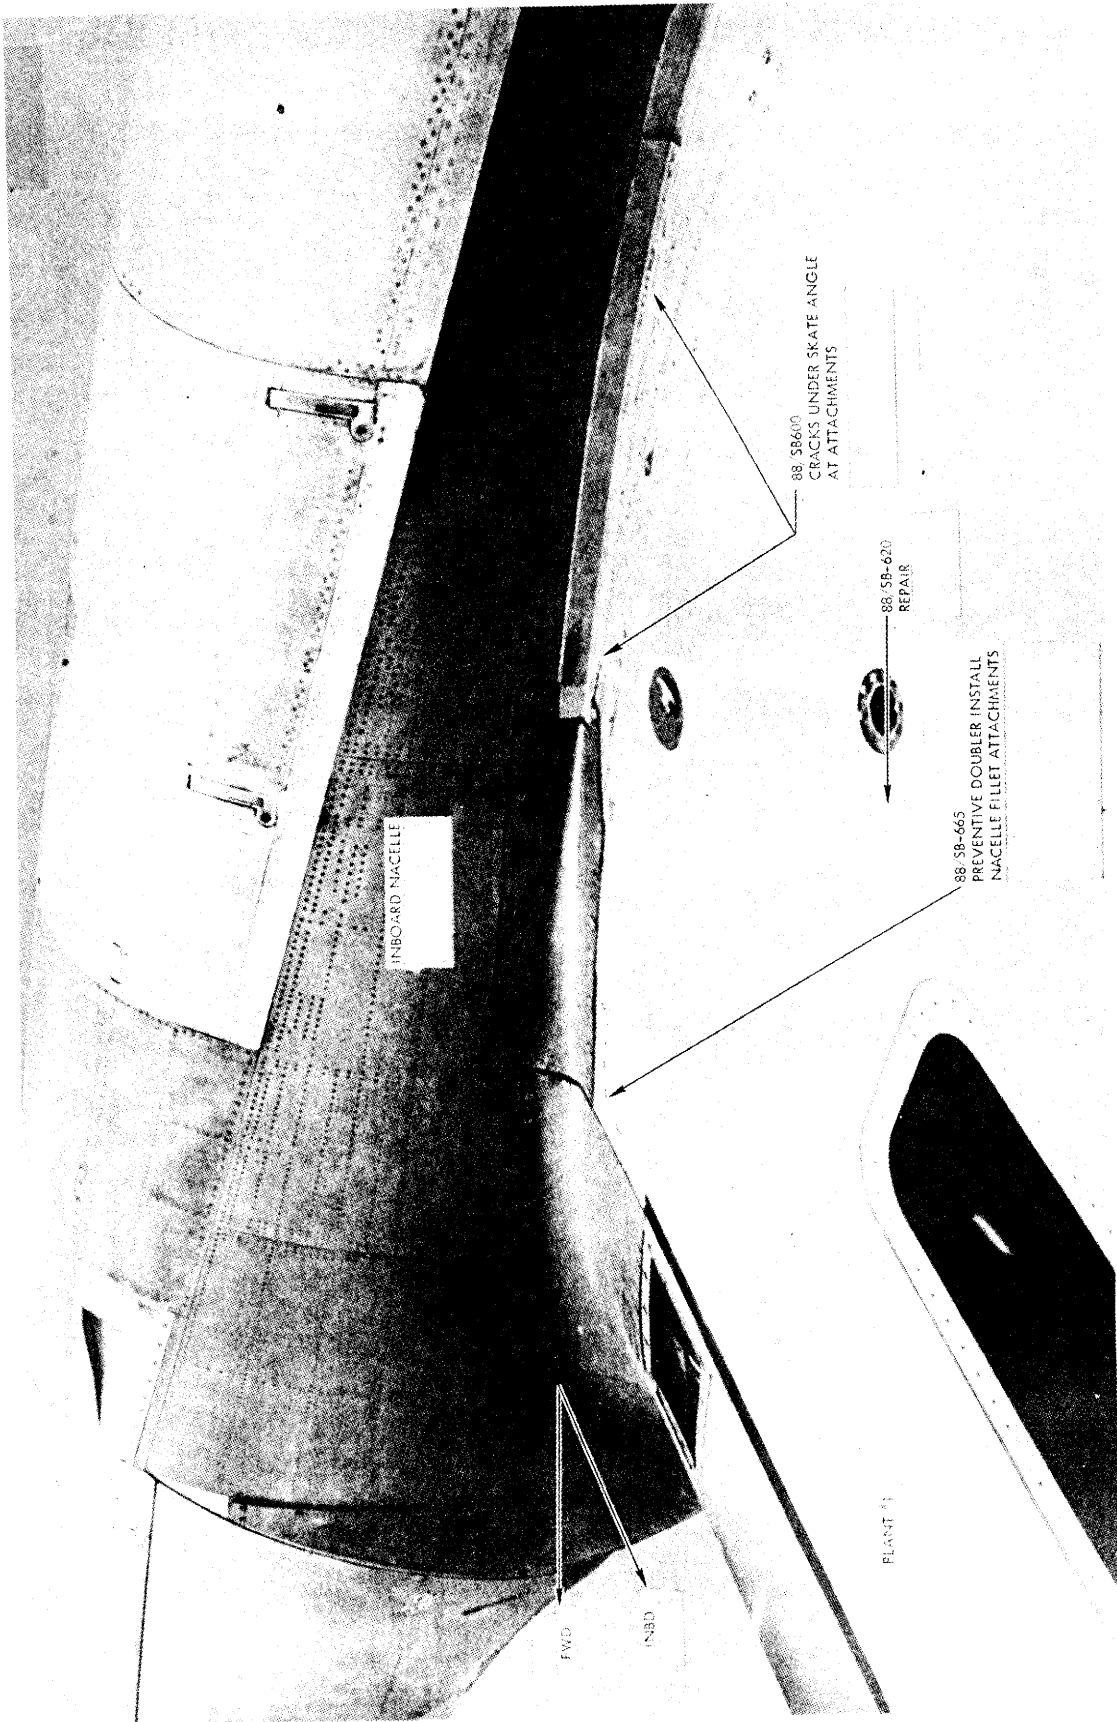
FIGURE F-12. WING UPPER SURFACE
Reference W-7, page 12
W-10, page 14
W-25, page 22

1	2	3	4	5	6
NO.	MAJOR ASSEMBLY	ITEM	SERVICE HISTORY	PAGE REF. FOR ILLUSTR.	S/N CODE
W-7	Outer Wing Upper Surface	Wing Planks under nacelle skate angles	Cracks up to three inches in length have occurred under the inboard and outboard skate angles of the inboard nacelle.	37	⚠
W-8	Outer Wing Upper and Lower Surfaces	Fuel Tank Access Door Lands	Corrosion has been reported on lower wing plank access door lands due to condensation.	38	⚠

7	8		9	10
RECOMMENDATIONS				
METHOD OF INSP.	FREQUENCY OF INSPECTION	TYPE OR METHOD OF REPAIR	PREVENTIVE ACTION	
<p>Visual (External, Internal) X-Ray</p>	<p>Initial external inspection at 450 ft. hrs. with repeat at next 450. Initial internal inspection at 900 ft. hrs. with repeat at 3000 hr. intervals. Discontinue inspections after 6000 hrs. if no cracks found.</p>	<p>(1) Repair cracks in planks per Electra Structural Repair Manual, Section 57-2-1. (2) Install skate angle attachment reinforcement at inbd. and outbd. nacelles per LAC Alert Service Bulletin 88/SB-600A (Ref: LAC Dwg. 841481).</p>	<p>Same as Column 9, Item (2).</p>	
<p>Visual</p>	<p>Within next 850 ft. hrs. Reinspect at each overhaul period.</p>	<p>Remove corrosion per Electra Structural Repair Manual Section 51-2-14 and add protective coating per LAC Service Bulletin 88/SB-606. Repair per LAC Drawing 841295 when damage exceeds .010 inch depth. NOTE: Contact LAC for repair of damage which exceeds allowable limits of Dwg. 841295. (Refer to 88/SB-620G for access door gap sealing instructions.)</p>	<p>Add protection per 88/SB-606. Refer to 88/SB-620G for access door gap sealing instructions.</p>

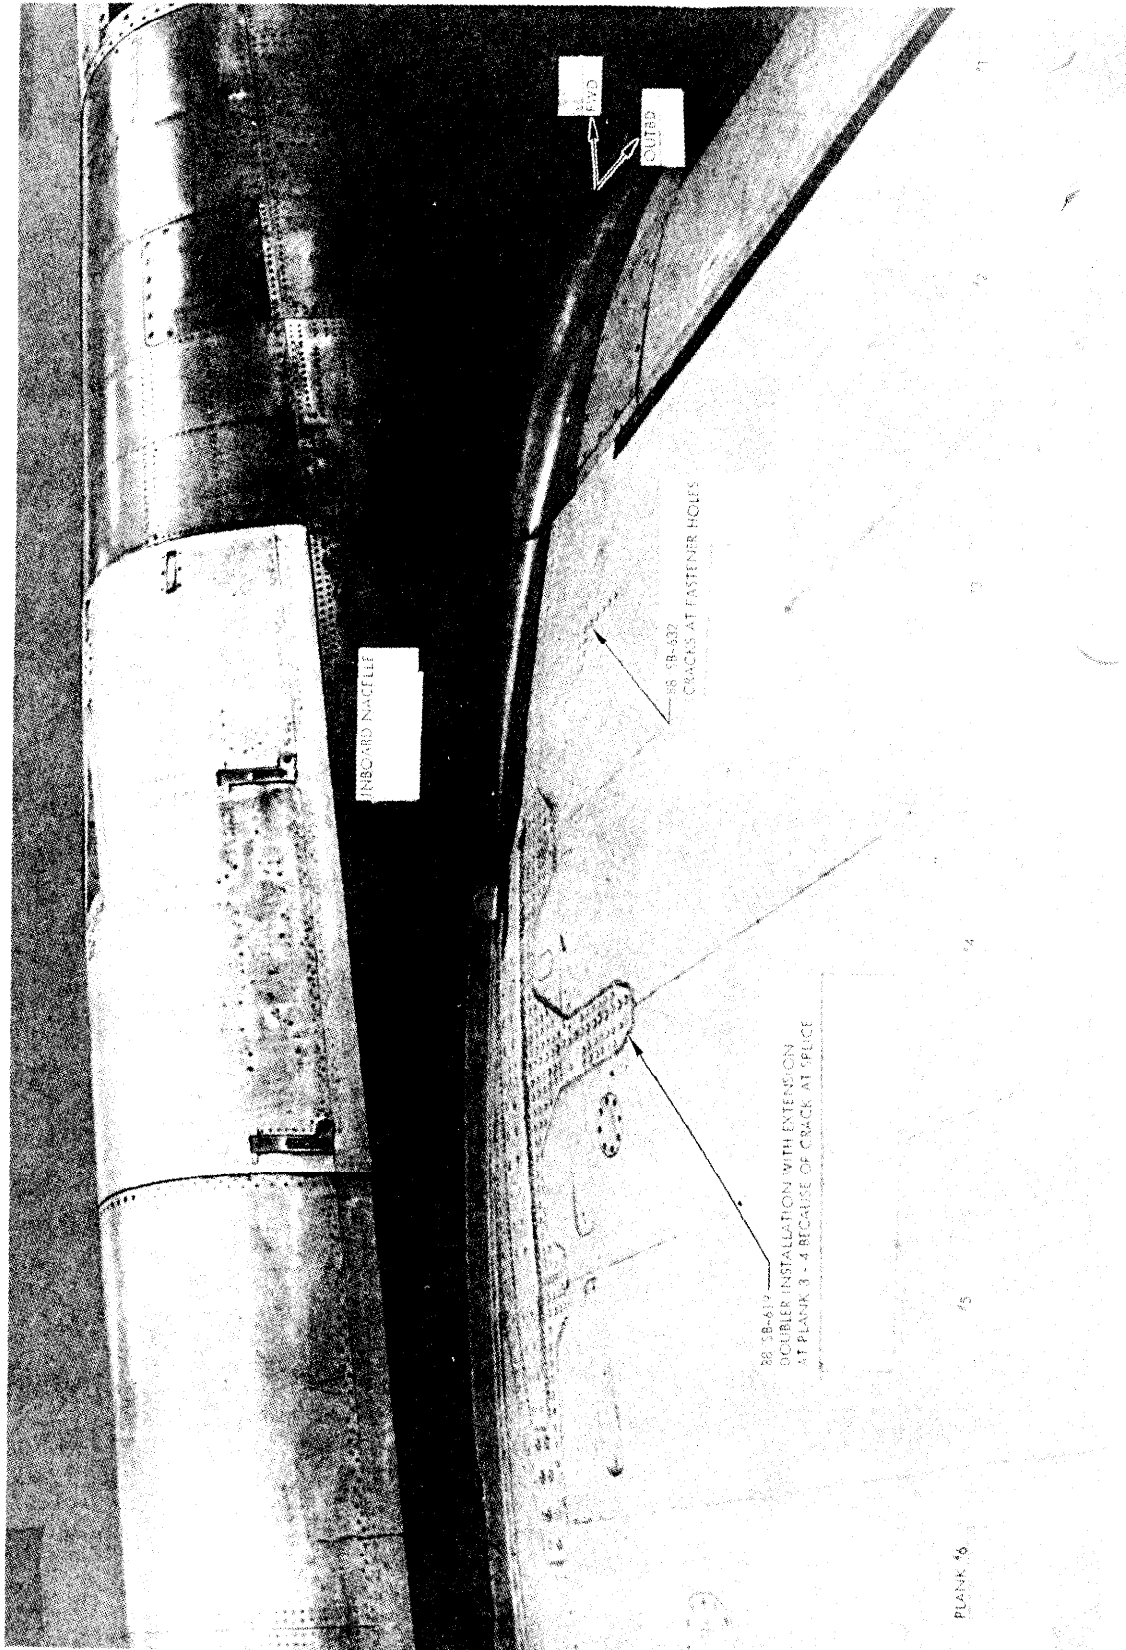
FIGURE F-14. WING UPPER SURFACE
Reference W-9, page 14
W-15, page 16

1 NO.	2 MAJOR ASSEMBLY	3 ITEM	4 SERVICE HISTORY	5 PAGE REF. FOR ILLUSTR.	6 S/N CODE
W-9	Outer Wing Upper Surface, W.S. 167 & W.S. 209	Wing Planks at MLG Rib Forgings	Cracks have occurred in the wing upper surface in the area of the MLG rib forgings.	39 40	△
W-10	Center Section Wing, Outer Wing	Wing Planks Upper and Lower Surfaces	Corrosion and cracks have occurred at various locations in the upper and lower wing plank splices.	30 37 38 41 42 43	△
W-11	Outer Wing Lower Surface, W.S. 167 & W.S. 209	Wing Plank Nos. 3, 4, 5, & 6.	Cracks have occurred in the lower wing No. 5 plank of the LH inboard MLG fulcrum fitting at the No. 4 and No. 5 splice; also, at a fastener hole in plank No. 6 at approx. W.S. 211.	44	△

7	8		9	10
RECOMMENDATIONS				
METHOD OF INSP.	FREQUENCY OF INSPECTION	TYPE OR METHOD OF REPAIR	PREVENTIVE ACTION	
<p>Visual and dye penetrant. Ultrasonic and X-Ray may be used in local areas.</p>	<p>Initial inspection within 700 landings with repeat inspections at 1400 landing intervals. No repeat inspections required after incorporation of reinforcements described in LAC Service Bulletin 88/SB-619.</p>	<p>Install 0.063 inch thick doublers under existing external doublers and install angle stiffeners on the wing internal surface at the Plank No. 3 & No. 4 splice on A/C S/N 1001, 1002, 1004 thru 1144, and 2001 thru 2019.</p> <p>Install new external doublers only on A/C S/N 1145 thru 1148 and 2020 thru 2022.</p> <p>Accomplish rework per LAC Service Bulletin 88/SB-619A.</p> <p>Ref. LAC Drawings 841314C, 841315C, 841345, 841346, SED/64-9010, SED/64-9011.</p>	<p>Same as Column 9.</p>	
<p>Visual, Ultrasonic</p>	<p>Repeat inspection intervals based on action taken.</p>	<p>As specified in LAC Service Bulletin 88/SB-620G.</p>	<p>Accomplish Service Bulletin 88/SB-620G.</p>

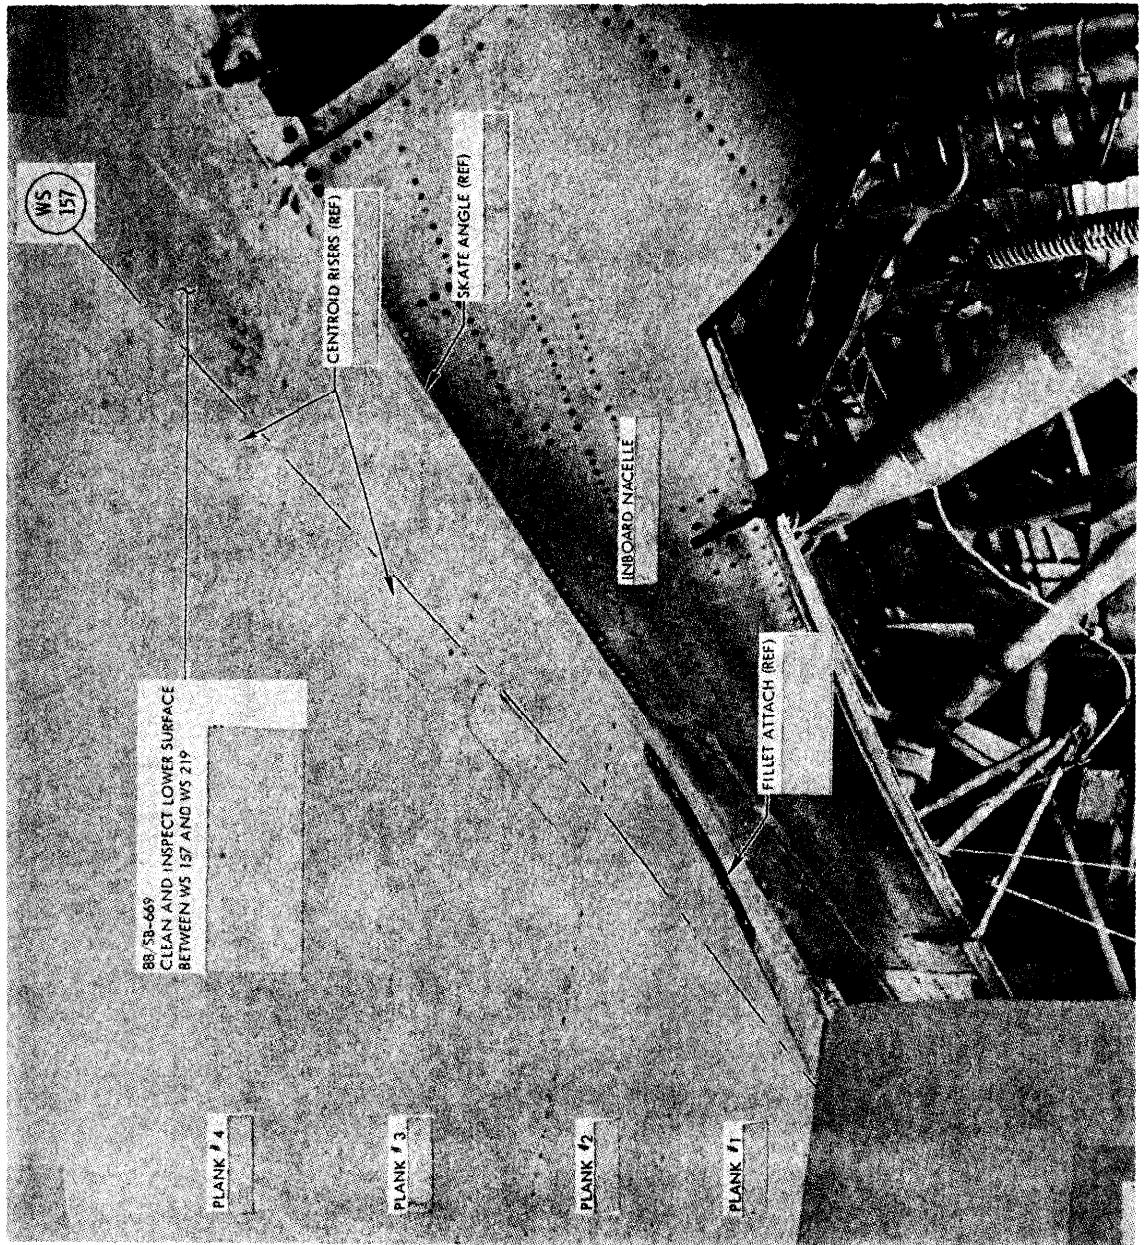
FIGURE F-29. WING LOWER SURFACE
Reference W-22, page 20
W-26, page 24

1	2	3	4	5	6
NO.	MAJOR ASSEMBLY	ITEM	SERVICE HISTORY	PAGE REF. FOR ILLUSTR.	S/N CODE
W-26	Outer Wing Lower Surface W.S. 157 to W.S. 219	Wing Planks Nos. 1 thru 8	Cracks have occurred in the lower wing planks in the vicinity of the Main Landing Gear ribs at W.S. 167 and 209.	35 44 54 55	⚠
W-27	Outer Wing Front Spar W.S. 168	Upper Cap and Spar Web	Cracks have occurred in upper spar cap vertical leg and in web at rib attach bolts at W.S. 168.	50 51	⚠
W-28	Outer Wing Upper Surface	Wing Planks Nos. 2 to 4 on each side of inboard nacelles	Cracks have occurred in upper wing planks 2, 3, and 4 in skate angle area.	56	⚠
W-29	Outer Wing Upper Surface W.S. 346	Wing Planks No. 1 thru 5 at inboard side of outboard nacelles	Cracks have occurred in upper wing planks No. 1 thru 5 at W.S. 346.	30	⚠

7	8		9	10
RECOMMENDATIONS				
METHOD OF INSP.	FREQUENCY OF INSPECTION	TYPE OR METHOD OF REPAIR		PREVENTIVE ACTION
Visual and Dye Penetrant	<p>Initial inspection within the next 400 hours time in service unless previously accomplished.</p> <p>LAC Service Bulletin 88/SB-669A for detailed instructions.</p> <p>Repeat inspections within 2500 ft. hours or 2500 landings whichever comes first.</p>	<p>Per listed repair installations in accordance with LAC Service Bulletin 88/SB-669A.</p> <p><u>INSTALLATION</u> <u>PLANK</u></p> <p>No. 841634 No. 1 & 2 841635 No. 1 841636 No. 3, 4, 5 841642 No. 5 & 6 841865 MLG Drag Strut Area</p>		Same as Column 9.
Visual, Eddy current	<p>On aircraft having 20,000 ft. hours or more inspect within 625 ft. hours. Repeat inspection at 1250 ft. hour intervals until preventive reinforcement or repair which eliminates repeat inspections is installed.</p>	<p>Repair in accordance with LAC Service Bulletin 88/SB-670D, paragraph 2.E.</p> <p><u>DRAWINGS</u> 841624B 841738A 841743B 841806B</p>		<p>Service Bulletin 88/SB-670D, paragraph 2.D. Ref: Dwg. 841717E</p>
