# Santana Row Development Fire

San Jose, California

USFA-TR-153/August 2002

# **Santana Row Development Fire San Jose, California**

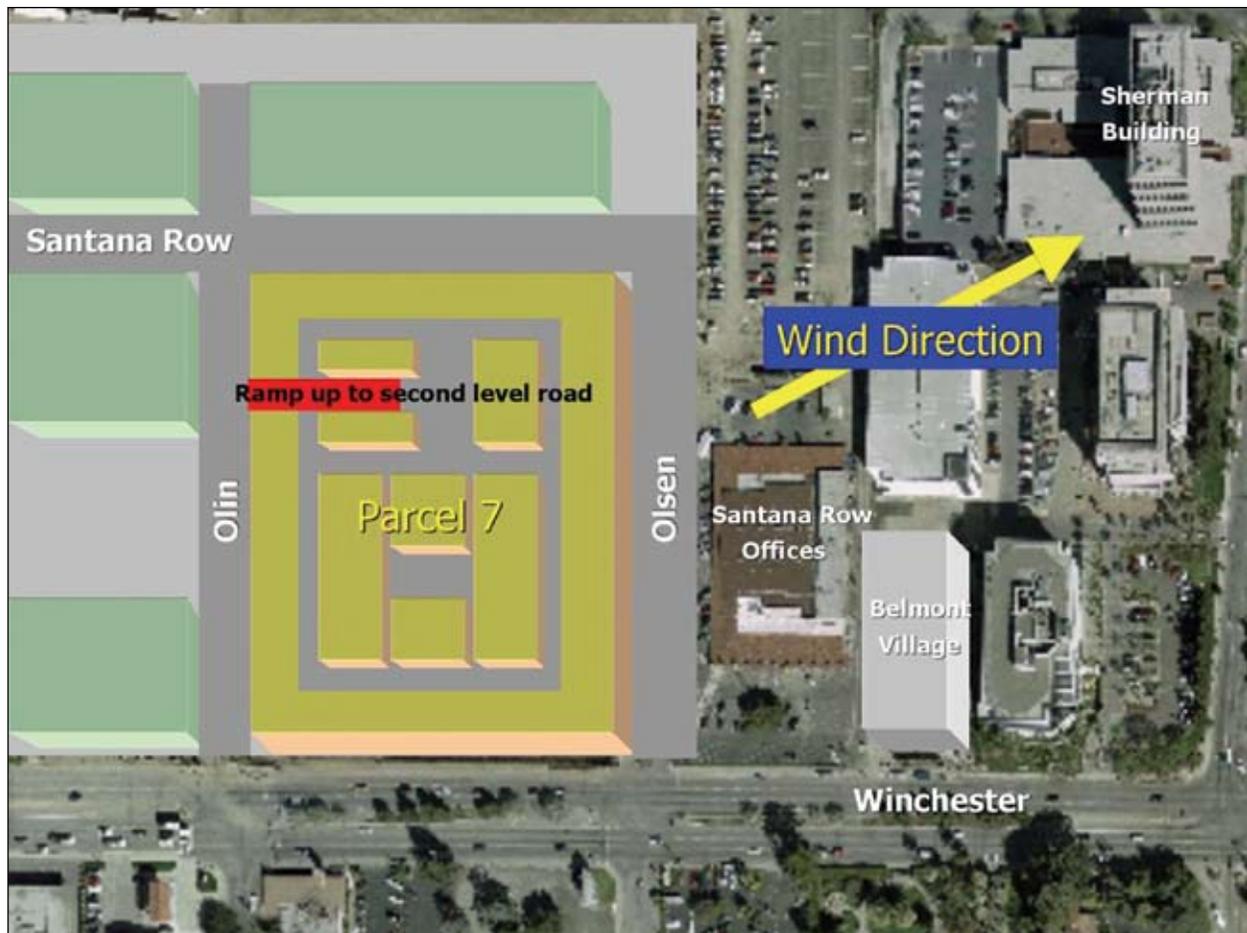
**Figure 1--Overview of Site Plan and Wind Direction**

Weather was not a factor when the original incident was dispatched, but traffic was. The incident occurred just as the afternoon rush hour was beginning. Heavy congestion resulted, which impeded the arrival of multiple-alarm companies. The San Jose Police Department established a perimeter and managed the traffic control efforts. The temperature was approximately 75 degrees Fahrenheit, skies were mostly clear, and the winds were moderate to calm. The fire, however, created its own weather, principally high winds. These winds carried burning embers into the air and began to ignite exposures south of the Santana Row fire.

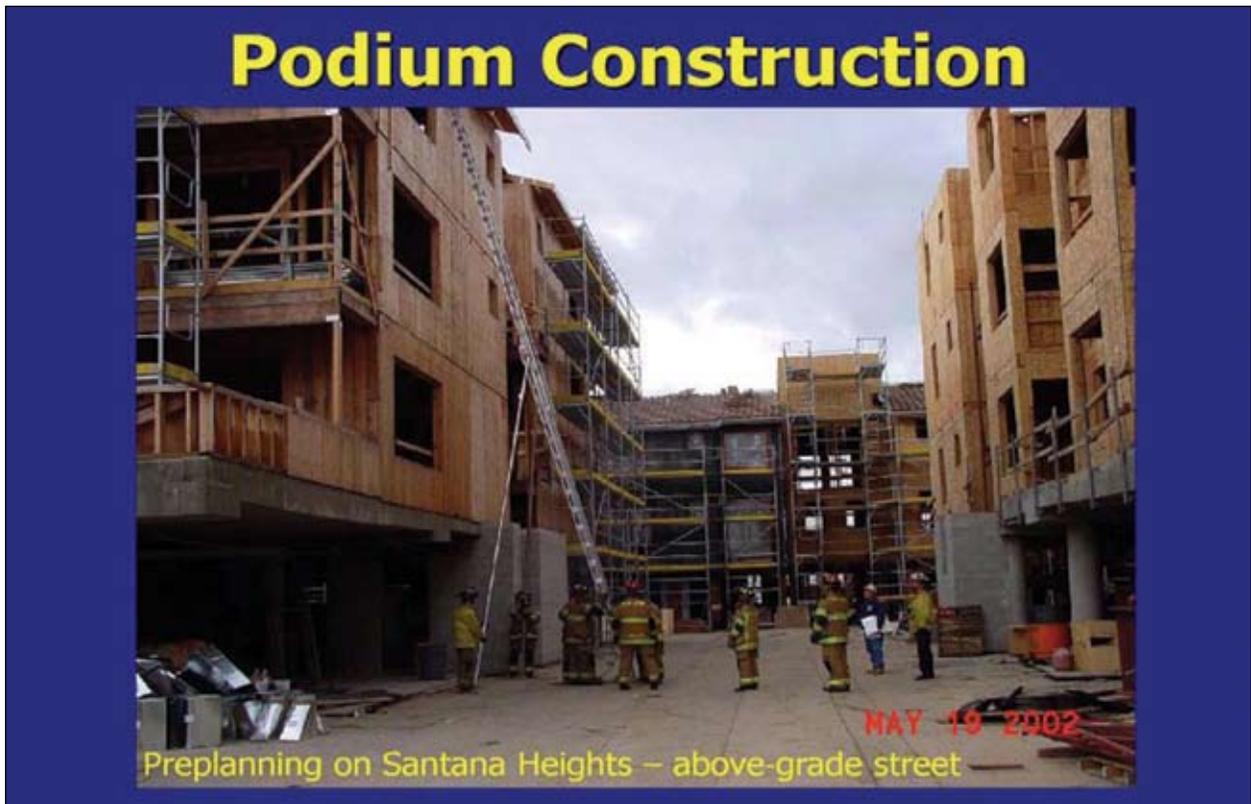
10. Podium construction

The basement and the retail and parking levels were constructed of reinforced concrete. The retail and the first 2 above-ground parking levels were approximately 20 feet in height. Along the outer perimeter of the podium, three-story wood-frame residential units were being constructed. The exterior sides facing the streets had been covered with stucco to give the appearance of being finished, but were in reality still in the framing stage in the interior portion of the units. Immediately behind these units an elevated street, the only one in San Jose, had been constructed. Dubbed Santana Heights, the street was 20 feet in width and was designed to carry the weight load of the Department's apparatus. An additional one-story pod was located in the interior portion of the complex. The reinforced concrete structure was designed to accommodate the vehicle parking for the three wood-frame buildings being constructed on top of the podium. Each of the buildings was 3 stories in height and consisted of 286 townhouses.

A fire watch was maintained at Santana Row for 2 days, and firefighters continued to pour water on the prestressed concrete podium in an effort to cool the structure and prevent damage. A fire watch also was maintained for an additional day in the Huff/ Moorpark area in case there was a rekindle.

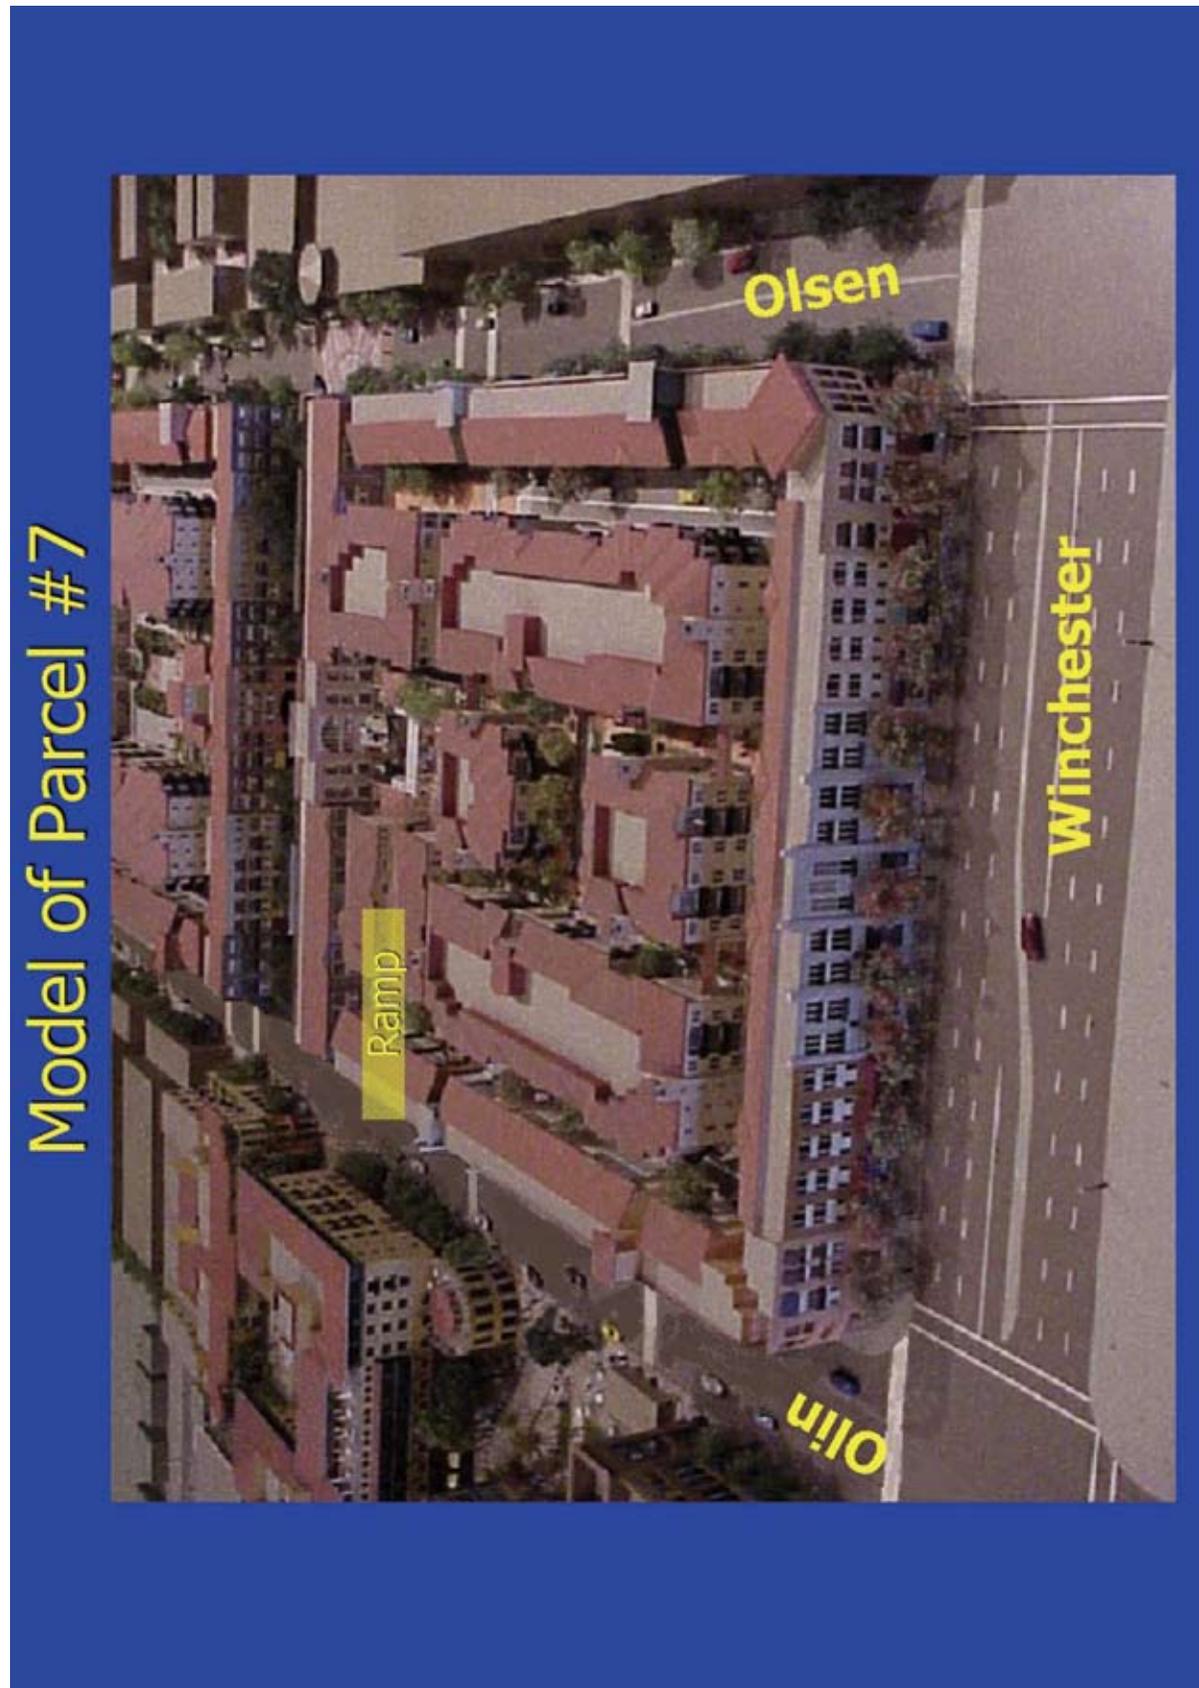
1. Model of Parcel Seven

Each block is assigned a parcel number and a number of the parcels have multiple buildings. The building of origin was located at 377 Santana Row in Parcel Seven. It was under construction as part of phase one of the project. Located on Winchester Boulevard, between Olin and Olsen Avenues, Parcel Seven was a six-story building spread out over 6 acres. There were retail shops, surface and underground parking, and residential units built on podium construction with an above-grade street over the retail and parking level. Each floor contained approximately 225,000 square feet. The basement was to be used exclusively for parking and the two levels of parking (104,000 square foot each) were located immediately behind the retail establishments. The overall height was 67 feet above grade, with 20 feet constructed of reinforced concrete and the top 47 feet of wood-frame construction.

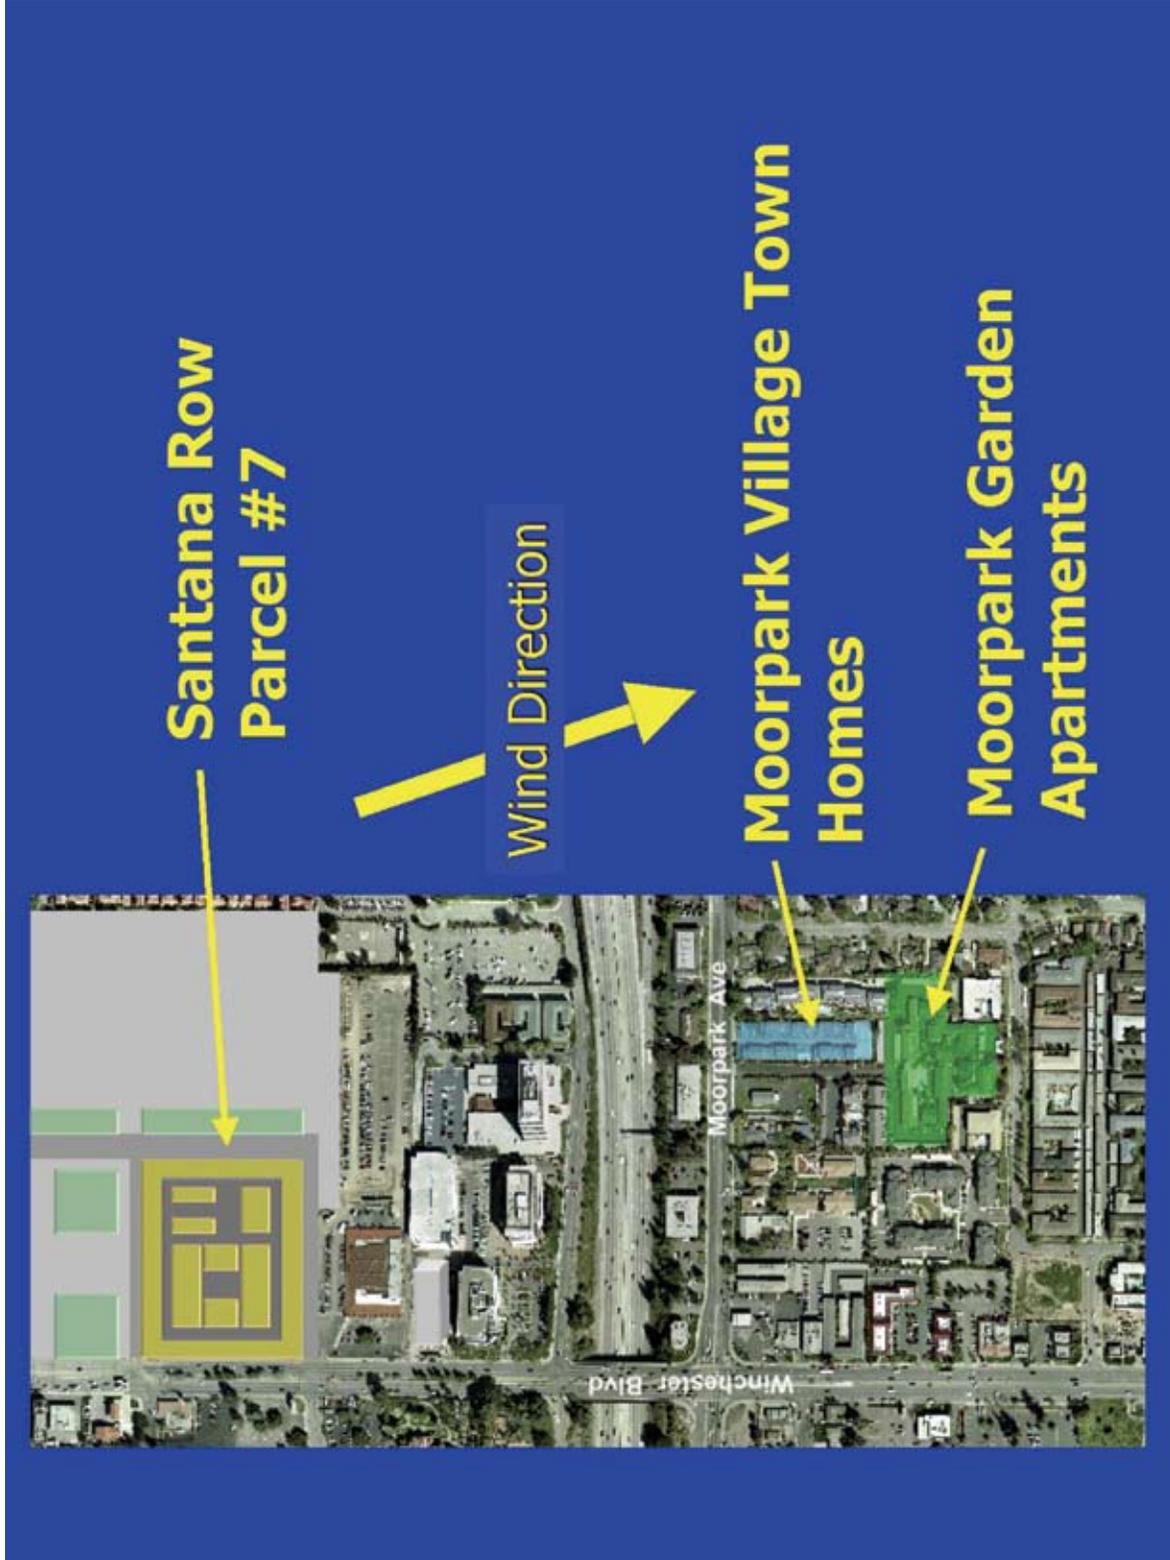
8. Wind direction and location of second incident

Flying embers carried aloft by winds generated by the convective currents of the fire at Santana Row ignited a number of fires downwind from the building of origin. The largest concentration of fires was along Moorpark Avenue. One of the most seriously damaged areas was Moorpark Village, which consists of 14 townhouses located in 3 buildings in the 2900 block of Moorpark Avenue. The buildings are two-story wood-frame units that were built during the late 1970's with wood siding on the ground level, stucco on the second story, and wood-shake roofs. The largest of the buildings contains seven units and has a footprint of 7,500 square feet. A second building contains four units with a footprint of 3,500 square feet, and the third building contains 3 units and is slightly smaller.

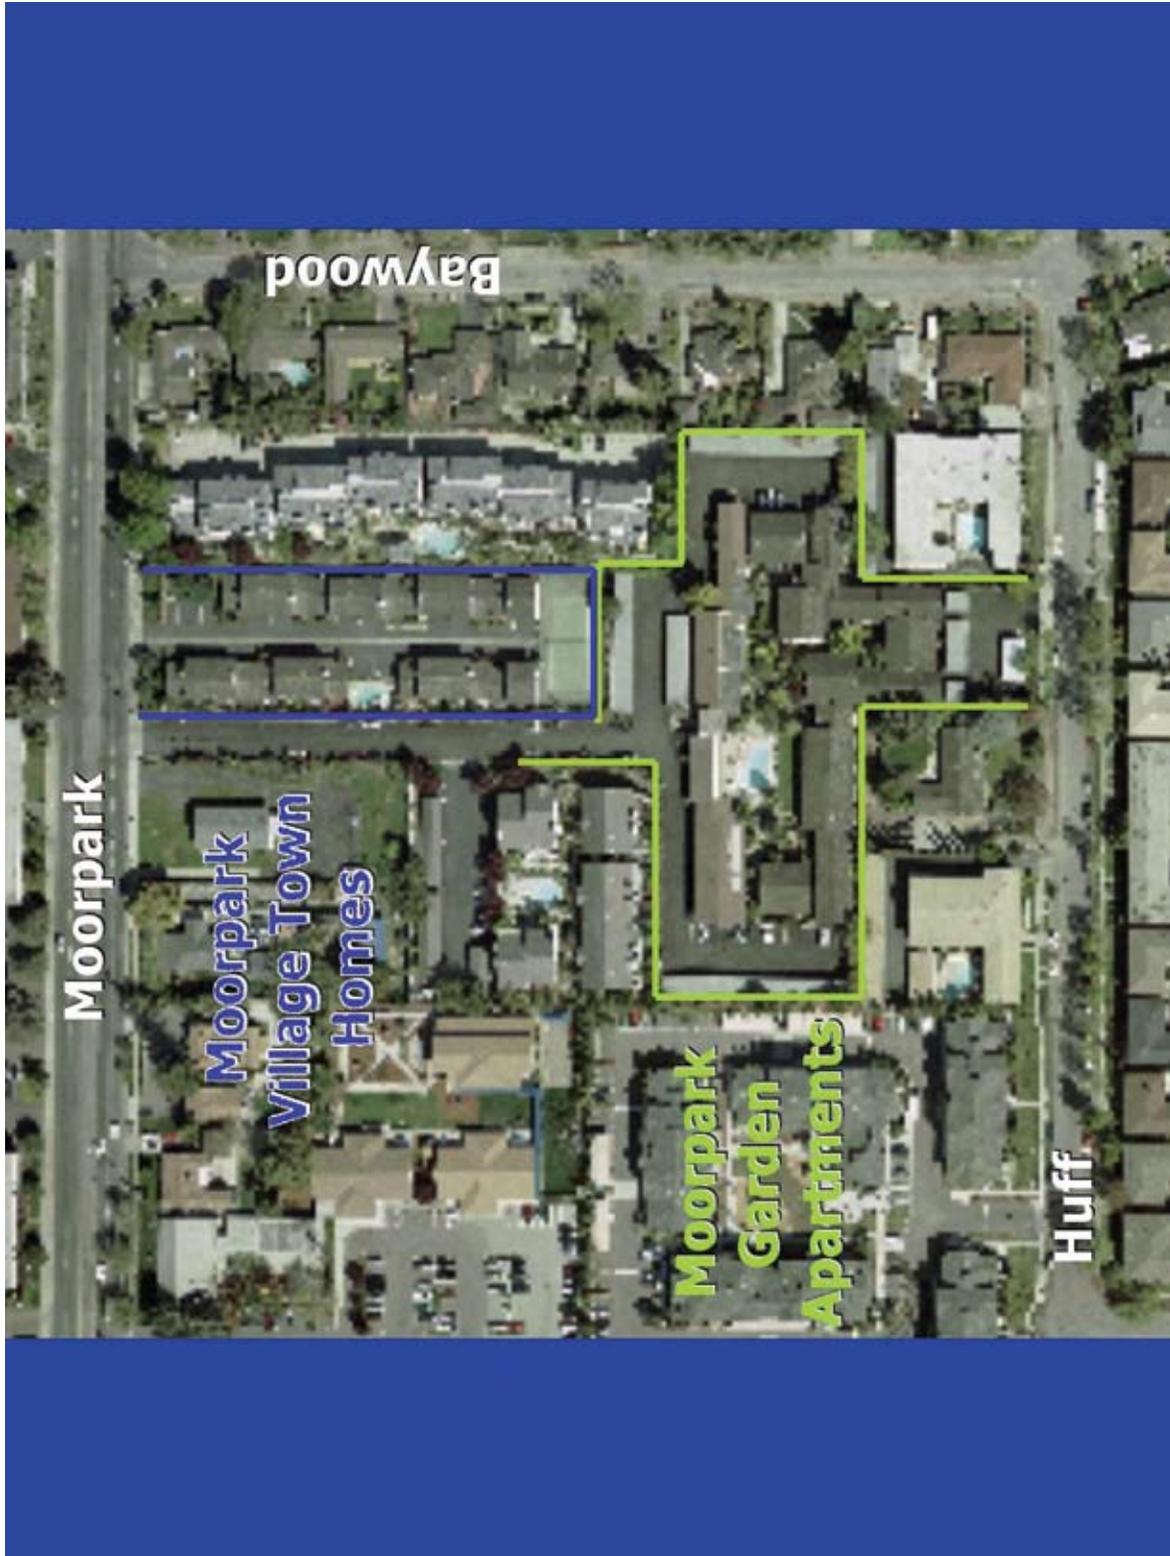
9. Location of Moorpark Apartments and Townhouses complex

Moorpark Gardens is an apartment complex located at 2966 Moorpark Avenue. The complex was constructed about 1970 and contains 68 apartments distributed in nine buildings with a stucco exterior. Some of the buildings had wood shakes and some had been reroofed with composition. All of the buildings in the complex that sustained fire damage had wood-shake roofs.
