U.S. Fire Administration/Technical Report Series

Four Firefighters Die in Seattle Warehouse Fire

Seattle, Washington

USFA-TR-077/January 1995

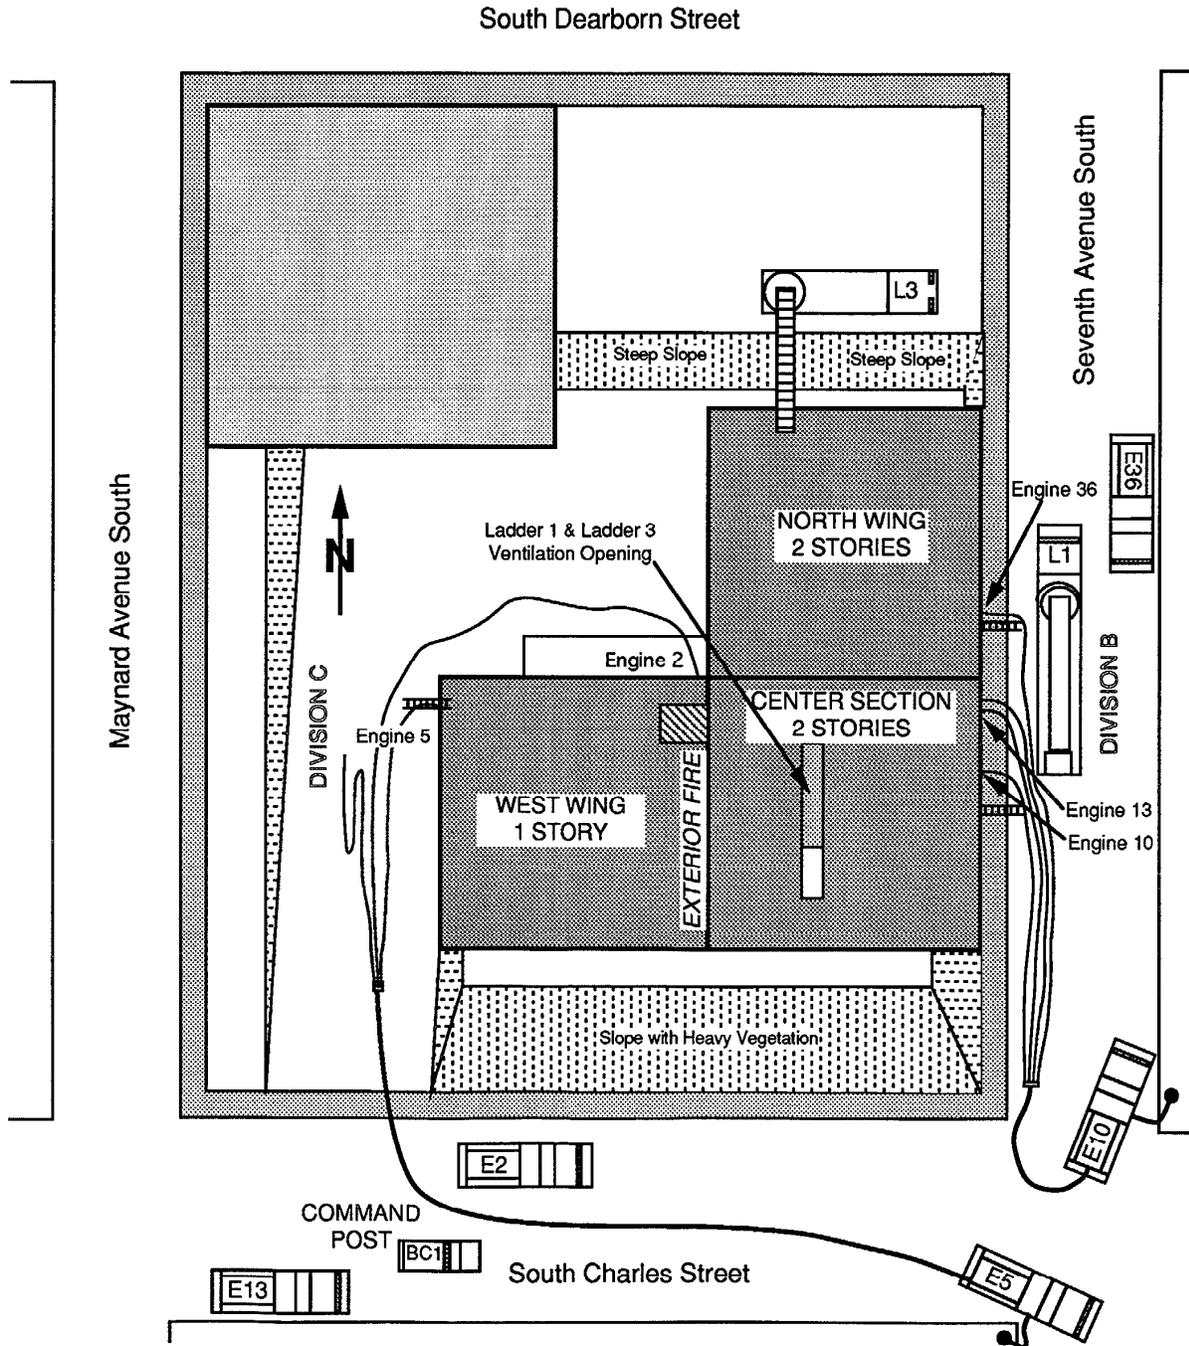
Figure 2

ladder the north wing. The crew then went to the roof with ventilation equipment. The deployment of first alarm companies is illustrated in Figure 2.

Locations Of 1st Alarm Companies

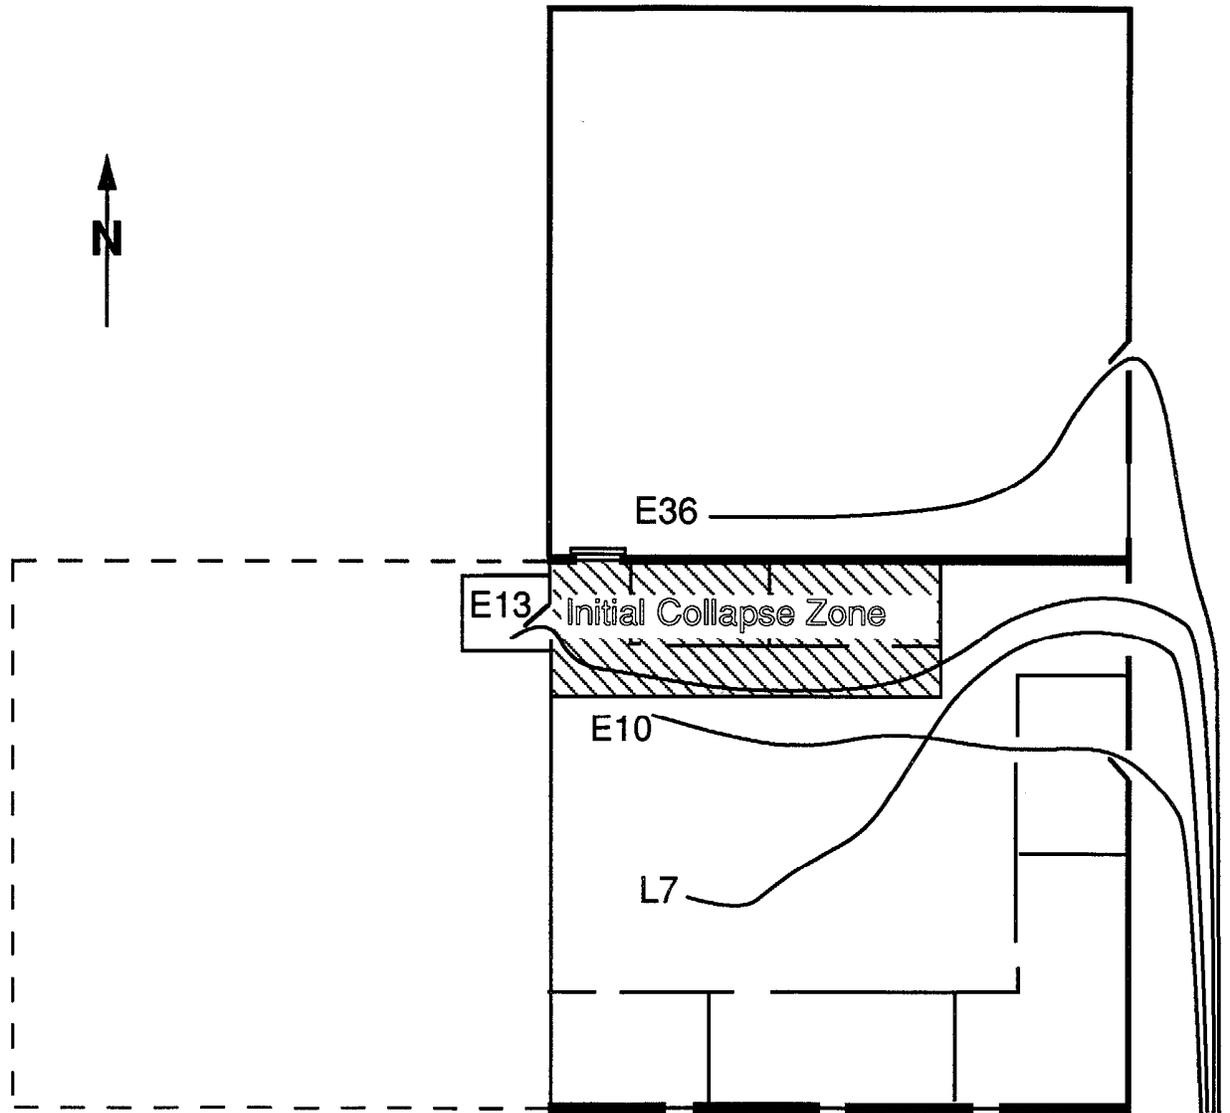
Figure 3

Engine 13 advanced all the way to the west wall and into the lunchroom, where they found that the fire had burned through the wall from the exterior. They conducted overhaul in this area and attacked some fire that was visible through the hole in the wall. Ladder 7 advanced a line toward the middle of the floor area searching for fire, while the Lieutenant and one crew member from Engine 10 were working to their right with the third line. (The approximate positions of the interior attack lines are illustrated in Figure 3.)

UPPER LEVEL FLOOR PLAN
Showing Attack Line Positions at Time of Collapse

4 Attack Lines
All 1 3/4 inch
Supplied by
E10 Manifold

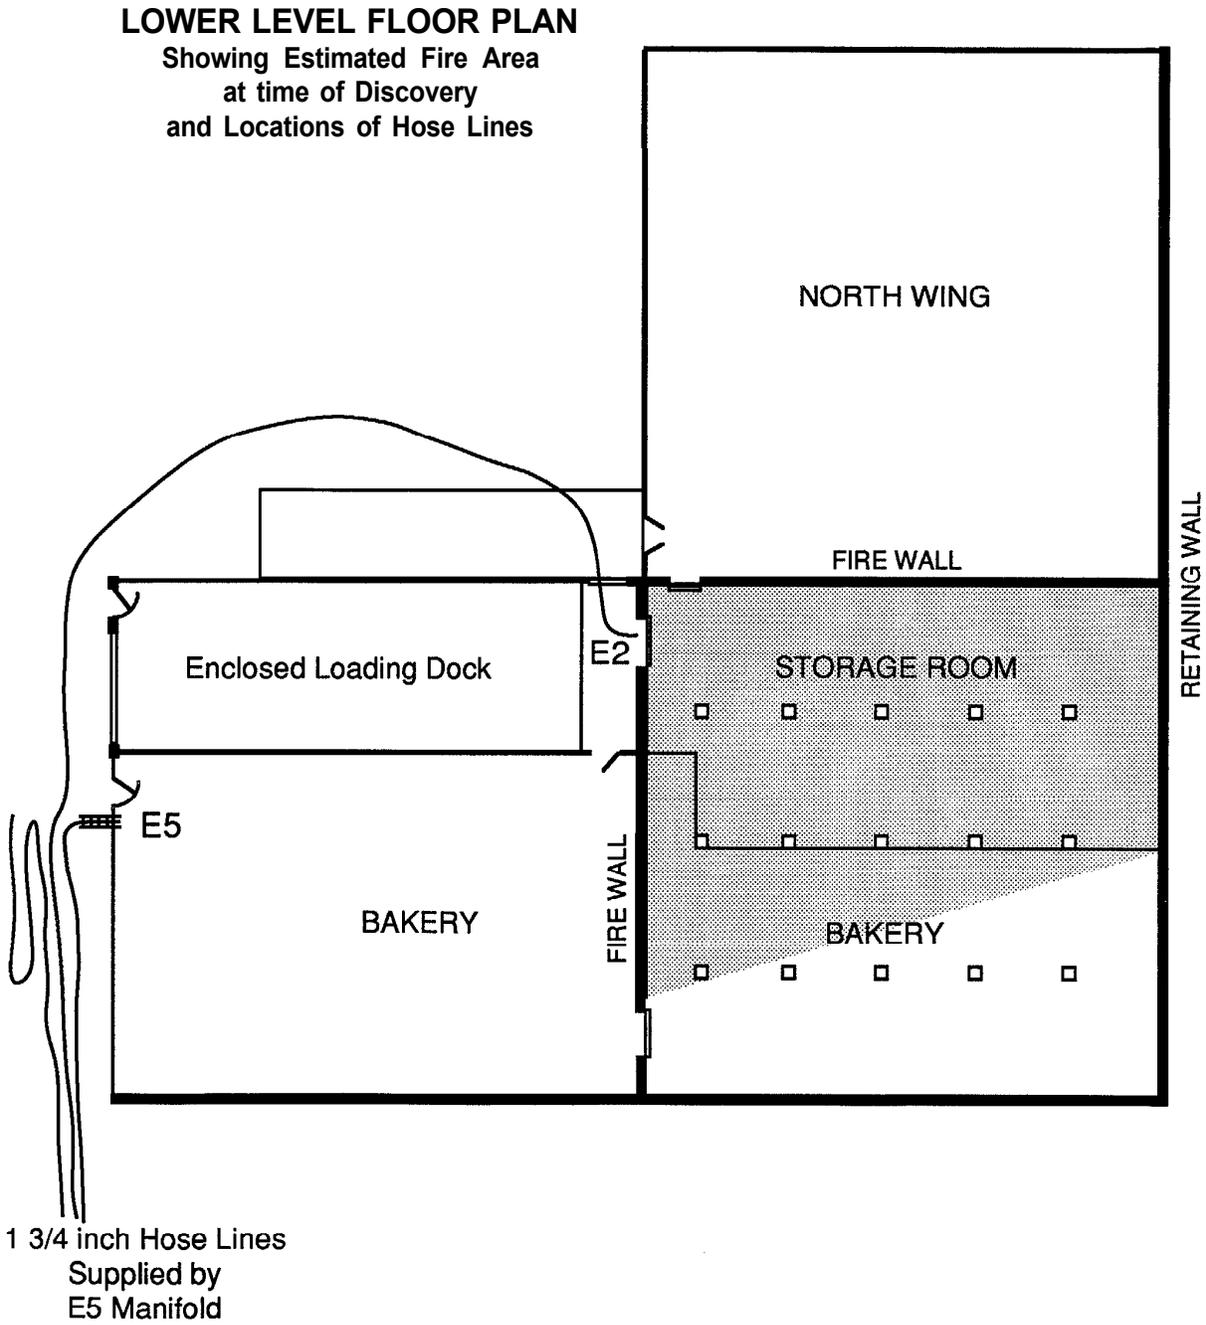
Figure 4

When they reached the loading dock they found the sliding fire door leading into the storage room partially open. The interior of the storage room was fully involved in fire; however, no smoke or flames were coming out of the doorway. The large fire was drawing air in through this opening. (This location is shown in Figure 4.)

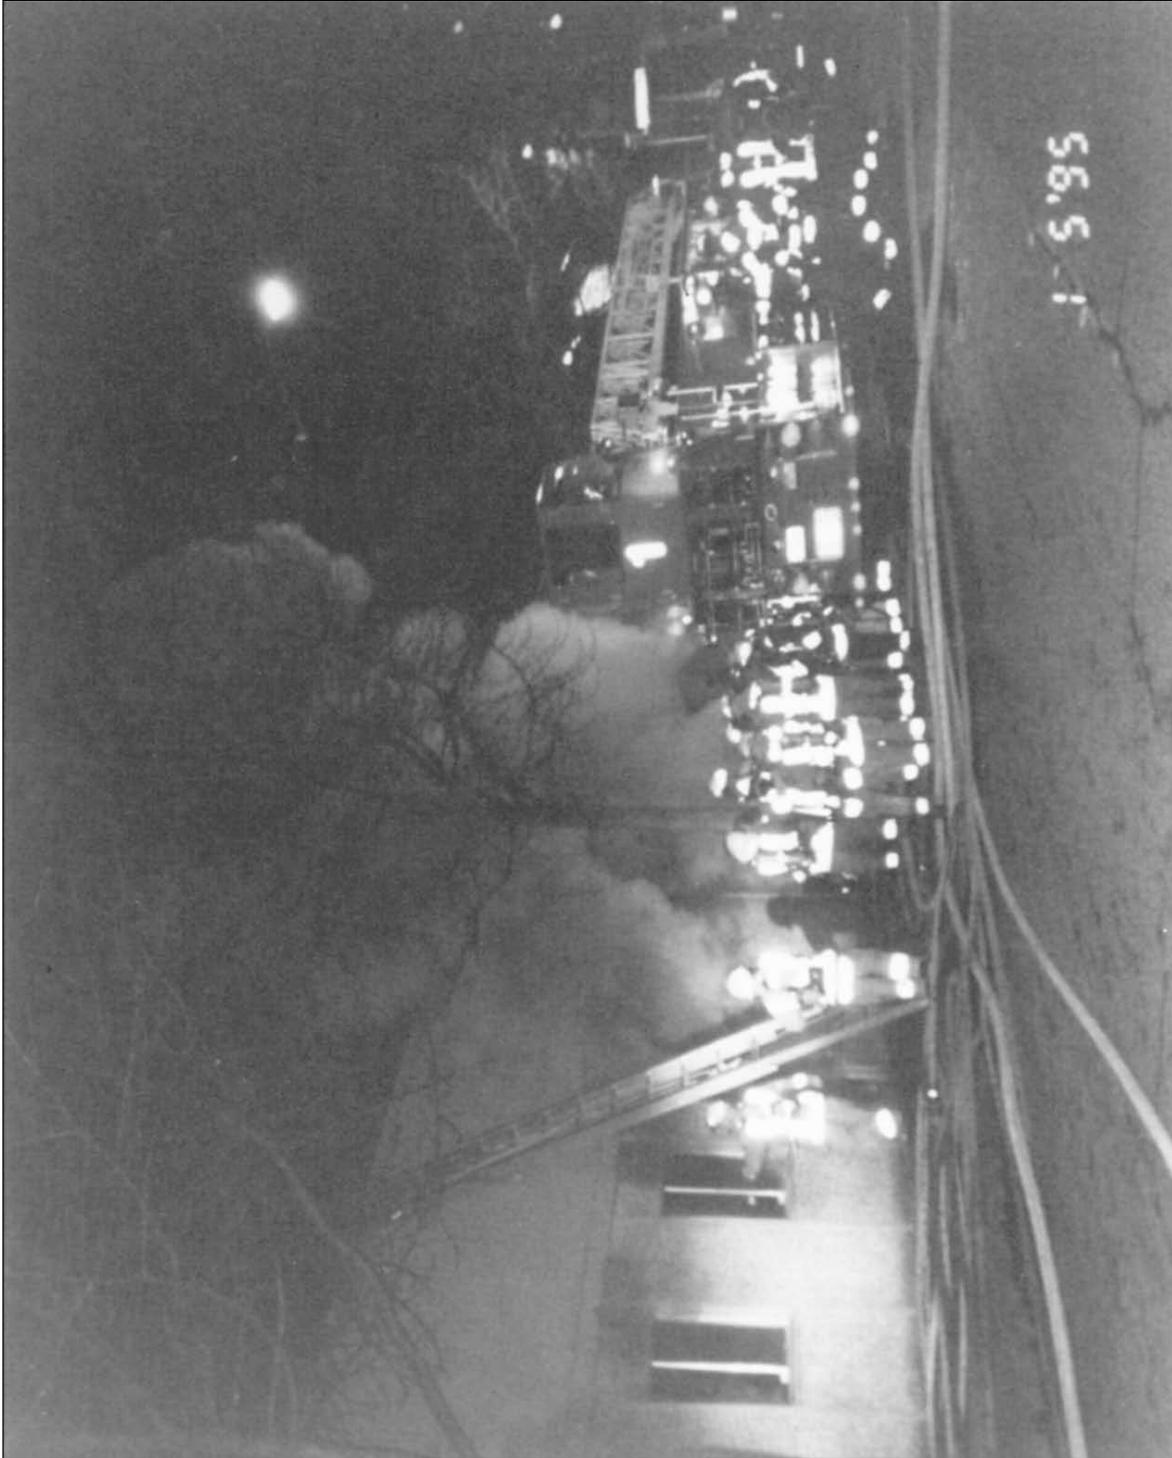
Crews prepare to enter the structure on the east side.
