FRACTOGRAPHY OF COMPOSITE DELAMINATION

FINAL REPORT

October 15, 1989

MATERIALS SCIENCE AND ENGINEERING DEPARTMENT
UNIVERSITY OF UTAH

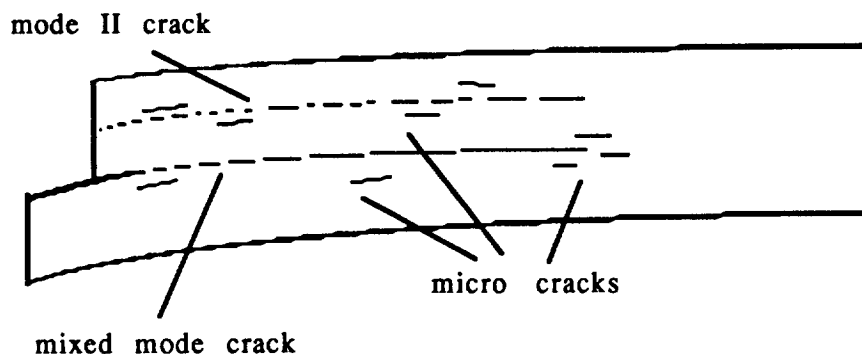
The general appearance of the cut sections is shown in Figure 10. Two major cracks developed in the specimen; the major crack along the central plane and a pure Mode II crack in the upper half of the specimen. The crack in the upper half of the specimen is designated as a "pure" Mode II crack based on the fact that there was relatively little displacement of the crack faces. In principle, a Mode II crack should not be visible since it involves only shear displacements. None the less, the cracks generated in this study are the result of primarily Mode II loads.

Figure 10 - Schematic of cracking in a Mode II specimen

As shown schematically in Figure 10, there were microcracks

near the major crack and especially ahead of the crack front. It was sometimes difficult to distinguish microcracks from laminate imperfections but there is the distinct possibility that "satellite" microcracks develop ahead of the main crack front but then close-up once the crack front has passed. The formation of these satellite cracks probably constitute part of the energy of Mode II crack propagation, at least for the test configuration used here.

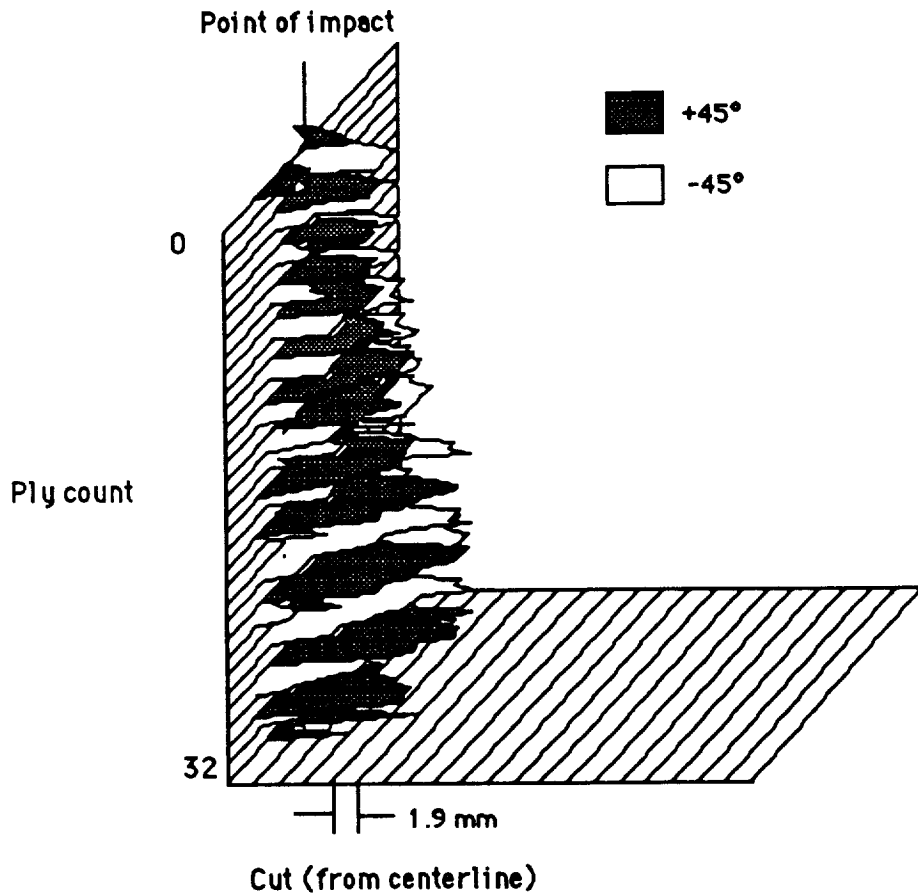
The second stage in the stiffness plot extended to higher cumulative impact energies and the third stage was not as clearly defined compared to the (0/90) laminate. The second stage corresponded to through the thickness damage as shown by the damage map in Fig 28. This damage extended to the edges of the laminate after a Σ I. E. of 300 J (Fig. 29)

Figure 28 - Damage map of AS4/3501-6, $(\pm 45)_{16s}$ after Σ I.E. = 80J.

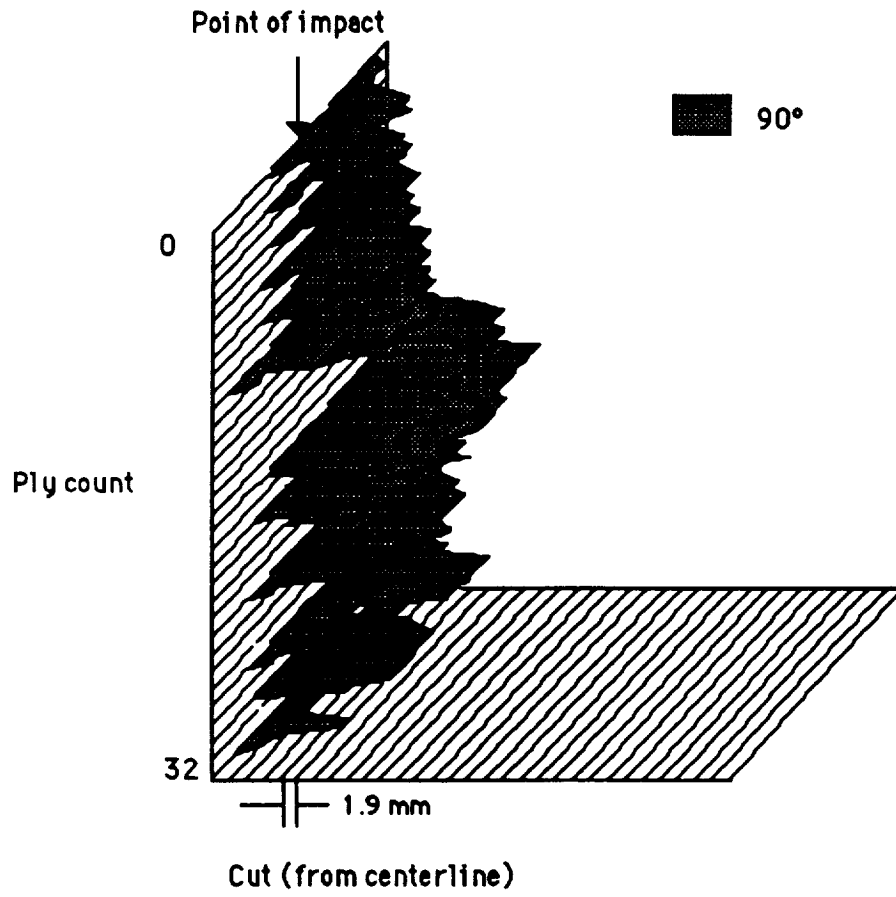
IM6/3501-6 (0/90) and IM6/3501-6 (± 45) Laminates: The stiffness and percent transferred energy vs cumulative impact energy for IM6/3501-6, (0/90) and (± 45) are presented in Figs 30 and 31. Three distinct stages were observed in the stiffness plot for the (0/90) laminate (Fig 30) and as with the AS4 materials the second and third stage corresponded to through the thickness damage and extension of the damage to the edges of the specimen. The corresponding damage maps are shown in Figs 32 and 33.

Figure 32 - Damage map of IM6/3501-6, (0/90)_{16s} after Σ I.E. = 110J.

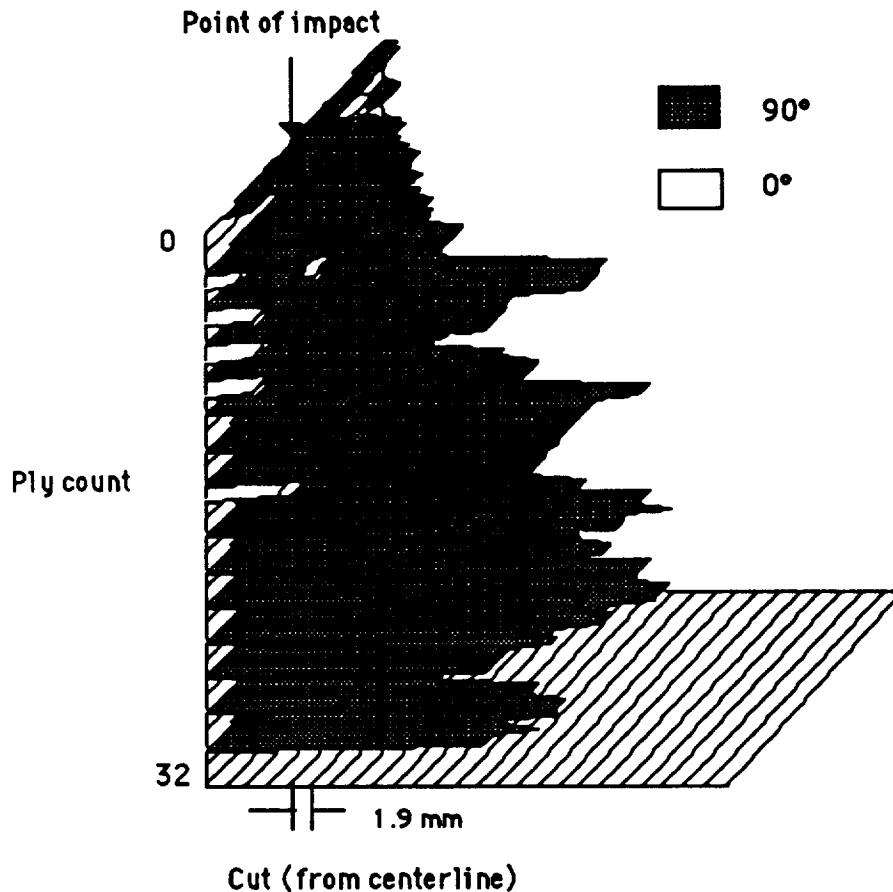
Figure 33 - Damage map of IM6/3501-6, (0/90)_{16s} after Σ I.E. = 190J.

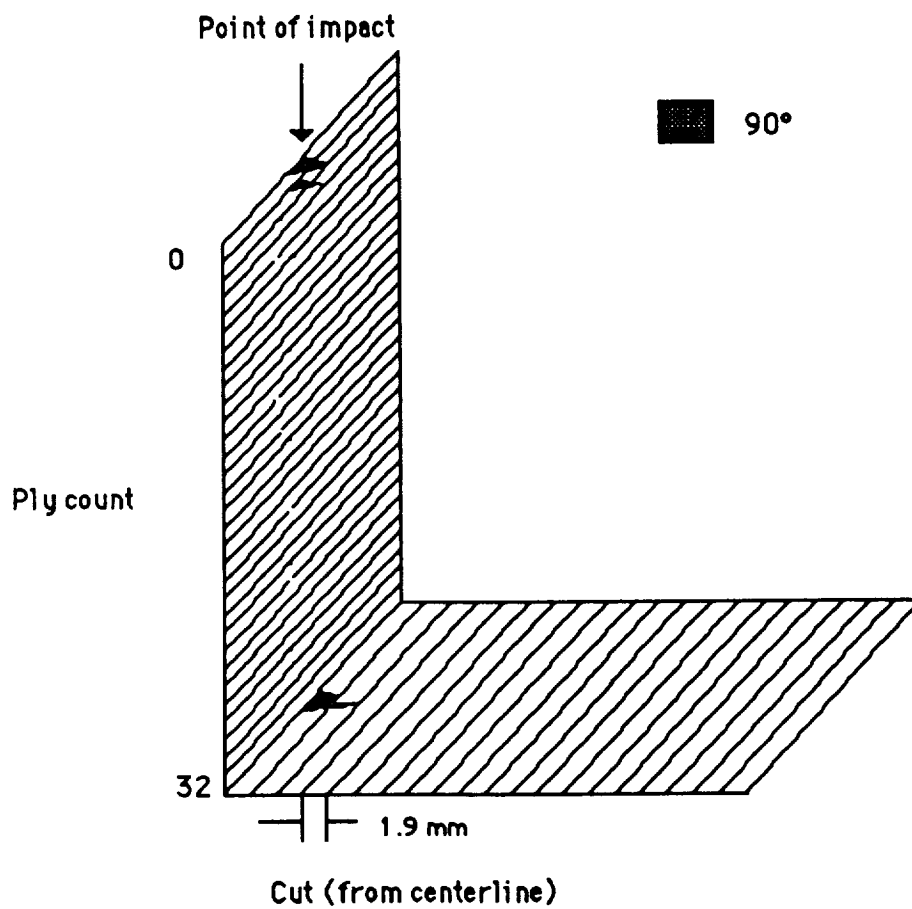
The results of the C-scans are given in Fig. 36 and the damage maps in Figs. 37, 38 and 39. In the initial stage (Σ I.E.= 35 J), the damage was small but clearly evident from the C-scan. (This C-scan was done at a higher impact energy than for the corresponding AS4/3501-6 laminate.) The map shows that damage was confined to the front and back plies, and was primarily transverse cracking. Damage at a Σ I.E. of 115 (J) was more localized compared to the 3501-6 systems. The major damage was in the mid plane of the laminate (Fig.38) and usually consisted of transverse-cracking and delamination (Fig.40) as well as some fiber breakage (Fig.41).

Figure 37 - Damage map of AS4/PEEK, (0/90)_{16s} after Σ I.E. = 35J.

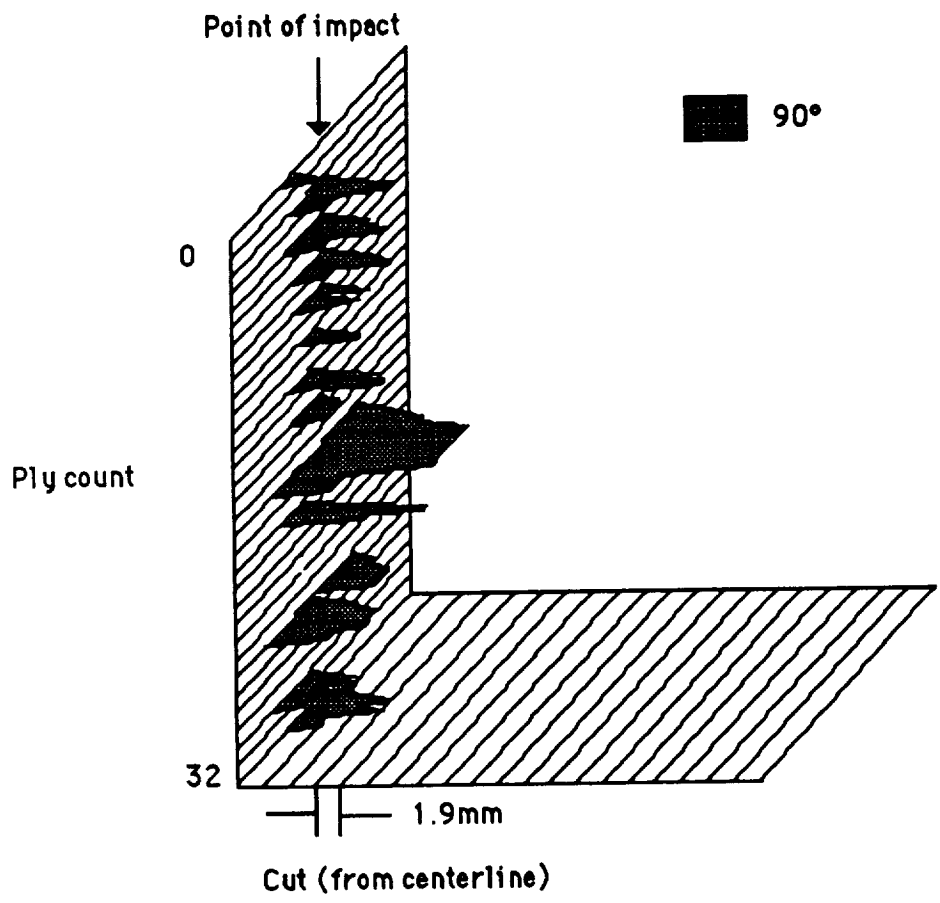
Figure 38 - Damage map of AS4/PEEK, (0/90)_{16s} after Σ I.E. = 115J.

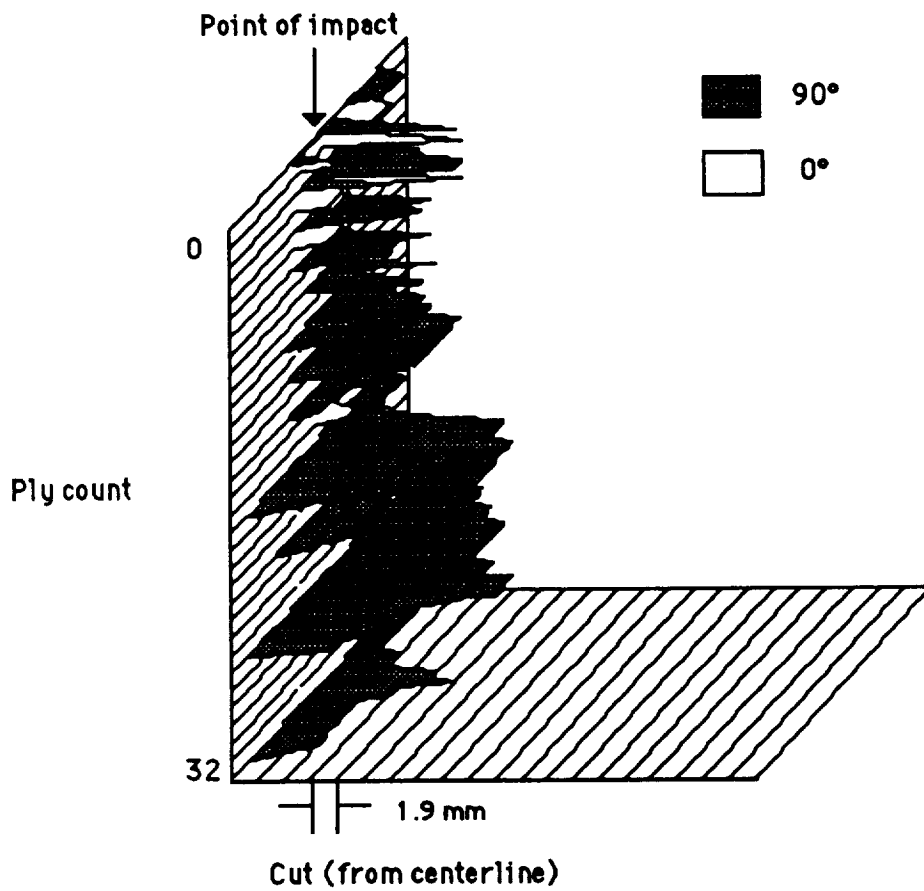
Figure 39 - Damage map of AS4/PEEK, (0/90)_{16s} at Σ I.E. = 280 J

Damage at Σ I.E. of 280 (J) extended to the edge of the sample but was confined to the midsection (Fig.36c) whereas in the 3501-6 matrix laminate the damage spread more or less uniformly. Extensive fiber breakage was observed (Fig.42).

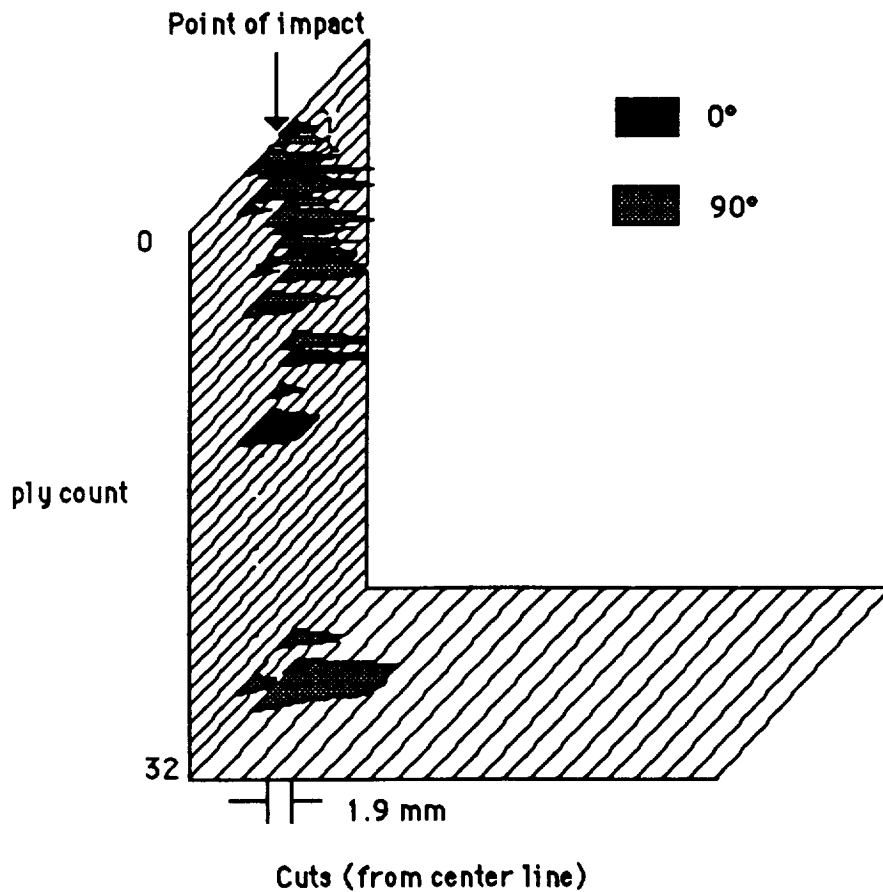
Figure 48 - Damage map of AS4/polycarbonate, (0/90)_{16s} at Σ I. E. = 270J

The C-scan and the damage map at Σ I.E. of 270 J are shown in Figs.47 and 48 respectively. The damage was highly localized and restricted to the front and the back plys. Some fiber breakage was observed. This material appears to be more damage resistant than the other composite materials in these tests.

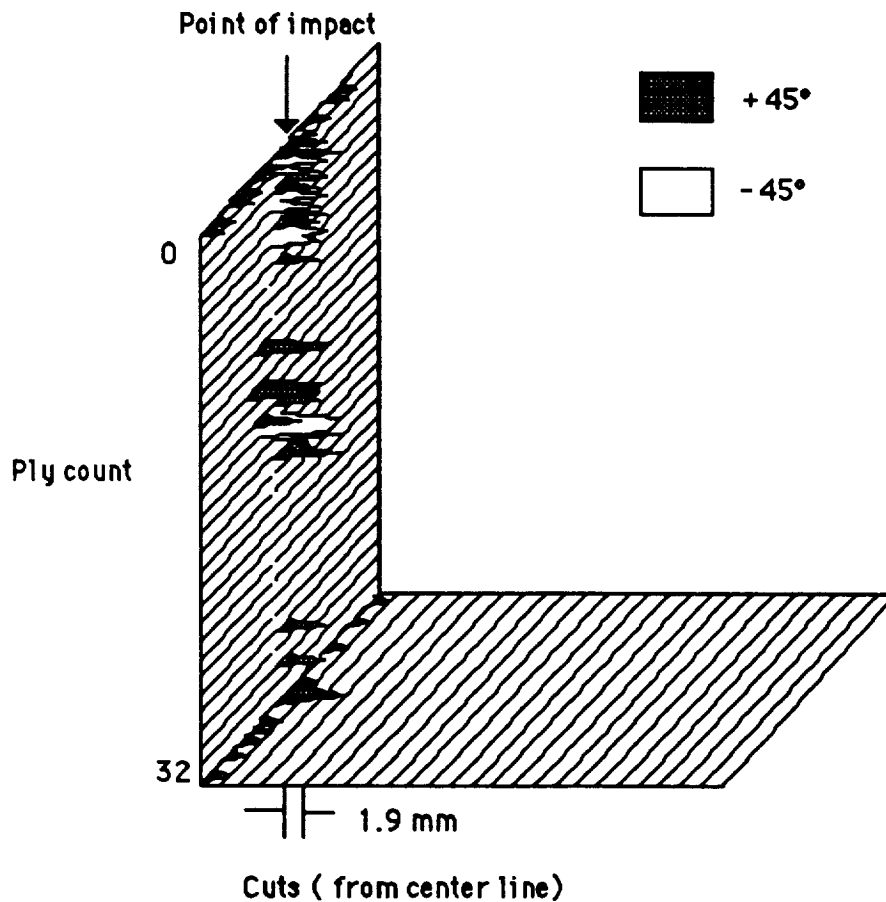
Figure 50 - Damage map for AS4/polycarbonate, (± 45) at Σ I.E. = 250J

AS4/polycarbonate(+45) laminate: Stiffness and percent transferred energy vs Σ I.E are shown in Fig.49. A C-scan and damage map for Σ I.E of 250J are presented in Figs. 50 and 51 respectively. The reduction in stiffness and the extent of damage were even less than for the (0/90) laminate.

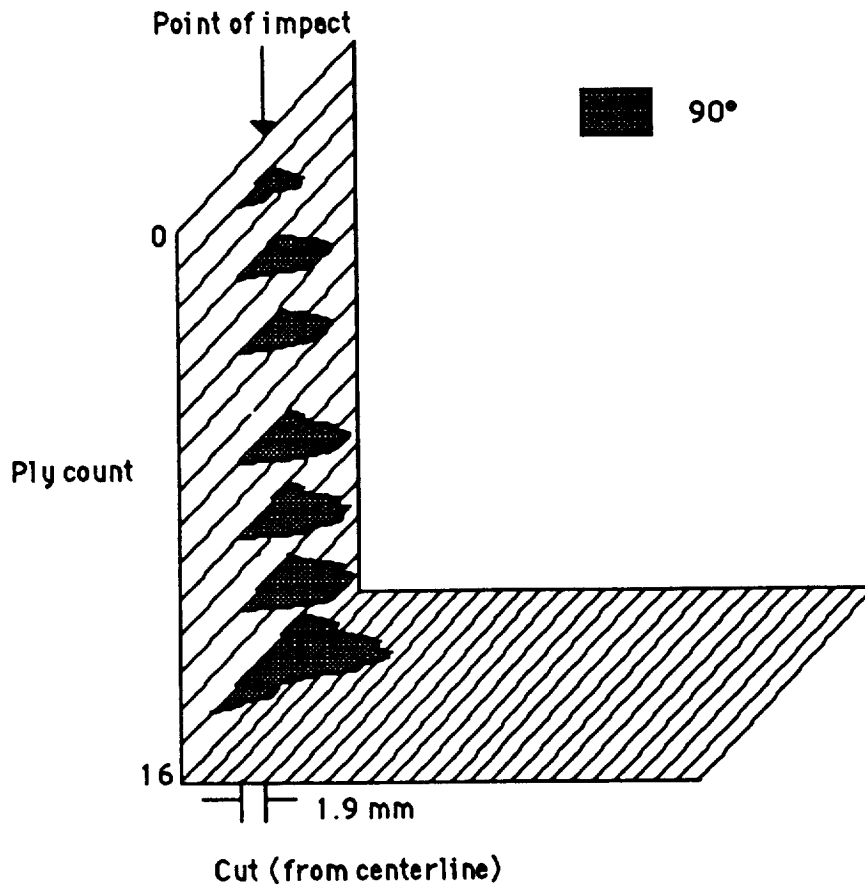
Figure 54 - Damage map for AS4/3501-6 (0/90)_{8s} at Σ I. E. = 10J

A damage map of a 16 ply specimen from the second stage (Σ I.E. = 10J) is shown in Fig. 54. The damage was through the thickness of the specimen and had a conical profile..

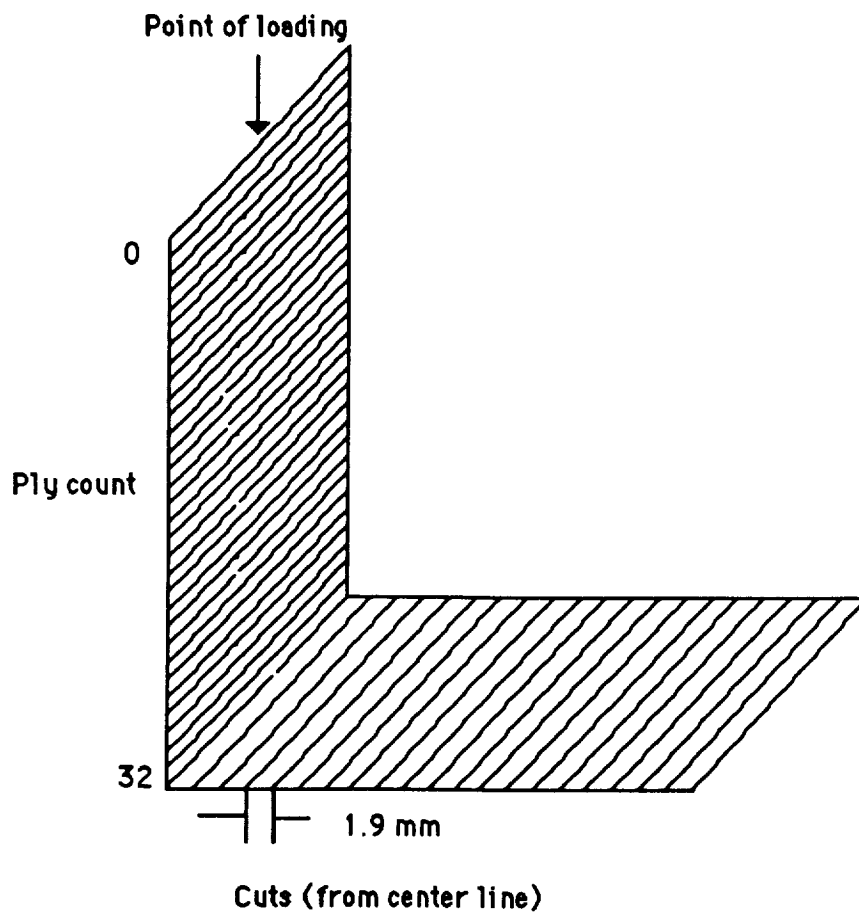
Figure 60 - Damage map of AS4/3501-6,(90/0)_{16s} laminate loaded to a displacement of ~ 1.5mm

The damage patterns from C-scans were similar to those of the dynamic test (compare Fig. 59 with Fig. 21). Damage maps of each of the stages from the static test are presented in Figs. 60-62. In the first damage stage of the static test, there was no contact damage on the front surface. In the second stage of this test, the pattern of damage was the same as that for dynamic loading, i.e., through the thickness and consisting of transverse cracking and delamination .

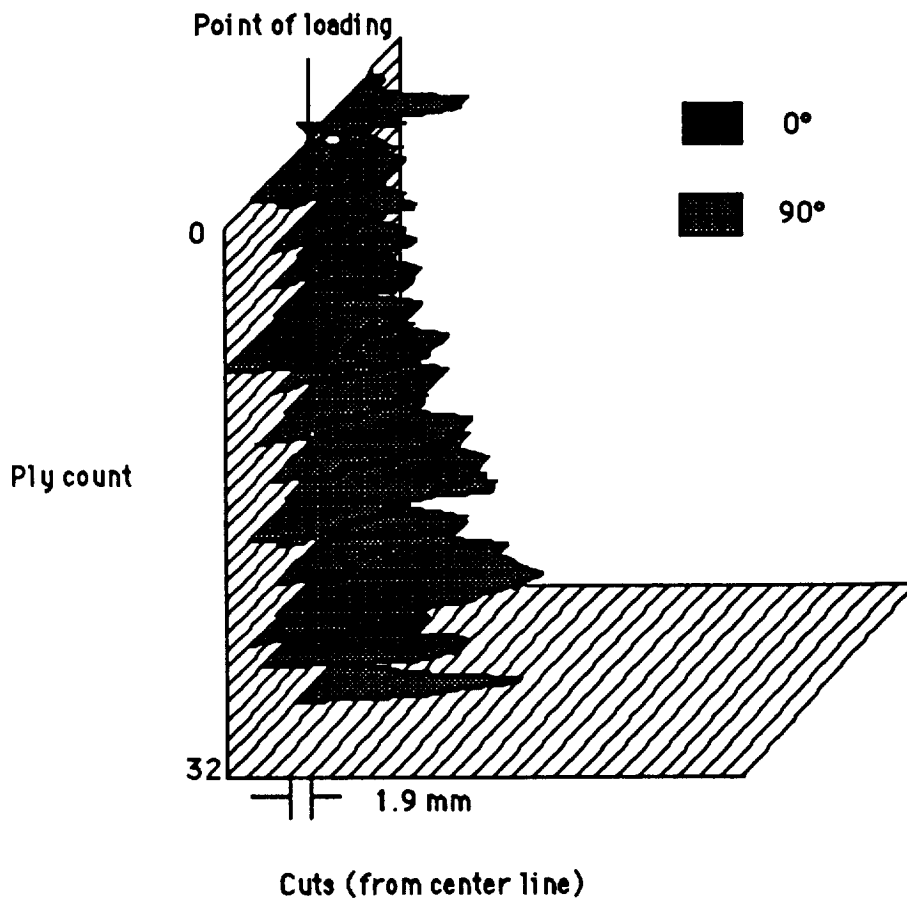
Figure 62 - Damage map of AS4/3501-6,(90/0)_{16s} laminate loaded to a displacement of ~ 4 mm

In the microscopy examination of the specimen loaded to 4mm displacement (Fig 62), fiber breakage was found on the back surface plys (Fig. 63) whereas fiber breakage was found in the front surface plys of the impacted specimen (Fig. 25B). Both the statically tested and impacted specimens showed the similar conical shape damage under the indenter.

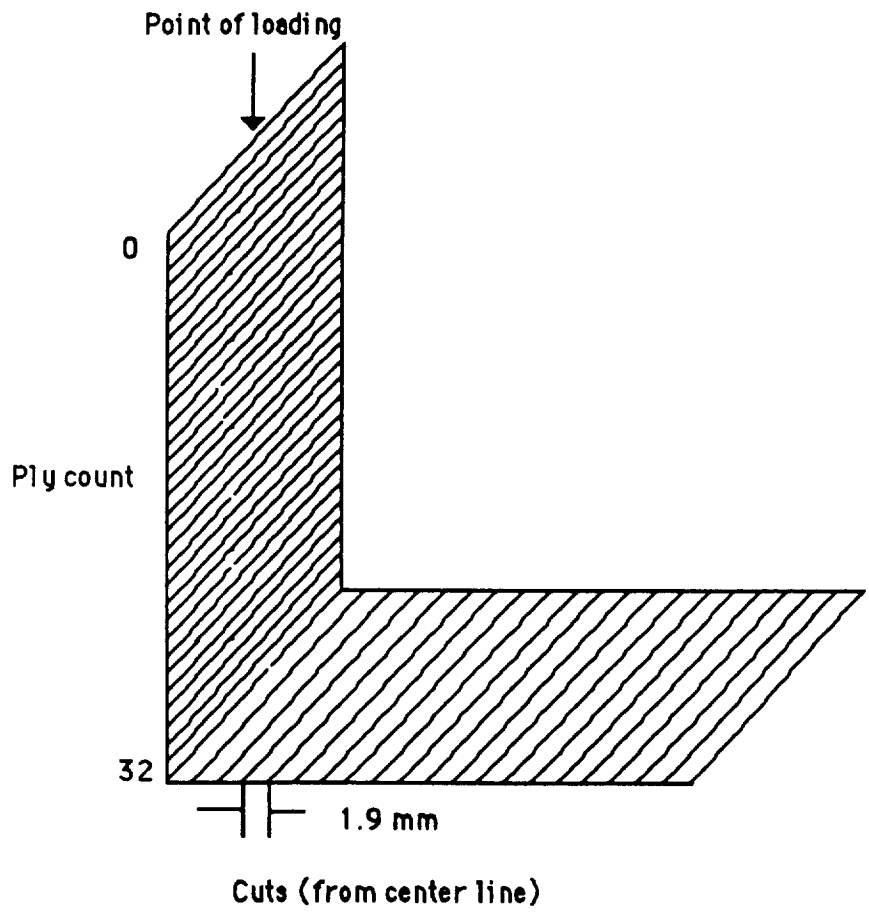
Figure 66 - Damage map for an AS4/PEEK,(90/0)_{16s} laminate loaded to about 2.5mm displacement

No damage was found in the first linear region of the static test (Fig. 66). The second damage map (Fig.67) was drawn after the initial drop in force and showed transverse cracking near the front and back surfaces. In addition there was a noticeable bulge in the back surface of the specimen. This type of deformation had not been observed for any of the 3501-6 laminates.

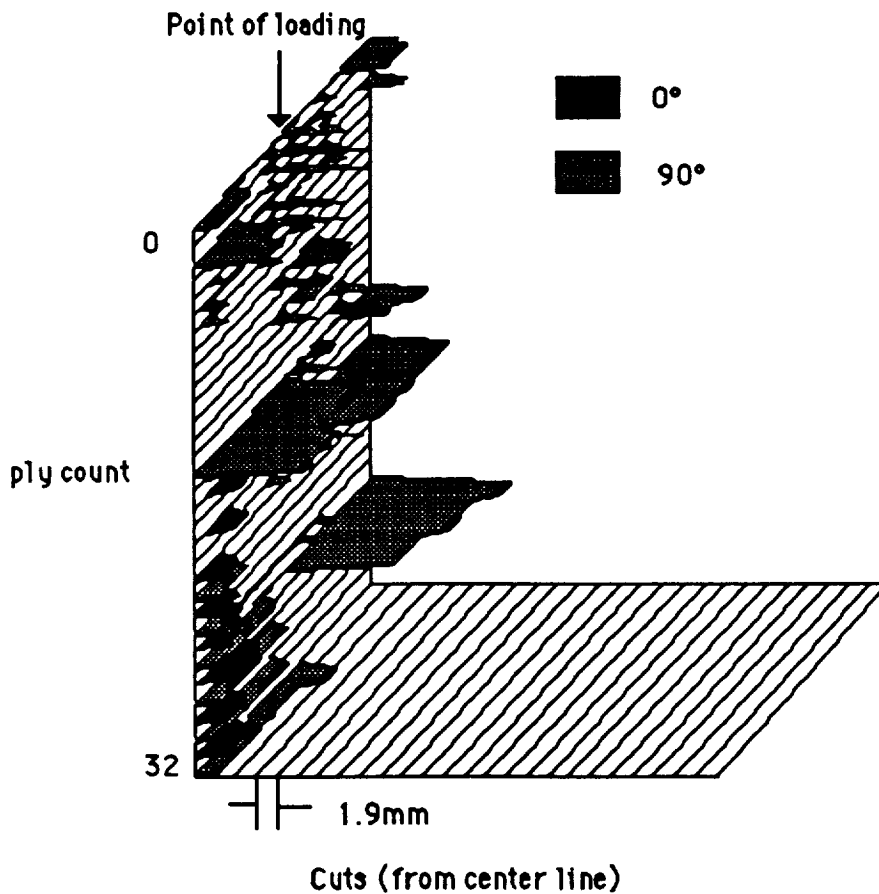
Figure 68 - Damage map for an AS4/PEEK,(90/0)_{16s} laminate loaded to about 5.5mm displacement

The fact that membrane deformation was involved in the PEEK composite is evident from the C-scan results. In the impact test, damage was confined to the contact region between impactor and sample (Fig.36c). In the static test, large amounts of damage can be found in the edge region of the sample (Fig.68) which are very likely the result of membrane deformation.

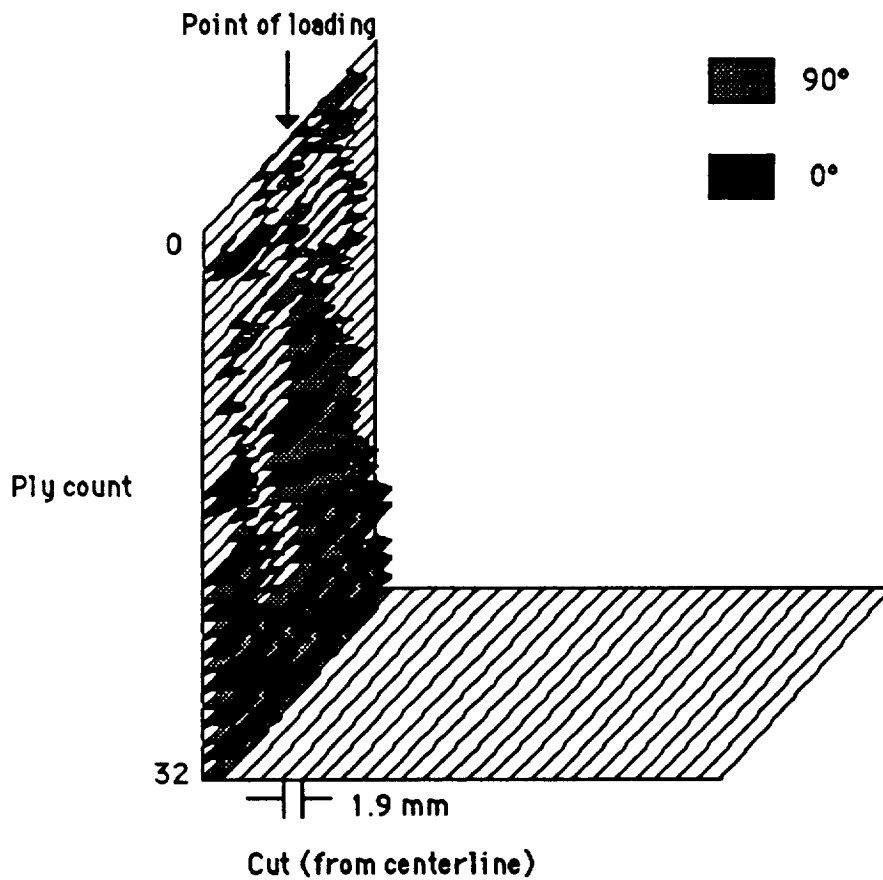
Figure 73 - Damage map of AS4/polycarbonate(0/90)_{16s} after 4.5mm displacement

Figure 72 is the static load-displacement plot for the AS4/polycarbonate(0/90)_{16s} laminate. At first the slope is linear up to 2.3 mm and then decreased at 3.8 mm displacement and again at 4mm. The constant slope in the linear region indicated a stiffness of ~3700 N/mm, which was less than the ~5300 N/mm observed in the impact tests (Fig. 46A). From C-scans, the sudden drop in force at 4 mm corresponds to the damage reaching one edge of the sample (Figs 73 and 74).
