Systems Tunnel Linear Shaped Charge Lightning Strike Final Test Report

August 1989

***Thiokol* CORPORATION**
SPACE OPERATIONS

Systems Tunnel Linear Shaped Charge Lightning Strike
Final Test Report

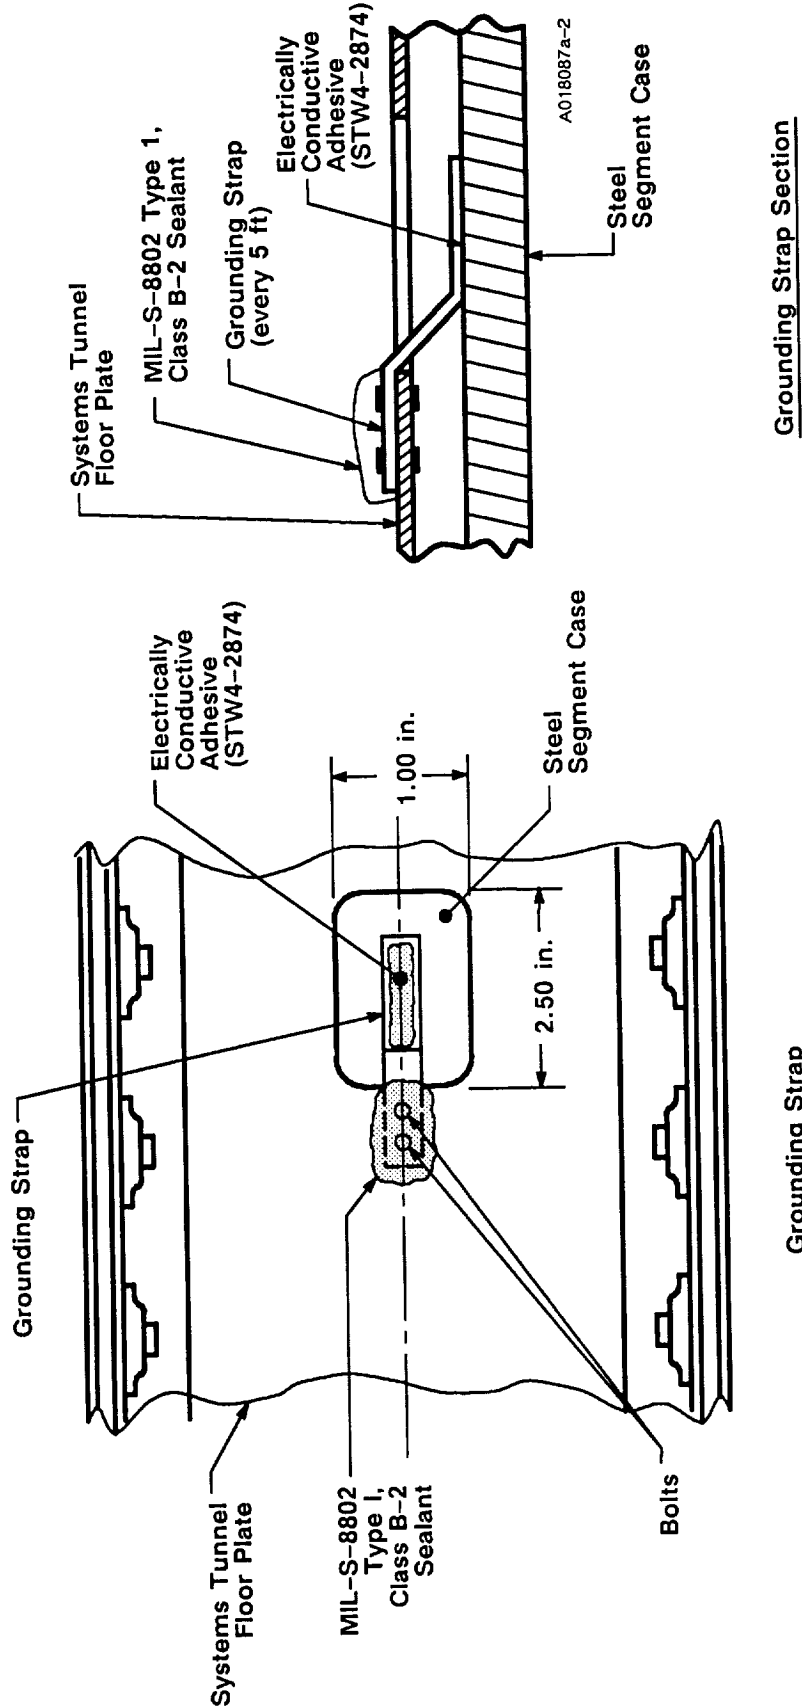
Figure 2. Systems Tunnel Floor Plate Assembly—Grounding Straps

The systems tunnel LSC is part of the redesigned solid rocket motor (RSRM) range destruct system and is located within the systems tunnel on the upper three segments of the RSRM. The systems tunnel floor plates are grounded with straps to the case wall approximately every 5 ft to provide a path for electrostatic and lightning current from the tunnel to the case. Each grounding strap is bolted to the floor plate and bonded to a grit-blasted surface on the case wall with STW4-2874 electrically conductive adhesive (Eccobond solder 56C). Grounding straps are bonded to the case surface through openings in the floor plates (Figures 1 and 2).

Removal of the systems tunnel floor plates from the case section showed that arcing occurred between these components in the vicinity of the grounding strap for the first discharge. This indicates that the injected current for this strike continued to flow through this area until the end of the pulse. Steel case surface hardening caused by the arc was significant enough to damage a case beyond repair. A small amount of arcing also occurred in the vicinity of the grounding straps for the second and third discharges. However, the raised portion of the case at the factory joint was located between these two strike locations, and a large amount of arcing between the case and the systems tunnel floor plates occurred in this area.

Because of the localized hardening of the steel case at the grounding strap area from the first discharge, it is recommended that steel case degradation due to lightning strikes be further investigated. This investigation could determine how different levels of lightning strike discharges cause case damage on preflight and flight RSRMs. Further investigation of the LSC test article to determine the depth of hardening to the steel case and to determine the extent of diffusion of aluminum into the steel matrix is also recommended.
