TWR-17591, Volume IV

## QM-8 FINAL PERFORMANCE EVALUATION REPORT - SEALS

June 1989

**NATIONAL AERONAUTICS AND SPACE ADMINISTRATION  
GEORGE C. MARSHALL SPACE FLIGHT CENTER  
MARSHALL SPACE FLIGHT CENTER, ALABAMA 35812**

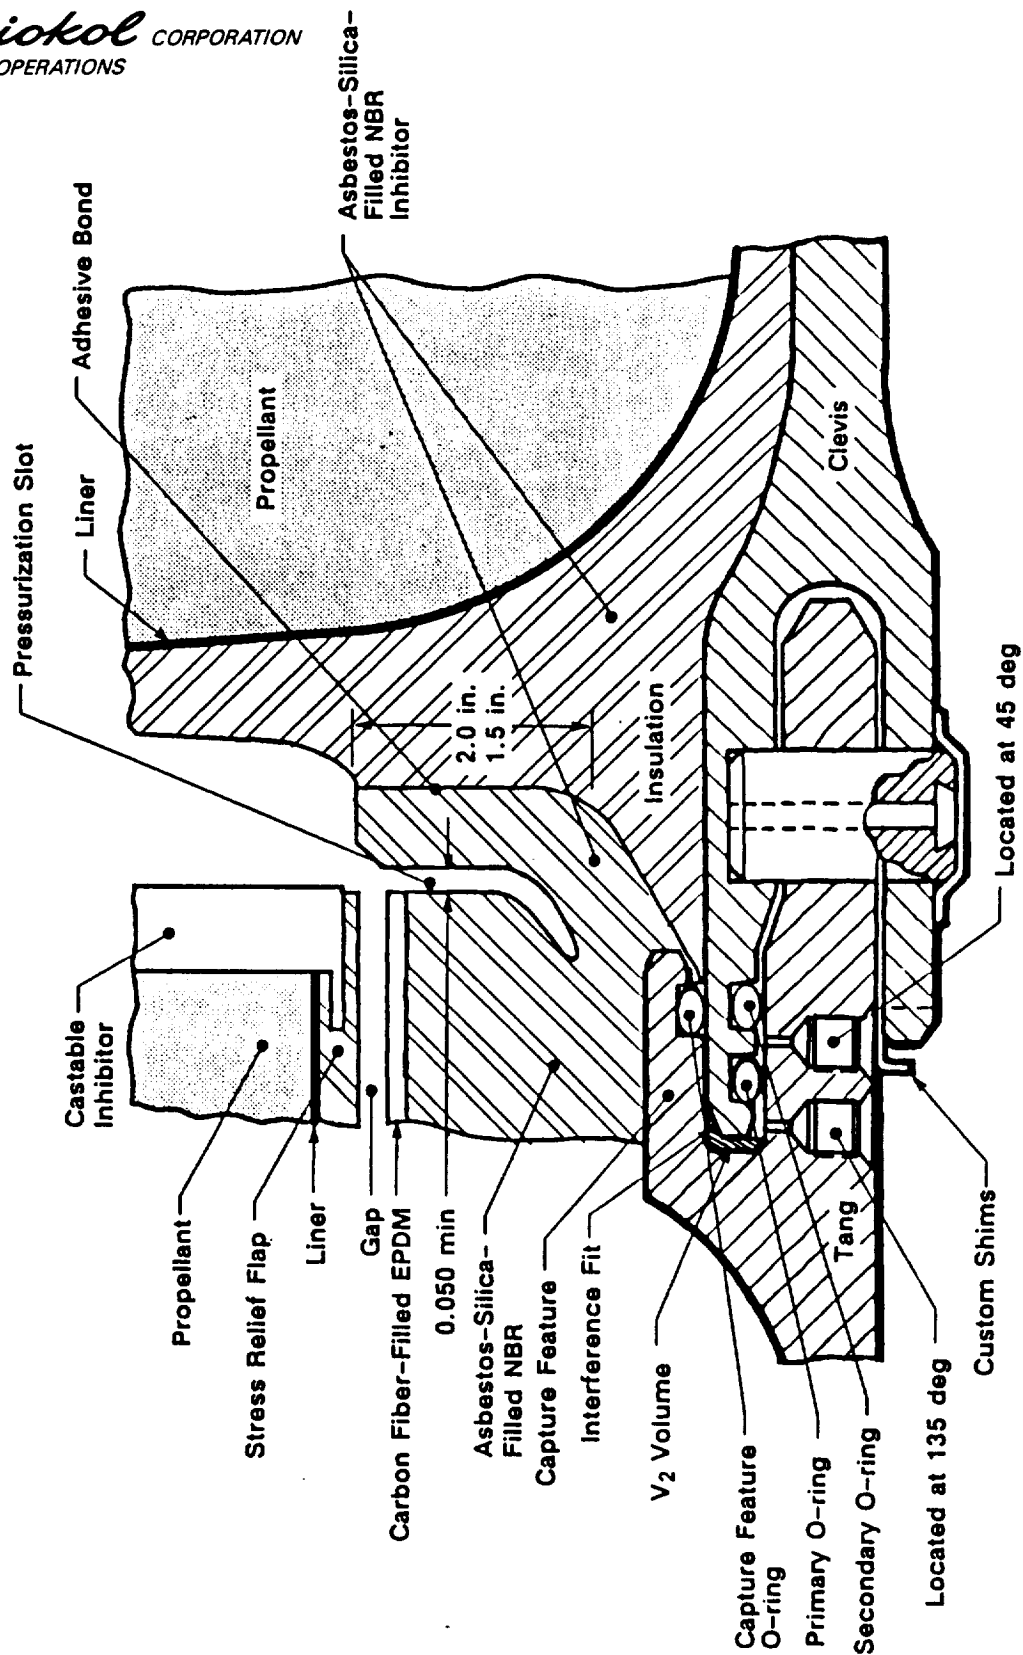
Figure 2 QM-8 Assembled Field Joint

The QM-8 field joint configuration is shown in Figure 2. Joint conditions were as expected; there was no field joint O-ring damage found by inspection at the time of disassembly. The V2 filler did not obstruct the

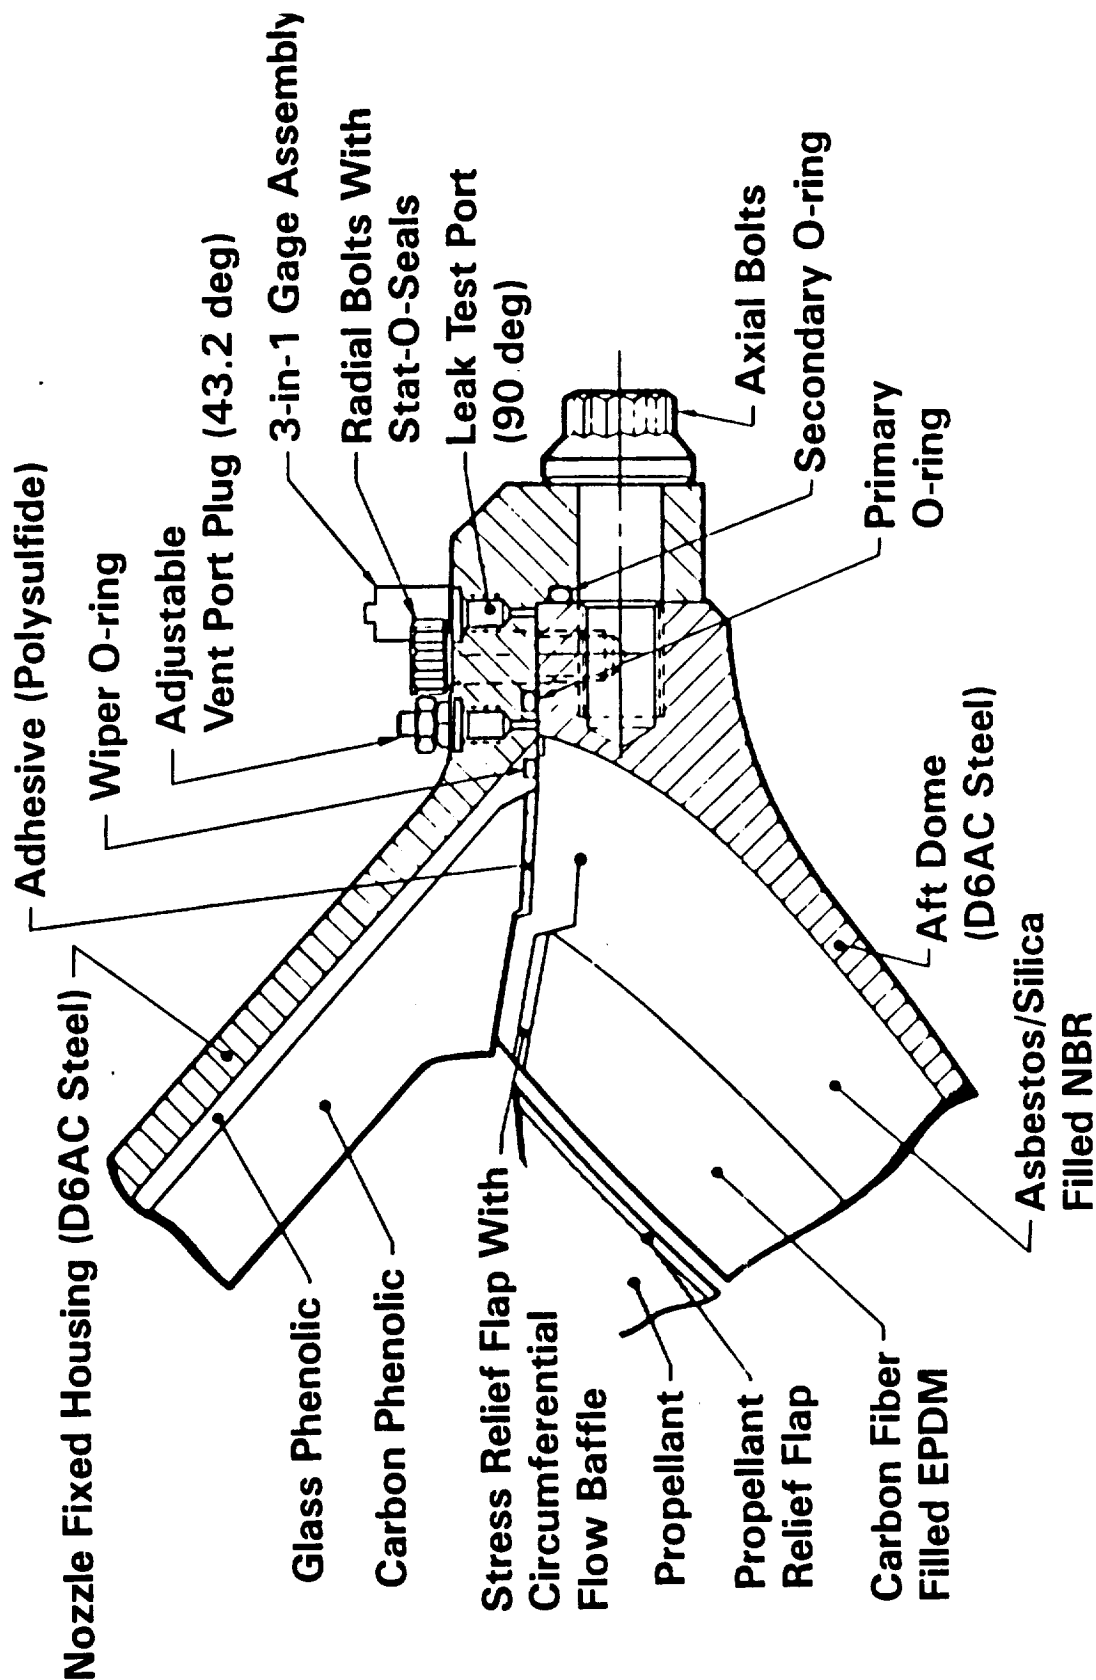
Figure 3 QM-8 Assembled Nozzle-to-Case Joint

The QM-8 nozzle-to-case joint (see Figure 3) was disassembled on 13 February 1989 (see pages A-18 through A-22, Appendix A). The overall condition of the joint was excellent. No hot gas or soot was observed past the polysulfide. There was no corrosion or metal damage found.

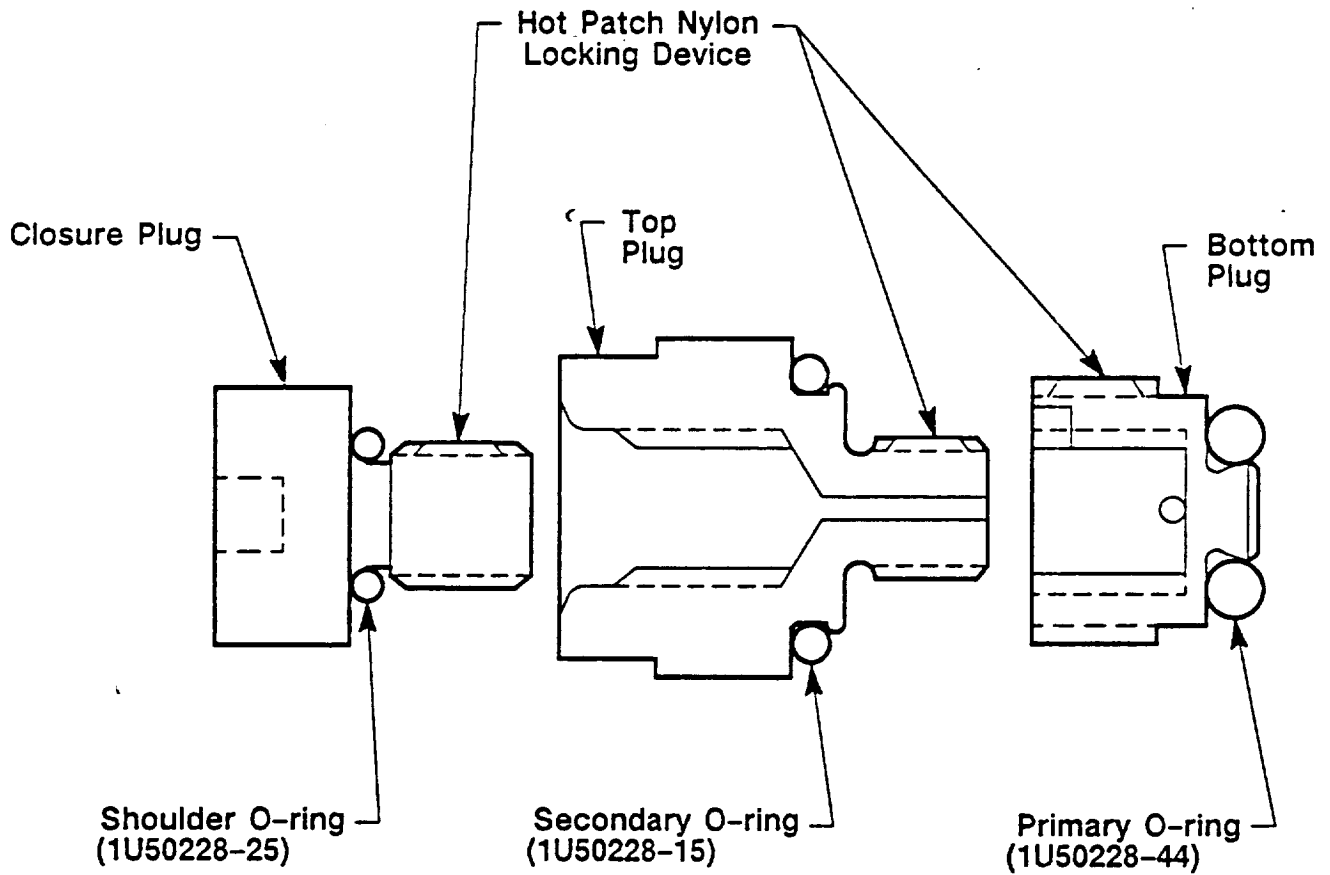
Figure 7 Adjustable Vent Port Plug

The adjustable vent port plug (AVPP), illustrated in Figure 7, was tested in QM-8. Four AVPPs were successfully installed in the case field joints and the nozzle-to-case joint vent ports at 135 and 43.2 degrees, respectively. A 2U132133 (8U76549) installation tool, shown in Figure 8, was used to install the bottom portion of the AVPPs in the vent ports. Each AVPP was installed per STW7-3499 (see Reference 8) and leak checked per STW7-3661 (see Reference 9).

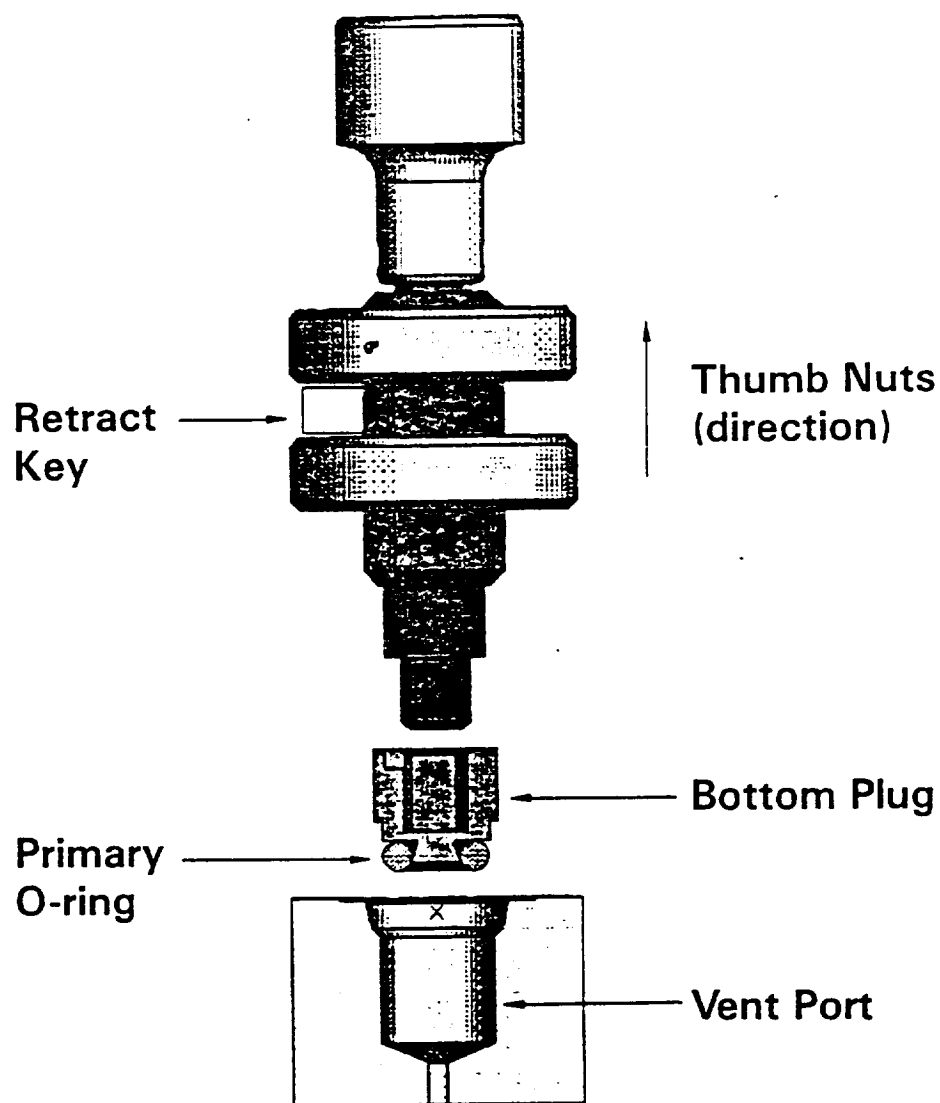
Figure 8 Bottom Plug Installation Setup

All bottom sections of the plugs were installed correctly with the installation tool. However, three bottom sections had to be replaced when the tool slipped causing raised metal on the bottom section. This problem was a result of inadequate training in the use of the tool, not the tool design (see Section 3.5). Objective CQ was met.

The tool size and weight are acceptable (see Figure 8).

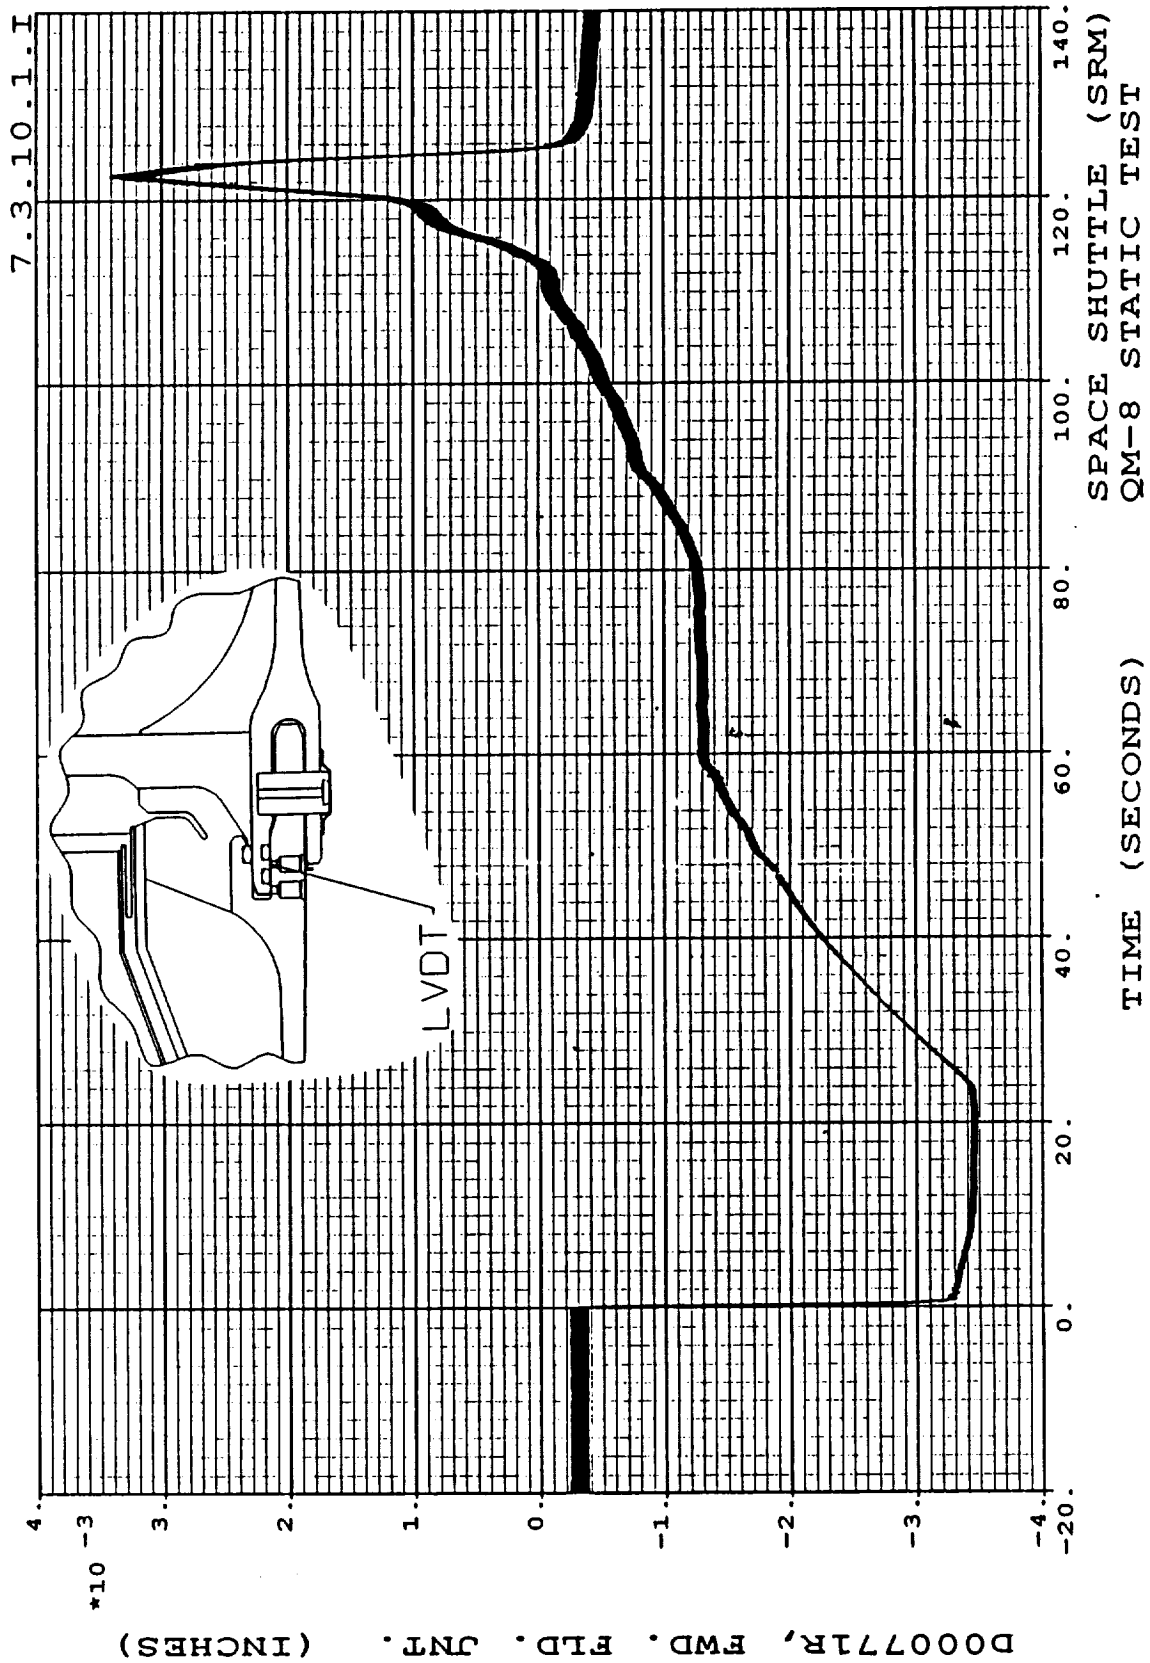
Figure 12 Forward Field Joint LVDT Measurement (Gap Opening)

The O-ring gap opening for QM-8 was measured directly for the forward, center and aft field joints via the 45 degree leak check ports. The LVDTs were lockwired, torque painted, and fitted tight into their respective ports. These measurements were also taken on the JES and TPTA tests. Figure 12 shows the actual test data for the forward field joint LVDT. The center, and aft field joint LVDT gages produced no data. Note that a negative value on the plot corresponds to gap opening and positive value to gap closing. Table 12 lists the maximum measured O-ring gap openings; the flaw, if any, to the joint; and the test pressure for QM-8, QM-7, QM-6, TPTA-1.1, JES-3A, and JES-3B. For QM-8, the maximum field joint gage pressure was estimated to be 833 psig, which occurred at the forward field joint between 9 to 11 seconds.

Therefore the value measured on QM-8 falls within the TPTA and JES data base which demonstrates that the O-rings would of remained sealed if motor pressure reached the primary O-ring. Also resiliency testing, which is an on-going study at this time, has shown that fluorocarbon will track 0.018 inch gap opening (see TWR-17991, Reference 14), given the following conditions:

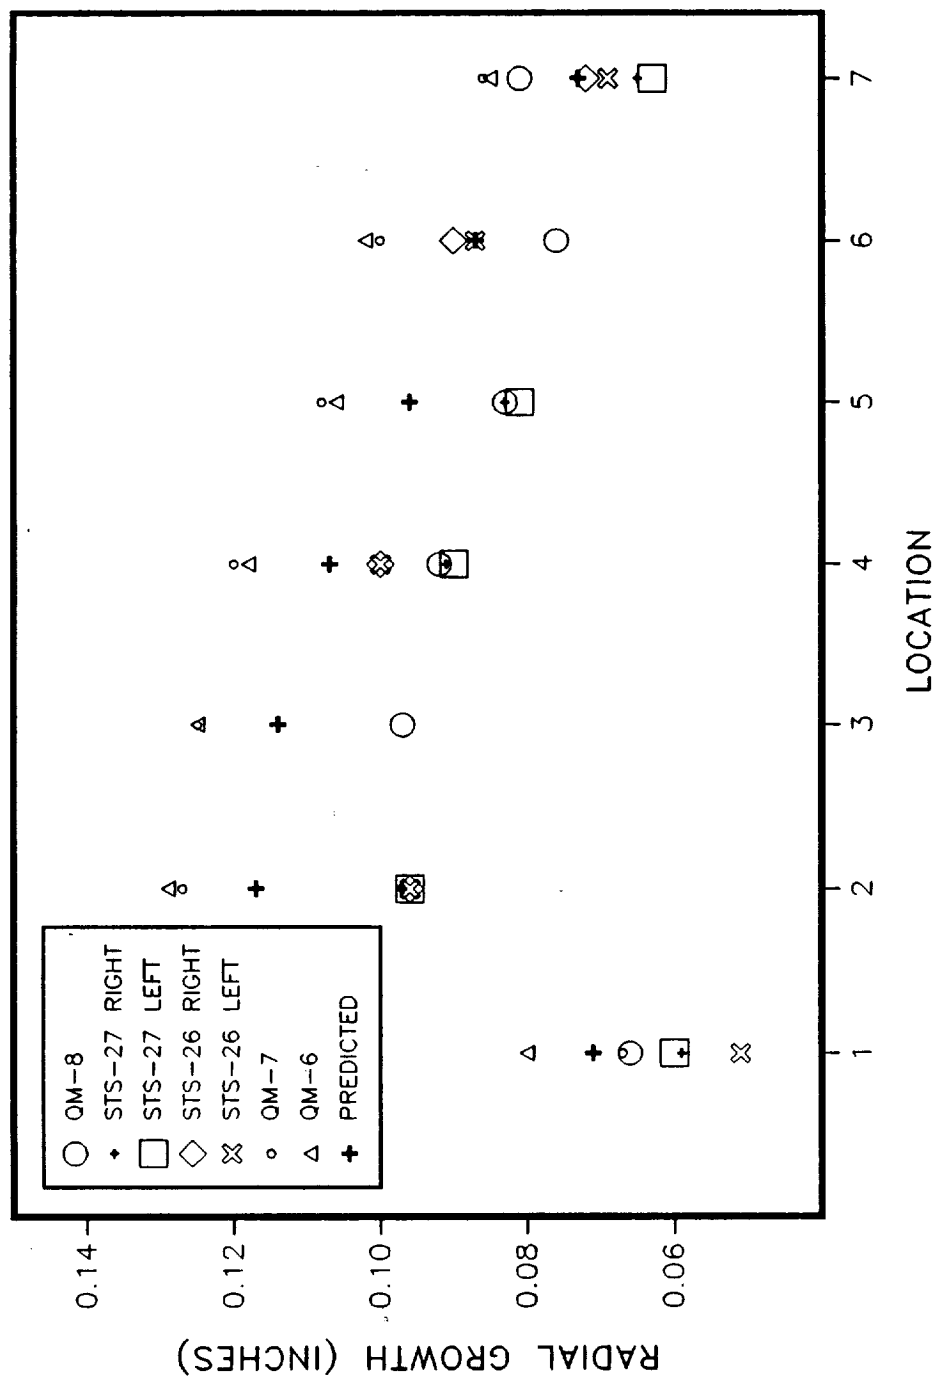
Figure 14 Case-to-Nozzle Joint Radial Growth Comparisons

Table 27 and Figure 14 compare the radial growth of the QM-8 nozzle-to-case joint with the same joint configuration (radial bolt design) used in 360L001, 360L002, PV-1, QM-7, QM-6, DM-9, DM-8, and analysis. Data from QM-8 radial growth compares closely to the other motors which again confirm the minimal effect strut loads have on this joint as far as gap growth is concerned. Since the O-ring sealing surface gap growth was not directly measured, it is assumed the growth is similar to that measured from NJES-2A, NJES-2B, and TPTA-1.1 testing, and predicted by analysis.

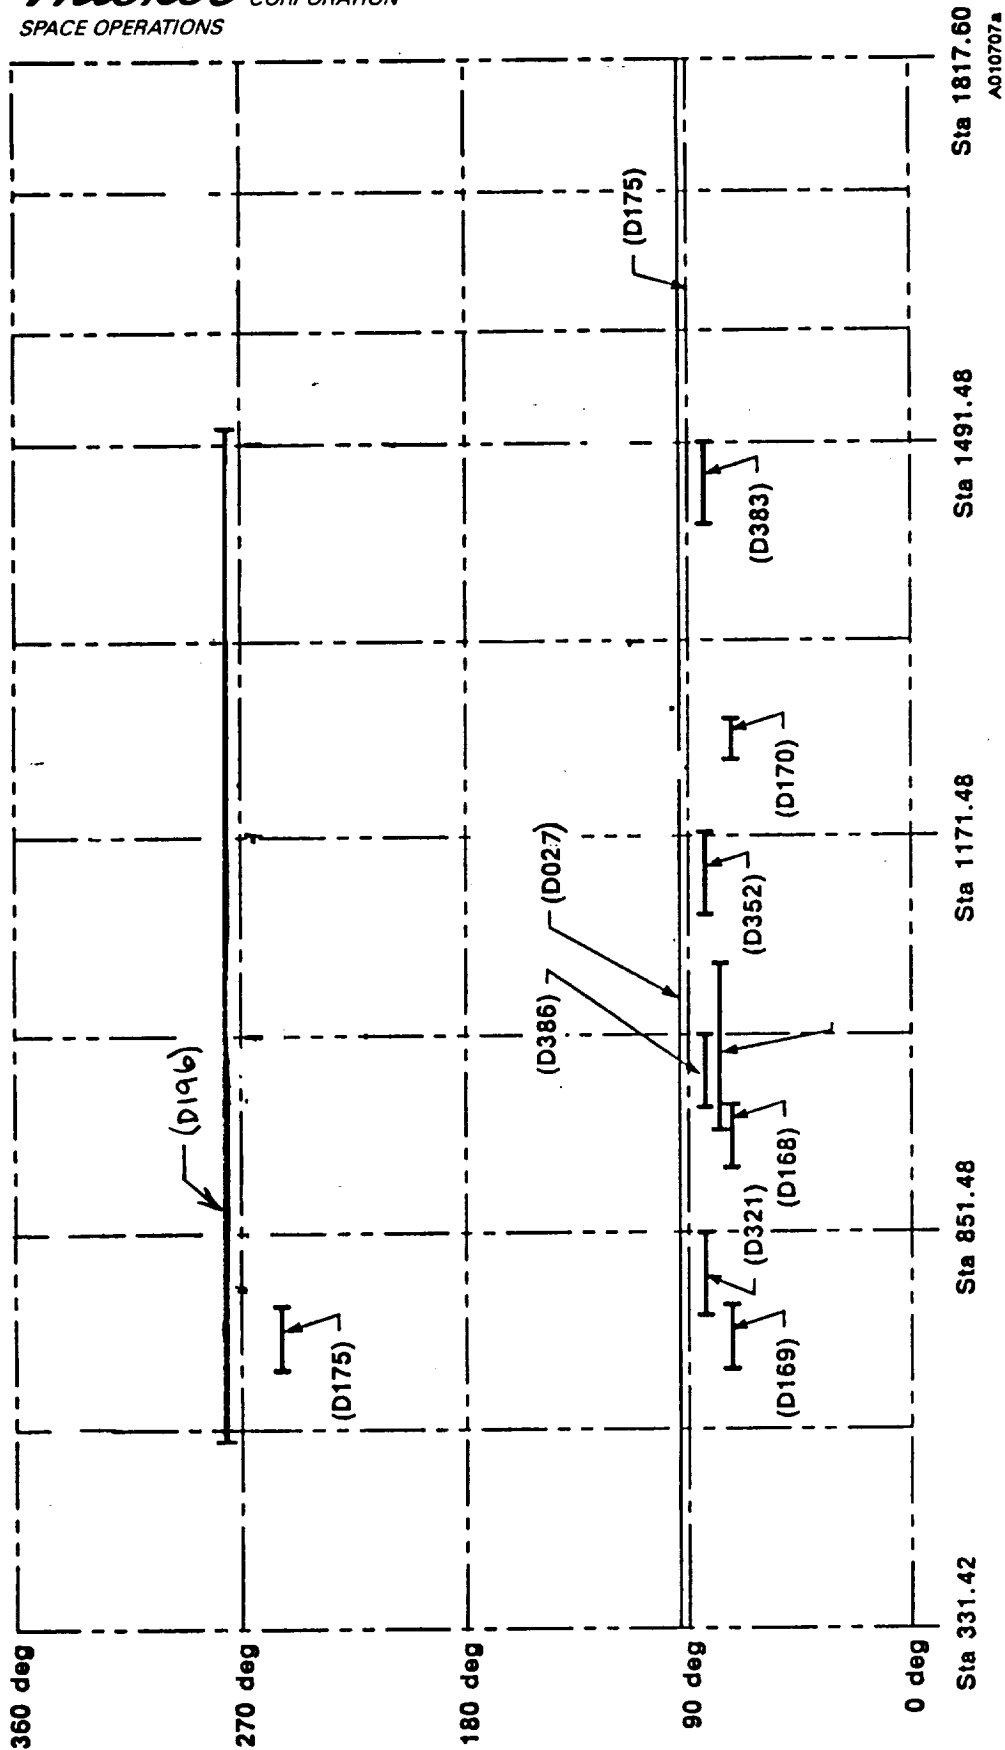
Figure 15 QM-8 Longwire Locations

Several long wire gages were installed along the length of the motor (see Figure 15), and across joints to measure the axial growth experienced in different areas of the motor during pressurization. Table 33 shows the maximum deflection experienced by each gage for the duration of the test. Locations 5, 7, and 8 are all across joints, and all show a negative deflection. Evaluation of the placement of these gage locations which experienced negative values supports that these values are in error. In other words, the instrument measured a negative value but the joint did not go negative. The measurement was that of of instrument, and not the joint. The aft field joint does not show a negative value because it has a higher stiffness due to the stiffener rings and struts.

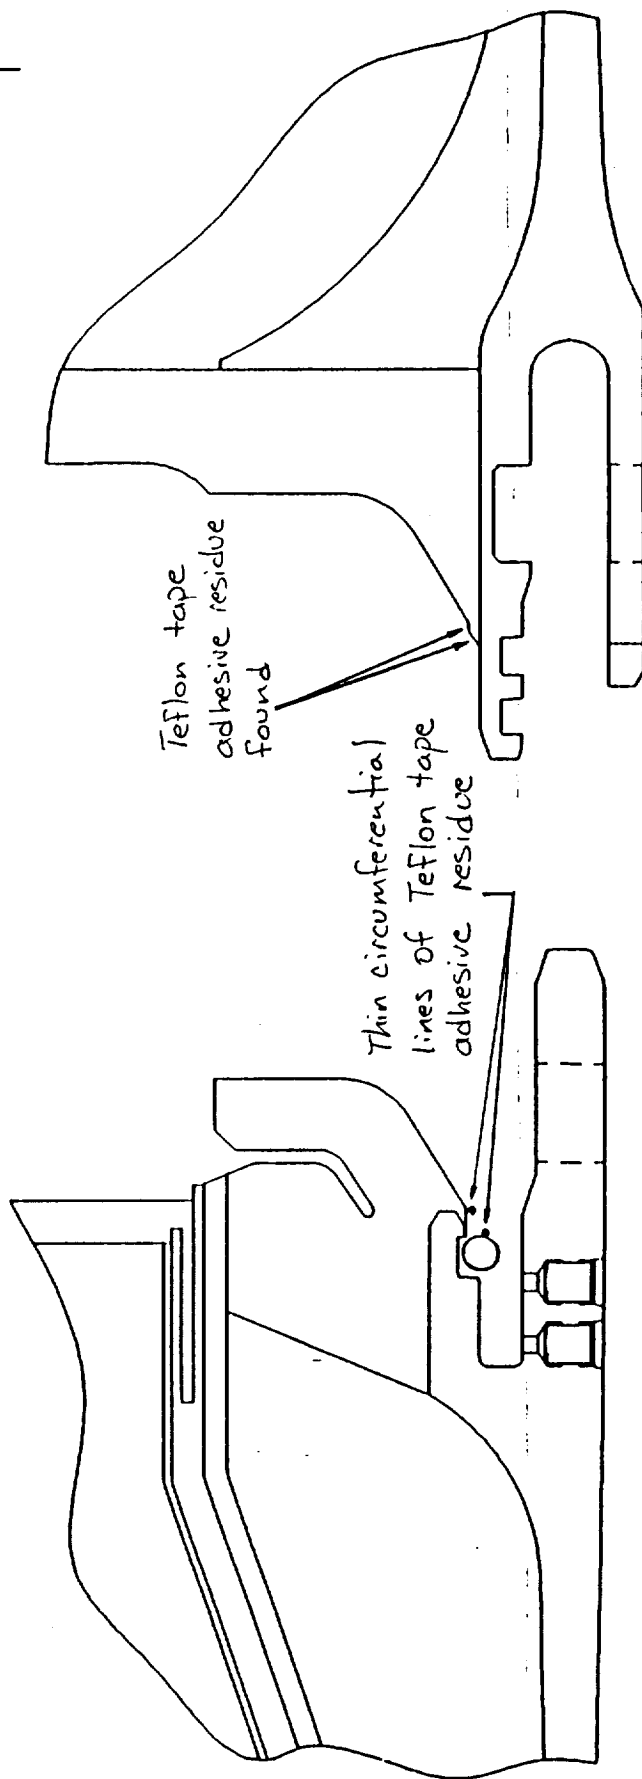
# QM-8 FORWARD FIELD JOINT

Small thin lines of the white colored material were found on the capture feature metal to J-leg interface (aft of the capture feature groove on the tang J-leg) at 153, 178, 180, 227, 228, and from 230 to 233 degrees. All of the thin lines of the white colored material ran circumferentially on the joint except for the lines of white colored material at 178 degrees. On the clevis, the white colored material was found on the top of the J-leg (near the inner clevis leg metal) at 138, 150, 152, 178, 180, and from 162 to 165, 167 to 170, 230 to 234, and 252 to 254 degrees. As on the tang, all of the thin lines of the white colored material ran circumferentially on the joint except for the lines of white colored material at 178 degrees.

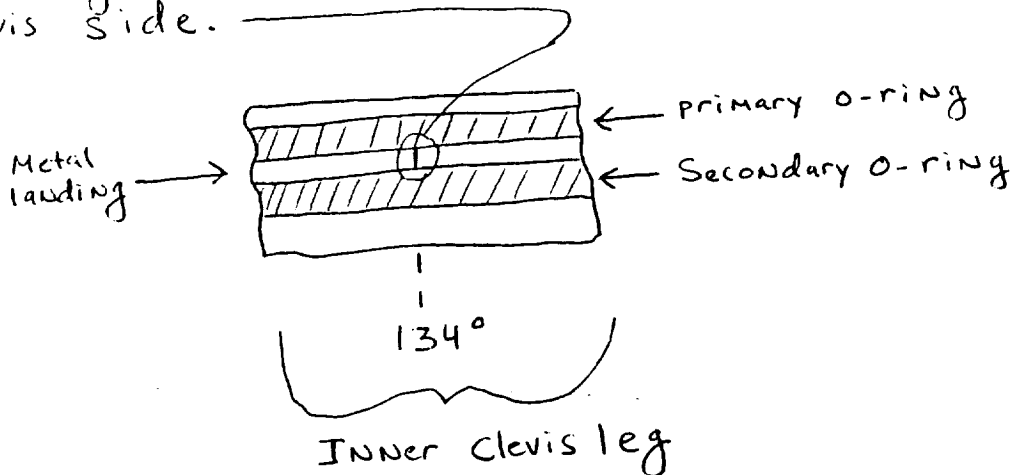
1. Very light thin line of corrosion on the landing between the O-ring grooves at 134°; clevis side.

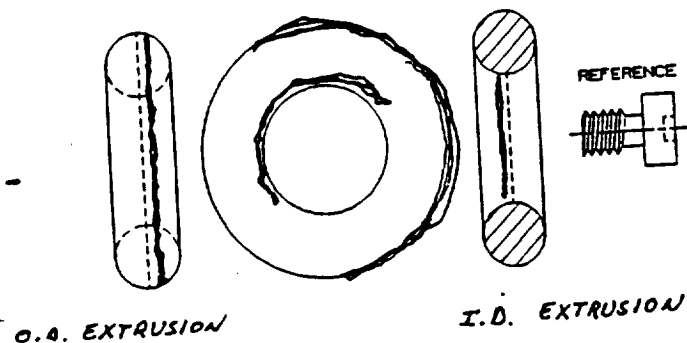
Note: Very, light coat of grease.  
Wrong size O-ring was installed  
(Too large "W" diameter) O-ring  
positioned on thread side

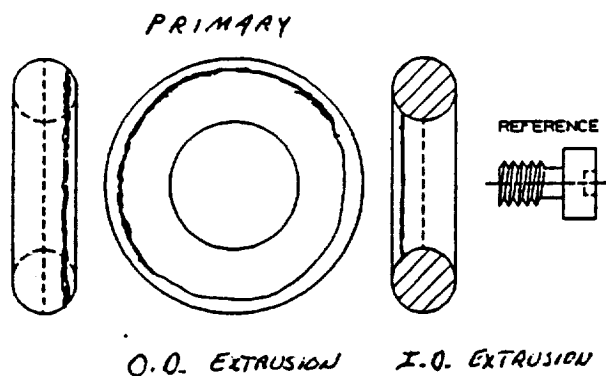
Description: Typical O.D. & I.D. Extrusion Damage (Acceptable)

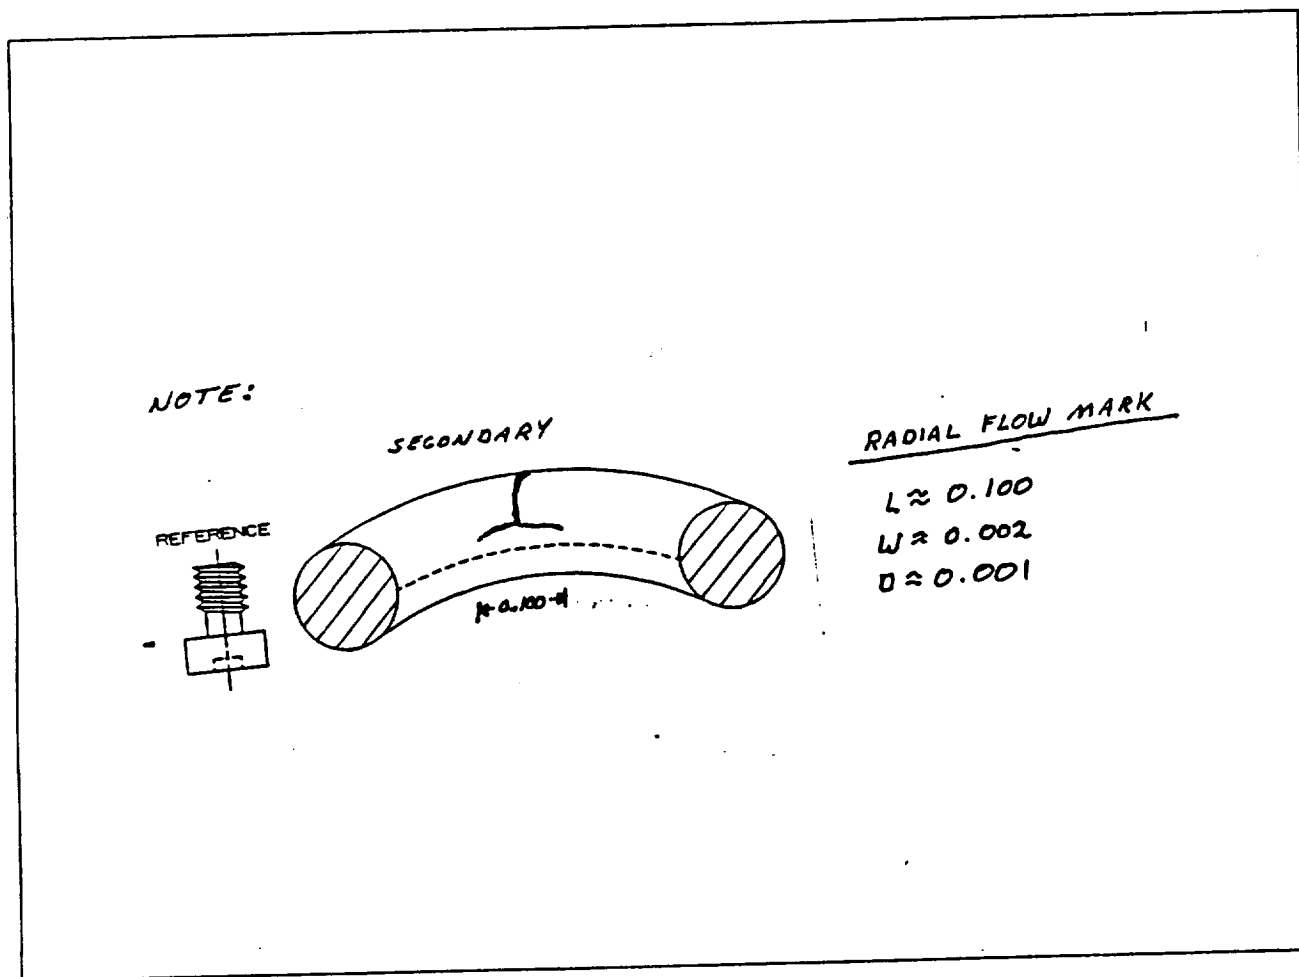
Figure B-3

RADIAL FLOW MARK ON SECONDARY O-RING,  
ANT VENT PORT PLUG

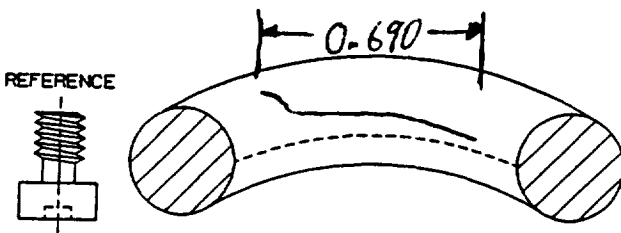
SECONDARY O-RING (or Shoulder)		N/A: _____		
Part No.: <u>1U50228-15</u>	Lot No.: <u>ECL0037</u>			Comment Number
A. Erosion (SORE)?	_____ Yes <u>✓</u> _____ No			_____
B. Heat Affect (HASOR)?	_____ Yes <u>✓</u> _____ No			_____
C. Cuts, Assembly/Disassembly Damage (SCUT, SDMG, SDIS)?	<u>✓</u> Yes _____ No			<u>1</u>
If any of the above conditions exist, record below:				
<u>1) I.O. circumferential cut</u> <u>1 ± 0.490</u> <u>0 ± 0.030</u>  <u>NOTE: O-ring positioned on thread side</u> <u>Chisel gouge on plug head O.D.</u> <u>Sharp last thread</u>

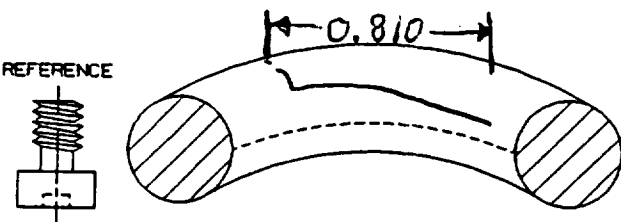
SECONDARY O-RING (or Shoulder)		N/A: _____		
Part No.: <u>1U50228-15</u>	Lot No.: <u>ECL0037</u>			Comment Number
A. Erosion (SORE)?	_____ Yes <u>✓</u> _____ No			_____
B. Heat Affect (HASOR)?	_____ Yes <u>✓</u> _____ No			_____
C. Cuts, Assembly/Disassembly Damage (SCUT, SDMG, SDIS)?	<u>✓</u> Yes _____ No			<u>1</u>
If any of the above conditions exist, record below:				
<p>1) I.O. circumferential cut</p> <p><math>L \approx 0.810</math></p> <p><math>D \approx 0.030</math></p> <p>NOTE: sharp last thread Ding in last thread O-ring positioned on last thread Chisel gauge on O.O. of plug head</p>
