Powerhouse Major Rehabilitation Program

Ice Harbor Lock & Dam
Snake River, WA

March 1997

SUBJECT: Evaluation Report for Major Rehabilitation of Generating Units 1-6 at Ice Harbor Lock and Dam Powerhouse dated March 1997, Advance Copies

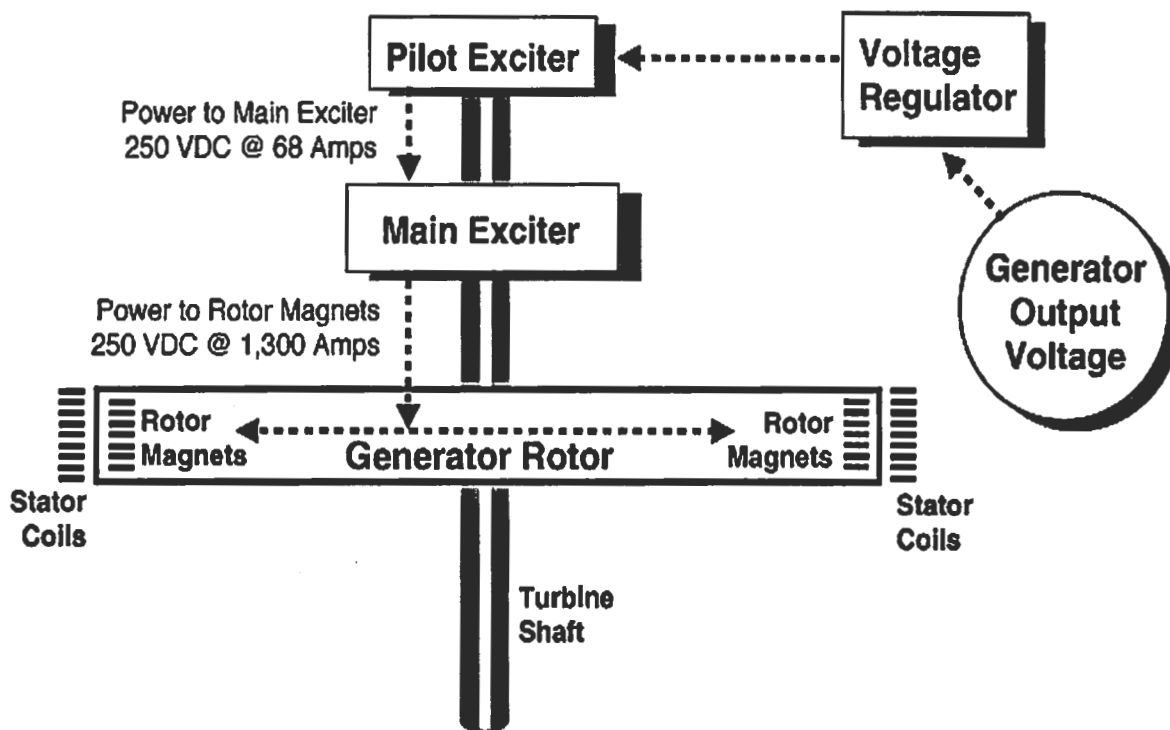
Figure 3-4
Generator Excitation System

Ice Harbor units 1 through 6 have the old rotating-type exciters typical of most large hydroelectric generators installed prior to 1975. Units 1 through 3 have had no major failures. However, the exciters are 35 years old, and they are showing the increase in routine maintenance typical of aging equipment. Since 1980, there have been four failures of the Ice Harbor unit 4 through 6 exciters due to commutator winding failures. Unit 6 failed in 1980, units 4 and 6 failed in 1992, and unit 5 failed in 1996. Each repair of a failure has had an average cost of \$20,000. A typical exciter winding failure puts a unit out of service from 4 to 8 weeks. Repair necessitates disassembling the exciter, shipping it offsite for repair, and reassembling the exciter.

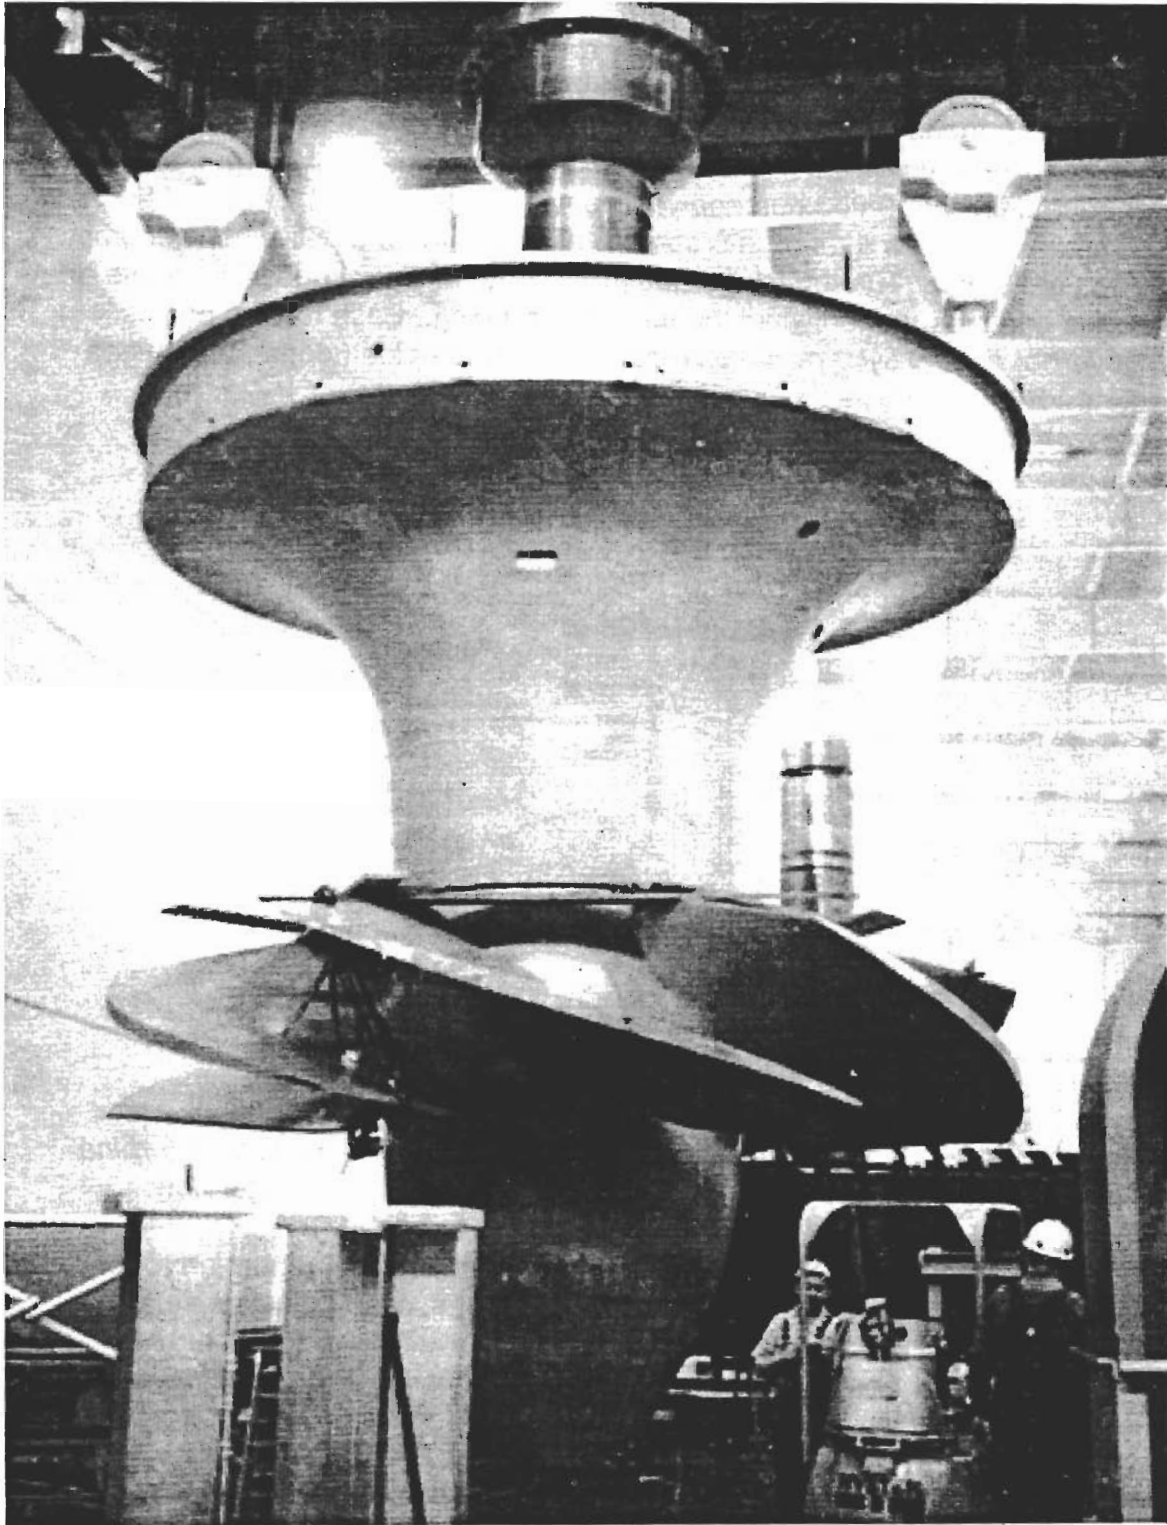
Figure 3-6. Turbine Runner Assembly

The turbine has six variable-angle blades, each weighing approximately 25,000 pounds. The photo shows a turbine runner for units 1-3 during initial assembly prior to installation.

The turbine efficiencies of units 1 through 3 and units 4 through 6 have deteriorated by about 2.4 and 1.1 percent, respectively, since they were first put into service. The primary cause of reduced turbine efficiency is wear and tear and roughened wetted surfaces. Smoother wetted surfaces will increase efficiency, and will also enhance fish survival.

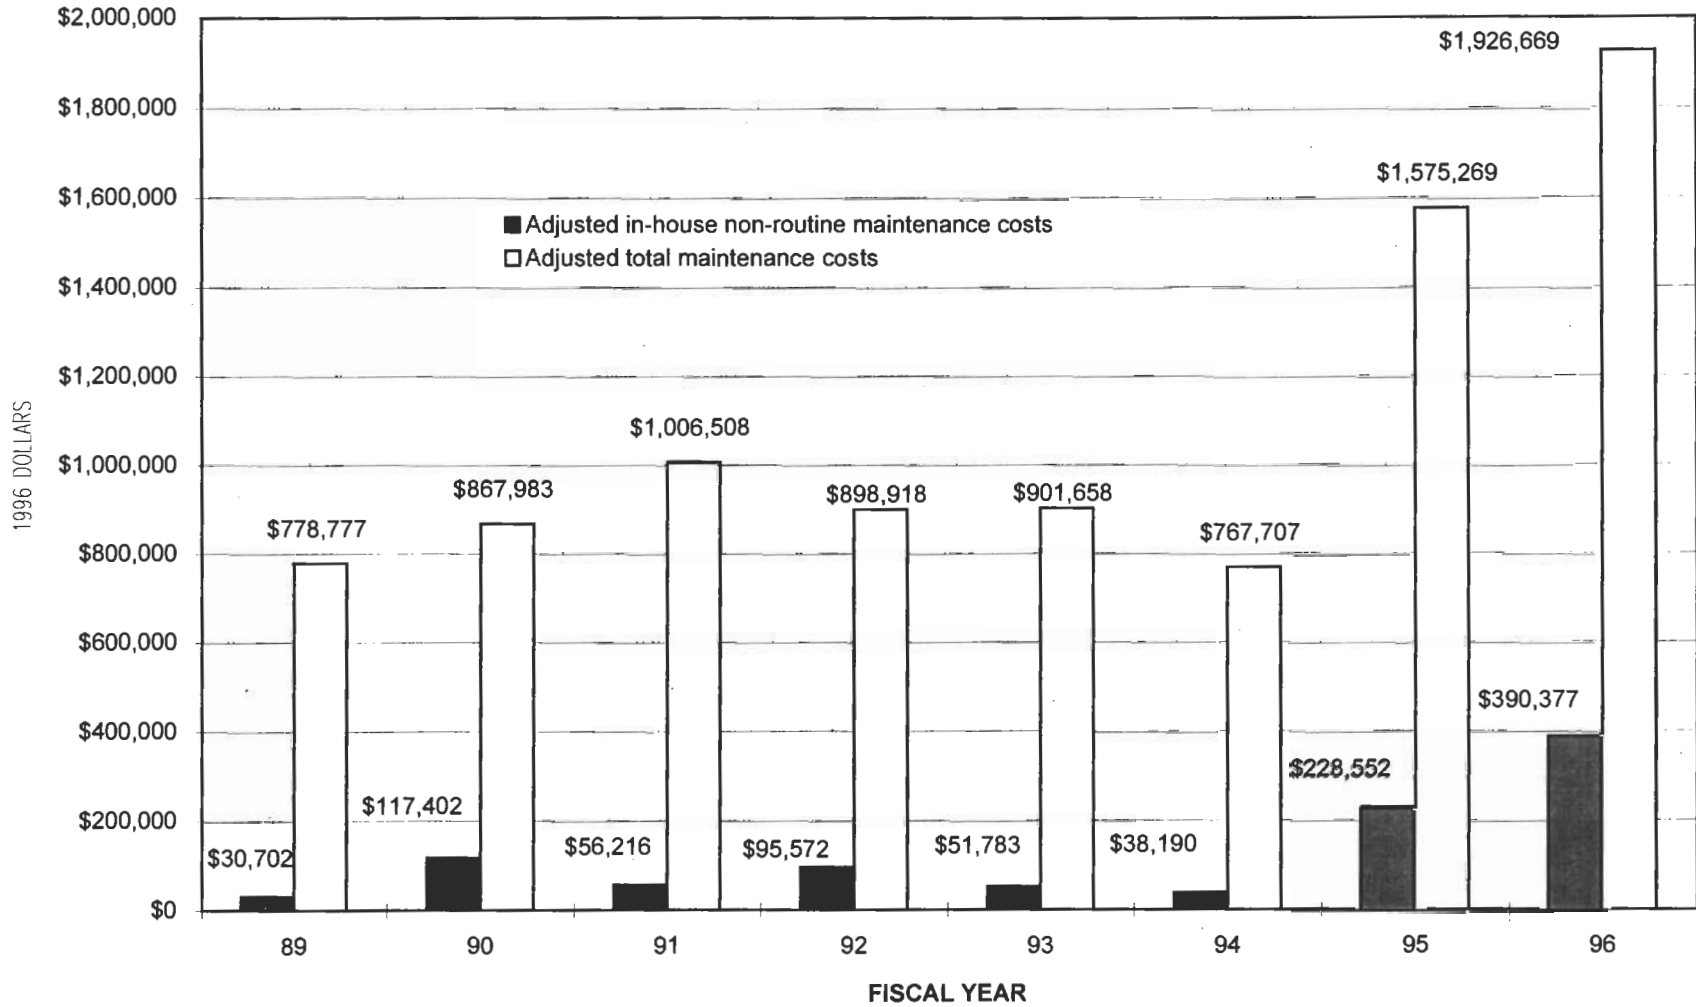
FIGURE 4-8 POWERHOUSE MAINTENANCE COSTS ADJUSTED TO 1996 DOLLARS

The adjusted powerhouse maintenance costs for in-house non-routine maintenance and adjusted total maintenance cost, including total in-house and contract costs, are indicated in figure 4-8 (note the increased costs for 1995 and 1996 as a result of generator failures). Future repair costs are not shown on this figure. The contract costs for cavitation repair of units 4 through 6, in the amount of \$2.958 million, were ignored in calculating the adjusted maintenance cost shown in this figure for Fiscal Year 1991. As can be seen, the data for adjusted maintenance costs from 1989 to 1994 shows a slight increase from 1989 to 1991 and a slight decrease from 1991 to 1994. In 1995, a contract to repair unit 5 was awarded, and the job was completed in 1996. During start-up of unit 5, on 1 May 1996, a second failure occurred due to the grounding of two or more of the unit's rotor poles. The next phase of repair work on unit 5 was completed in December 1996, using in-house crews and hired labor from Tennessee Valley

Authority (TVA). In the first quarter of Fiscal Year 1997, approximately \$300,000 was spent on non-routine maintenance for the powerhouse, and most of that was for completing repairs on unit 5. On 16 December 1996, unit 5 failed for the third time due to a stator winding failure that was caused by foreign object damage. The total cost for repairing unit 5, from 15 May 1994 until 31 September 1996, was \$1.377 million (1996 cost level). Since 16 December 1996, another \$44,000 has been spent on outside labor hired to investigate this third failure. Costs estimated to repair unit 5 are approximately \$1.8 million, which is being direct funded by BPA. Funds for all other repairs came from Walla Walla District's Operations and Maintenance budget.
