# Posttraffic Testing at the National Airport Pavement Test Facility: Test Item MFC

September 2001

DOT/FAA/AR-TN01/49

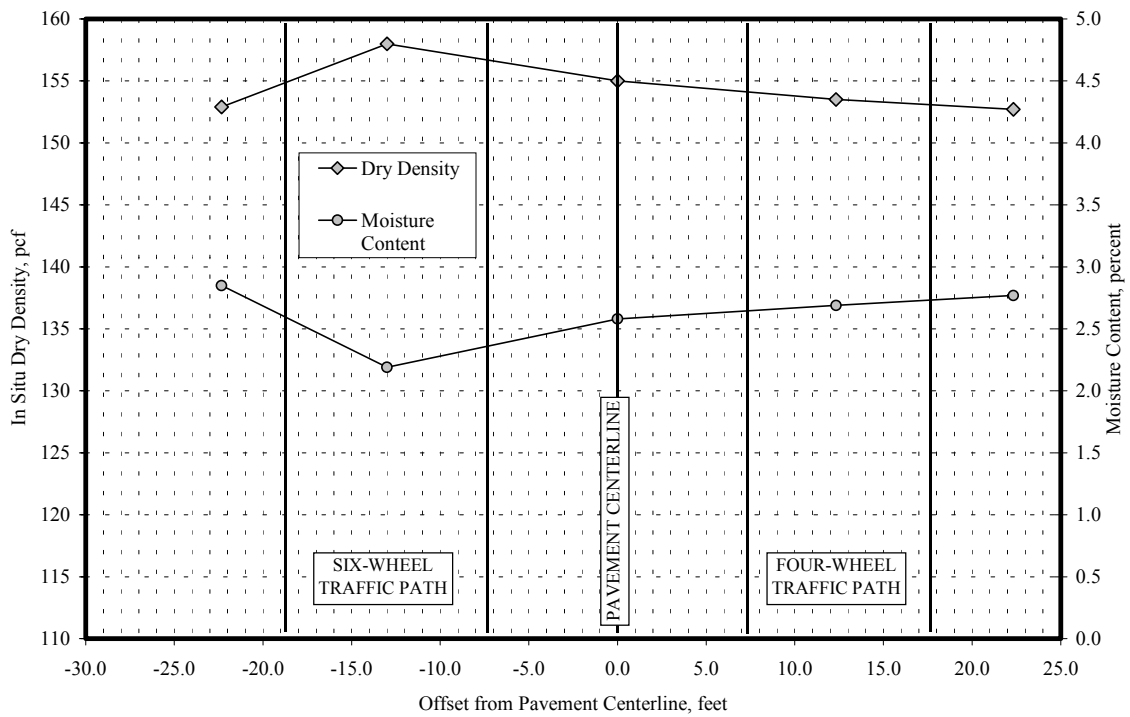
FIGURE 13. RESULTS FROM SAND CONE DENSITY TESTS ON P-209 CRUSHED STONE BASE

Table 3 shows the results from the 12-inch (305-mm) sand cone tests on the P-209 layer. The in situ dry densities in the wheel tracks were slightly higher than the dry densities in the untrafficked areas. The dry densities ranged from 152.7 pcf (2446 kg/cu.m) to 158 pcf (2531 kg/cu.m). Figure 13 shows the dry density of the P-209 layer measured in the trench. Samples were collected for determination of moisture content. Moisture contents ranged from 2.19 percent to 2.85 percent. No significant change in the dry density was observed when compared to the as-constructed dry density of 158 pcf (2531 kg/cu.m). A decrease in the moisture content was observed when compared to the as-constructed moisture content (3.6 percent). The maximum dry density and optimum moisture content obtained from the P-209 layer, using the modified Proctor test (ASTM D1557), were 154.9 pcf (2481 kg/cu.m) and 4.7 percent respectively.

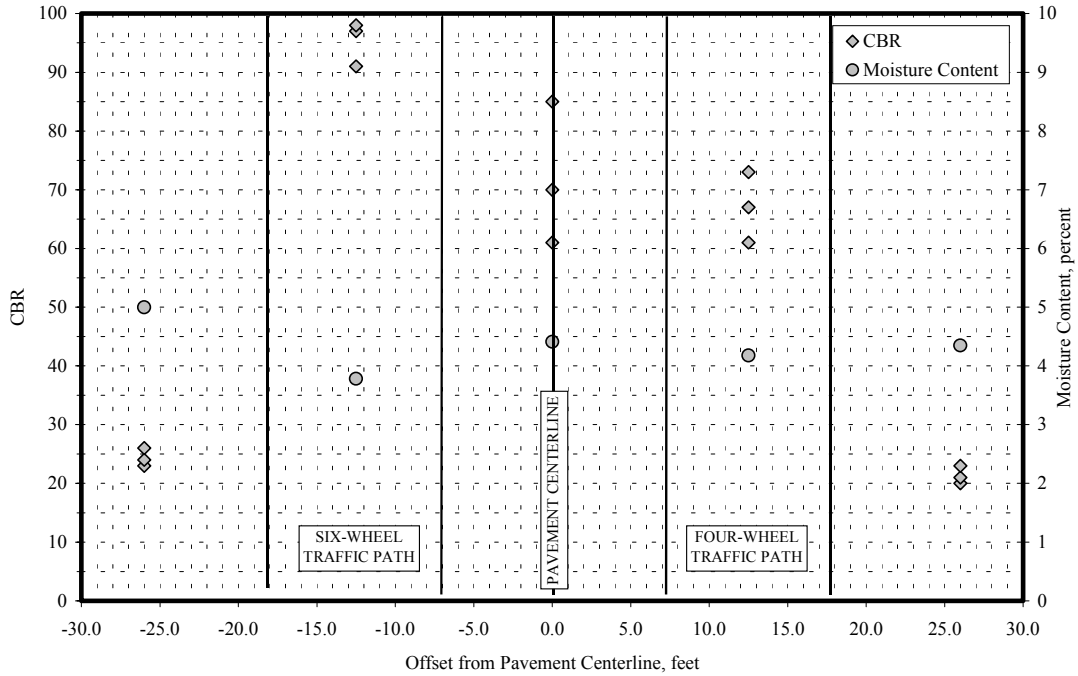
FIGURE 16. POSTTRAFFIC CBR TEST RESULTS ON P-154 SUBBASE

Table 4 and figure 16 show the results from the CBR tests on the P-154 layer. The CBR values ranged from 20 to 98. Higher CBR values were observed in the trafficked areas (61 to 98) and lower CBR values (20 to 26) were observed in the untrafficked areas. Table 5 and figure 17 show the results from sand cone tests on the P-154 layer. The dry density values ranged from 117.8 pcf (1887 kg/cu.m) to 135.1 pcf (2164 kg/cu.m). The moisture contents ranged from 3.79 percent to 4.65 percent. The dry density values were lower when compared to the as-constructed dry density of 131 pcf (2098 kg/cu.m). About a 2 percent decrease in the moisture content was observed when compared to the as-constructed moisture content (6.4 percent). The maximum dry density and optimum moisture content obtained from the P-154 layer, using the modified Proctor test (ASTM D1557), were 128.3 pcf (2055 kg/cu.m) and 6.5 percent respectively.

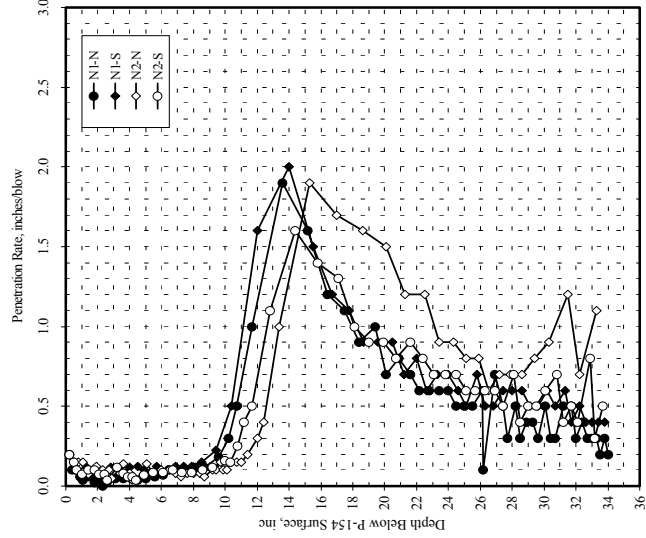
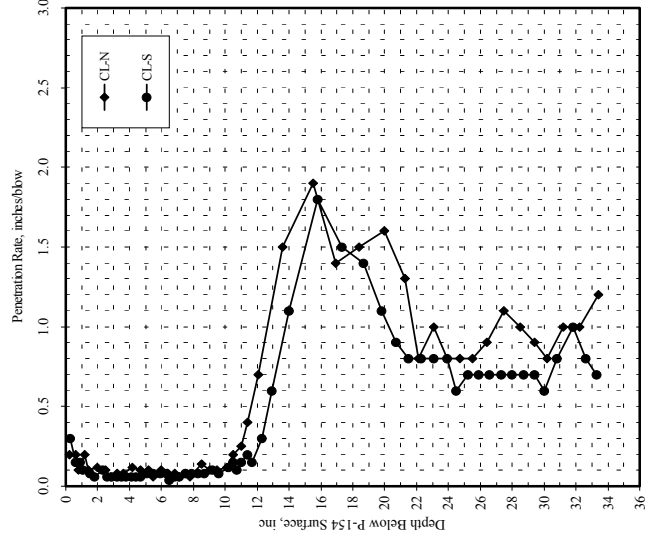
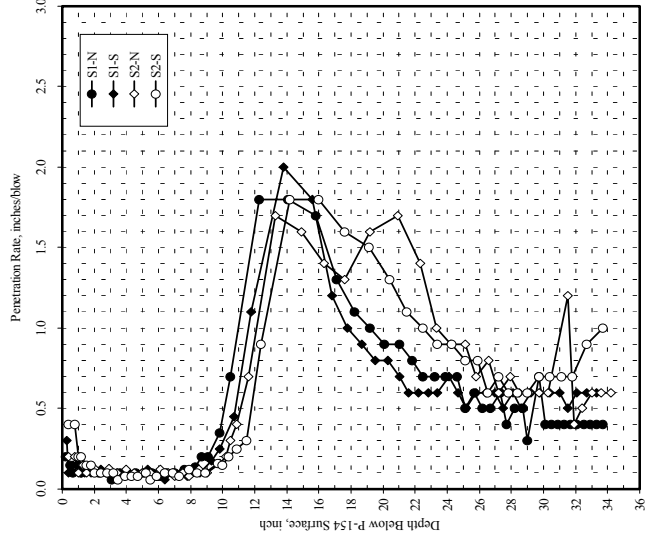
FIGURE 19. DCP TEST RESULTS ON P-154 LAYER

The locations of the DCP tests within the test pits are shown in figure 18. Tests were performed in the diagonally opposite corners inside the test pit. A total of ten DCP tests were performed using disposable cones. Figure 19 shows the test results from the DCP tests. Tests on the P-154 surface were performed using the 17.6-lb (8-kg) hammer. The results are fairly consistent.

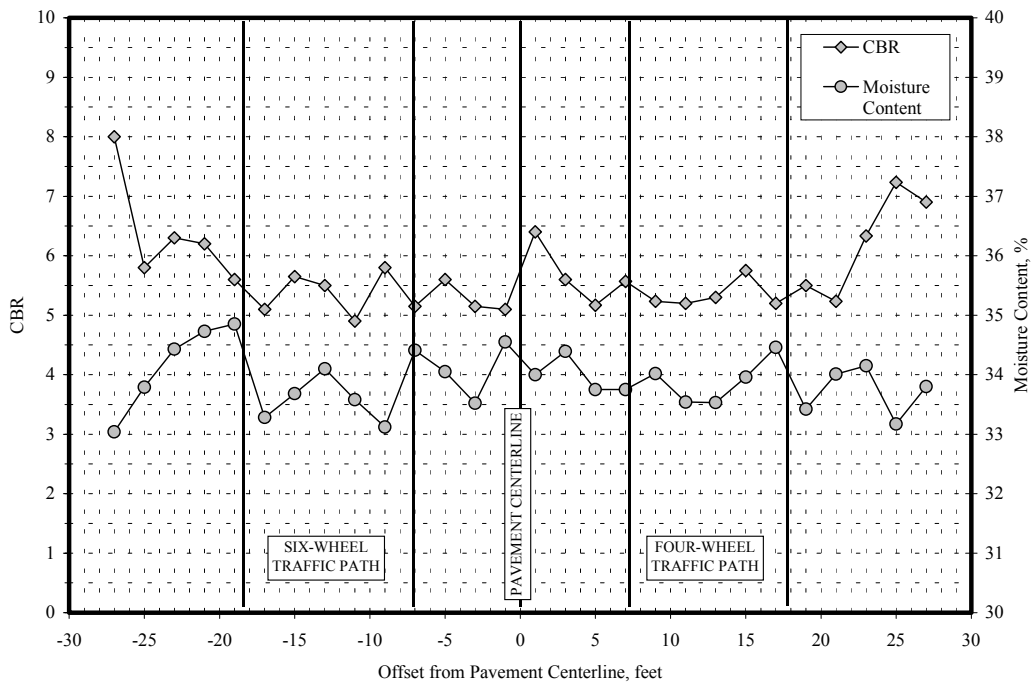
FIGURE 25. RESULTS FROM POSTTRAFFIC CBR TESTS ON SUBGRADE SURFACE

ranged from 3.7 to 8 with a mean value of 5.7. Moisture content ranged from 33.04 percent to 34.85 percent with a mean value of 33.87 percent. Figure 25 shows the CBR test results with the location of tests. Generally, lower CBR values were observed in the trafficked areas.

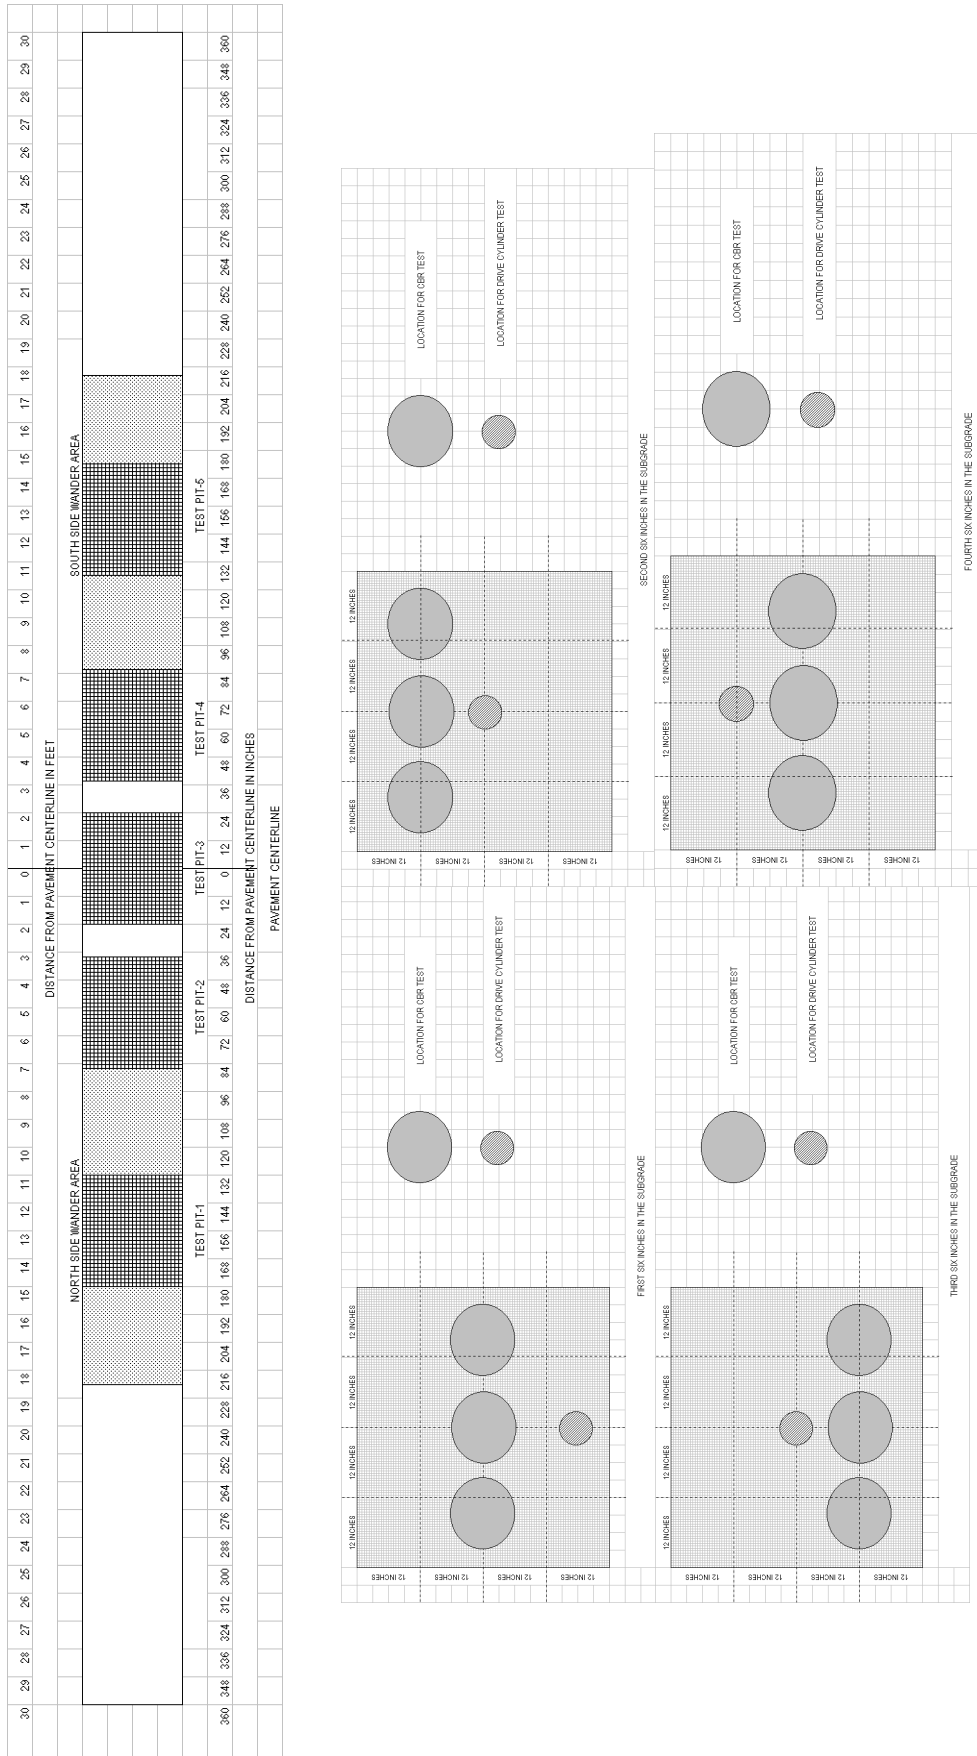
FIGURE 26. TEST PIT LOCATIONS AND TEST LOCATIONS WITHIN THE TEST PITS IN SUBGRADE

After the completion of testing on the subgrade surface, five test pits (4 feet by 4 feet) (1.2 m by 1.2 m) were excavated in the subgrade at 6-inch (152-mm) depths. The location of the test pits is shown in figure 23. They were selected to get maximum information about the subgrade in critical locations (location of maximum rut depths and maximum upheaval). Figure 26 shows the locations of the tests in the test pits. In situ density was determined using the drive cylinder method (ASTM D 2937-94). The test locations were selected to characterize density changes from the location of maximum rutting to the location of maximum upheaval. Moisture content was determined using ASTM D 4959-89 or ASTM D 4643-93.

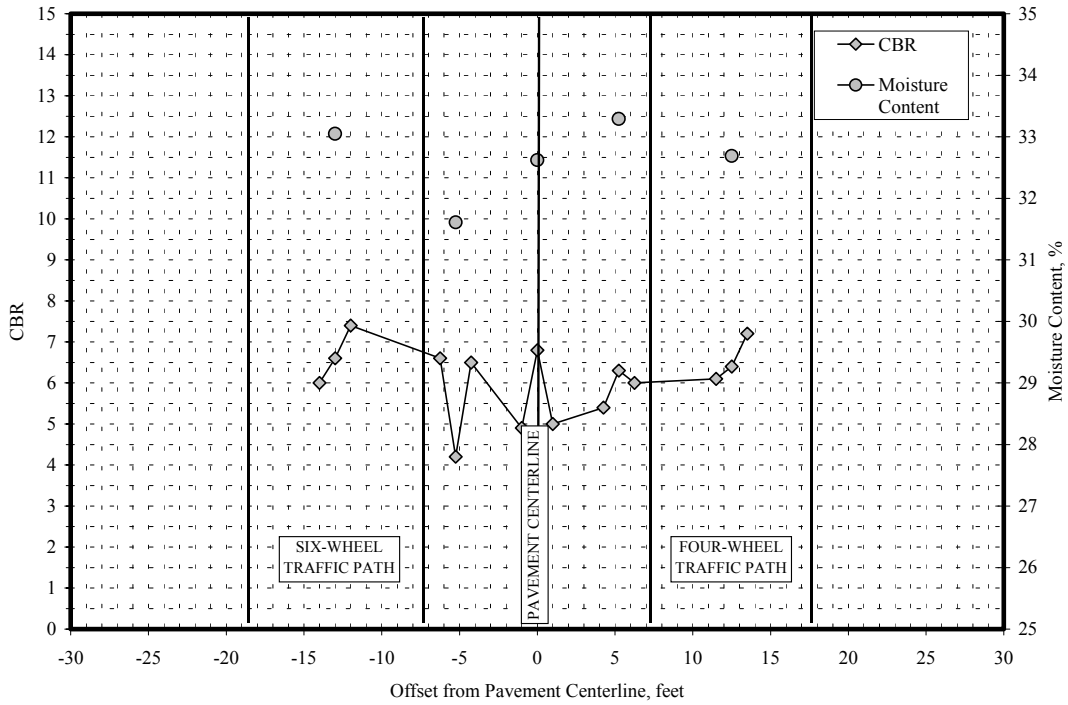
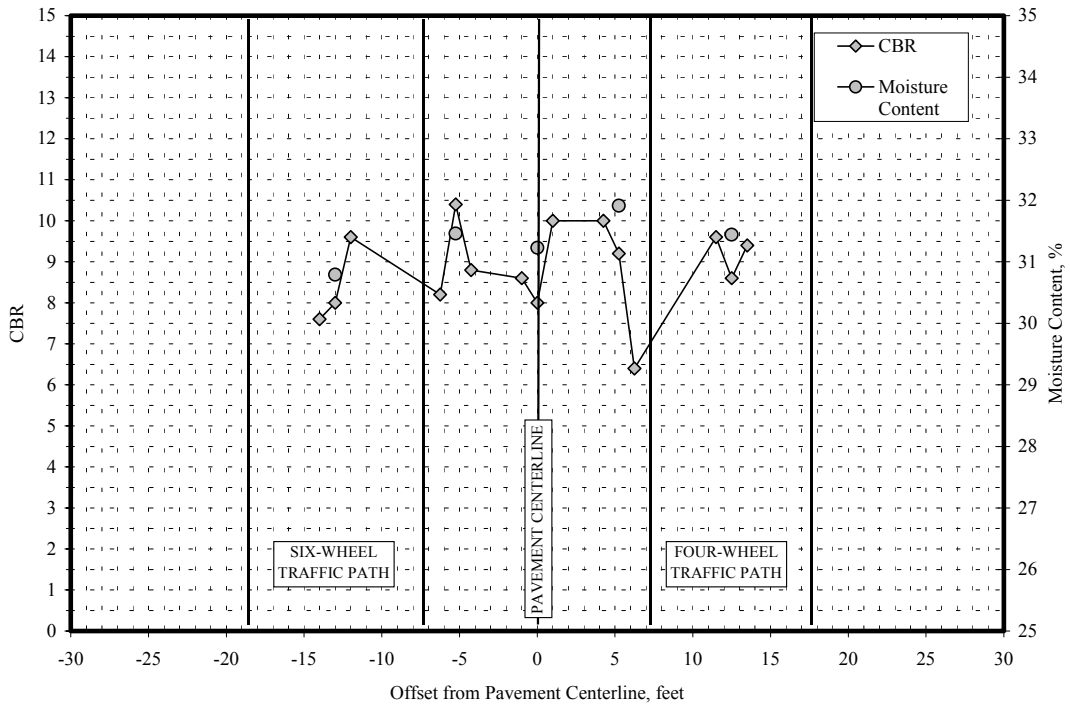
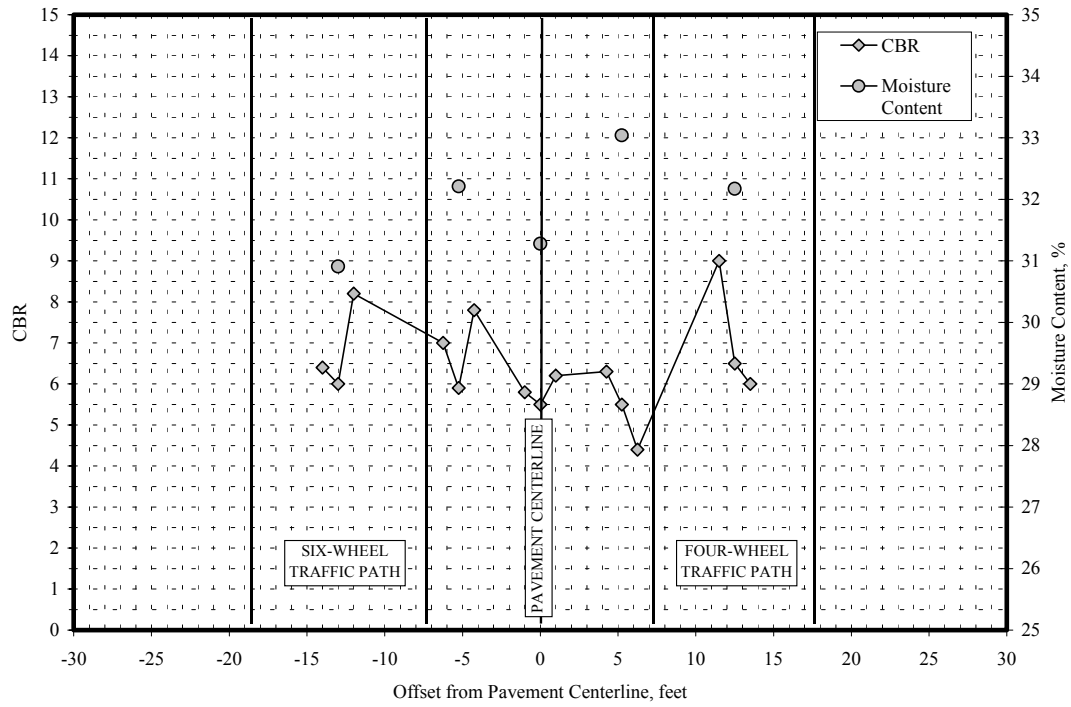
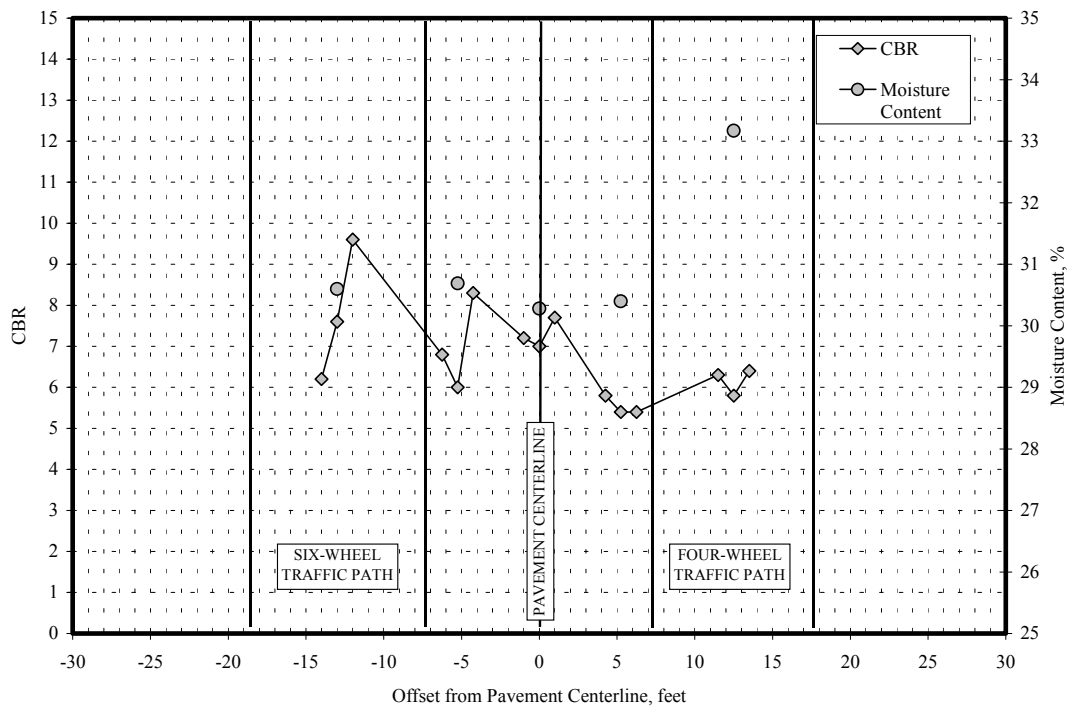
Tables 7 through 10 summarize the CBR test results inside the test pits at depths of 6 inches (152 mm), 12 inches (305 mm), 18 inches (457 mm), and 24 inches (610 mm) respectively. The CBR values range from 4.2 to 10.4. The results of the moisture content tests ranged from 30.28 percent to 33.29 percent. Figures 27 through 30 show the CBR test results and moisture contents with locations within the test pits. Figure 31 shows the variation in the CBR and moisture content with subgrade depth. The moisture content reduces with depth. The CBR values are higher at the 12-inch (305-mm) depth in the subgrade. Figure 32 shows that for the CBR tests conducted on the subgrade surface, 85 percent of the values were higher than 5.2. For all the CBR tests conducted, 85 percent of CBR values were higher than 5.2.

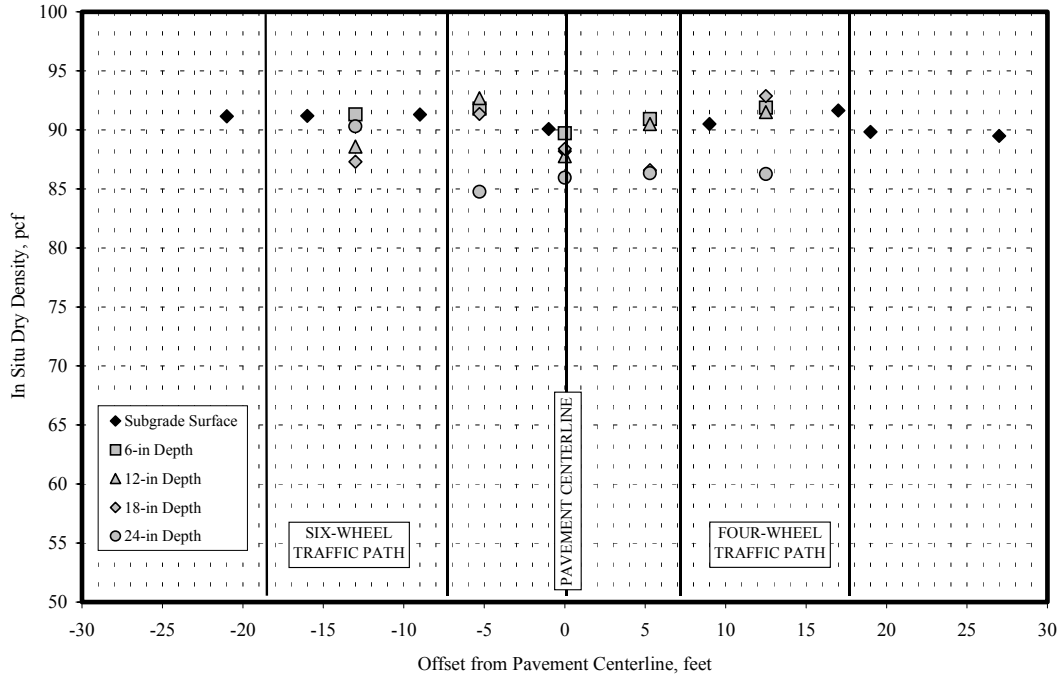
FIGURE 33. RESULTS FROM DRIVE CYLINDER DENSITY TESTS ON SUBGRADE

Drive cylinder test results are summarized in table 11 and figures 33 and 34. The dry density values ranged from 84.8 pcf (1358 kg/cu.m) to 92.9 pcf (1488 kg/cu.m) with a mean value of 89.7 pcf (1437 kg/cu.m). The moisture content values ranged from 30.2 percent to 33.4 percent with a mean value of about 32 percent. In general, the moisture content and the dry density reduced with the depth of the subgrade (figure 35). The moisture content reduced by about 2 percent at the 24-inch (610-mm) depth compared to the subgrade top. The average dry density reduced by 5 pcf (80 kg/cu.m) at the 24-inch (610-mm) depth compared to the subgrade top. From the test data collected during initial construction of the medium-strength subgrade, the mean moisture content was 30.3 percent and the mean dry density was 94 pcf (1506 kg/cu.m).

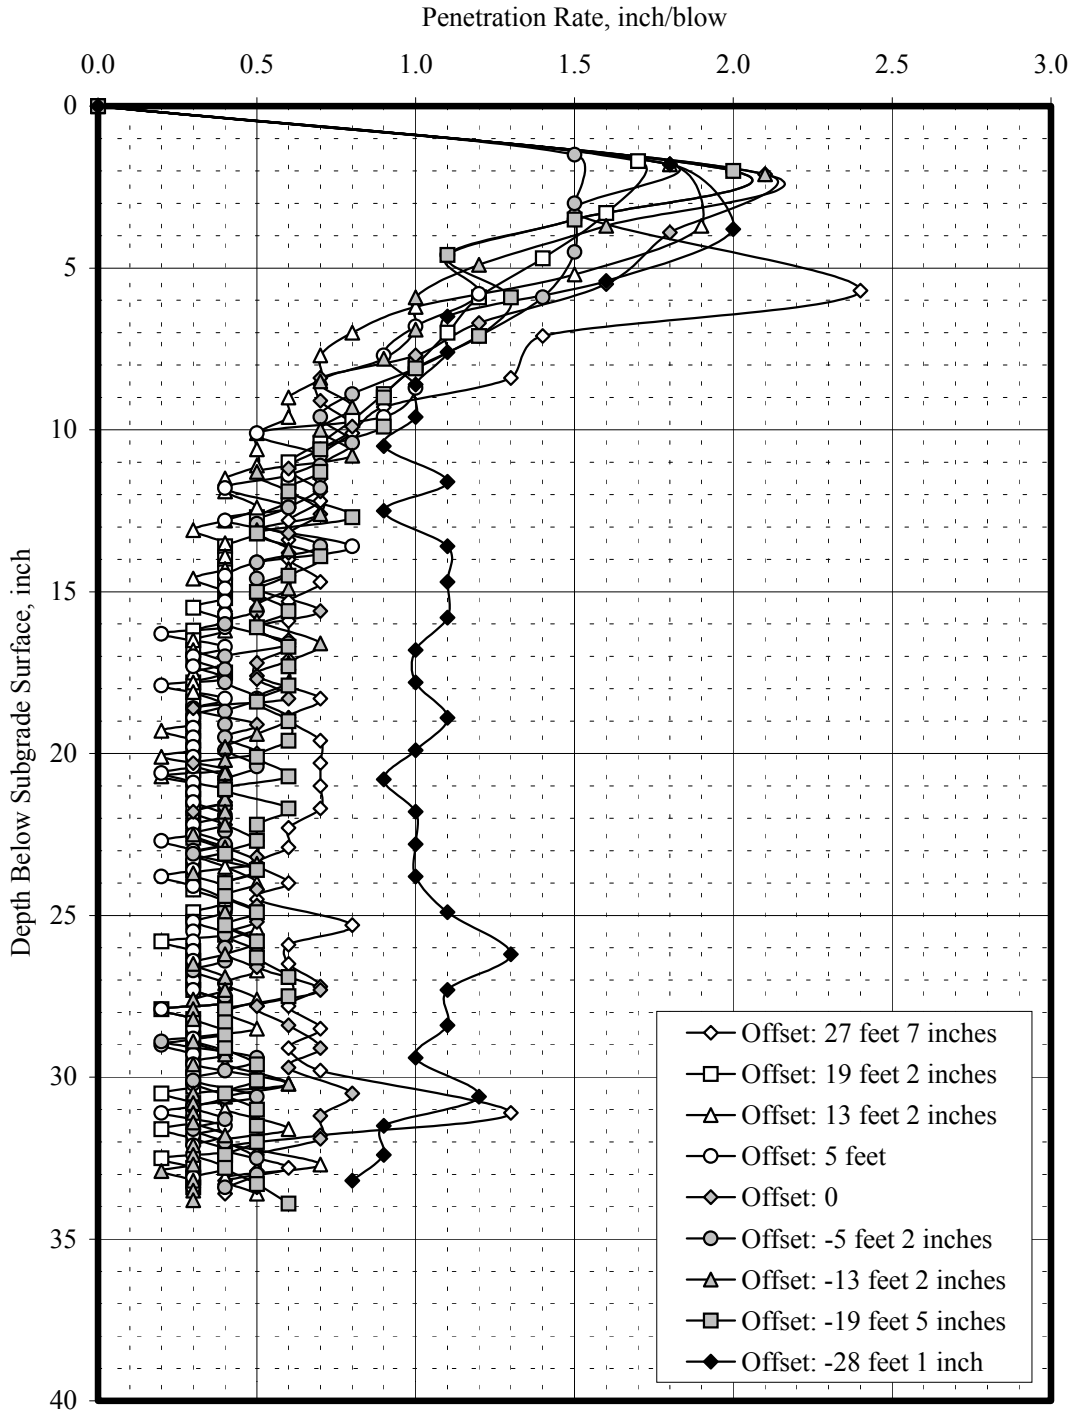
FIGURE 36. DCP TEST RESULTS AT SUBGRADE SURFACE

The DCP tests were performed on the surface of the subgrade and at 24 inches (610 mm) below the surface of the subgrade. The 10.12-lb (4.5-kg) hammer was used for the tests in the subgrade. Test results for the DCP tests at the subgrade surface are shown in figure 36. In general, the penetration rate values ranged from 0.2 inch/blow (5 mm/blow) to 0.7 inch/blow (18 mm/blow). Higher penetration rates were observed in the top 8 to 10 inches (203 to 254 mm) of subgrade because of the lack of confining pressure developed due to the overburden. For the DCP tests performed at 24 inches (610 mm) below the subgrade surface (figure 37), a larger variation in penetration rates was observed. The DCP data will be examined in more detail later if time permits.
