Modification of Visual Approach Slope Indicator Baffles at Pearson Field Airpark, Vancouver, WA

June 2007

DOT/FAA/AR-TN07/12

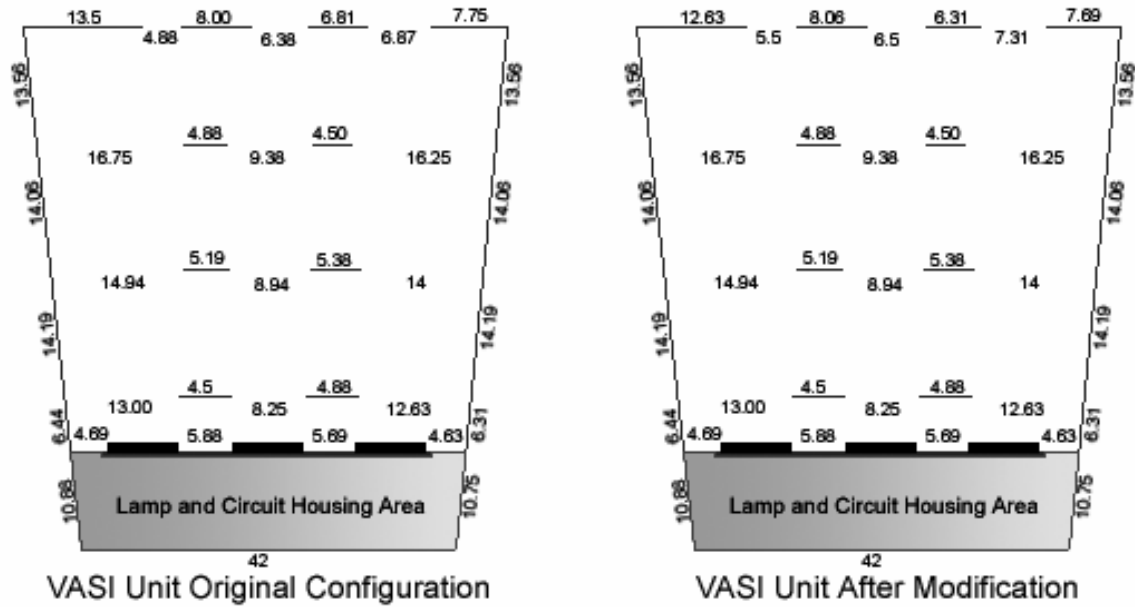
Figure A-1. The VASI Unit 1 Measurements

offset distances between the baffles varied with each unit. Furthermore, the inner baffles were attached using rivets to the sectional supports of the ceiling of the boxes, and were left in a hanging position without any support on the bottom. The inner baffles were constructed of 1/16-in.-thick aluminum. Over time, this type of material does have a tendency to warp and twist, and can contribute to the problem with the light being visible beyond the obstruction. It was determined, however, that the twisting and nonsymmetrical positioning of the baffles was not the cause of the problem at Pearson.
