US Army Corps  
Of Engineers  
Nashville District

## Briefing Outline

This is the basic outline of the Wolf Creek briefing.

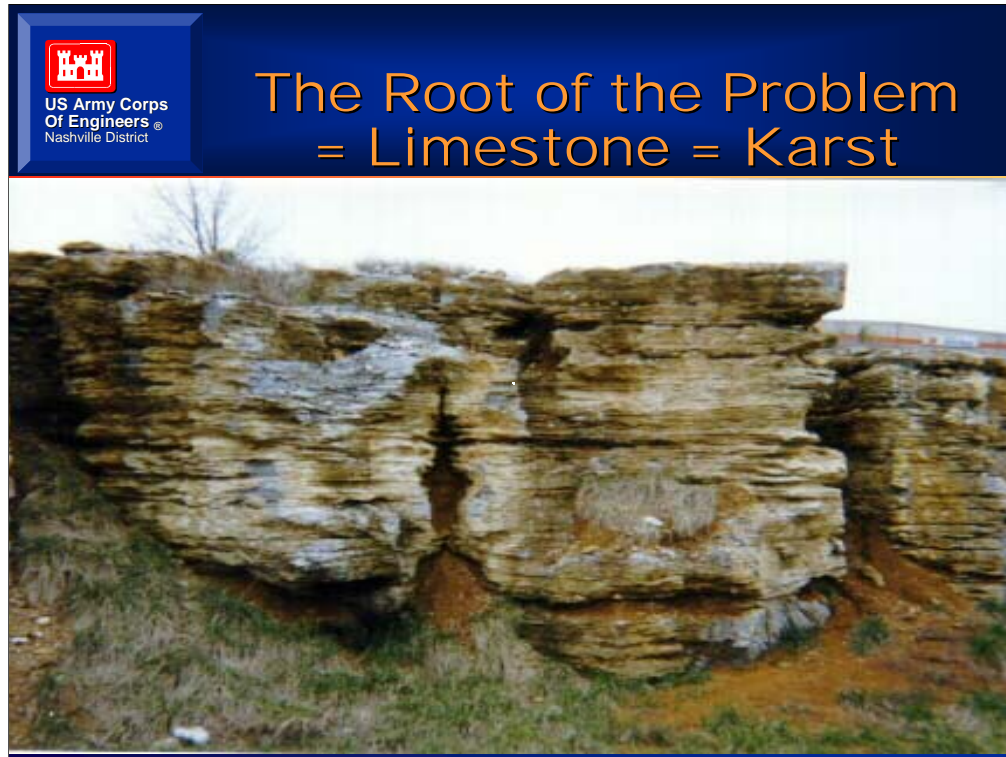
The underlying problem results from caves and cavities in the limestone foundation. Limestone is soluble in weak acid resulting in the formation of openings in the rock. As the limestone dissolves impurities are left behind as clay filling in these openings. Most road-cuts in this part of the country show some evidence of this process.

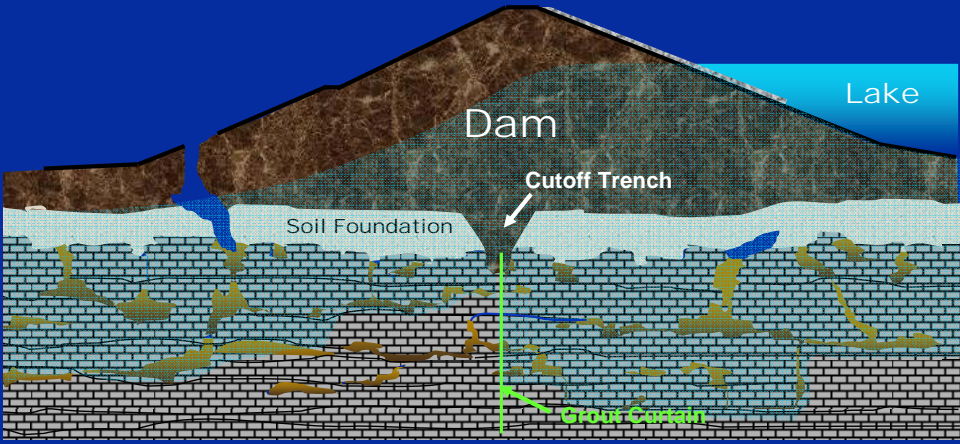
## Dam Section Hypothetical Damage Progression

Treatment of foundations for dams under these conditions involve excavation of a cutoff trench and placement of a grout curtain by drilling a line or lines of closely spaced drill holes in the rock and backfilling these under pressure with a mixture of cement and water called grout. Over time, under the influence of the reservoir pressures grout curtains may lose their effectiveness allowing high pressures to impact the clay filling in the cavities. If this pressure is sufficient, erosion of the clay infilling may begin and progress upstream toward the reservoir. This process is called piping and if left untreated can lead to a breach of the embankment and failure.

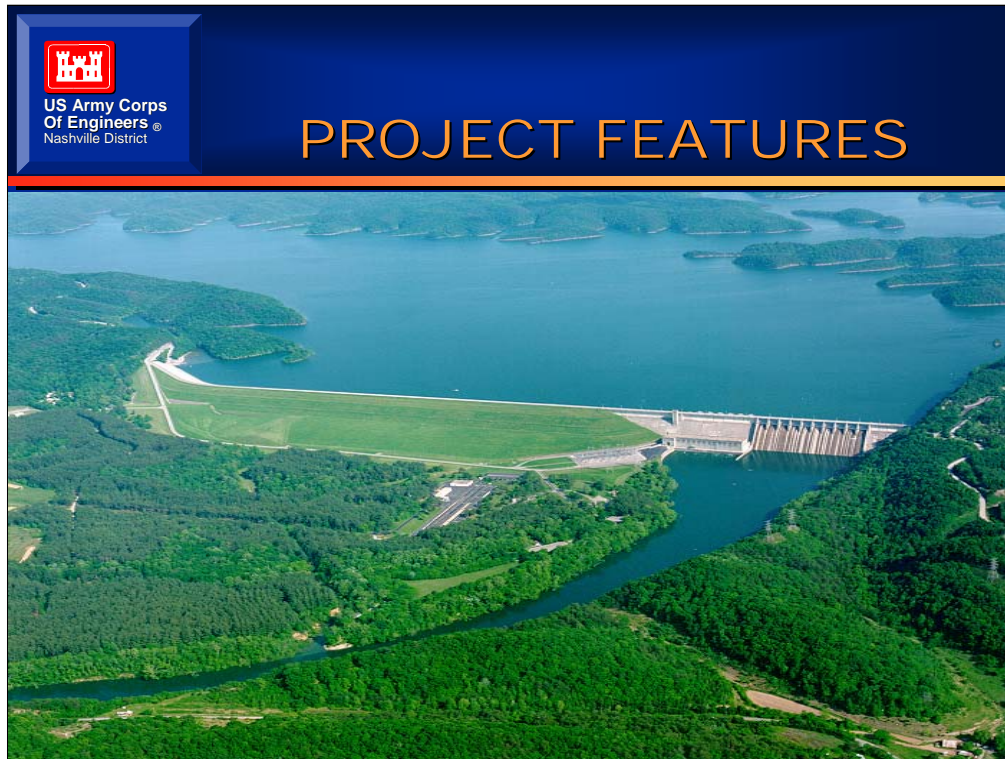
- Point out Cone or Wraparound Section – critical area where embankment ties in to concrete section
- Developed serious seepage problems in 1968. Wet areas D/S near the right abutment, muddy flows in the tailrace, 2 large sinkholes in the embankment just above the switchyard

- All these indicated dam and foundation material was being washed away due to seepage

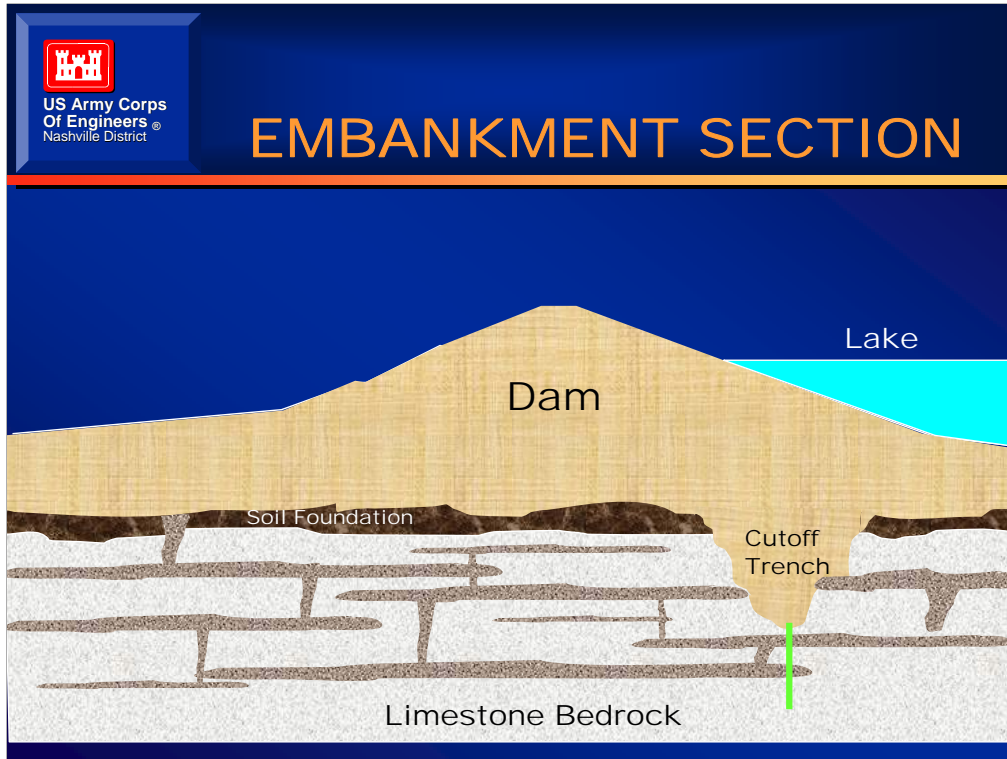
A typical section through Wolf Creek Dam showing the location of the cut-off trench.

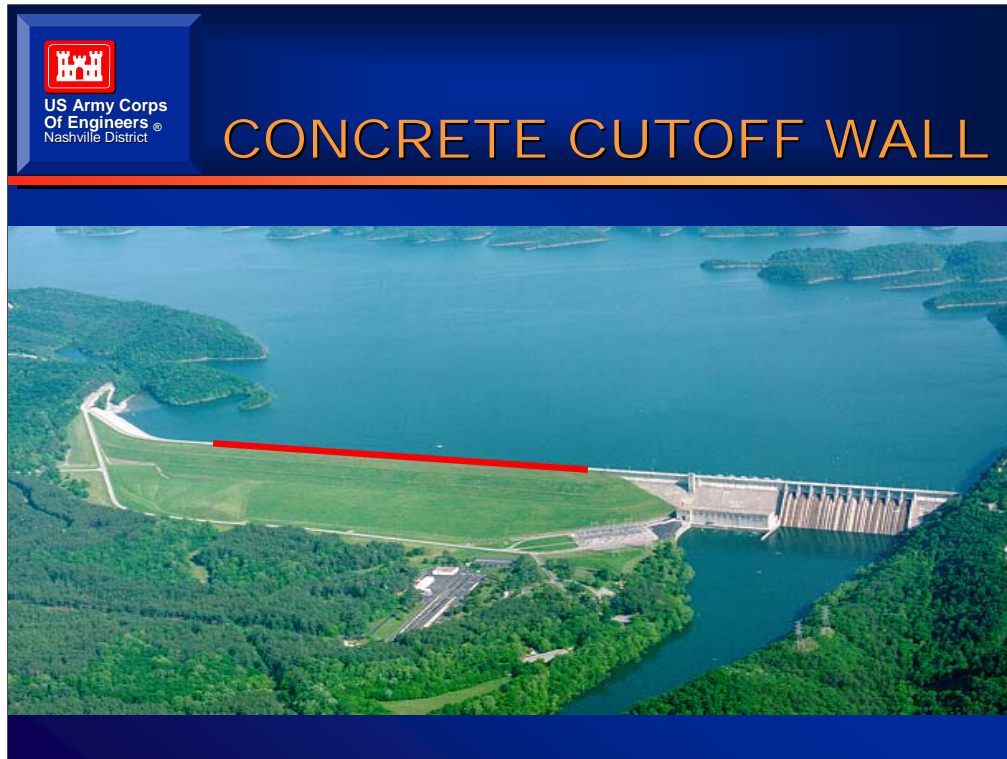
Based on information from the earlier grouting and the high cost of construction it was decided that only two-thirds of the embankment required a cut-off wall as shown on this aerial view. Some members of the expert panel felt this was a short sighted cost saving measure and expressed the opinion that eventually a wall would be required for the entire length of the embankment.
