# COLUMBIA

## ACCIDENT INVESTIGATION BOARD

REPORT VOLUME I  
AUGUST 2003

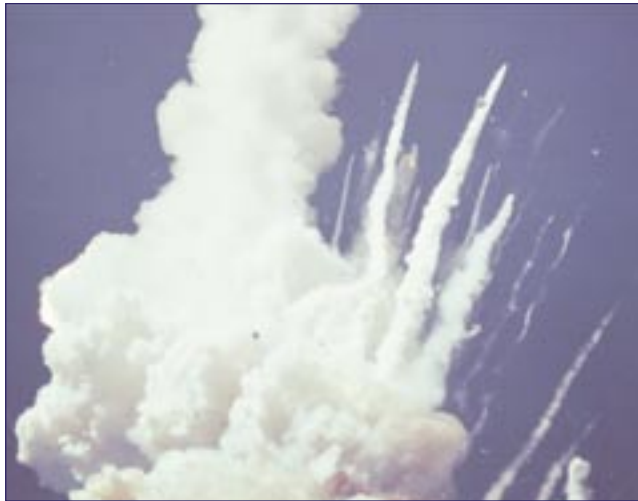
The illusion that the Space Shuttle was an operational system, safe enough to carry legislators and a high-school teacher into orbit, was abruptly and tragically shattered on the morning of January 28, 1986, when *Challenger* was destroyed 73 seconds after launch during the 25th mission (see Figure 1.5-1). The seven-member crew perished.

Figure 1.5-1. the Space Shuttle Challenger was lost during ascent on January 28, 1986, when an O-ring and seal in the left Solid Rocket Booster failed.

The Rogers Commission report, issued on June 6, 1986, recommended a redesign and recertification of the Solid Rocket Motor joint and seal and urged that an independent body oversee its qualification and testing. The report concluded that the drive to declare the Shuttle operational had put enormous pressures on the system and stretched its resources to the limit. Faulting NASA safety practices, the Commission also called for the creation of an independent NASA Office of Safety, Reliability, and Quality Assurance, reporting directly to the NASA Administrator, as well as structural changes in program management.<sup>20</sup> (The Rogers Commission findings and recommendations are discussed in more detail in Chapter 5.) It would take NASA 32 months before the next Space Shuttle mission was launched. During this time, NASA initiated a series of longer-term vehicle upgrades, began the construction of the Orbiter *Endeavour* to replace *Challenger*, made significant organizational changes, and revised the Shuttle manifest to reflect a more realistic flight rate.

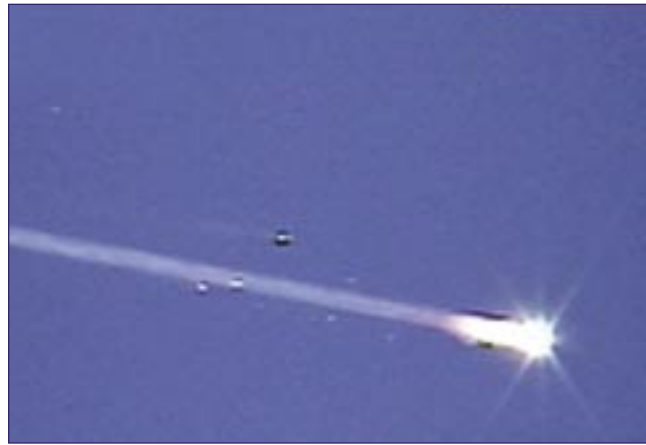
Taken at the same time as the photo at left, but from Hewitt, Texas, looking north.

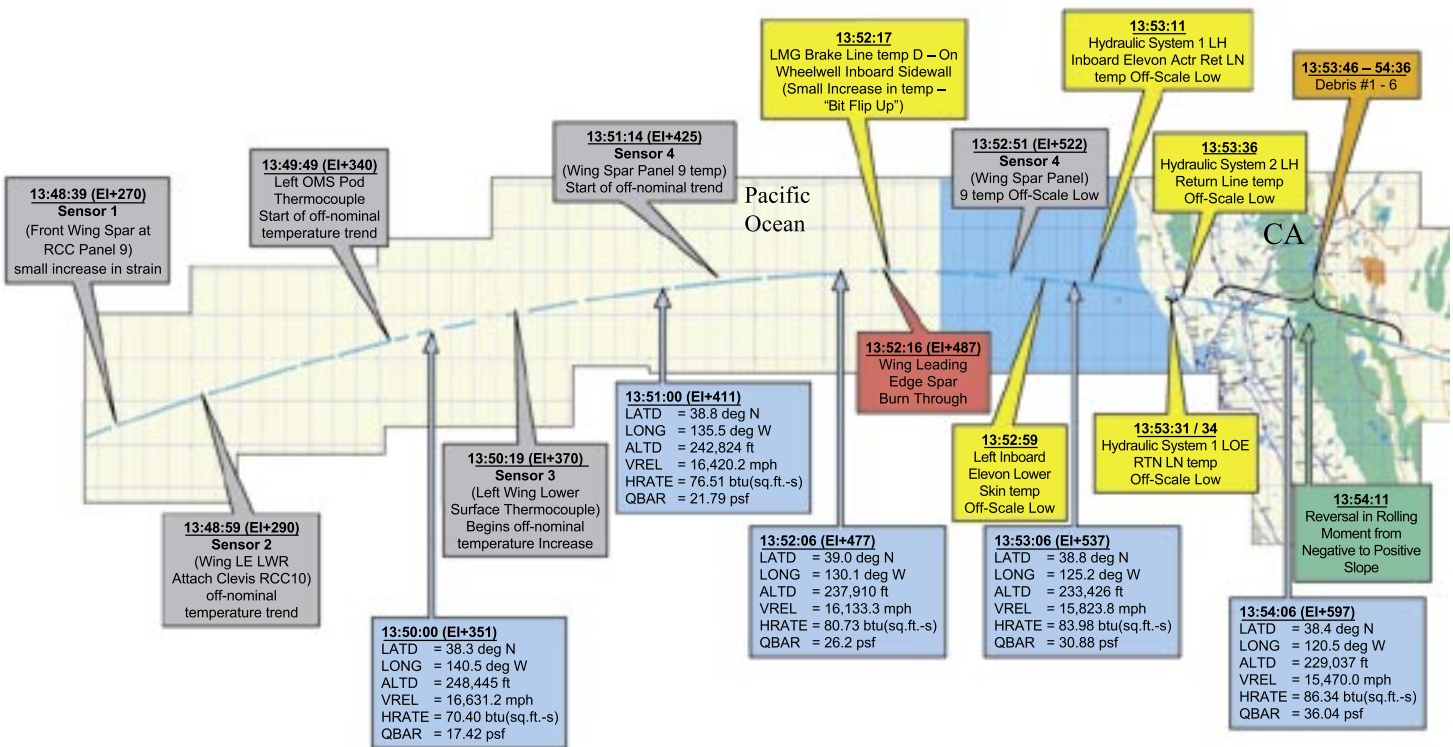
At 8:48:39 a.m. (EI+270), a sensor on the left wing leading edge spar showed strains higher than those seen on previous *Columbia* re-entries. This was recorded only on the Modular Auxiliary Data System, and was not telemetered to ground controllers or displayed to the crew (see Figure 2.6-1).

Figure 2.6-1. This simplified timeline shows the re-entry path of Columbia on February 1, 2003. The information presented here is a composite of sensor data telemetered to the ground combined with data from the Modular Auxiliary Data System recorder recovered after the accident. Note that the first off-nominal reading was a small increase in a strain gauge at the front wing spar behind RCC panel 9-left. The chart is color-coded: blue boxes contain position, attitude, and velocity information; orange boxes indicate when debris was shed from the Orbiter; green boxes are significant aerodynamic control events; gray boxes contain sensor information from the Modular Auxiliary Data System; and yellow boxes contain telemetered sensor information. The red boxes indicate other significant events.

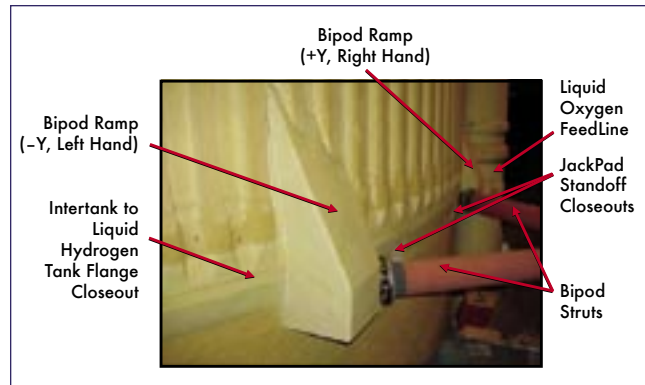
Figure 3.2-2. The exterior of the left bipod attachment area showing the foam ramp that came off during the ascent of STS-107.

A combination of factors, rather than a single factor, led to the loss of the left bipod foam ramp during the ascent of STS-107. NASA personnel believe that testing conducted during the investigation, including the dissection of as-built hardware and testing of simulated defects, showed conclusively that pre-existing defects in the foam were a major factor, and in briefings to the Board, these were cited as a necessary condition for foam loss. However, analysis indicated that pre-existing defects alone were not responsible for foam loss.

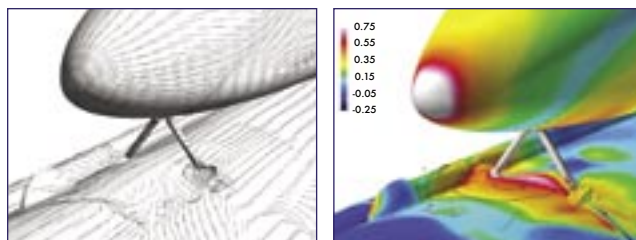
*Figure 3.2-5. Computational Fluid Dynamics was used to understand the complex flow fields and pressure coefficients around bipod strut. The flight conditions shown here approximate those present when the left bipod foam ramp was lost from External Tank 93 at Mach 2.46 at a 2.08-degree angle of attack.*

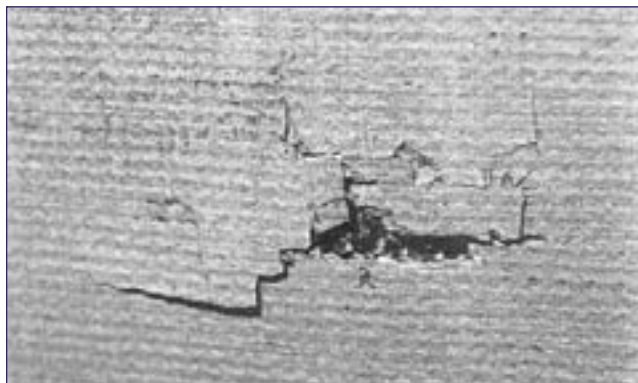
RCC components have been struck by objects throughout their operational life, but none of these components has been completely penetrated. A sampling of 21 post-flight reports noted 43 hypervelocity impacts, the largest being 0.2 inch. The most significant low-velocity impact was to *Atlantis*' panel 10-right during STS-45 in March and April 1992. The damaged area was 1.9 inches by 1.6 inches on the exterior surface and 0.5 inches by 0.1 inches in the interior surface. The substrate was exposed and oxidized, and the panel was scrapped. Analysis concluded that the damage was caused by a strike by a man-made object, possibly during ascent. Figures 3.3-2 and 3.3-3 show the damage to the outer and inner surfaces, respectively.

Figure 3.3-3. Damage on the inner surface of RCC panel 10-right from *Atlantis* after STS-45.

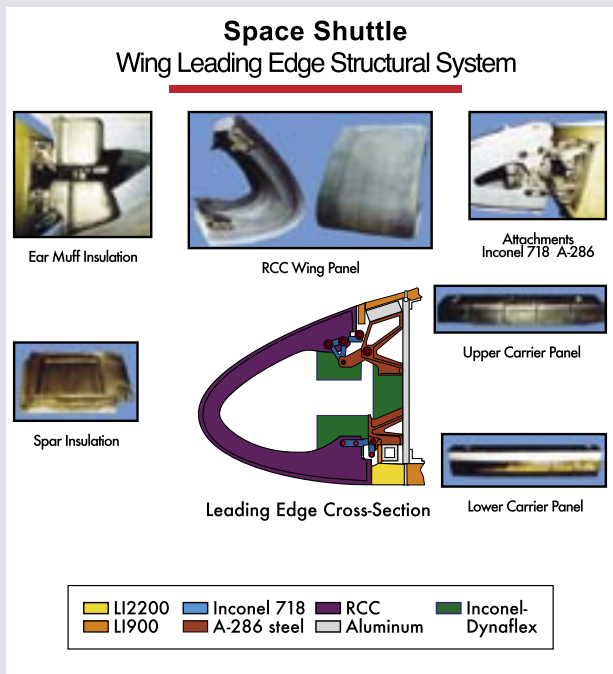
The mid-wing area on the left wing, behind where the breach occurred, is supported by a series of trusses, as shown in red in the figure below. The mid-wing area is bounded in the front and back by the Xo1040 and Xo1191 cross spars, respectively. The numerical designation of each spar comes from its location along the Orbiter's X-axis; for example, the Xo1040 spar is 1,040 inches from the zero point on the X-axis. The cross spars provide the wing's structural integrity. Three major cross spars behind the Xo1191 spar provide the primary structural strength for the aft portion of the wing. The inboard portion of the mid-wing is the outer wall of the left wheel-well, and the outboard portion of the mid-wing is the wing leading edge spar, where the RCC panels attach.

The Wing Leading Edge Structural System on Columbia.

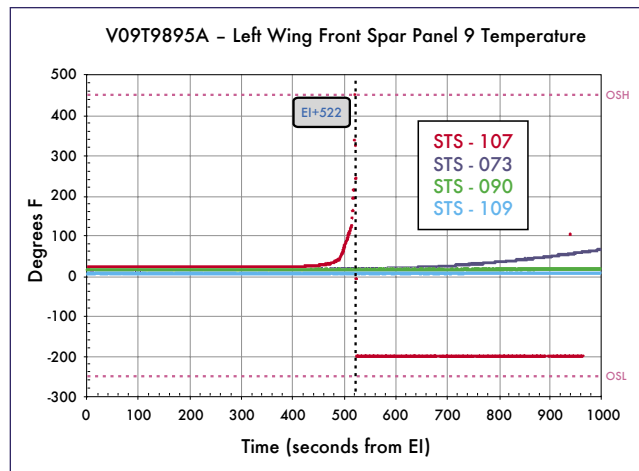
Figure 3.6-7. Sensor 4 also began reading significantly higher than previous flights before it fell off-scale low. The relatively late reaction of this sensor compared to Sensor 2, clearly indicated that superheated air started on the outside of the wing leading edge spar and then moved into the mid-wing after the spar was burned through. Note that immediately before the sensor (or the wire) fails, the temperature is at 450 degrees Fahrenheit and climbing rapidly. It was the only temperature sensor that showed this pattern.

later. Because the distance between bundle A and bundle E is 9 inches, the failure of all these wires indicates that the breach in the wing leading edge spar was at least 9 inches from top to bottom by EI+522 seconds.

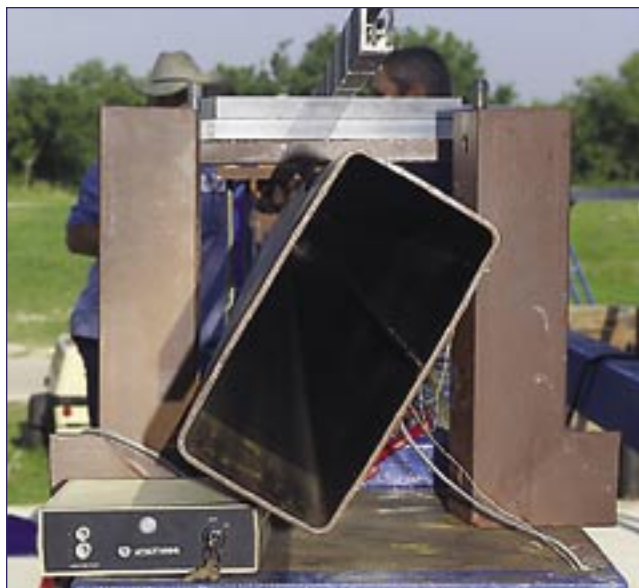
Figure 3.8-4. The barrel on the nitrogen gun could be rotated to adjust the impact point of the foam projectile.

greater force. During the fiberglass tests, it was found that a clocking angle of 30 degrees allowed the 11.5-inch-edge to fully contact the panel at impact, resulting in a greater local force than a zero degree angle, which was achieved with the barrel aligned vertically. A zero-degree angle was used for the test on RCC panel 6, and a 30-degree angle was used for RCC panel 8.

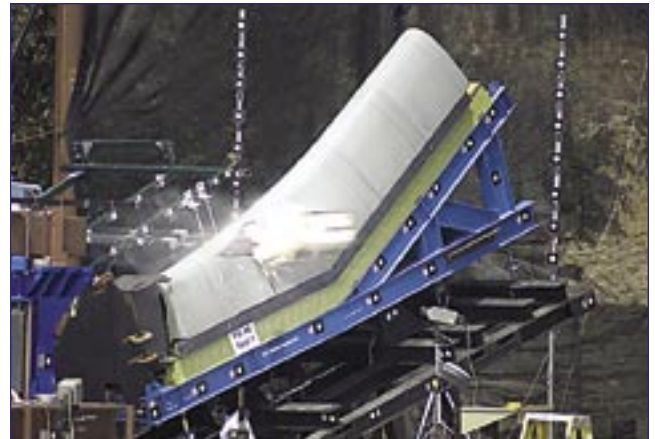
Figure 3.8-5. A typical foam strike leaves impact streaks, and the foam projectile breaks into shards and larger pieces. Here the foam is striking Panel 6 on a fiberglass test article.

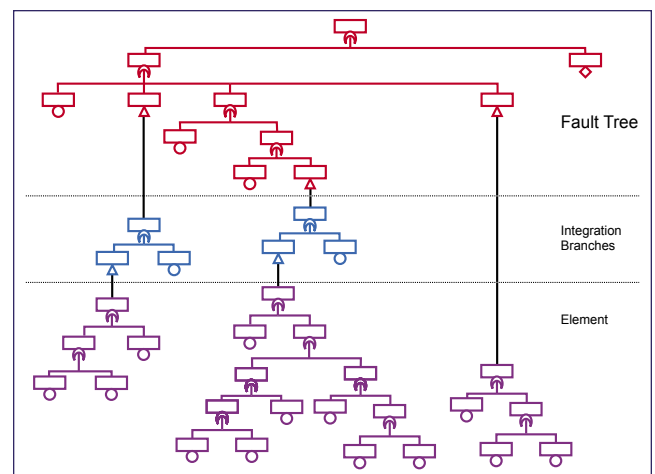
Figure 4.1-1. Accident investigation fault tree structure.

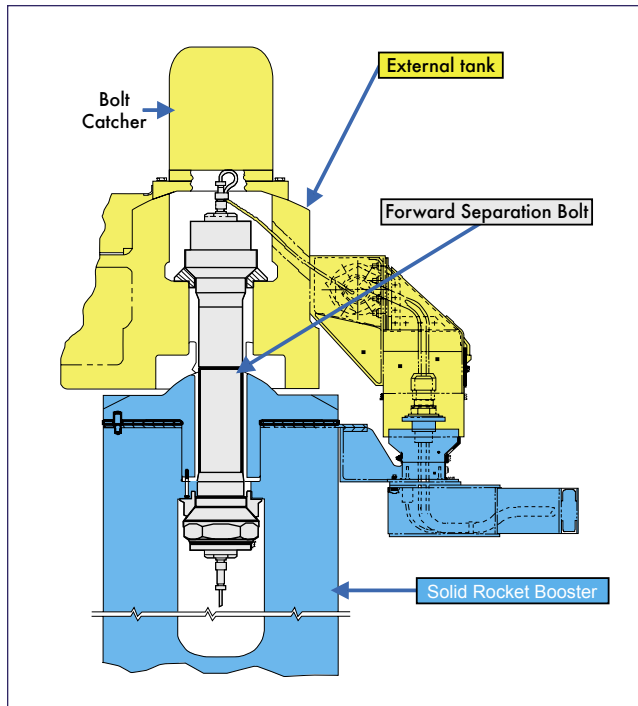
If one of the bolt catchers failed during STS-107, the resulting debris could have damaged *Columbia's* wing leading edge. Concerns that the bolt catchers may have failed, causing metal debris to ricochet toward the Orbiter, arose because the configuration of the bolt catchers used on Shuttle missions differs in important ways from the design used in

Figure 4.2-1. A cutaway drawing of the forward Solid Rocket Booster bolt catcher and separation bolt assembly.

initial qualification tests.<sup>1</sup> First, the attachments that currently hold bolt catchers in place use bolts threaded into inserts rather than through-bolts. Second, the test design included neither the Super Lightweight Ablative material applied to the bolt catcher apparatus for thermal protection, nor the aluminum honeycomb configuration currently used. Also, during these initial tests, temperature and pressure readings for the bolt firings were not recorded.

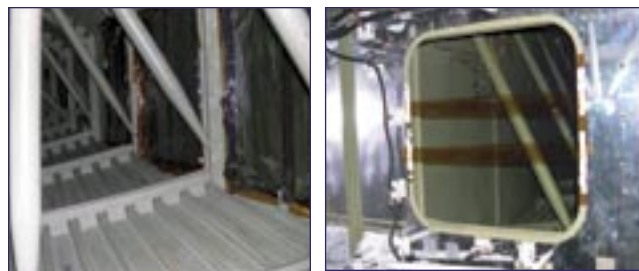
*Figure 4.2-5. At left, a wing section open for inspection; at right, wing access closed off after inspection.*

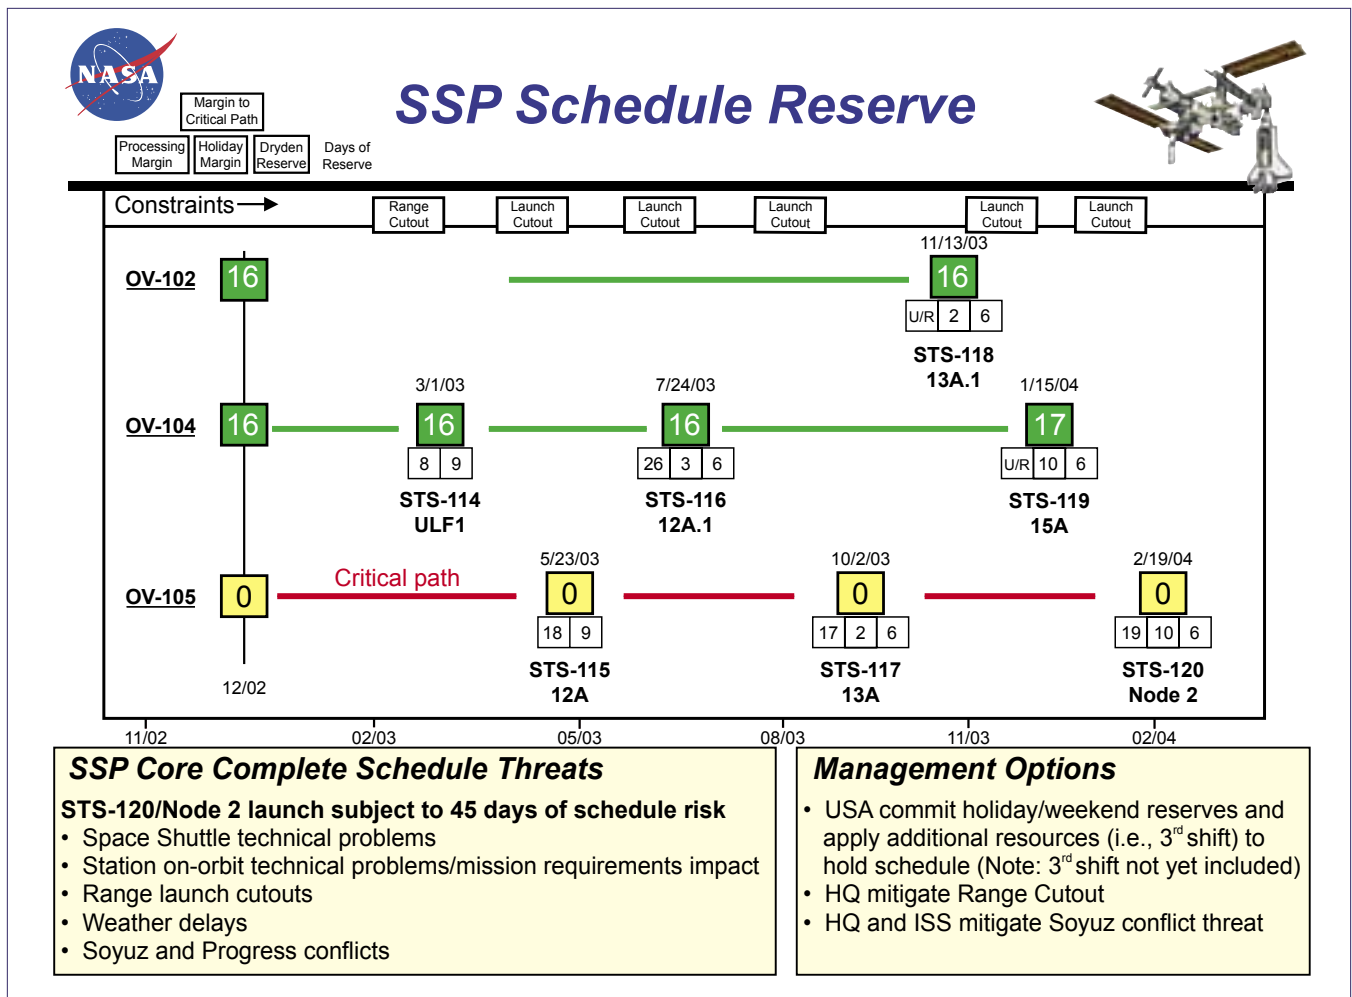
Figure 6.2-5 shows the margin for each vehicle (*Discovery*, OV-103, was in extended maintenance). The large boxes indicate the “margin to critical path” (to Node 2 launch date). The three smaller boxes underneath indicate (from

Figure 6.2-5. This slide shows the margin for each Orbiter. The large boxes show the number of days margin to the Node 2 launch date, while the three smaller boxes indicate vehicle processing margin, holiday margin, and the margin if a Dryden landing was not required.

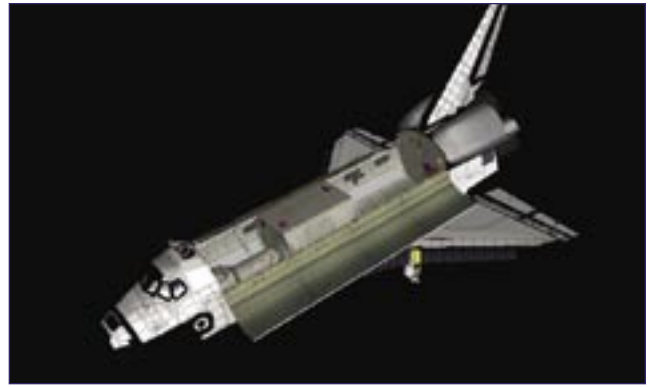
The repair option (see Figure 6.4-1), while logistically viable using existing materials onboard *Columbia*, relied on so many uncertainties that NASA rated this option "high risk." To complete a repair, the crew would perform a spacewalk to fill an assumed 6-inch hole in an RCC panel with heavy metal tools, small pieces of titanium, or other metal scavenged from the crew cabin. These heavy metals, which would help protect the wing structure, would be held in place during

Figure 6.4-1. The speculative repair option would have sent astronauts hanging over the payload bay door to reach the left wing RCC panels using a ladder scavenged from the crew module.

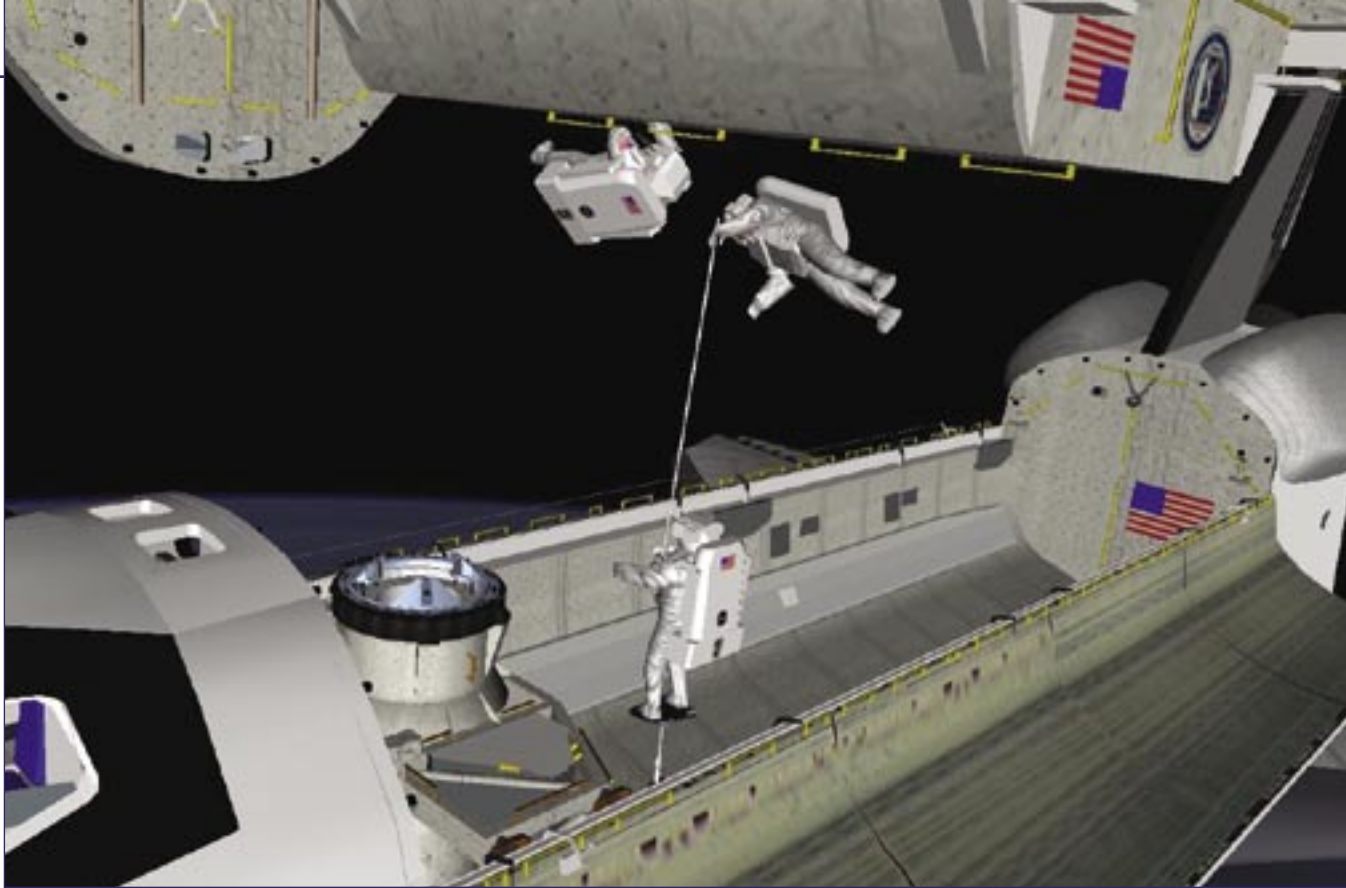
Figure 6.4-2. The rescue option had Atlantis (lower vehicle) rendezvousing with Columbia and the STS-107 crew transferring via ropes. Note that the payload bay of Atlantis is empty except for the external airlock/docking adapter.

er, pilot, and two astronauts trained for spacewalks. In January, seven commanders, seven pilots, and nine spacewalk-trained astronauts were available. During the rendezvous on Atlantis's first day in orbit, the two Orbiters would maneuver to face each other with their payload bay doors open (see Figure 6.4-2). Suited Columbia crew members would then be transferred to Atlantis via spacewalks. Atlantis would return with four crew members on the flight deck and seven in the mid-deck. Mission Control would then configure Columbia for a de-orbit burn that would ditch the Orbiter in the Pacific Ocean, or would have the Columbia crew take it to a higher orbit for a possible subsequent repair mission if more thorough repairs could be developed.
