Part One

The Accident

Part One of the report of the Columbia Accident Investigation Board is organized into four chapters. In order to set the background for further discussion, Chapter 1 relates the history of the Space Shuttle Program before the *Challenger* accident. The events leading to the original approval of the Space Shuttle Program are recounted, as well as an examination of some of the promises made in order to gain that approval. In retrospect, many of these promises could never have been achieved. Chapter 2 documents the final flight of *Columbia*. As a straightforward record of the event, it contains no findings or recommendations. Chapter 3 reviews five analytical paths – aerodynamic, thermodynamic, sensor data timeline, debris reconstruction, and imaging evidence – to show that all five independently arrive at the same conclusion. Chapter 4 describes the investigation into other possible physical factors that might have contributed to the accident, but were subsequently dismissed as possible causes.

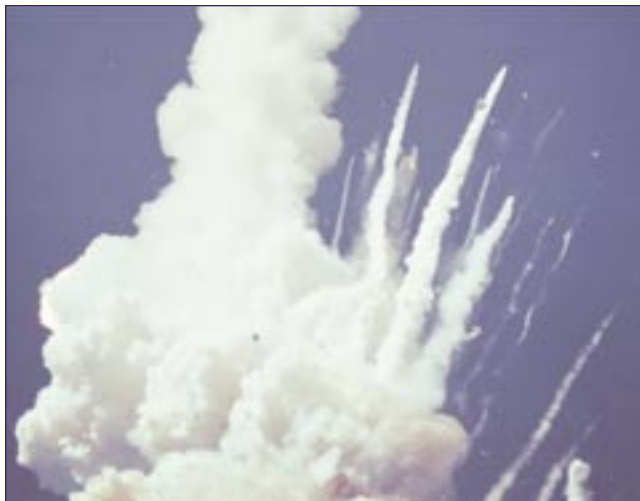
The illusion that the Space Shuttle was an operational system, safe enough to carry legislators and a high-school teacher into orbit, was abruptly and tragically shattered on the morning of January 28, 1986, when *Challenger* was destroyed 73 seconds after launch during the 25th mission (see Figure 1.5-1). The seven-member crew perished.

Figure 1.5-1. the Space Shuttle Challenger was lost during ascent on January 28, 1986, when an O-ring and seal in the left Solid Rocket Booster failed.

The Rogers Commission report, issued on June 6, 1986, recommended a redesign and recertification of the Solid Rocket Motor joint and seal and urged that an independent body oversee its qualification and testing. The report concluded that the drive to declare the Shuttle operational had put enormous pressures on the system and stretched its resources to the limit. Faulting NASA safety practices, the Commission also called for the creation of an independent NASA Office of Safety, Reliability, and Quality Assurance, reporting directly to the NASA Administrator, as well as structural changes in program management.²⁰ (The Rogers Commission findings and recommendations are discussed in more detail in Chapter 5.) It would take NASA 32 months before the next Space Shuttle mission was launched. During this time, NASA initiated a series of longer-term vehicle upgrades, began the construction of the Orbiter *Endeavour* to replace *Challenger*, made significant organizational changes, and revised the Shuttle manifest to reflect a more realistic flight rate.

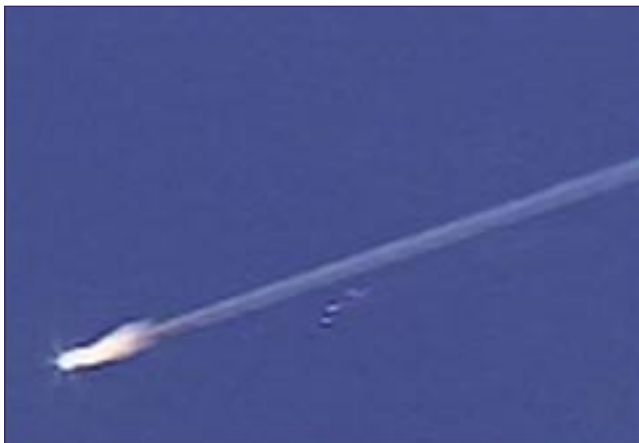
The Orbiter has a large glowing field surrounding it in this view taken from Mesquite, Texas, looking south.

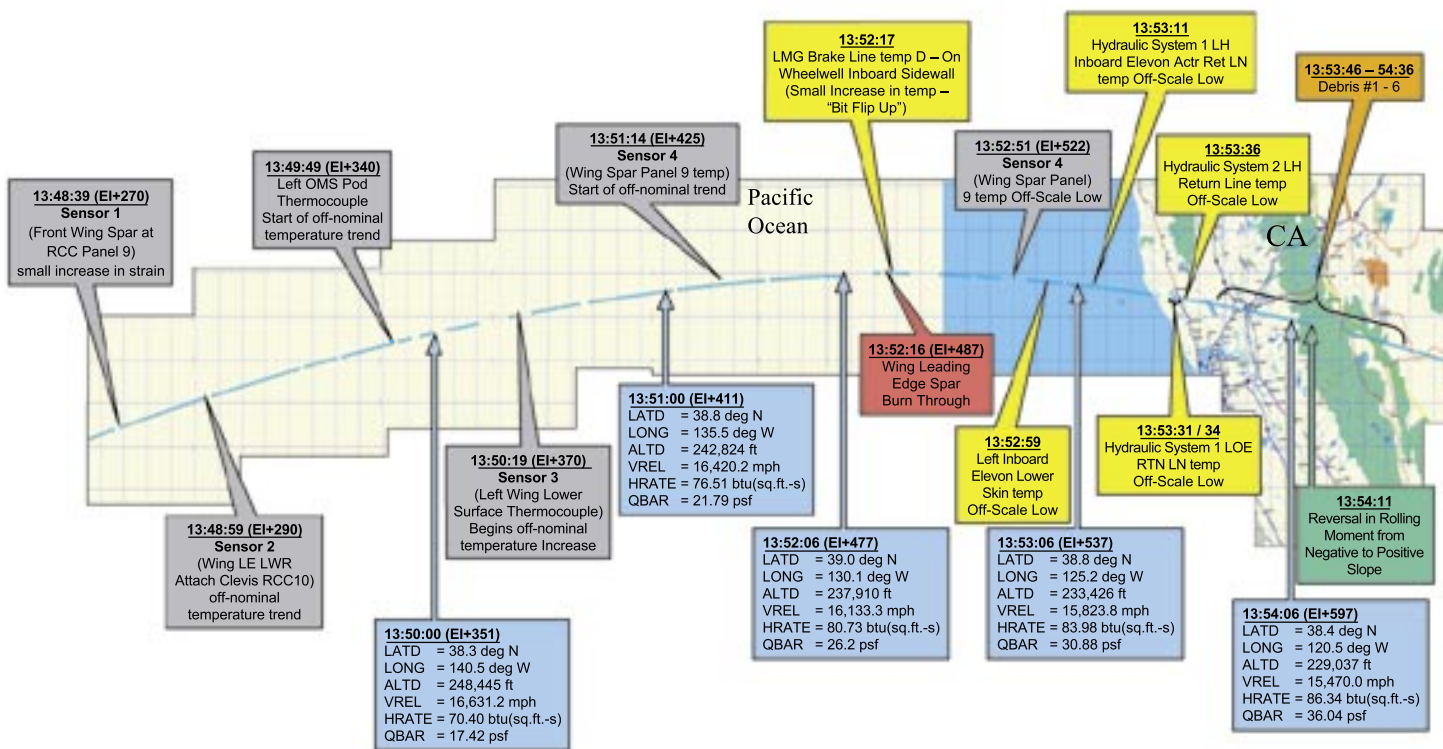
At 8:48:39 a.m. (EI+270), a sensor on the left wing leading edge spar showed strains higher than those seen on previous *Columbia* re-entries. This was recorded only on the Modular Auxiliary Data System, and was not telemetered to ground controllers or displayed to the crew (see Figure 2.6-1).

Figure 2.6-1. This simplified timeline shows the re-entry path of Columbia on February 1, 2003. The information presented here is a composite of sensor data telemetered to the ground combined with data from the Modular Auxiliary Data System recorder recovered after the accident. Note that the first off-nominal reading was a small increase in a strain gauge at the front wing spar behind RCC panel 9-left. The chart is color-coded: blue boxes contain position, attitude, and velocity information; orange boxes indicate when debris was shed from the Orbiter; green boxes are significant aerodynamic control events; gray boxes contain sensor information from the Modular Auxiliary Data System; and yellow boxes contain telemetered sensor information. The red boxes indicate other significant events.

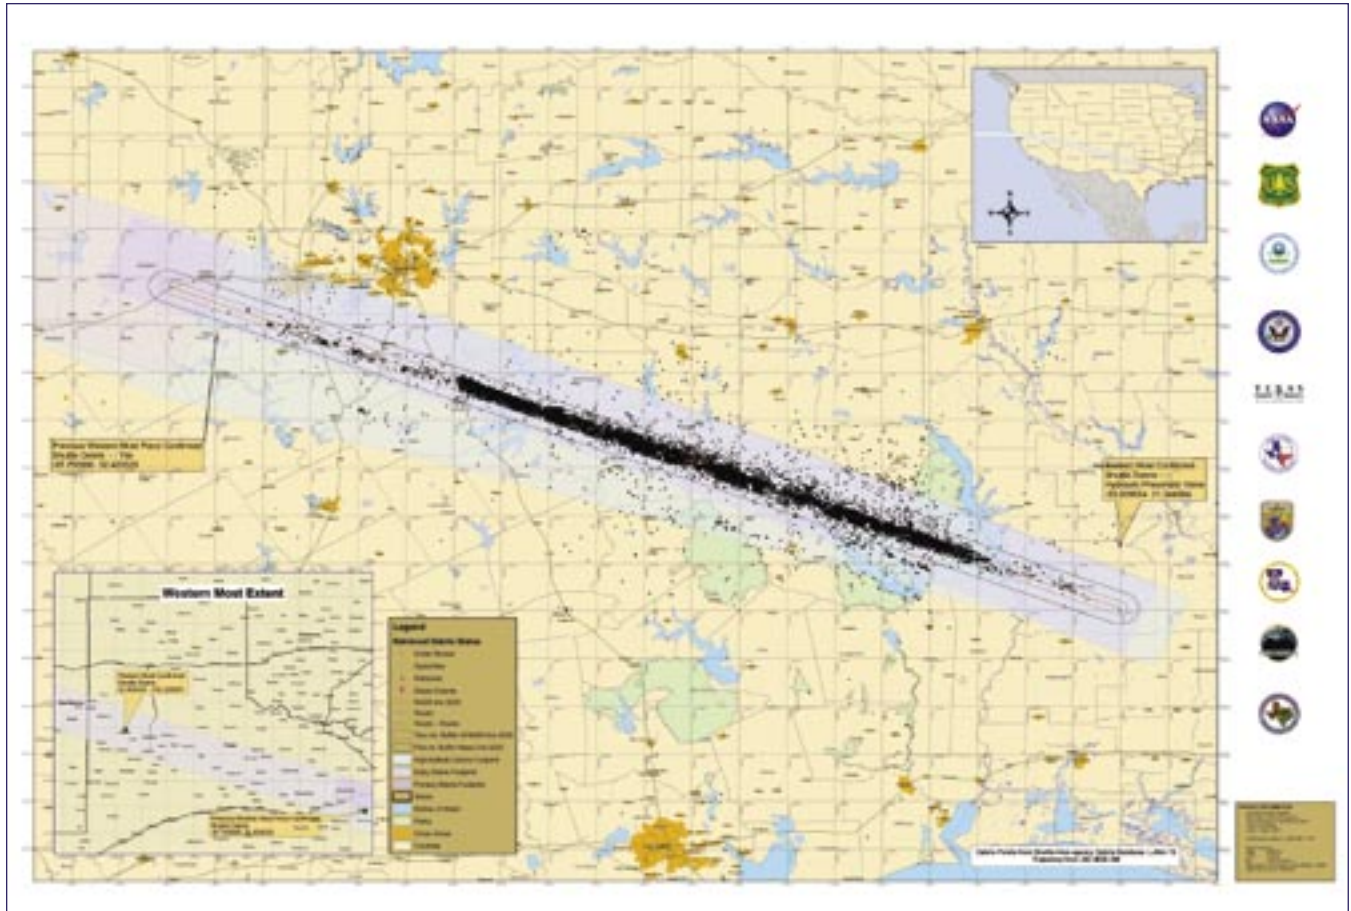
Figure 2.7-1. The debris field in East Texas spread over 2,000 square miles, and eventually over 700,000 acres were searched.

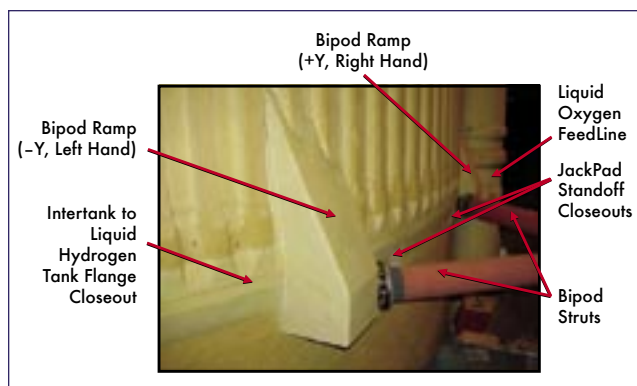
A large object from the left bipod area of the External Tank struck the Orbiter, apparently impacting the underside of the left wing near RCC panels 5 through 9. The object’s large size and the apparent momentum transfer concerned Intercenter Photo Working Group personnel, who were worried that *Columbia* had sustained damage not detectable in the limited number of views their tracking cameras captured. This concern led the Intercenter Photo Working Group Chair to request, in anticipation of analysts’ needs, that a high-resolution image of the Orbiter on-orbit be obtained by the Department of Defense. By the Board’s count, this would be the first of three distinct requests to image *Columbia* on-orbit. The exact chain of events and circumstances surrounding the movement of each of these requests through Shuttle Program Management, as well as the ultimate denial of these requests, is a topic of Chapter 6.

Figure 3.2-2. The exterior of the left bipod attachment area showing the foam ramp that came off during the ascent of STS-107.

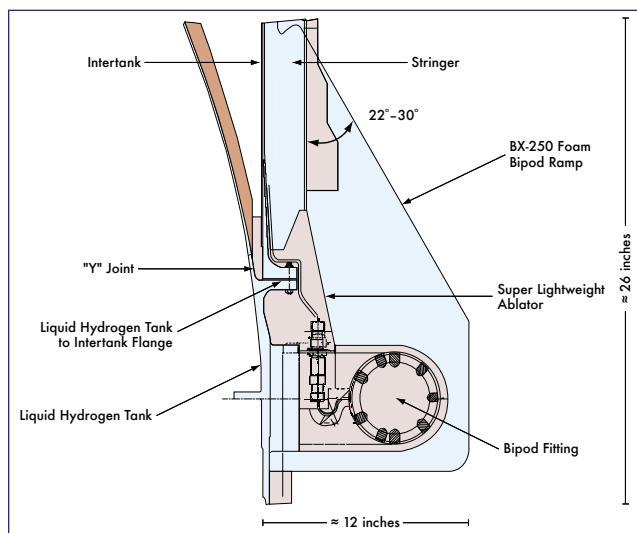
ternal Tank by two umbilical fittings at the bottom (that also contain fluid and electrical connections) and by a “bipod” at the top. The bipod is attached to the External Tank by fittings at the right and left of the External Tank centerline. The bipod fittings, which are titanium forgings bolted to the External Tank, are forward (above) of the intertank-liquid hydrogen flange joint (see Figures 3.2-2 and 3.2-3). Each forging contains a spindle that attaches to one end of a bipod strut and rotates to compensate for External Tank shrinkage during the loading of cryogenic propellants.

Figure 3.2-3. Cutaway drawing of the bipod ramp and its associated fittings and hardware.

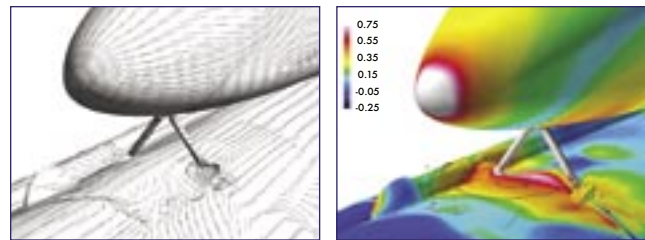
Significant analytical advancements have been made since the External Tank was first conceived, particularly in computational fluid dynamics (see Figure 3.2-5). Computational fluid dynamics comprises a computer-generated model that represents a system or device and uses fluid-flow physics and software to create predictions of flow behavior, and stress or deformation of solid structures. However, analysis must always be verified by test and/or flight data. The External Tank and the bipod ramp were not tested in the complex flight environment, nor were fully instrumented External Tanks ever launched to gather data for verifying analytical tools. The accuracy of the analytical tools used to simulate the External Tank and bipod ramp were verified only by using flight and test data from other Space Shuttle regions.

Figure 3.2-5. Computational Fluid Dynamics was used to understand the complex flow fields and pressure coefficients around bipod strut. The flight conditions shown here approximate those present when the left bipod foam ramp was lost from External Tank 93 at Mach 2.46 at a 2.08-degree angle of attack.

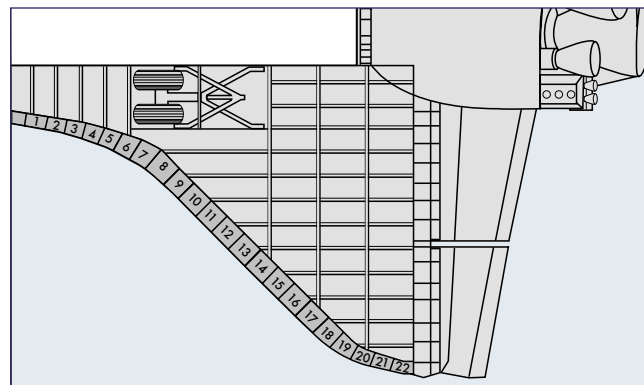
Each wing leading edge consists of 22 RCC panels (see Figure 3.3-1), numbered from 1 to 22 moving outward on each wing (the nomenclature is "5-left" or "5-right" to differentiate, for example, the two number 5 panels). Because the shape of the wing changes from inboard to outboard, each panel is unique.

Figure 3.3-1. There are 22 panels of Reinforced Carbon-Carbon on each wing, numbered as shown above.

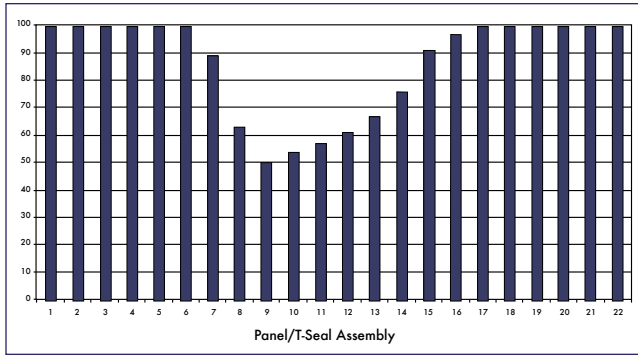
For the first five missions of *Columbia*, the RCC components were not coated with Type A sealant, and had shorter mission service lives than the RCC components on the other Orbiters. (*Columbia*'s panel 9 has the shortest mission service life of 50 flights as shown in Figure 3.3-4.) The predicted life for panel/T-seals 7 through 16 range from 54 to 97 flights.⁷

Figure 3.3-4. The expected mission life for each of the wing leading edge RCC panels on Columbia. Note that panel 9 has the shortest life expectancy.

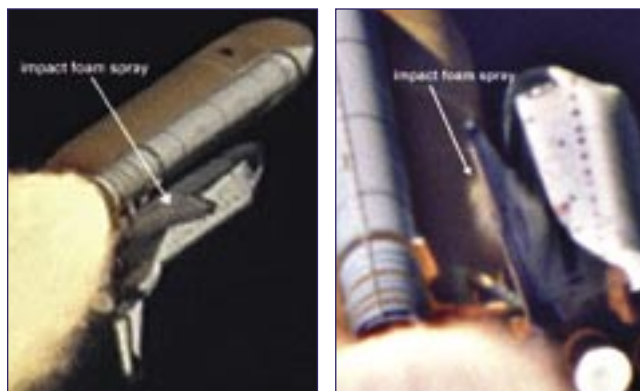
Figure 3.4-1 (color enhanced and "de-blurred" by Lockheed Martin Gaithersburg) and Figure 3.4-2 (processed by the National Imagery and Mapping Agency) are samples of the type of visual data used to establish the time of the impact (81.9 seconds), the altitude at which it occurred (65,860 feet), and the object's relative velocity at impact (about 545 mph relative to the Orbiter).

A 35-mm film camera, E212, which recorded the foam strike from 17 miles away, and video camera E208, which recorded it from 26 miles away, provided the best of the available evidence. Analysis of this visual evidence (see Figures 3.4-1 and 3.4-2) along with computer-aided design analysis, refined the potential impact area to less than 20 square feet in RCC panels 6 through 9 (see Figure 3.4-3), including a portion of the corresponding carrier panels and adjacent tiles. The investigation image analysis team found no conclusive visual evidence of post-impact debris flowing over the top of the wing.

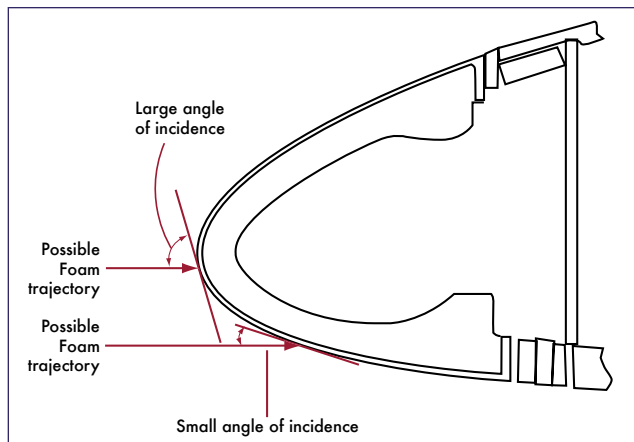
Image analysis determined that the foam was moving almost parallel to the Orbiter's fuselage at impact, with about a five-degree angle upward toward the bottom of the wing and slight motion in the outboard direction. If the foam had hit the tiles adjacent to the leading edge, the angle of incidence would have been about five degrees (the angle of incidence is the angle between the relative velocity of the projectile and the plane of the impacted surface). Because the wing leading edge curves, the angle of incidence increases as the point of impact approaches the apex of an RCC panel. Image and transport analyses estimated that for impact on RCC panel 8, the angle of incidence was between 10 and 20 degrees (see Figure 3.4-4).⁹ Because the total force delivered by the impact depends on the angle of incidence, a foam strike near the apex of an RCC panel could have delivered about twice the force as an impact close to the base of the panel.

Figure 3.4-4. This drawing shows the curve of the wing leading edge and illustrates the difference the angle of incidence has on the effect of the foam strike.

The precise impact location of the foam determined the impact angle because the debris was moving almost parallel to the Orbiter's fuselage at impact. Tile areas would have been hit at very small angles (approximately five degrees), but the curvature of the leading edge created angles closer to 20 degrees (see Figure 3.4-4).

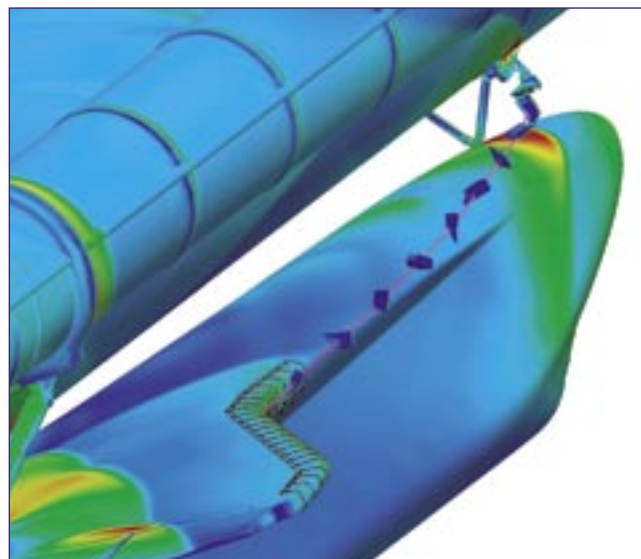
Figure 3.4-6. These are the results of a trajectory analysis that used a computational fluid dynamics approach in a program called CART-3D, a comprehensive (six-degree-of-freedom) computer simulation based on the laws of physics. This analysis used the aerodynamic and mass properties of bipod ramp foam, coupled with the complex flow field during ascent, to determine the likely position and velocity histories of the foam.

The undetermined and yet certainly irregular shape of the foam introduced substantial uncertainty about its estimated aerodynamic characteristics. Appendix D.8 contains an independent analysis conducted by the Board to confirm that the estimated range of ballistic coefficients of the foam in Figure 3.4-6 was credible, given the foam dimension results from the image analyses and the expected range of the foam density. Based on the results in Figure 3.4-7, the physical dimensions of the bipod ramp, and the sizes and shapes of the available barrels for the compressed-gas gun used in the impact test program described later in this chapter, the Board and the NASA Accident Investigation Team decided that a foam projectile 19 inches by 11.5 inches by 5.5 inches, weighing 1.67 pounds, and with a weight density of 2.4 pounds per cubic foot, would best represent the piece of foam that separated from the External Tank bipod ramp and was hit by the Orbiter’s left wing. See Section 3.8 for a full discussion of the foam impact testing.

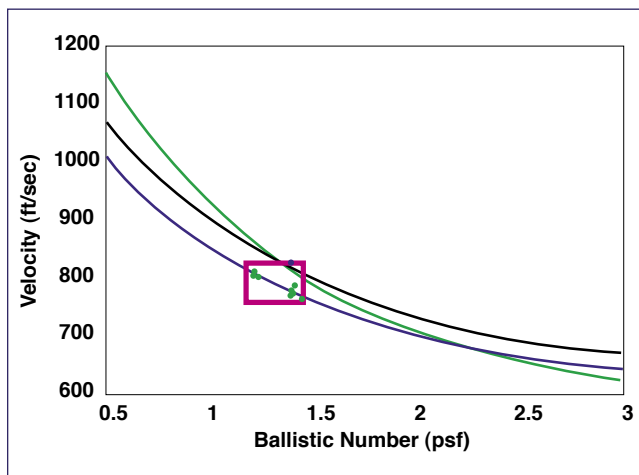
Figure 3.4-7. The results of numerous possible trajectories based on various assumed sizes, shapes, and densities of the foam. Either the foam had a slightly higher ballistic coefficient and the Orbiter struck the foam at a lower speed relative to the Orbiter, or the foam was more compact and the wing struck the foam at a higher speed. The “best fit” box represents the overlay of the data from the image analysis with the transport analysis computations. This data enabled a final selection of projectile characteristics for impact testing.

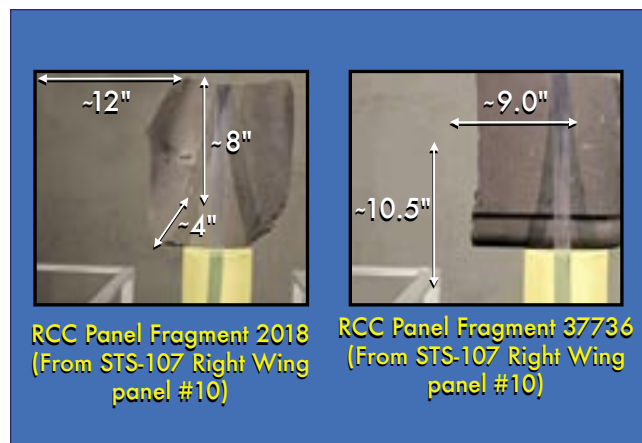
Figure 3.5-1. These representative RCC acreage pieces matched the radar cross-section of the Flight Day 2 object.

In the Advanced Compact Range at the Air Force Research Laboratory in Dayton, Ohio, analysts tested 31 materials from the Orbiter's exterior and payload bay. Additional supercomputer radar cross-section predictions were made for Reinforced Carbon-Carbon T-seals. After exhaustive radar cross-section analysis and testing, coupled with ballistic analysis of the object's orbital decay, only a fragment of RCC panel would match the UHF radar cross-section and ballistic coefficients observed by the Space Surveillance network. Such an RCC panel fragment must be approximately 140 square inches or greater in area to meet the observed radar cross-section characteristics. Figure 3.5-1 shows RCC panel fragments from *Columbia*'s right wing that represent those meeting the observed characteristics of object 2003-003B.¹⁰

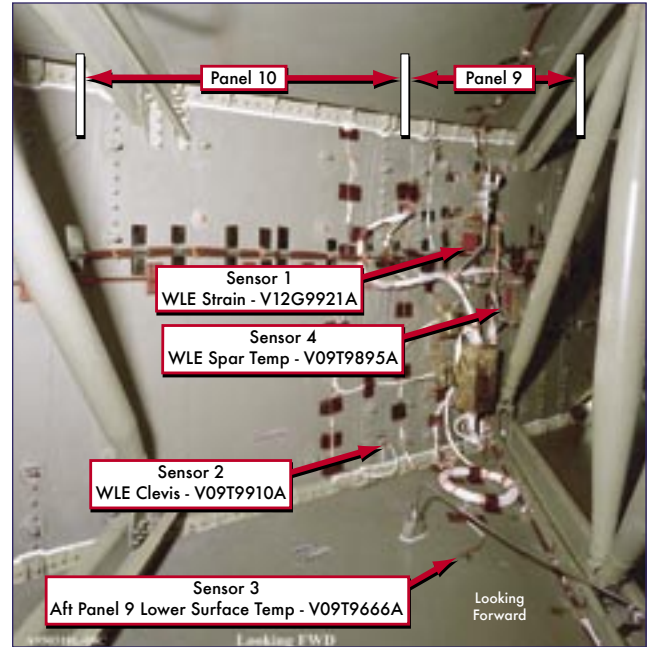
Figure 3.6-2. Location of sensors on the back of the left wing leading edge spar (vertical aluminum structure in picture). Also shown are the round truss tubes and ribs that provided the structural support for the mid-wing in this area.

or outside the wing leading edge spar near Reinforced Carbon-Carbon (RCC) panel 9-left, helped tell the story of what happened on the left wing of the Orbiter early in the re-entry. These four sensors were: strain gauge V12G9921A (Sensor 1), resistance temperature detector V09T9910A on the RCC clevis between panel 9 and 10 (Sensor 2), thermocouple V07T9666A, within a Thermal Protection System tile (Sensor 3), and resistance temperature detector V09T9895A (Sensor 4), located on the back side of the wing leading edge spar behind RCC panels 8 and 9 (see Figure 3.6-2).

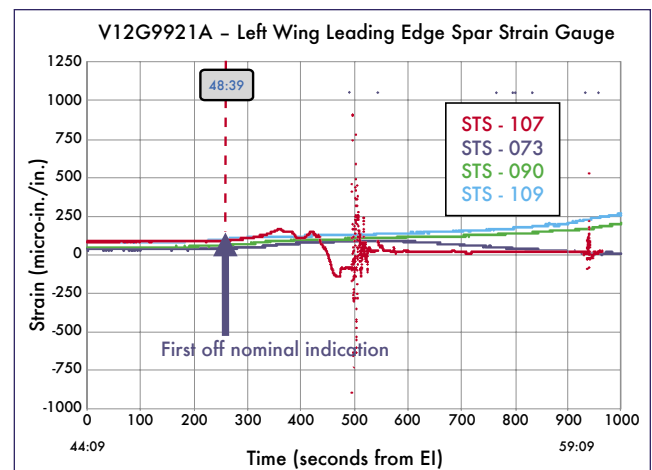
Figure 3.6-3. The strain gauge (Sensor 1) on the back of the left wing leading edge spar was the first sensor to show an anomalous reading. In this chart, and the others that follow, the red line indicates data from STS-107. Data from other Columbia re-entries, similar to the STS-107 re-entry profile, are shown in the other colors.

Sensor 1 provided the first anomalous reading (see Figure 3.6-3). From EI+270 to EI+360, the strain is higher than that on previous *Columbia* flights. At EI+450, the strain reverses, and then peaks again in a negative direction at EI+475. The strain then drops slightly, and remains constant and negative until EI+495, when the sensor pattern becomes unreliable, probably due to a propagating soft short, or “burn-through” of the insulation between cable conductors caused by heating or combustion. This strain likely indicates significant damage to the aluminum honeycomb spar. In particular, strain reversals, which are unusual, likely mean there was significant high-temperature damage to the spar during this time.

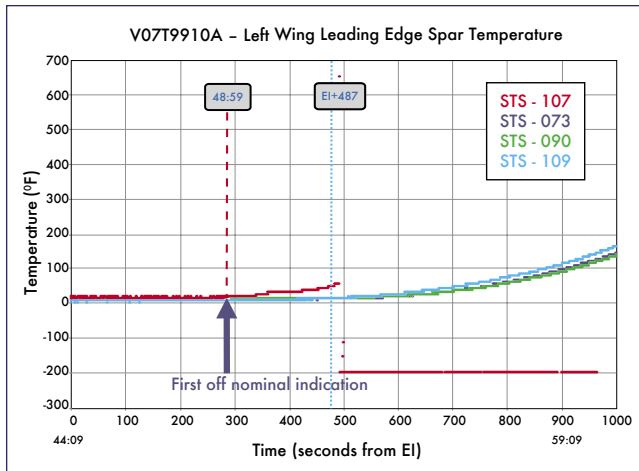
Figure 3.6-4. This temperature thermocouple (Sensor 2) was mounted on the outside of the wing leading edge spar behind the insulation that protects the spar from radiated heat from the RCC panels. It clearly showed an off-nominal trend early in the re-entry sequence and began to show an increase in temperature much earlier than the temperature sensor behind the spar.

left wing leading edge spar, recorded the beginning of a gradual and abnormal rise in temperature from an expected 30 degrees Fahrenheit to 65 degrees at EI+493, when it then dropped to “off-scale low,” a reading that drops off the scale at the low end of the sensor’s range (see Figure 3.6-4). Sensor 2, one of the first to fail, did so abruptly. It had indicated only a mild warming of the RCC attachment clevis before the signal was lost.

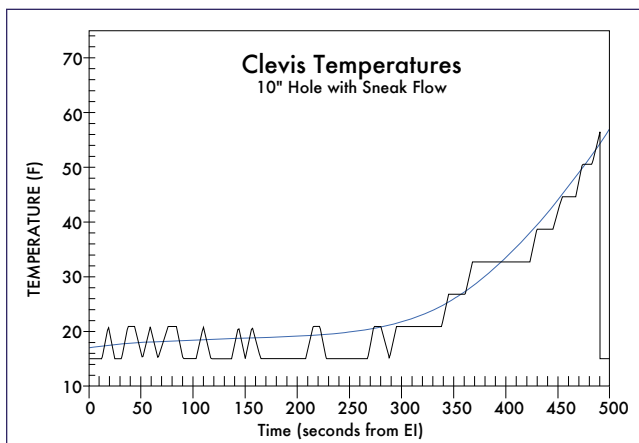
Figure 3.6-5. The analysis of the effect of a 10-inch hole in RCC panel 8 on Sensor 2 from EI to EI+500 seconds. The jagged line shows the actual flight data readings and the smooth line the calculated result for a 10-inch hole with some sneak flow of superheated air behind the spar insulation.

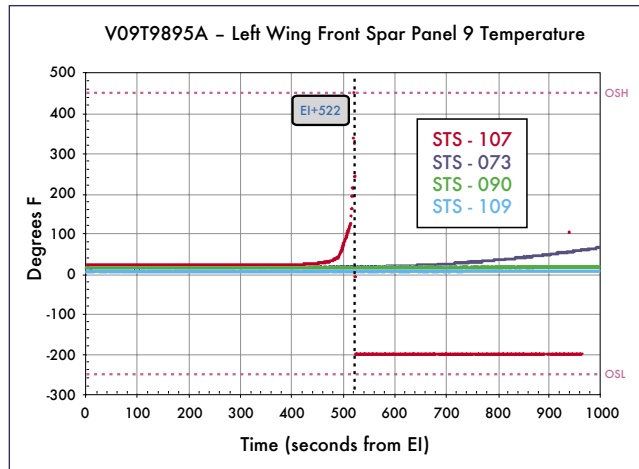
Figure 3.6-7. Sensor 4 also began reading significantly higher than previous flights before it fell off-scale low. The relatively late reaction of this sensor compared to Sensor 2, clearly indicated that superheated air started on the outside of the wing leading edge spar and then moved into the mid-wing after the spar was burned through. Note that immediately before the sensor (or the wire) fails, the temperature is at 450 degrees Fahrenheit and climbing rapidly. It was the only temperature sensor that showed this pattern.

Finally, the rapid rise in Sensor 4 at EI+425, before the other sensors began to fail, indicates that high temperatures were responsible. Comparisons of sensors on the outside of the wing leading edge spar, those inside of the spar, and those in the wing and left wheel well indicate that abnormal heating first began on the outside of the spar behind the RCC panels and worked through the spar. Since the aluminum spar must have burned through before any cable harnesses attached to it failed, the breach through the wing leading edge spar must have occurred at or before EI+487.

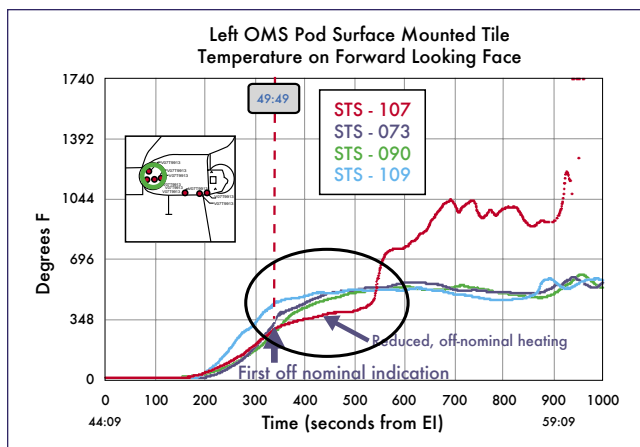
Figure 3.6-9. Orbital Maneuvering System (OMS) pod heating was initially significantly lower than that seen on previous Columbia missions. As wing leading edge damage later increased, the OMS pod heating increased dramatically. Debris recovered from this area of the OMS pod showed substantial pre-breakup heat damage and imbedded drops of once-molten metal from the wing leading edge in the OMS pod thermal tiles.

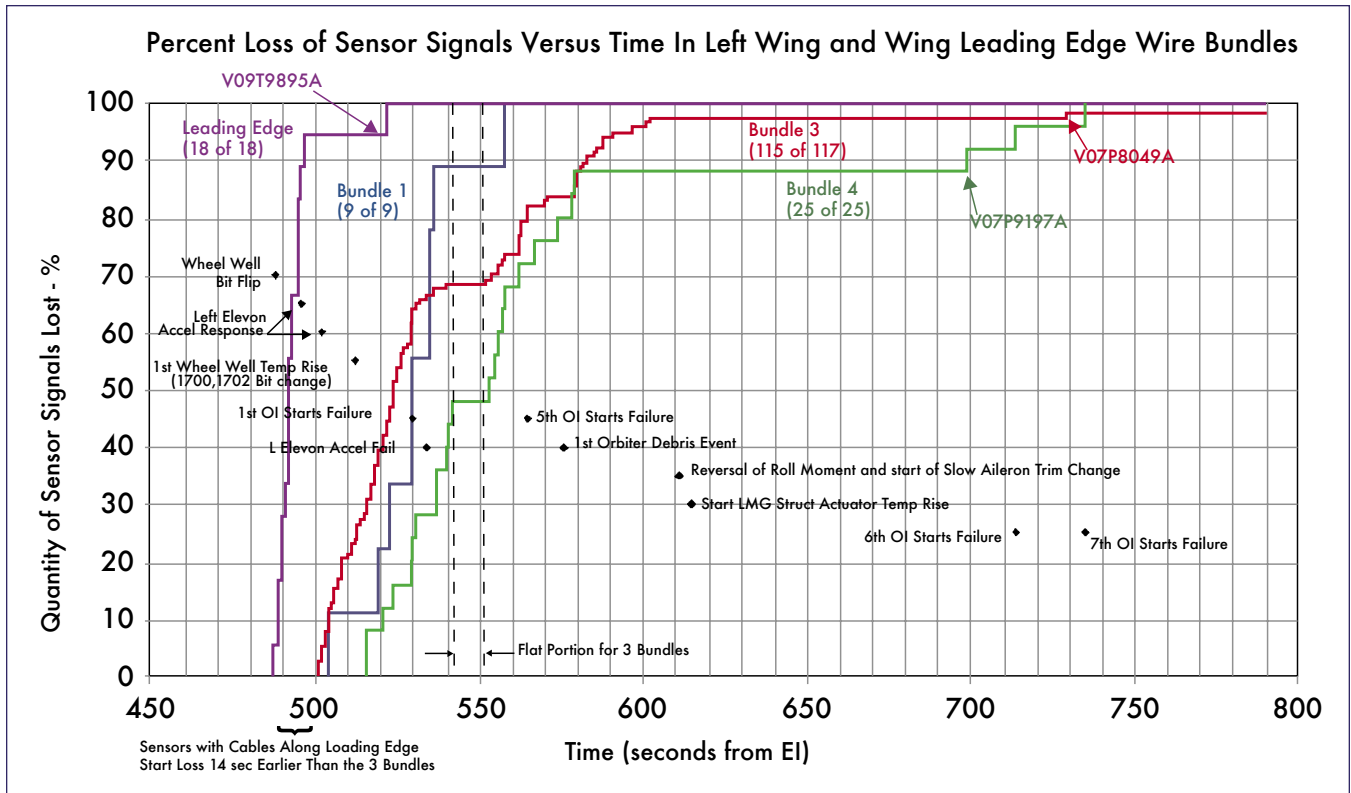
Fourteen seconds after the loss of the first sensor wire on the wing leading edge spar at EI+487, a sensor wire in a bundle of some 150 wires that ran along the upper outside corner of the left wheel well showed a burn-through. In the next 50 seconds, more than 70 percent of the sensor wires in three cables in this area also burned through (see Figure 3.6-10). Investigators plotted the wiring run for every left-wing sensor, looking for a relationship between their location and time of failure.

Only two sensor wires of 169 remained intact when the Modular Auxiliary Data System recorder stopped, indicat-

Figure 3.6-10. This chart shows how rapidly the wire bundles in the left wing were destroyed. Over 70 percent of the sensor wires in the wiring bundles burned through in under a minute. The black diamonds show the times of significant timeline sensor events.

ing that the burn-throughs had to occur in an area that nearly every wire ran through. To sustain this type of damage, the wires had to be close enough to the breach for the gas plume to hit them. Arc jet testing (in a wind tunnel with an electrical arc that provides up to a 2,800-degree Fahrenheit airflow) on a simulated wing leading edge spar and simulated wire bundles showed how the leading edge spar would burn through in a few seconds. It also showed that wire bundles would burn through in a timeframe consistent with those seen in the Modular Auxiliary Data System information and the telemetered data.

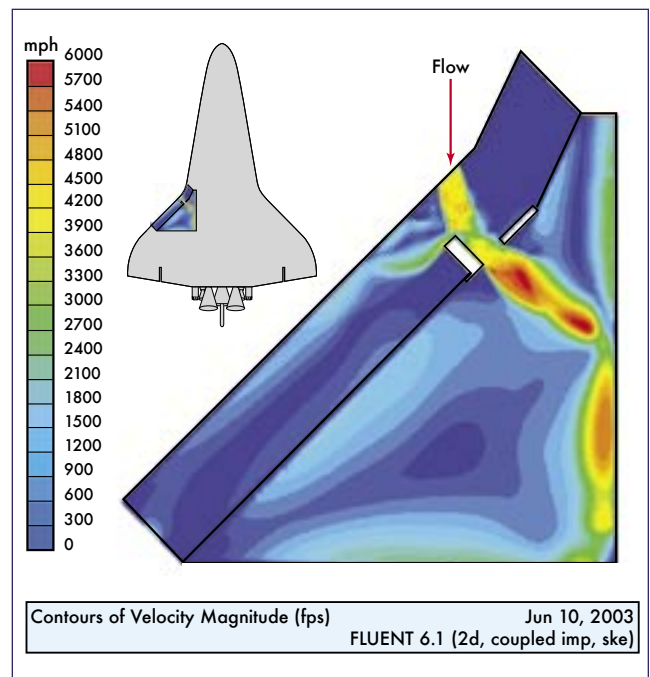
Later computational fluid dynamics analysis of the mid-wing area behind the spar showed that superheated air flowing into a breached RCC panel 8 and then interacting with the internal structure behind the RCC cavity (RCC ribs and spar insulation) would have continued through the wing leading edge spar as a jet, and would have easily allowed superheated air to traverse the 56.5 inches from the spar to the outside of the wheel well and destroy the cables (Figure 3.6-11). Controllers on the ground saw these first anomalies in the telemetry data at EI+613, when four hydraulic sensor cables that ran from the aft part of the left wing through the wiring bundles outside the wheel well failed.

Figure 3.6-11. The computational fluid dynamics analysis of the speed of the superheated air as it entered the breach in RCC panel 8 and then traveled through the wing leading edge spar. The darkest red color indicates speeds of over 4,000 miles per hour. Temperatures in this area likely exceeded 5,000 degrees Fahrenheit. The area of detail is looking down at the top of the left wing.

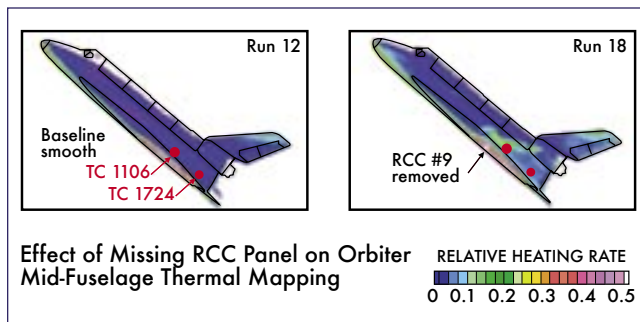
Figure 3.6-13. The effects of removing RCC panel 9 are shown in this figure. Note the brighter colors on the front of the OMS pod show increased heating, a phenomenon supported by both the OMS pod temperature sensors and the debris analysis.

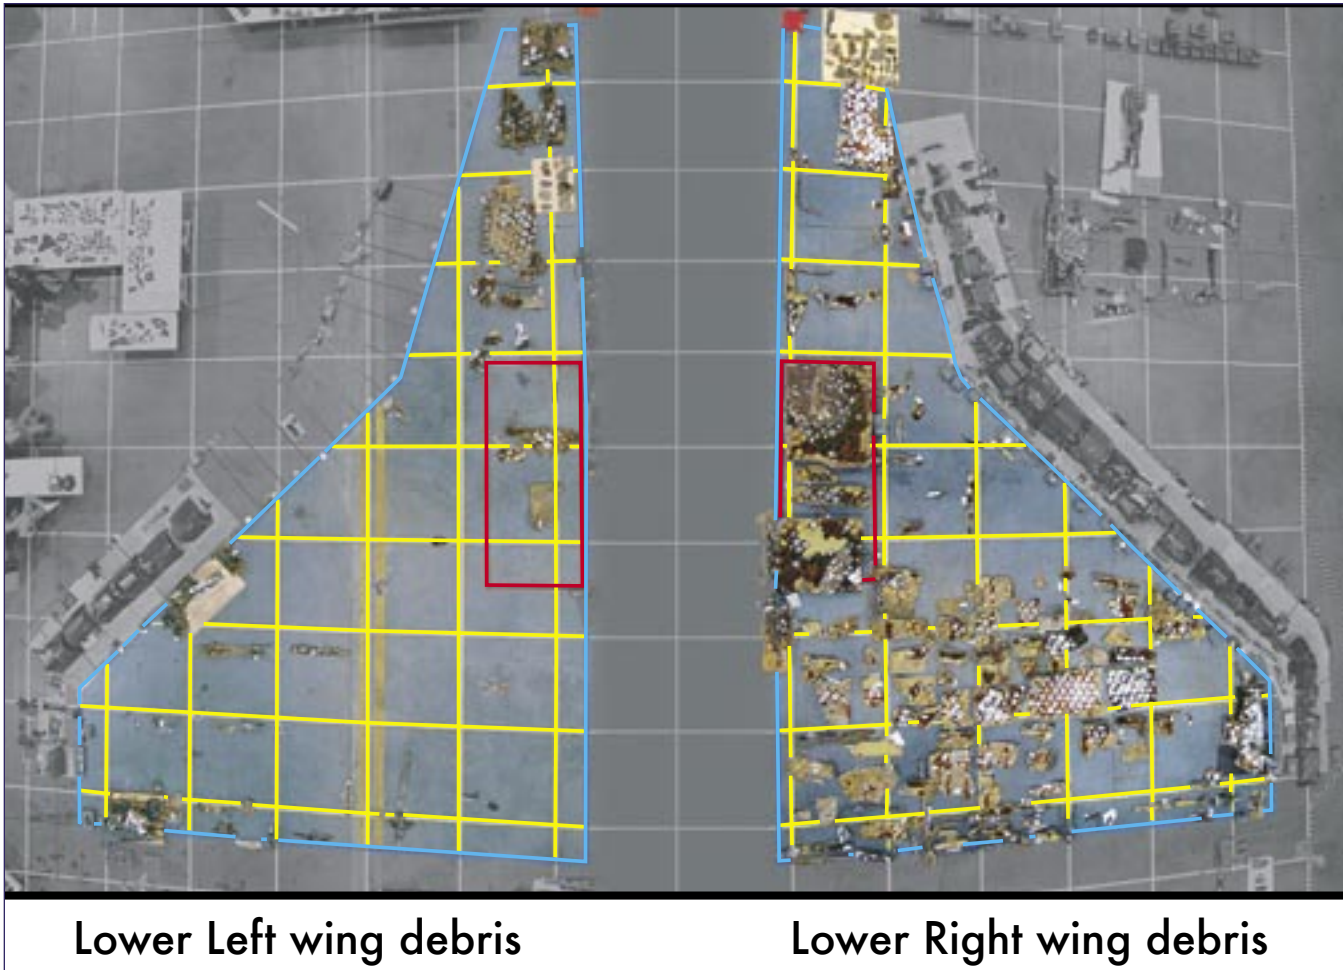
Figure 3.7-1. Comparison of amount of debris recovered from the left and right wings of Columbia. Note the amount of debris recovered from areas in front of the wheel well (the red boxes on each wing) were similar, but there were dramatic differences in the amount of debris recovered aft of each wheel well.

Detailed analysis of the debris revealed unique features and convincing evidence that the damage to the left wing differed significantly from damage to the right, and that significant differences existed in pieces from various areas of the left wing. While a substantial amount of upper and lower right wing structure was recovered, comparatively little of the upper and lower left wing structure was recovered (see Figure 3.7-1).

The difference in recovered debris from the Orbiter's wings clearly indicates that after the breakup, most of the left wing succumbed to both high heat and aerodynamic forces, while the right wing succumbed to aerodynamic forces only. Because the left wing was already compromised, it was the first area of the Orbiter to fail structurally. Pieces were exposed to higher heating for a longer period, resulting in more heat damage and ablation of left wing structural material. The left wing was also subjected to superheated air that penetrated directly into the mid-body of the wing for a substantial period. This pre-heating likely rendered those components unable to absorb much, if any, of the post-breakup heating. Those internal and external structures were likely vaporized during post-breakup re-entry. Finally, the left wing likely lost significant amounts of the Thermal Protection System prior to breakup due to the effect of internal wing heating on the Thermal Protection System bonding materials, and this further degraded the left wing's ability to resist the high heat of re-entry after it broke up.

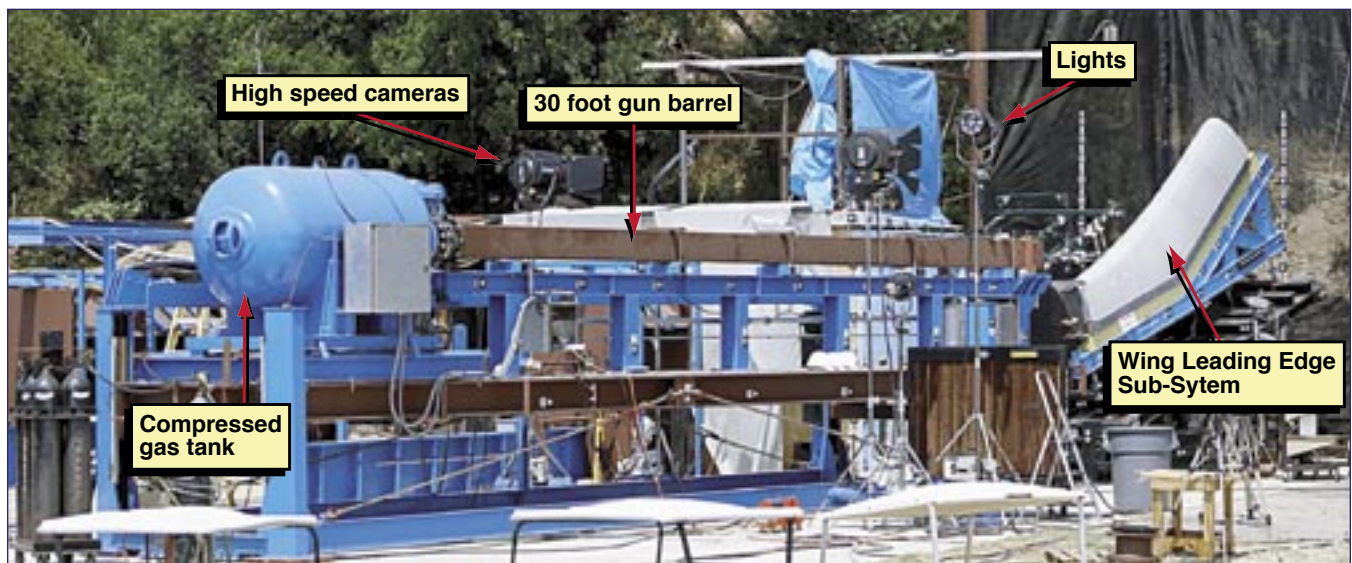
Figure 3.8-1. Nitrogen-powered gun at the Southwest Research Institute used for the test series.

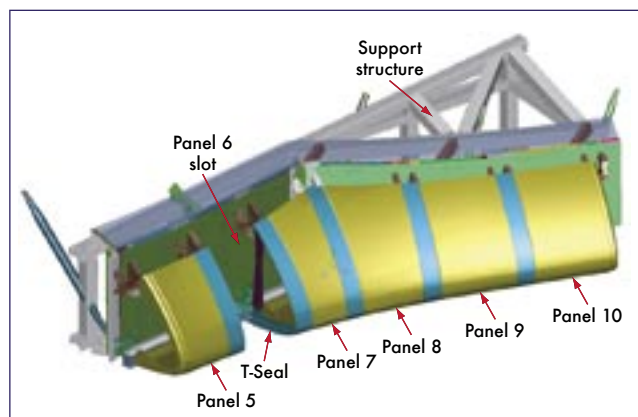
Figure 3.8-2. Test assembly that provided a structural mounting for RCC panel assemblies 5 to 10 and would accommodate some 200 sensors and other test equipment.

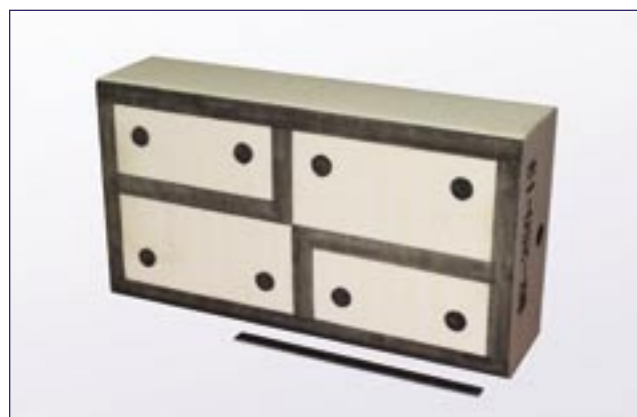
Figure 3.8-3. A typical foam projectile, which has marks for determining position and velocity as well as blackened outlines for indicating the impact footprint.

The testing required a projectile (see Figure 3.8-3) made from standard stock, so investigators selected a rectangular cross-section of 11.5 by 5.5 inches, which was within 15 percent of the footprint of the mean debris size initially estimated by image analysis. To account for the foam's density, the projectile length was cut to weigh 1.67 pounds, a figure determined by image and transport analysis to best represent the STS-107 projectile. For foam with a density of 2.4 pounds per cubic foot,¹⁵ the projectile dimensions were 19 inches by 11.5 inches by 5.5 inches.

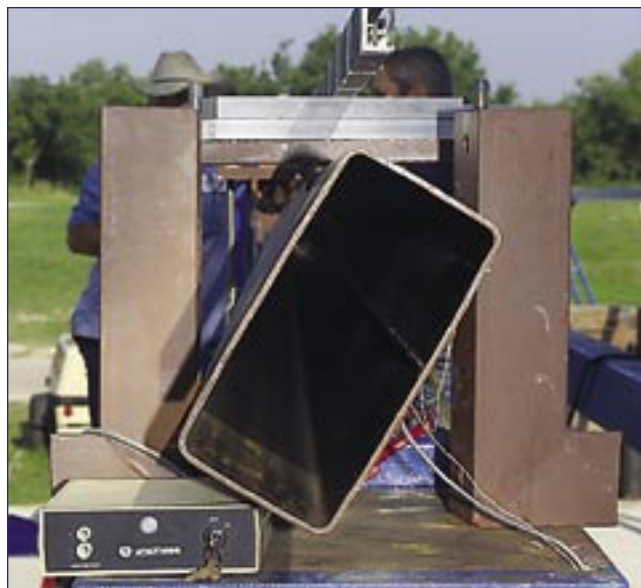
The "clocking angle" was an additional consideration. As shown in Figure 3.8-4, the gun barrel could be rotated to change the impact point of the foam projectile on the leading edge. Investigators conducted experiments to determine if the corner of the foam block or the full edge would impart a

Figure 3.8-4. The barrel on the nitrogen gun could be rotated to adjust the impact point of the foam projectile.

greater force. During the fiberglass tests, it was found that a clocking angle of 30 degrees allowed the 11.5-inch-edge to fully contact the panel at impact, resulting in a greater local force than a zero degree angle, which was achieved with the barrel aligned vertically. A zero-degree angle was used for the test on RCC panel 6, and a 30-degree angle was used for RCC panel 8.

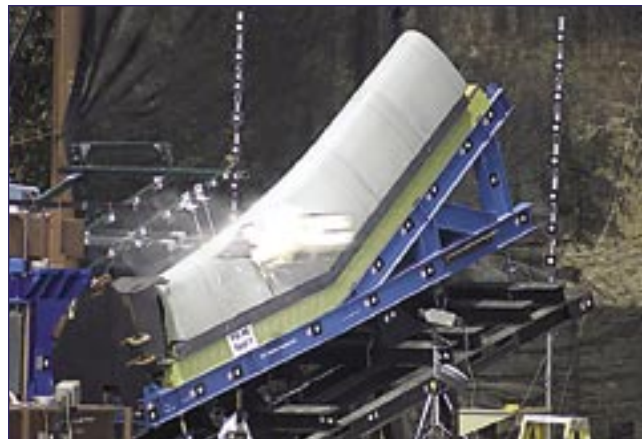
Five engineering tests on fiberglass panels (see Figure 3.8-5) established the test parameters of the impact tests on RCC panels. Details of the fiberglass tests are in Appendix D.12.

Figure 3.8-5. A typical foam strike leaves impact streaks, and the foam projectile breaks into shards and larger pieces. Here the foam is striking Panel 6 on a fiberglass test article.

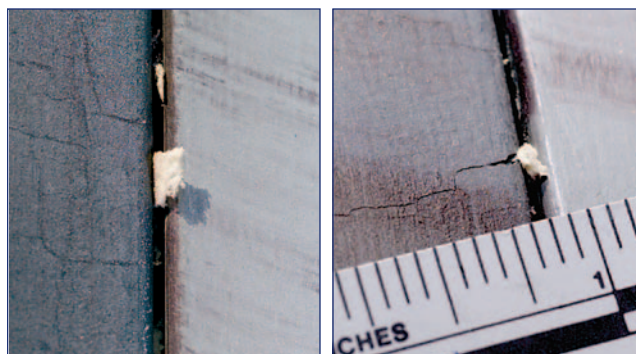
Figure 3.8-8. Two views of foam lodged into the slit during tests.

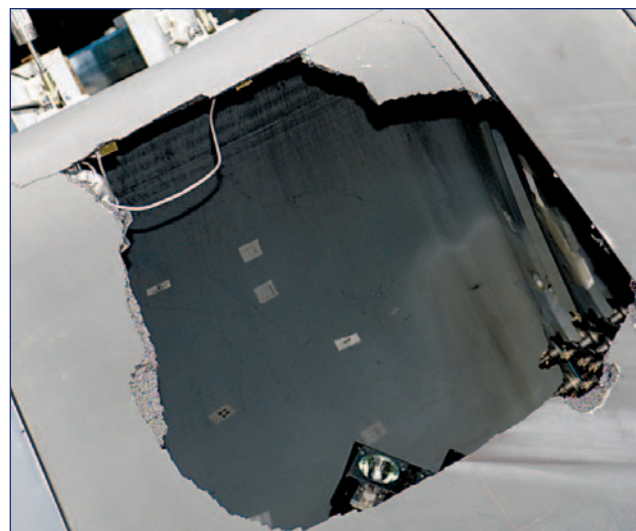
The second impact test of RCC material used panel 8 from *Atlantis*, which had flown 26 missions. Based on forensic evidence, sensor data, and aerothermal studies, panel 8 was considered the most likely point of the foam debris impact on *Columbia*.

Figure 3.8-9. The large impact hole in Panel 8 from the final test.

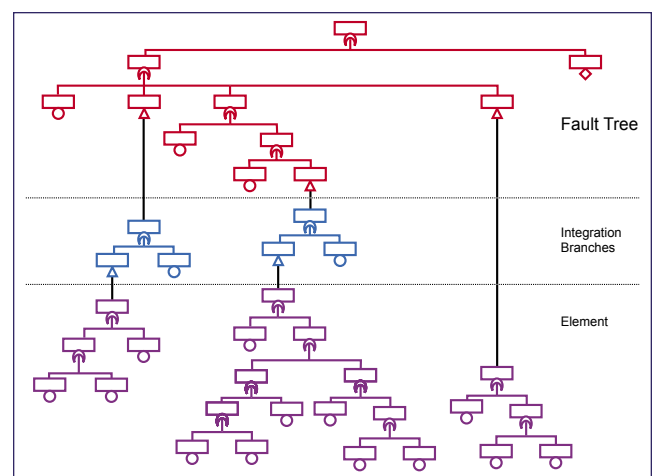
Figure 4.1-1. Accident investigation fault tree structure.
