Type A Accident Investigation Report

THE JULY 27, 2007
TANK 241-S-102 WASTE SPILL
AT
THE HANFORD TANK FARMS

Volume 2

September 2007

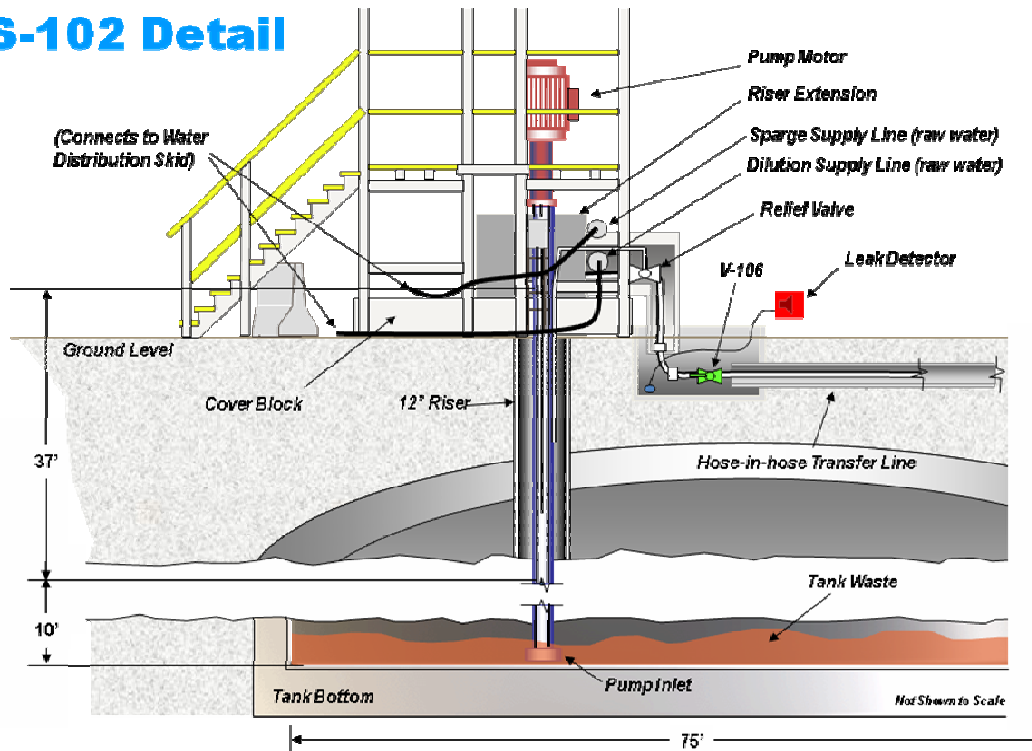
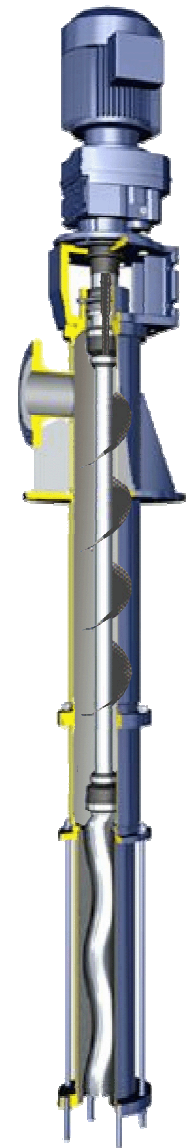
S-102 Detail

The waste in Tank S-102 is a phosphate-laden sludge with a dense gummy consistency that must be mobilized and suspended as slurry in order to be pumped out of the tank. The waste removal pump is mounted on top of Tank S-102 and extends into the tank through a 12-inch riser down to near, or at, the bottom of Tank S-102, as shown in the figure below. The pump is a reversible, positive displacement, progressive cavity type pump that is driven by a reversible, variable speed, 480-VAC motor located above the tank riser extension on a platform.

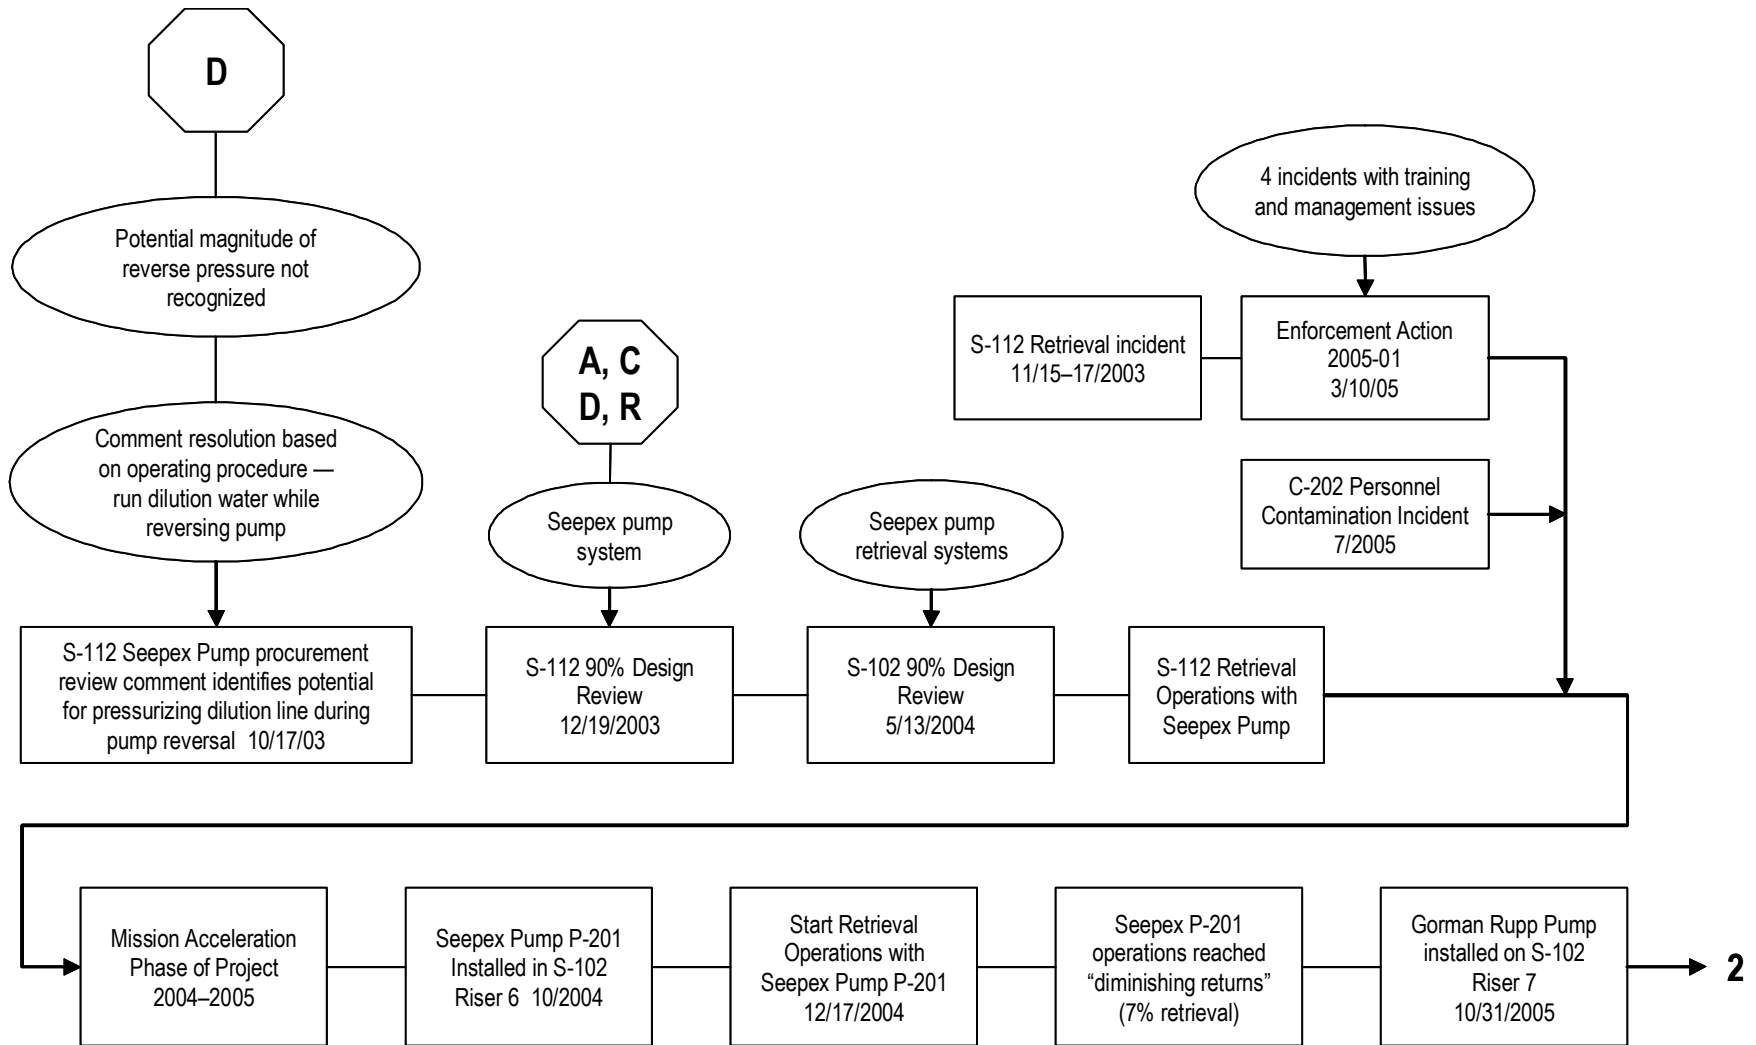
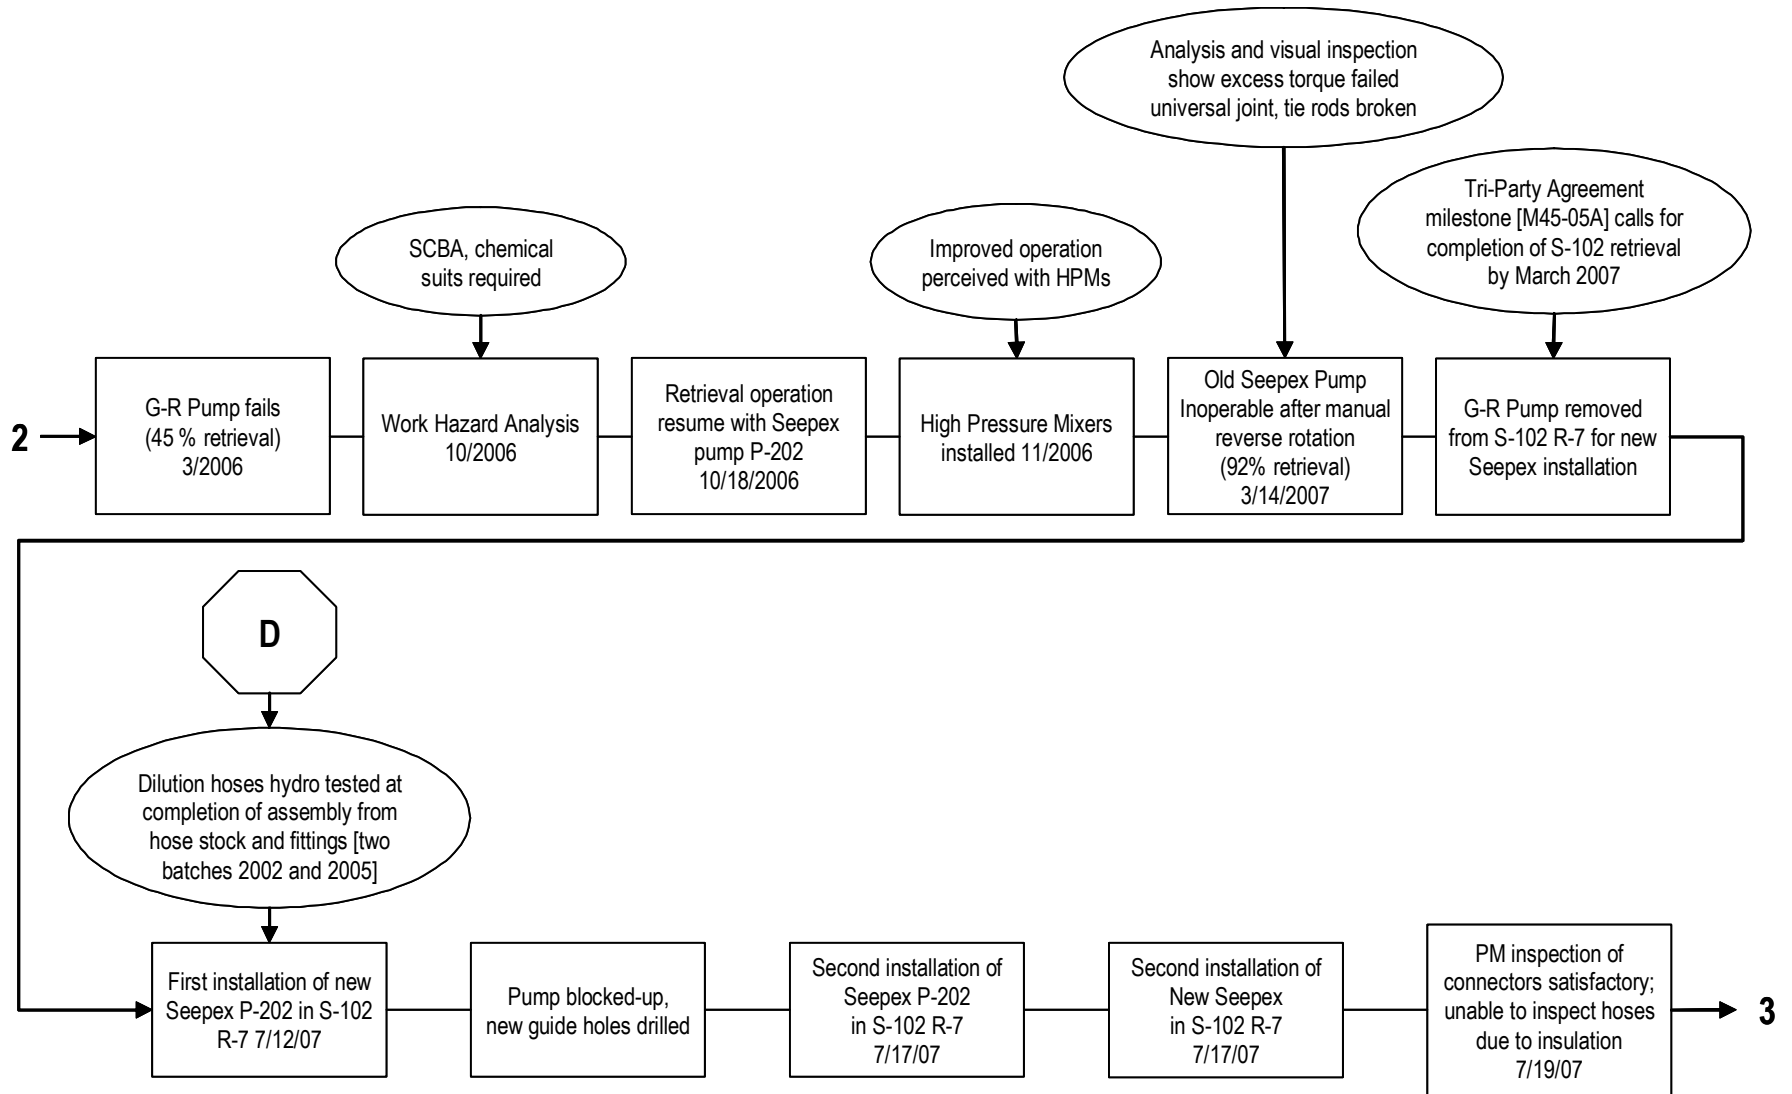
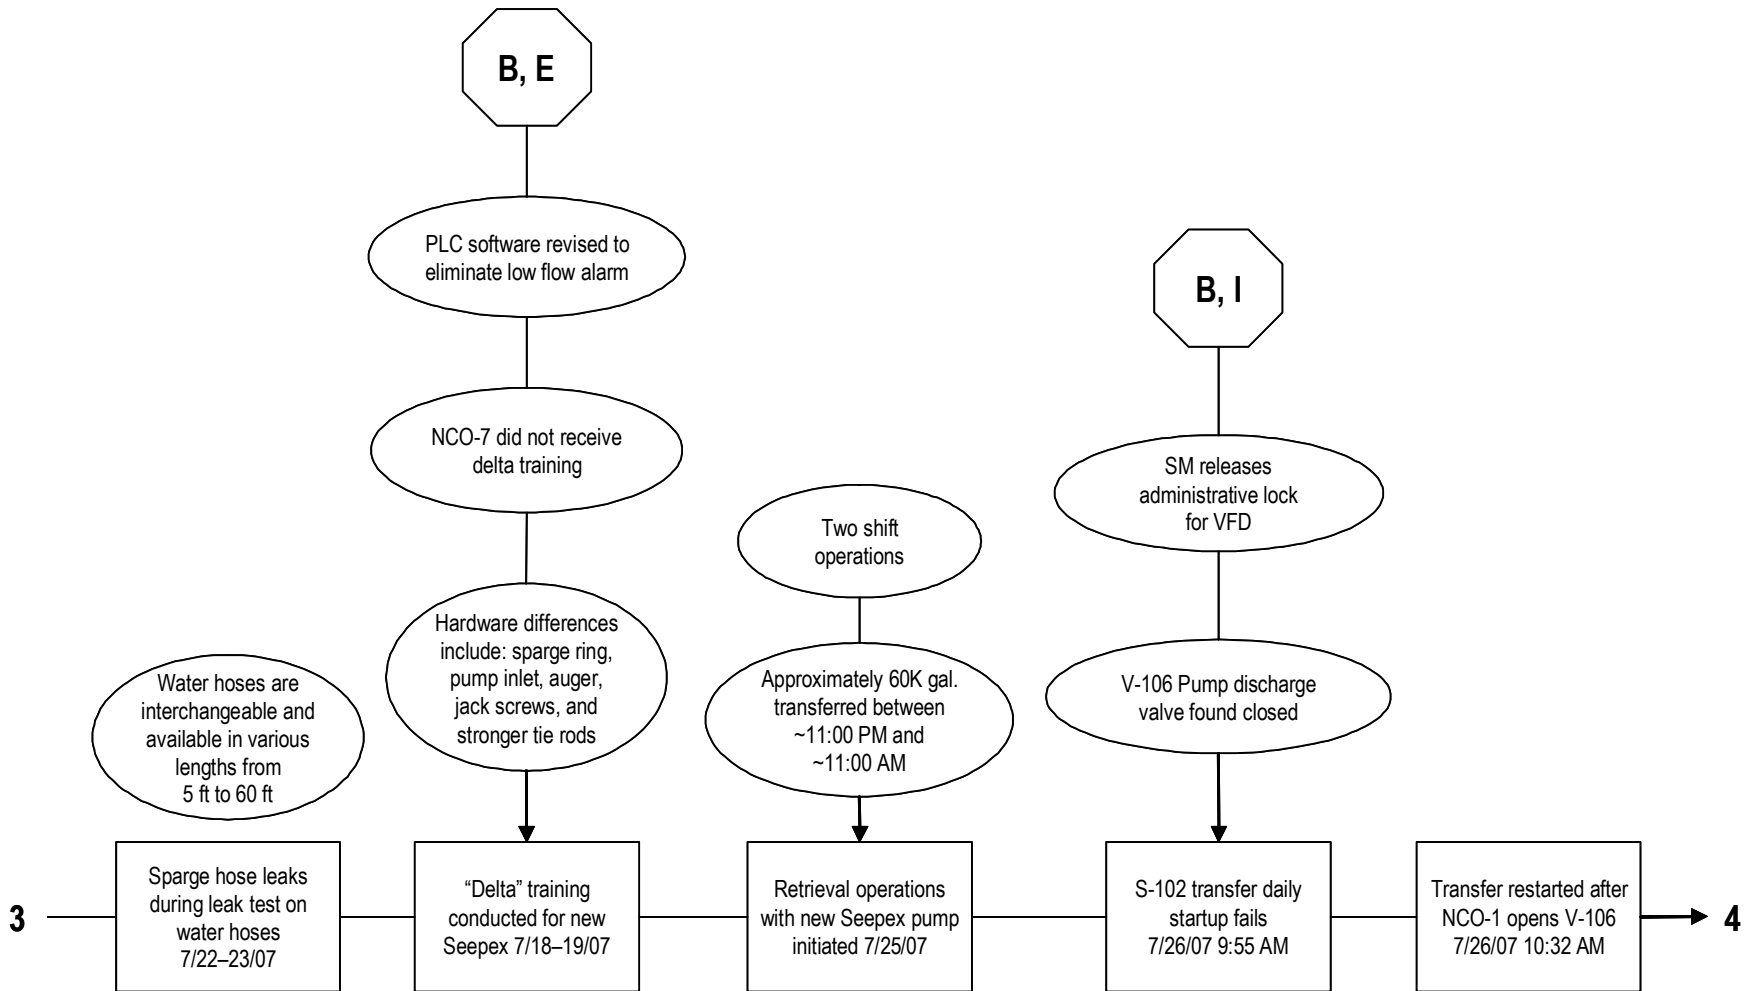
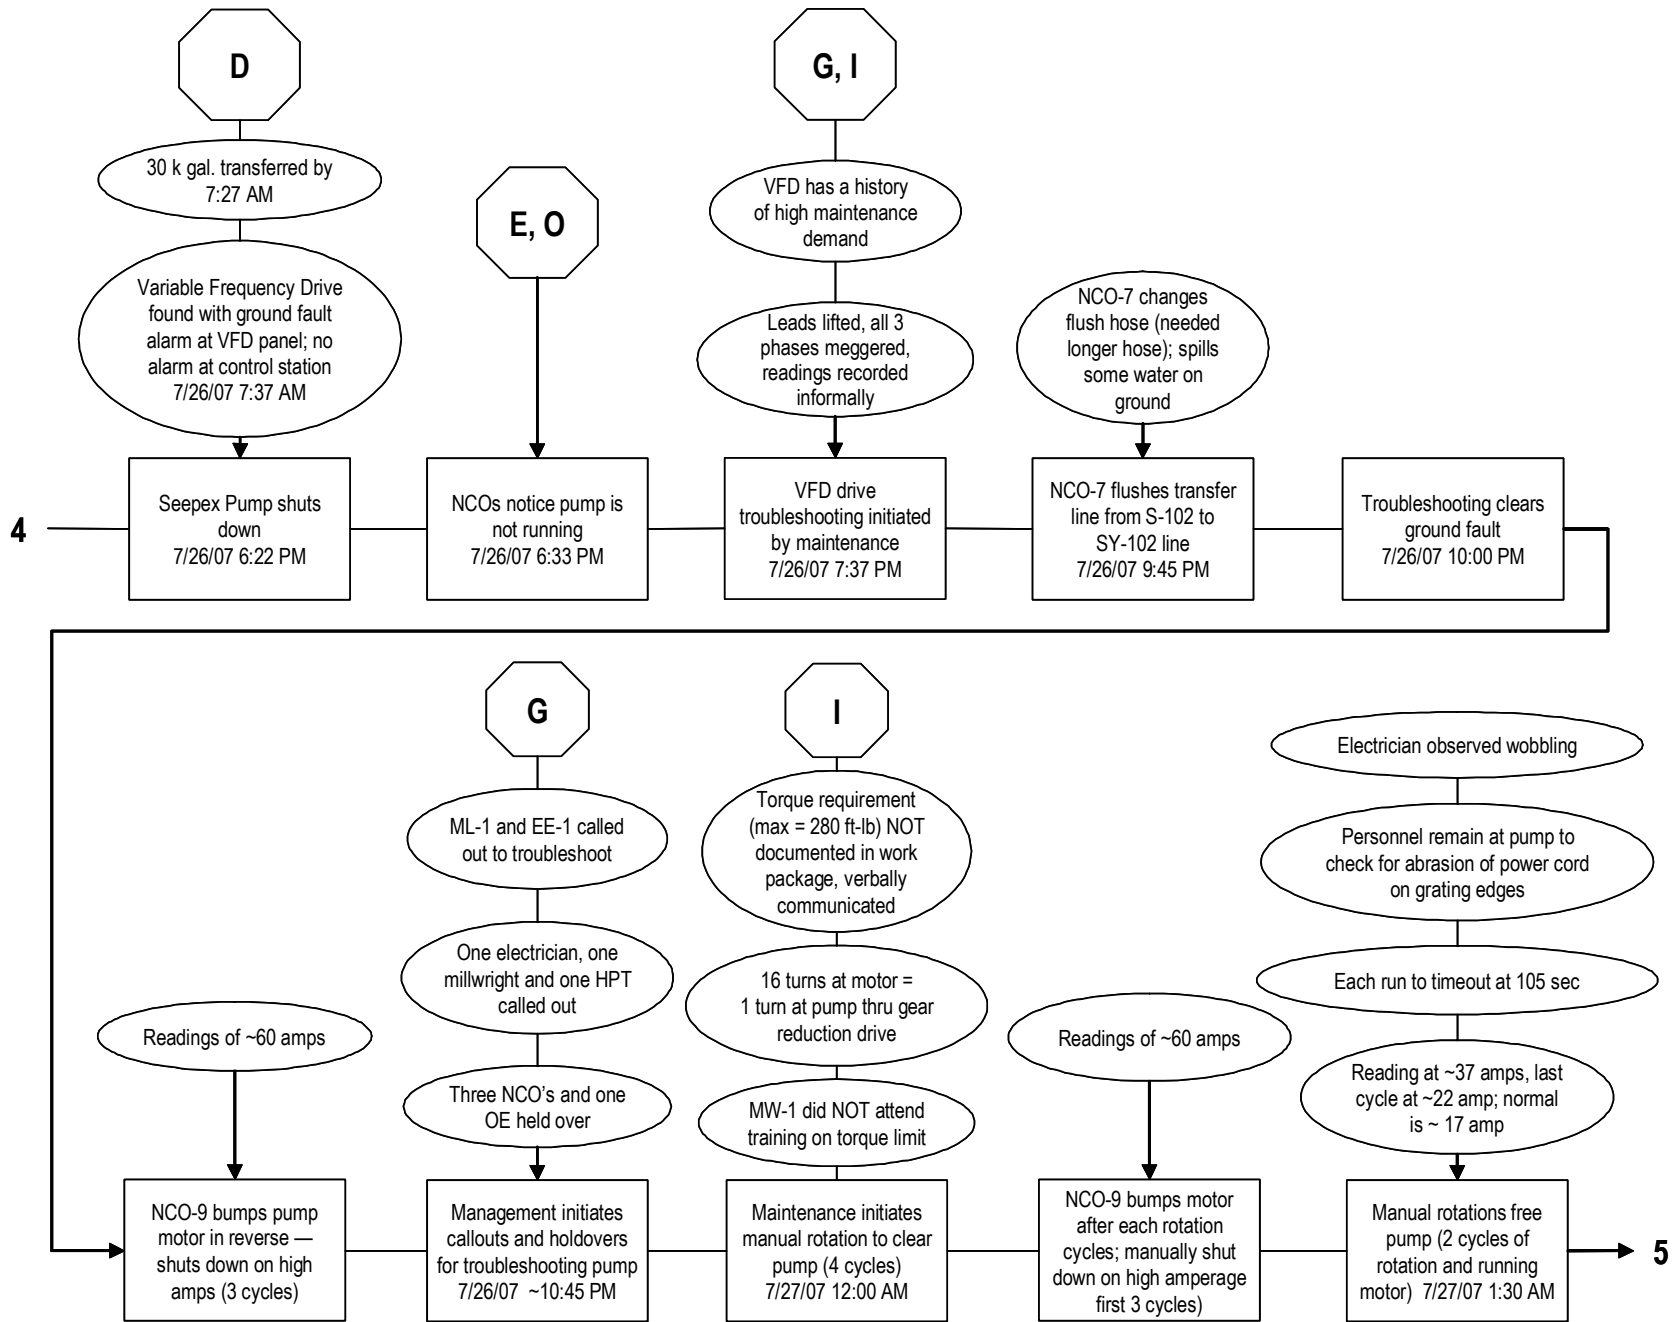
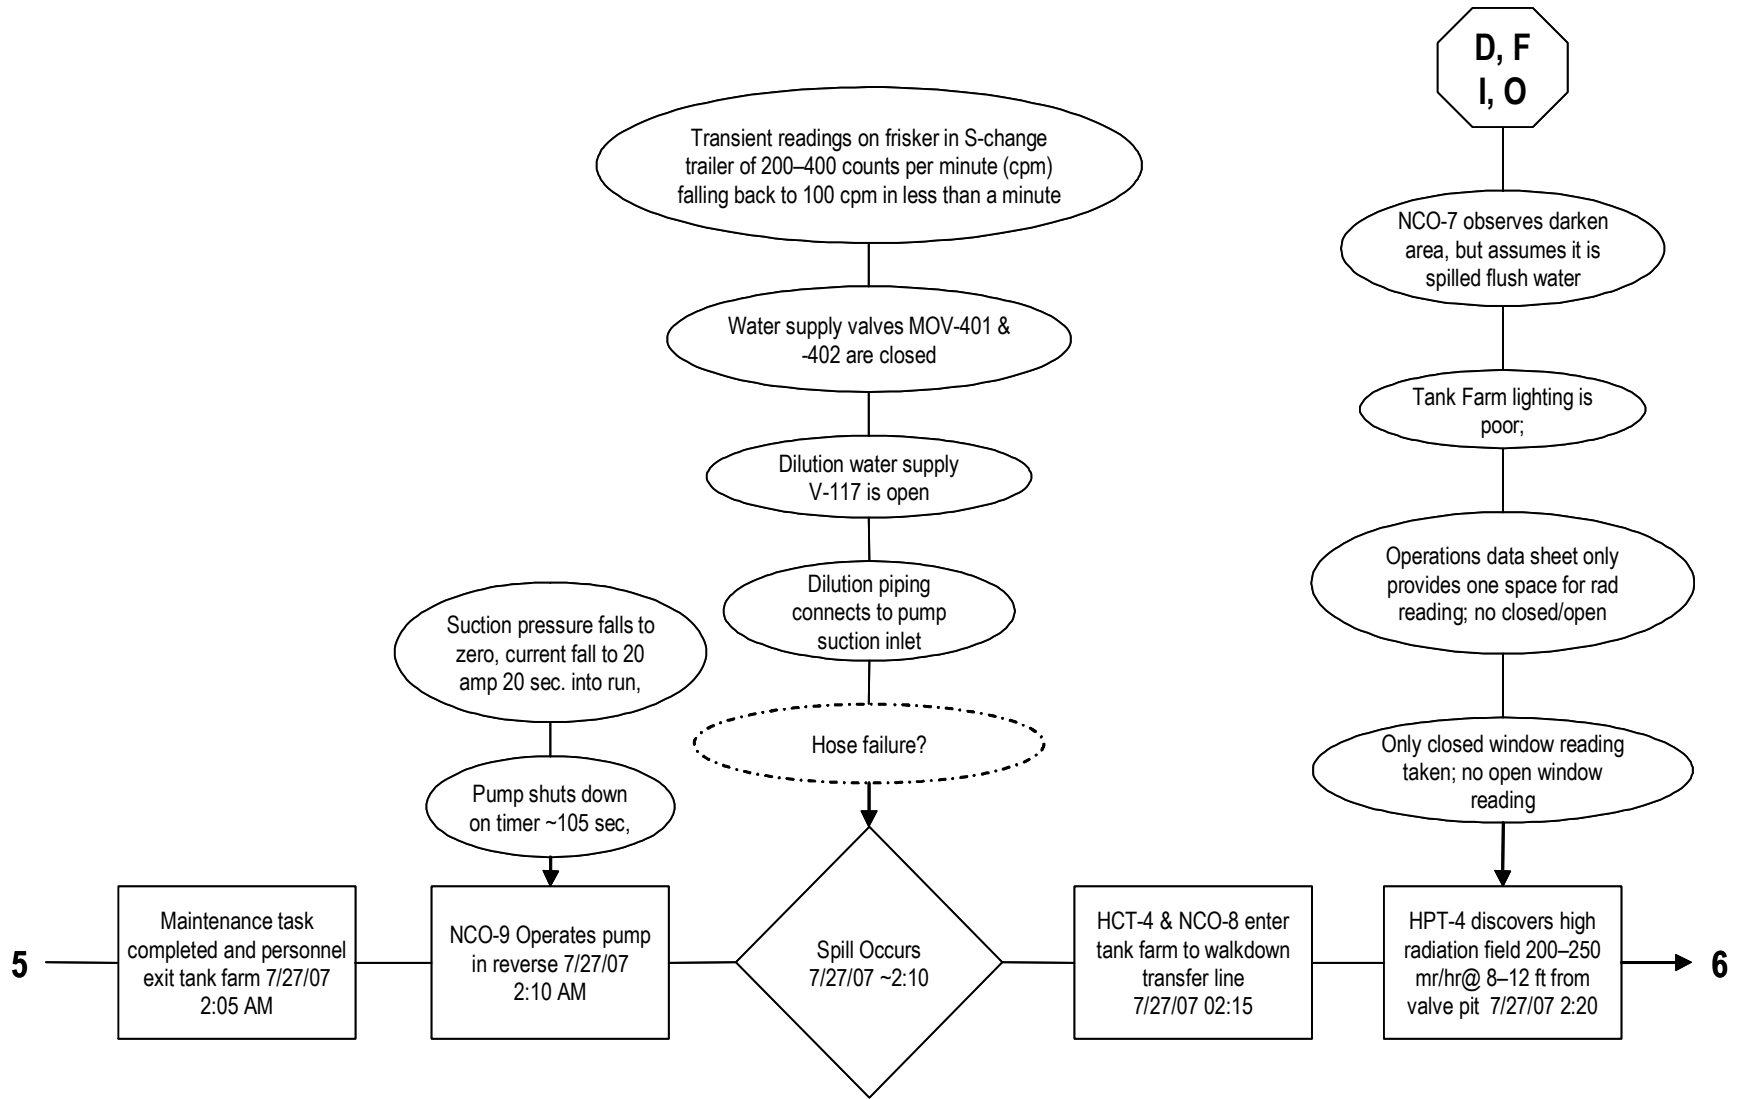
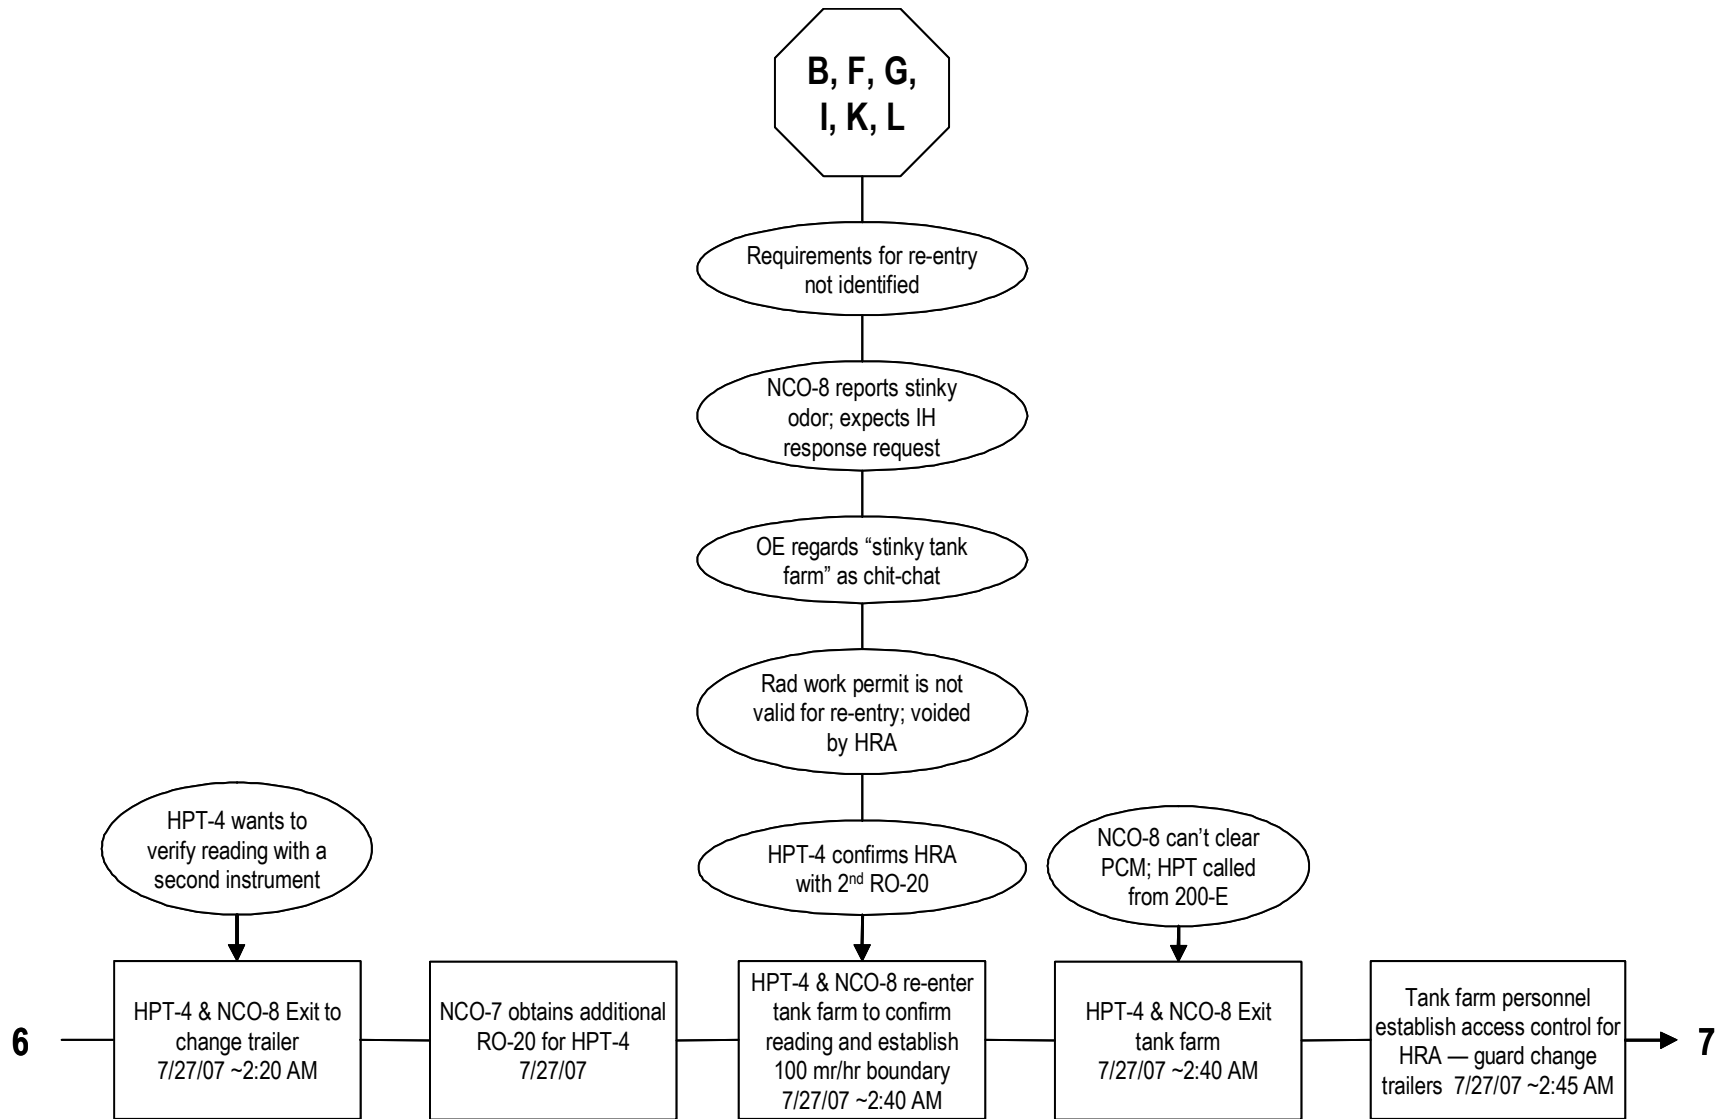
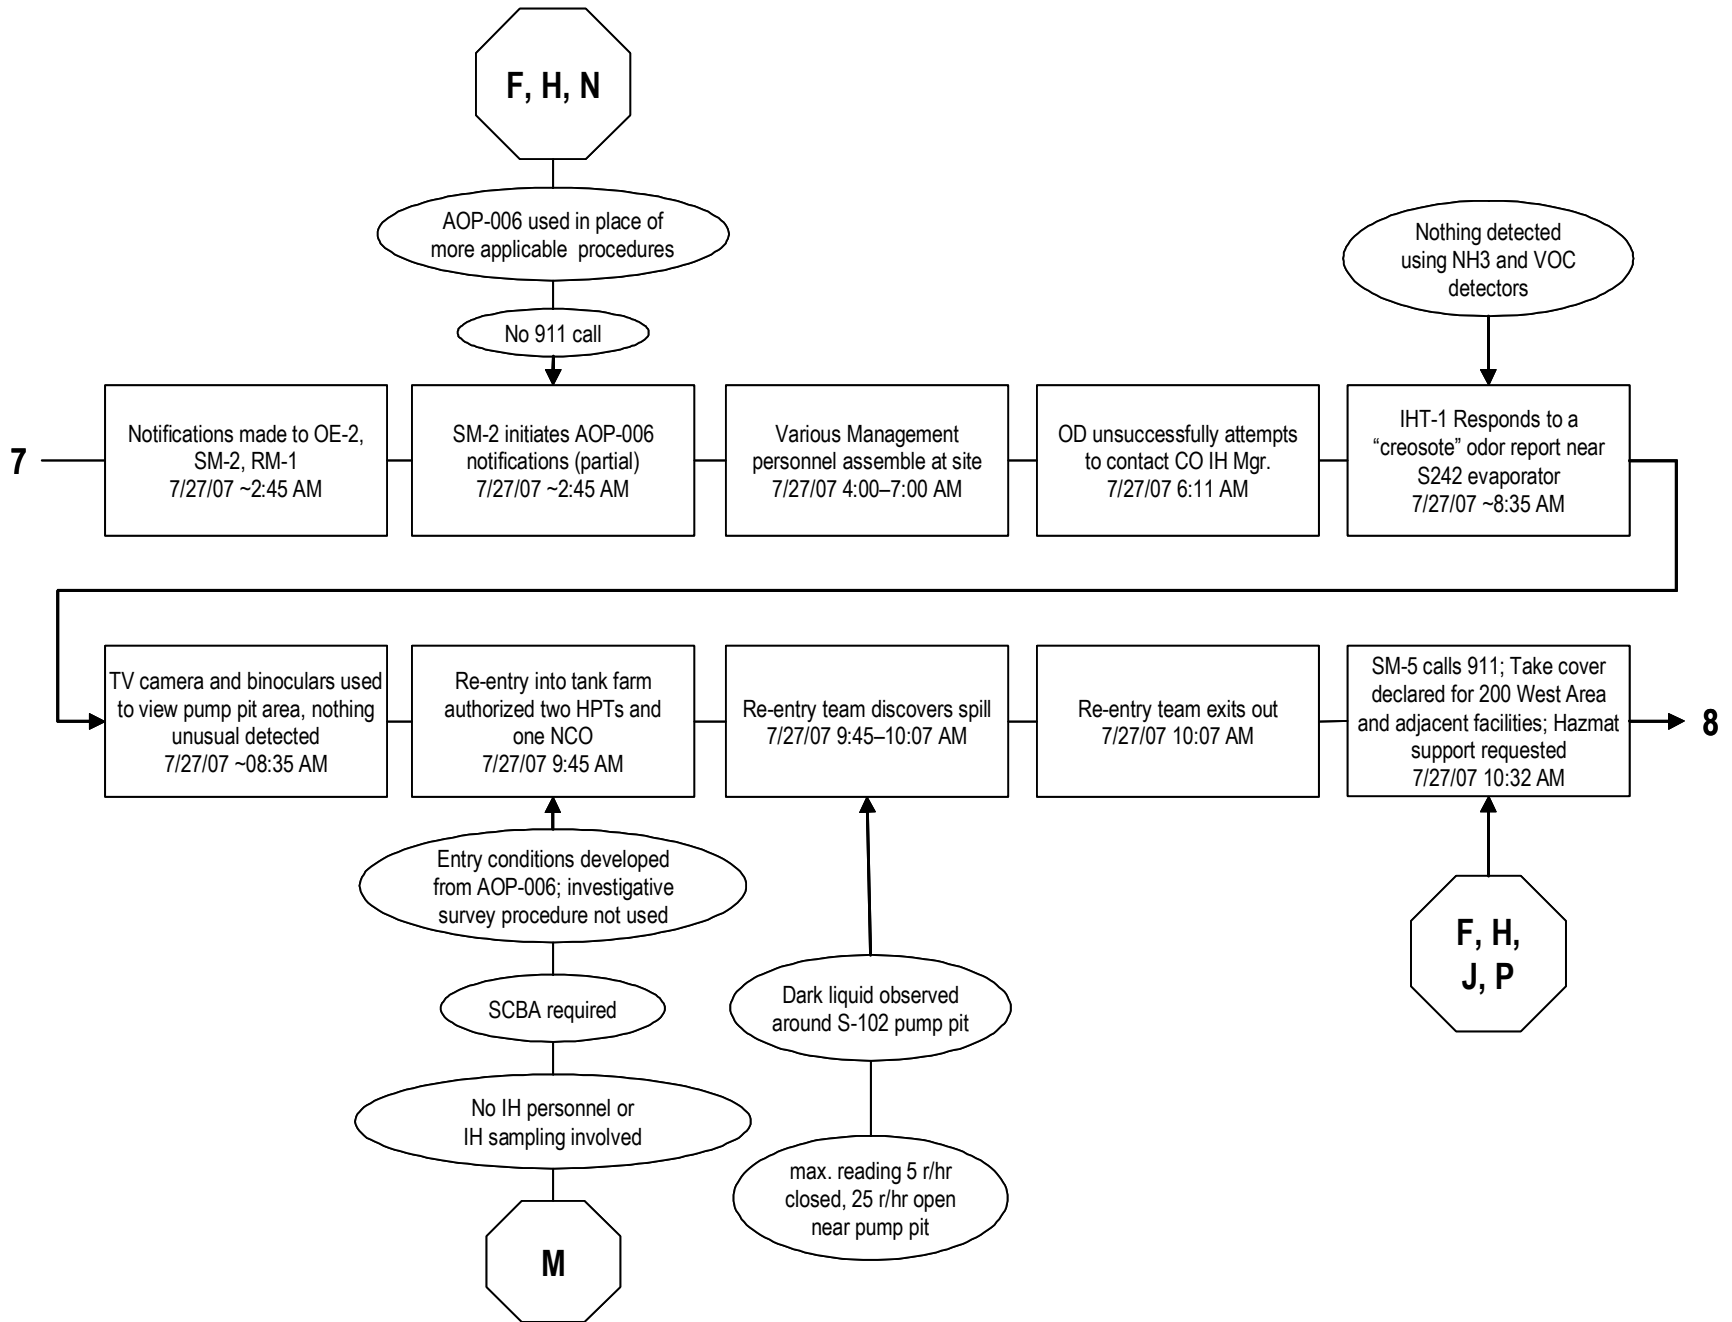
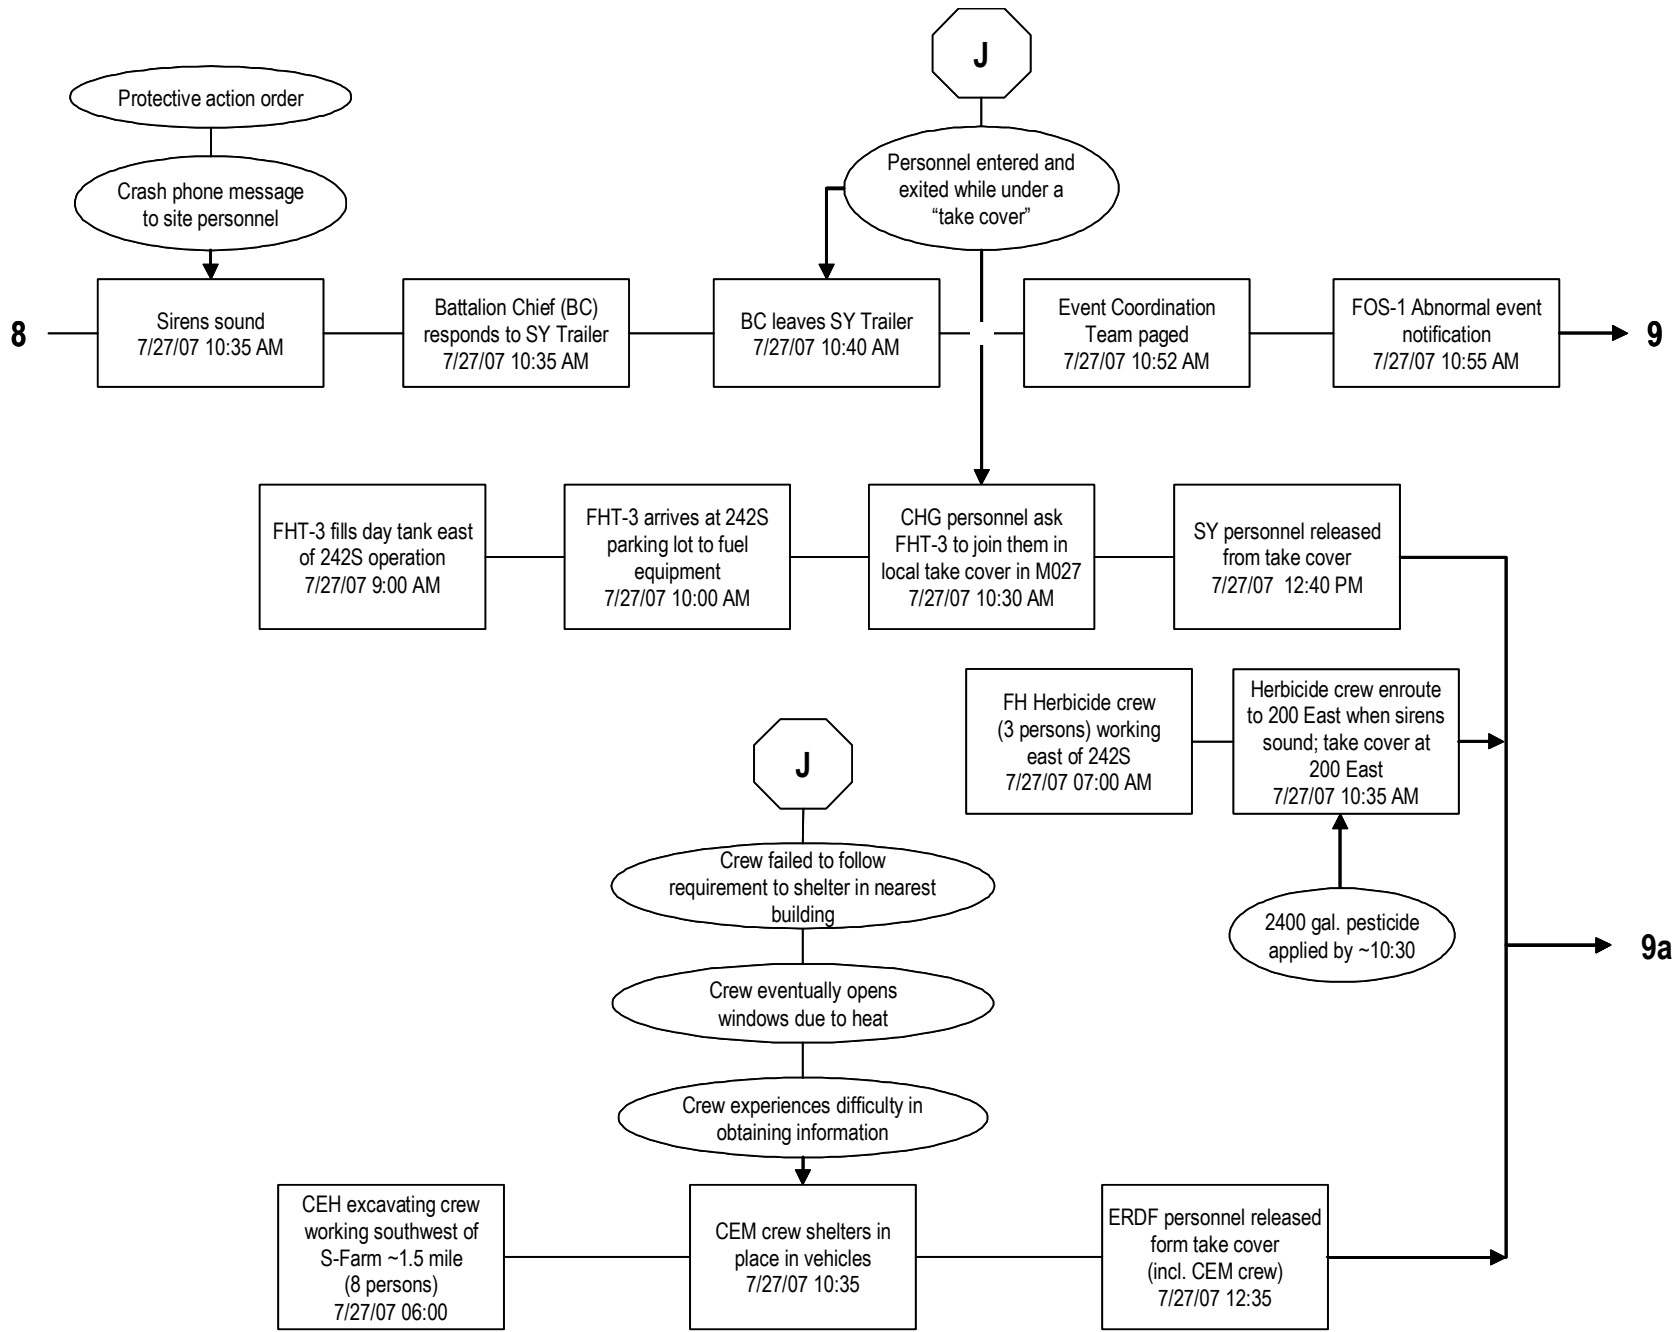
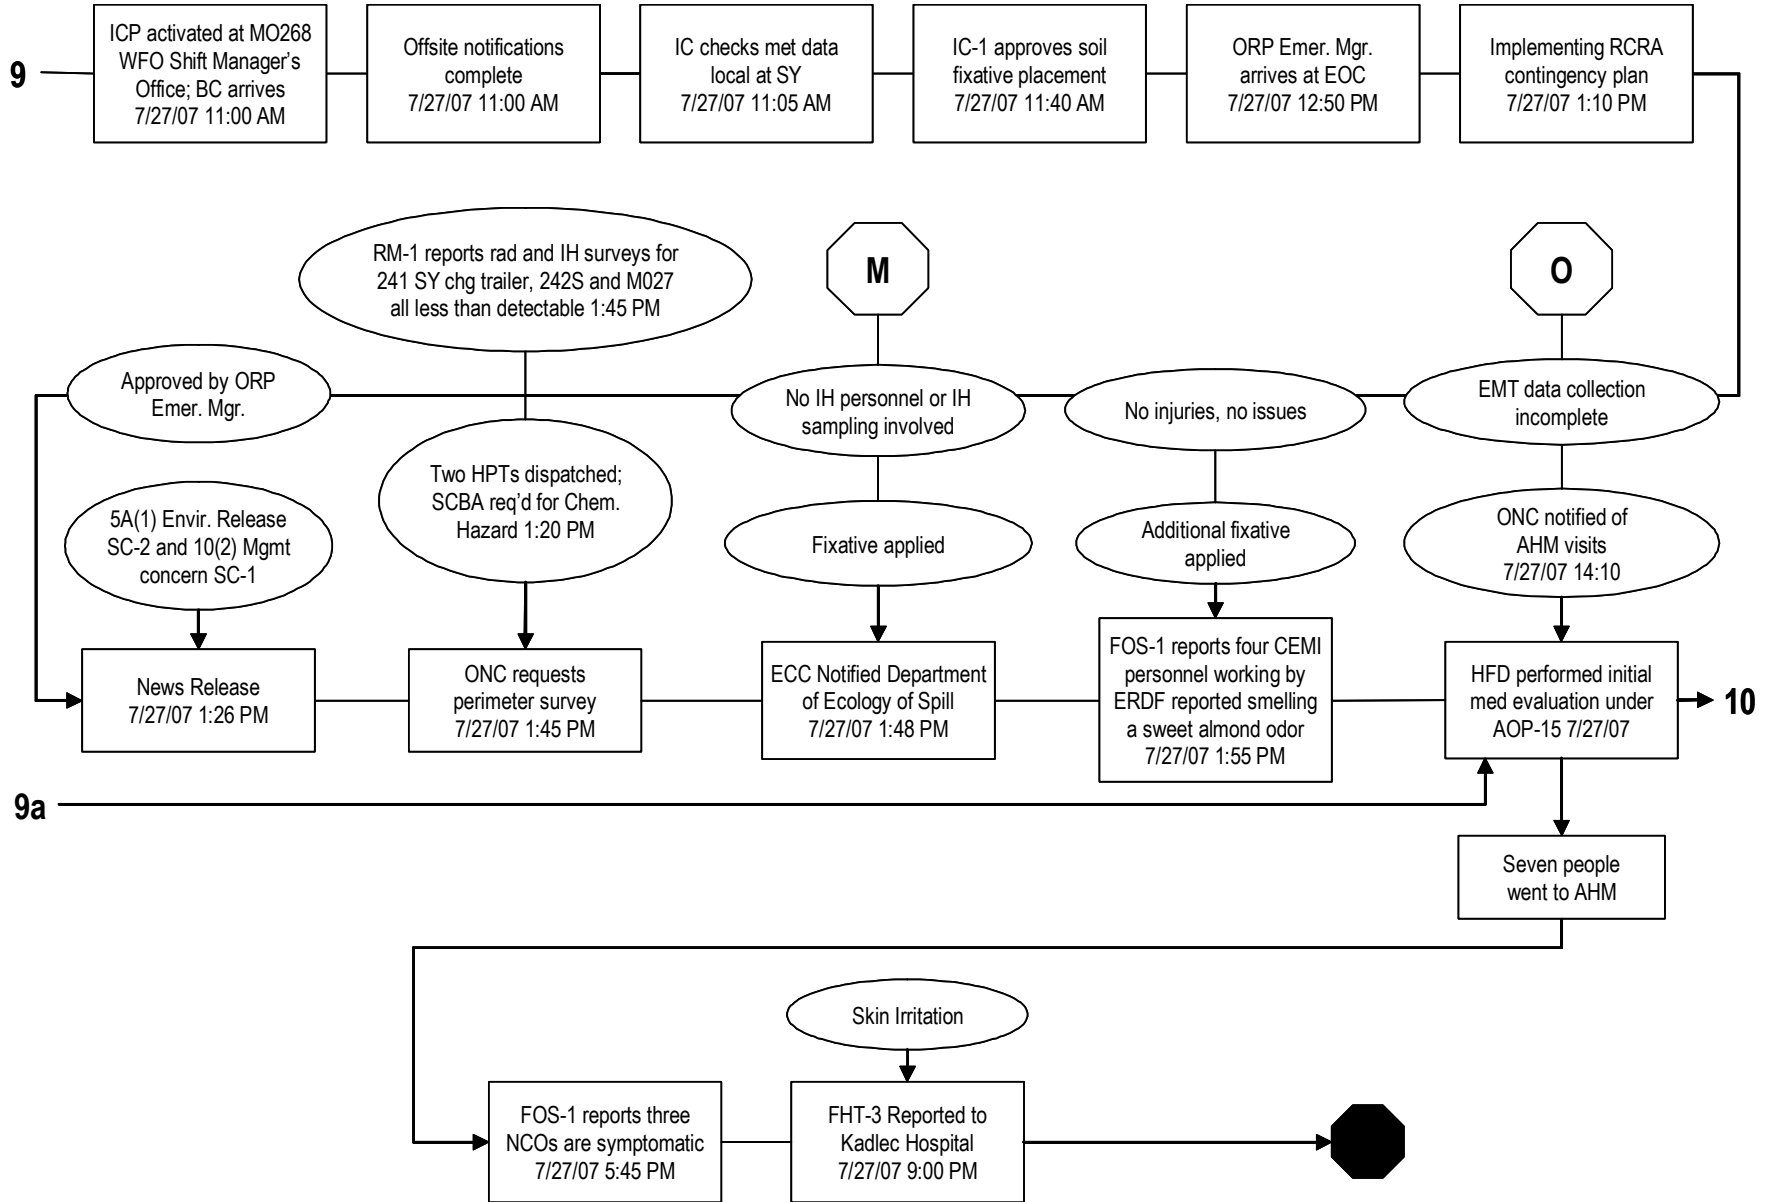
Events and Causal Factors Analysis

A	Failure to identify back pressurization hazard
B	Failure to apply lessons learned from previous contamination and vapor exposure incidents
C	Physical confinement for radioactive materials not safety significant
D	Procedure flow down less than adequate
E	Failure to develop response procedures for expected abnormal events
F	Failure to act as if an HRA is a leak until proven otherwise
G	Management allowed informal work activities
H	Management failed to follow procedure steps
I	Workers failed to follow procedural steps
J	Equipment failed
K	Hazards analysis not performed
L	Workers were not wearing necessary PPE for the work being performed
M	Industrial hygiene monitoring not performed
N	Abnormal operating procedures less than adequate
O	Operating procedures less than adequate
P	Event not analyzed in Emergency Planning Hazard Assessment (EPHA)
R	Schedule pressure
