APPENDIX

A.
Erosion Hazard Data Sheets
for
Methodology 1: 16 Physical Factors and One Economic
Factor

Erosion Hazard Data Sheets for Methodology 1: 16 Physical Factors and one Economic Factor

Sacramento River, RM 43.3R

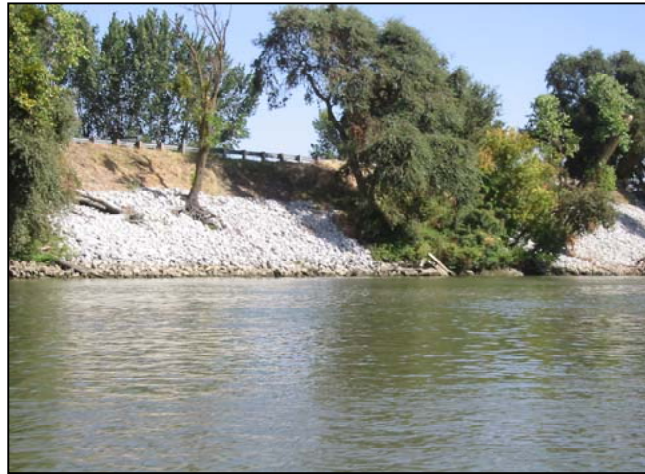
Site Photograph

Criteria	Pre-Rock	Post-Rock	Notes
Bank Slope (*2)	4	4	1:1 or less
Berm Width (*2) - Estimated	5	5	no berm
Length of erosion	4	4	1060 ft
Location of erosion	5	5	toe and underwater, bank (still eroding underwater and at the toe with the rock)
Bank Stability	4	2	vertical sections, greater than half height (still some vertical sections with rock, but not as tall)
Radius of Curvature (R_c/w)	3	3	$R/w = 2.4$ (Ayres calculation)
Site Relative to Bend	5	5	outside of a less than 90 degree bend
Geomorph	0	0	no migration expected
Vegetation Cover	2	4	40 to 60 % (with rock, less vegetation, removed what was there and didn't replant, less than 20%)
Tree Hazard	5	5	large leaning trees, visible roots (tree hazards are still present even with the rock)
Soil Type (*2)	3	3	sand
Velocity (*2)	4	4	5.4 ft/s (UNET model)
Wave Action (Wind/Boat)	4	4	heavy waves
Economic Factor (*2)	2	2	farms and small town (Clarksburg)
Human Usage	5	5	daily

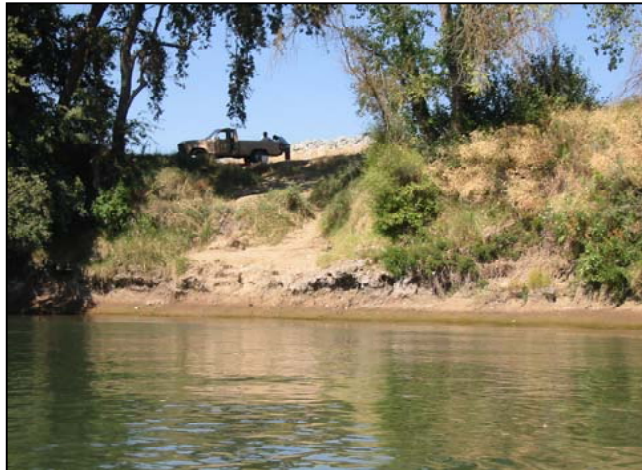
Site Photograph

Criteria	Score	Notes
Bank Slope (*2)	4	1:1 or less slope
Berm Width (*2) - Estimated	3	0 - 15 ft of berm (varies)
Length of erosion	4	1100 ft
Location of erosion	5	toe and underwater
Bank Stability	5	animal burrows, vertical sections
Radius of Curvature (R_c/w)	0	$R/w = 7$ (Ayres calculation)
Site Relative to Bend	2	just downstream of a bend
Geomorph	0	no migration expected
Vegetation Cover	1	75-80 %
Tree Hazard	5	exposed roots and leaning trees
Soil Type (*2)	2	silts and clays
Velocity (*2)	3	4.7 ft/s (UNET calculation)
Wave Action (Wind/Boat)	3	moderate
Economic Factor (*2)	5	adjacent to Sacramento, population 407,018 (2000 US census)
Human Usage	4	weekly
Seepage Potential	5	yes, known history
Tidal Fluctuation	1	about 1 ft or less of tidal flux

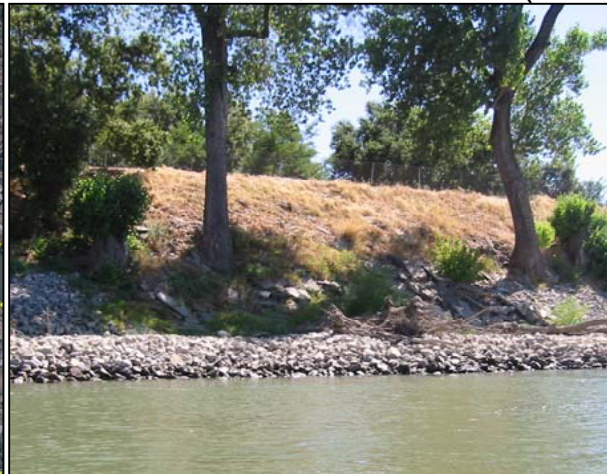
Site Photograph

Criteria	Score	Notes
Bank Slope (*2)	4	1:1 slope
Berm Width (*2) - Estimated	5	no berm
Length of erosion	5	1675 ft
Location of erosion	4	toe and lower slope
Bank Stability	5	large beaver holes, multiple vertical sections
Radius of Curvature (R_c/w)	0	straight
Site Relative to Bend	1	straight
Geomorph	0	no migration
Vegetation Cover	1	about 60 - 70 %
Tree Hazard	5	exposed roots, large trees, some overturned, and leaning
Soil Type (*2)	3	sand
Velocity (*2)	3	4.5 ft/s (UNET)
Wave Action (Wind/Boat)	5	heavy boat use
Economic Factor (*2)	5	Sacramento
Human Usage	0	rare, against freeway and railroad.
Seepage Potential	0	no know seepage history
Tidal Fluctuation	2	about 2 ft of tidal flux

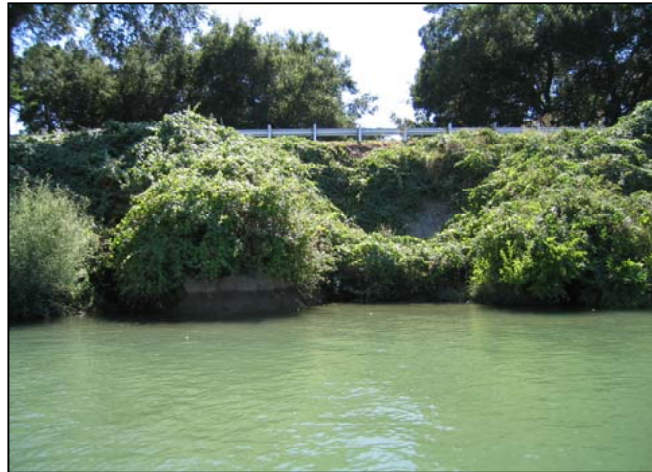
Site Photograph

Criteria	Score	Notes
Bank Slope (*2)	4	1:1 or less slope
Berm Width (*2) - Estimated	5	no berm
Length of erosion	5	1850 ft
Location of erosion	5	bank, toe, and underwater
Bank Stability	5	vertical sections, not more than half bank height, some caves, erosion is threatening the road
Radius of Curvature (R_c/w)	0	straight
Site Relative to Bend	1	straight
Geomorph	0	no migration expected
Vegetation Cover	1	about 70 - 80 % cover
Tree Hazard	5	large trees, lots of roots showing, leaning
Soil Type (*2)	3	sand
Velocity (*2)	4	5.6 ft/s (UNET model)
Wave Action (Wind/Boat)	4	heavy waves
Economic Factor (*2)	1	Farms
Human Usage	4	weekly
Seepage Potential	0	no known seepage history
Tidal Fluctuation	3	about 3 ft of tidal flux

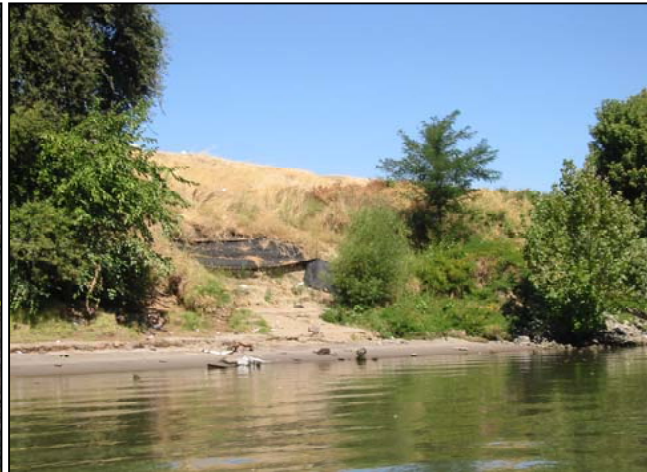
Site Photograph

Criteria	Score	Notes
Bank Slope (*2)	4	close to 1:1
Berm Width (*2) - Estimated	5	no berm
Length of erosion	3	850 ft
Location of erosion	2	into the lower bank
Bank Stability	4	vertical slope sections, more than half bank height
Radius of Curvature (R_c/w)	2	$R/w = 3.3$ (Ayres calculation)
Site Relative to Bend	0	inside of a bend
Geomorph	0	no migration expected
Vegetation Cover	2	about 40 to 60% cover
Tree Hazard	3	Large trees
Soil Type (*2)	3	sand
Velocity (*2)	3	4.5 ft/s (UNET model)
Wave Action (Wind/Boat)	5	heavy boats
Economic Factor (*2)	4	adjacent to West Sacramento, population 31, 615 (2000 US Census)
Human Usage	4	weekly
Seepage Potential	0	no known seepage history
Tidal Fluctuation	2	about 2 ft of tidal flux

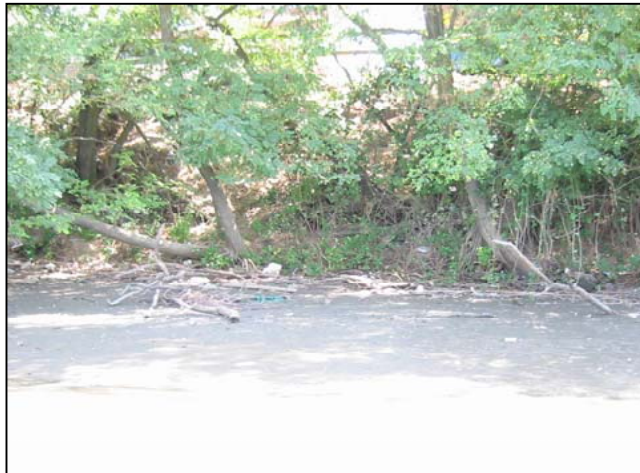
Site Photograph

Criteria	Score	Notes
Bank Slope (*2)	3	1.5:1 slope
Berm Width (*2) - Estimated	5	no berm
Length of erosion	2	460 ft
Location of erosion	2	lower bank
Bank Stability	4	vertical sections, more than half the height
Radius of Curvature (R_c/w)	1	$R/w = 4.4$ (Ayres calculation)
Site Relative to Bend	1	straight
Geomorph	0	no migration expected
Vegetation Cover	3	about 40% cover
Tree Hazard	5	trees with exposed roots and leaning
Soil Type (*2)	3	sand
Velocity (*2)	3	4.9 ft/s (UNET model)
Wave Action (Wind/Boat)	4	Heavy waves
Economic Factor (*2)	2	Walnut Grove, population 669 (2000 US Census)
Human Usage	5	Daily
Seepage Potential	0	no known seepage history
Tidal Fluctuation	4	4 ft of tidal flux

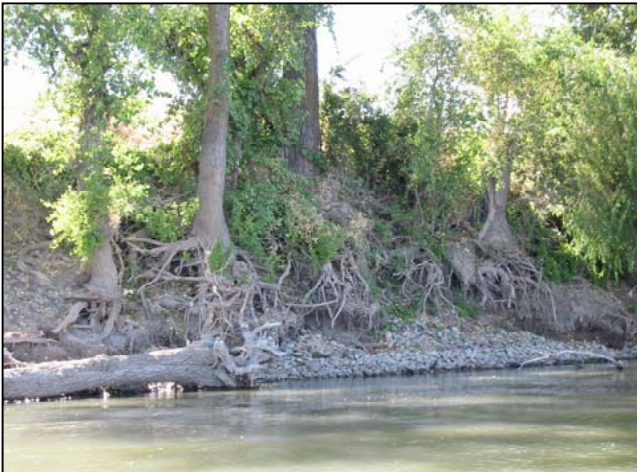
Site Photograph

Criteria	Score	Notes
Bank Slope (*2)	4	1:1 slope
Berm Width (*2) - Estimated	4	1 to 4 ft of berm (0 ft in some spots)
Length of erosion	2	430 ft
Location of erosion	4	lower bank and toe
Bank Stability	5	small animal burrows, caves from fallen trees, vertical sections
Radius of Curvature (R_c/w)	4	$R/w = 1.6$ (Ayres calculation)
Site Relative to Bend	4	outside of a 90 degree bend
Geomorph	0	no migration expected
Vegetation Cover	1	60-80% cover
Tree Hazard	5	Huge trees, all roots exposed, many leaning
Soil Type (*2)	2	silts and clay
Velocity (*2)	3	4.5 ft/s (UNET model)
Wave Action (Wind/Boat)	1	occasional boats
Economic Factor (*2)	2	near Knight's Landing
Human Usage	1	occasional usage, road nearby, so accessible, but no signs
Seepage Potential	5	yes, history of seepage
Tidal Fluctuation	0	not tidal

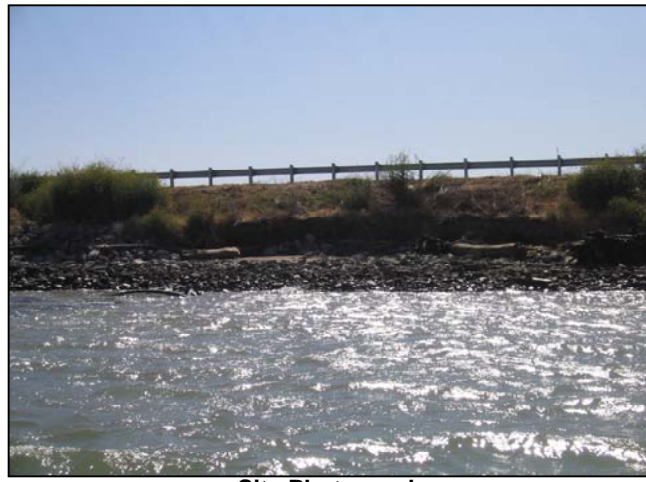
Site Photograph

Criteria	Score	Notes
Bank Slope (*2)	4	1:1 slope
Berm Width (*2) - Estimated	5	no berm
Length of erosion	5	1600 ft
Location of erosion	2	All bank
Bank Stability	4	vertical sections more than half bank height
Radius of Curvature (R_c/w)	1	$R/w = 4.4$ (Ayres calculation)
Site Relative to Bend	1	just about straight
Geomorph	0	no migration expected
Vegetation Cover	2	about 50 - 60 % cover
Tree Hazard	0	no trees
Soil Type (*2)	1	clays and rock at toe
Velocity (*2)	5	6.8 ft/s (UNET model)
Wave Action (Wind/Boat)	5	Heavy winds, large ships
Economic Factor (*2)	1	Farms
Human Usage	5	Daily, trash, and shelter set up
Seepage Potential	0	no known history
Tidal Fluctuation	5	5 ft of flux

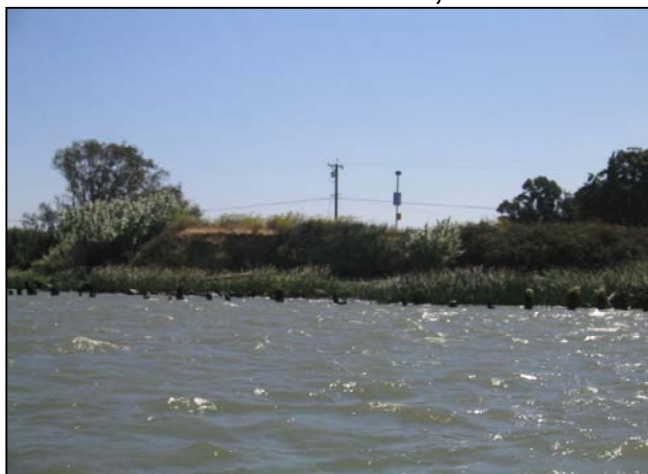
Site Photograph

Criteria	Score	Notes
Bank Slope (*2)	5	Vertical Bank
Berm Width (*2) - Estimated	3	8-10 ft (about at levee height)
Length of erosion	1	98 ft
Location of erosion	2	All Bank
Bank Stability	4	Vertical sections, greater than half the slope height
Radius of Curvature (R_c/w)	2	$R/w = 3$ (Ayres calculation)
Site Relative to Bend	3	outside of gentle bend
Geomorph	0	no migration expected
Vegetation Cover	3	about 20 - 30 % cover
Tree Hazard	0	No trees
Soil Type (*2)	1	Clays
Velocity (*2)	3	4.9 ft/s (UNET model)
Wave Action (Wind/Boat)	5	Heavy Wind, large ships pass by
Economic Factor (*2)	1	Farms
Human Usage	4	weekly, path down, but steep
Seepage Potential	0	no know seepage problems
Tidal Fluctuation	5	about 5 ft of tidal flux

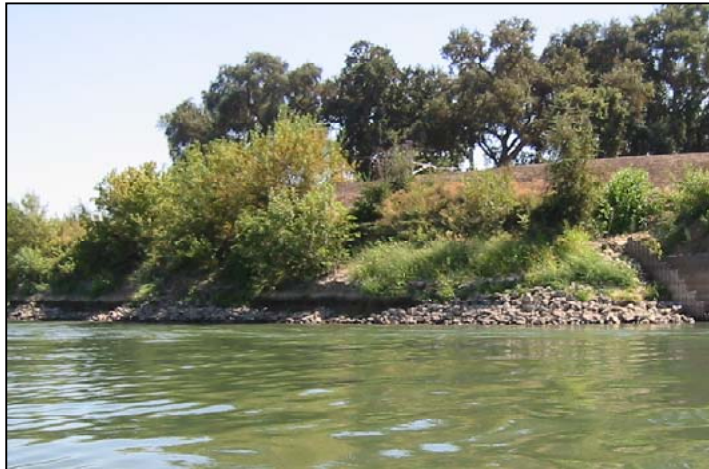
Sacramento River, RM 99.5R

Criteria	Score	Notes
Bank Slope (*2)	3	1.5:1 slope
Berm Width (*2) - Estimated	5	no berm
Length of erosion	4	1020 ft
Location of erosion	5	toe and underwater
Bank Stability	2	vertical section
Radius of Curvature (R_c/w)	4	$R/w = 1.0$ (Ayres calculation)
Site Relative to Bend	4	outside of a 90 degree bend
Geomorph	0	no migration expected
Vegetation Cover	2	50-60 %
Tree Hazard	0	small trees
Soil Type (*2)	2	clays and silts
Velocity (*2)	2	4.2 ft/s (UNET model)
Wave Action (Wind/Boat)	2	low
Economic Factor (*2)	1	Farms
Human Usage	0	not easily accessible, rare
Seepage Potential	0	no known seepage history
Tidal Fluctuation	0	not tidal

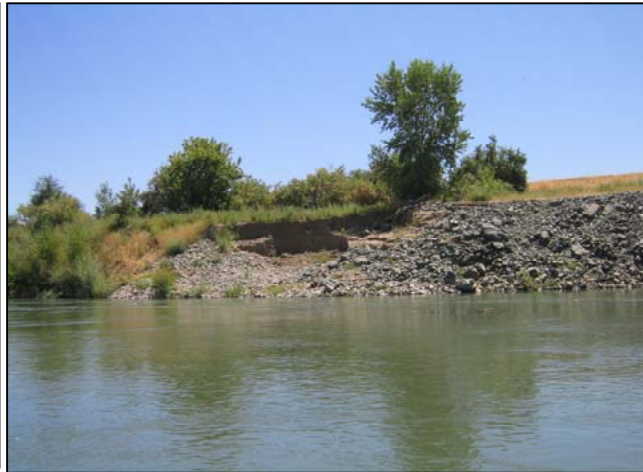
Sacramento River, RM 154.5R

Criteria	Score	Notes
Bank Slope (*2)	5	Near Vertical
Berm Width (*2) - Estimated	1	20 - 30 ft
Length of erosion	2	210 ft
Location of erosion	3	bank and toe
Bank Stability	4	vertical sections, more than half height
Radius of Curvature (R_c/w)	2	$R/w = 3.9$ (ayres calculation)
Site Relative to Bend	3	outside of a greater than 90 degree bend
Geomorph	2	has room to migrate on the left bank
Vegetation Cover	3	20 - 30 %
Tree Hazard	0	no trees
Soil Type (*2)	1	clays and rock
Velocity (*2)	2	4.2 ft/s (UNET model)
Wave Action (Wind/Boat)	2	low
Economic Factor (*2)	3	upstream of Colusa, population 5,402 (2000 US Census)
Human Usage	3	monthly, adjacent to road, easy access, but steep
Seepage Potential	0	no known seepage history
Tidal Fluctuation	0	not tidal

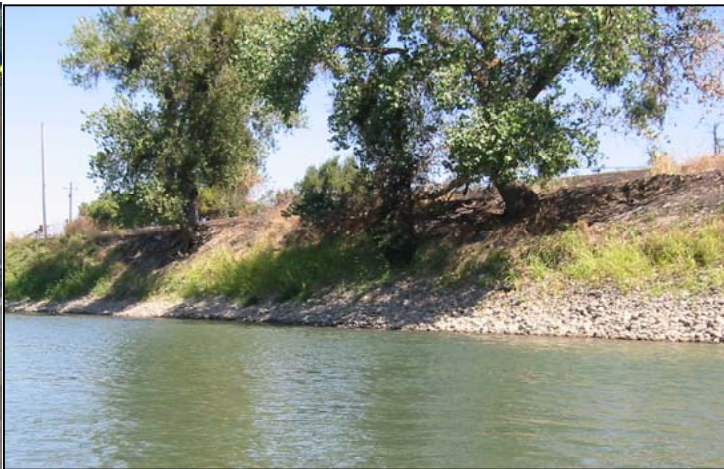
Sacramento River, RM 130L

Criteria	Score	Notes
Bank Slope (*2)	3	1.5 : 1 slope
Berm Width (*2) - Estimated	2	10 - 20 ft
Length of erosion	3	560 ft
Location of erosion	1	upper and middle bank
Bank Stability	2	small vertical section
Radius of Curvature (R_c/w)	4	$R/w = 1.3$ (Ayres calculation)
Site Relative to Bend	4	outside of 90 degree bend
Geomorph	0	no immediate effect
Vegetation Cover	3	burnt vegetation, 30 %
Tree Hazard	4	exposed roots
Soil Type (*2)	1	clays
Velocity (*2)	3	4.5 ft/s (UNET model)
Wave Action (Wind/Boat)	2	low
Economic Factor (*2)	2	small town of Meridian
Human Usage	1	occassional, no evidence of people however near the highway
Seepage Potential	0	no known history
Tidal Fluctuation	0	not tidal

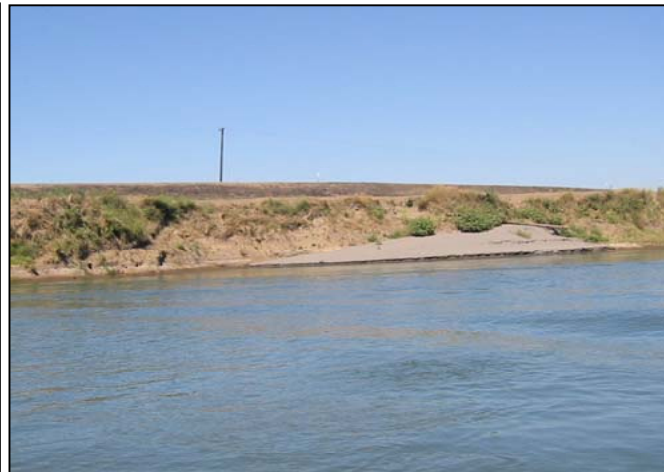
Sacramento River, RM 96.2L

Criteria	Score	Notes
Bank Slope (*2)	4	1:1 slope
Berm Width (*2) - Estimated	1	about 25 ft
Length of erosion	3	900 ft
Location of erosion	4	bank and toe, sand has deposited on the downstream end
Bank Stability	5	small vertical sections, multiple small animal holes
Radius of Curvature (R_c/w)	4	$R/w = 1.2$ (Ayres calculation)
Site Relative to Bend	2	just downstream of a bend
Geomorph	0	no migration expected
Vegetation Cover	3	about 30%
Tree Hazard	0	no trees
Soil Type (*2)	2	clays and silts, sand has deposited on the downstream end
Velocity (*2)	2	4.2 ft/s (UNET model)
Wave Action (Wind/Boat)	2	low waves
Economic Factor (*2)	1	Farms
Human Usage	2	seasonal usage
Seepage Potential	0	no known seepage history
Tidal Fluctuation	0	not tidal

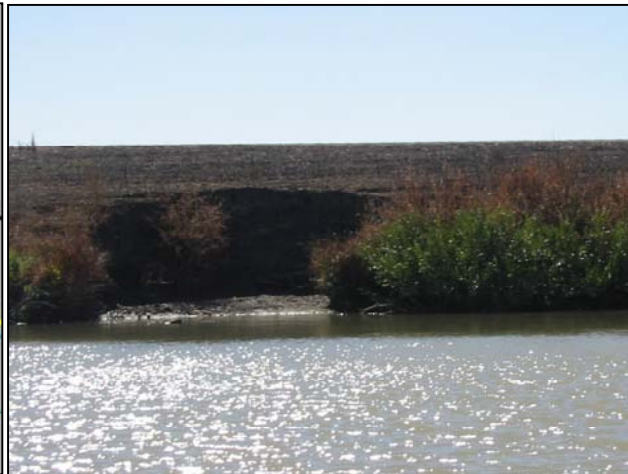
Cache Slough, RM 21.8R

Criteria	Score	Notes
Bank Slope (*2)	2	2:1 slope
Berm Width (*2) - Estimated	5	no berm
Length of erosion	5	1590 ft
Location of erosion	4	lower bank and toe
Bank Stability	4	vertical sections, greater than half the bank height
Radius of Curvature (R_c/w)	0	straight
Site Relative to Bend	1	straight
Geomorph	0	no, backwater slough
Vegetation Cover	4	burned, less than 20 %
Tree Hazard	0	one tree, not a problem
Soil Type (*2)	1	clays
Velocity (*2)	0	backwater, less than 2 ft/s
Wave Action (Wind/Boat)	4	Heavy wind
Economic Factor (*2)	1	Farms
Human Usage	0	none, private land
Seepage Potential	0	no known seepage history
Tidal Fluctuation	4	about 4 ft of tidal flux

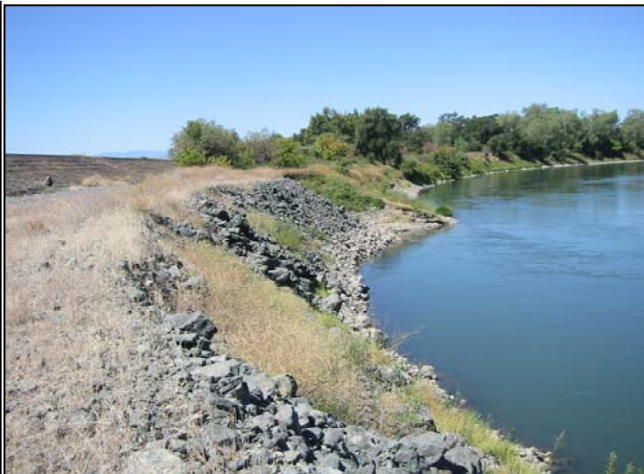
Sacramento River, RM 164R

Criteria	Score	Notes
Bank Slope (*2)	4	1:1 or less slope
Berm Width (*2) - Estimated	2	15 ft
Length of erosion	2	490 ft
Location of erosion	4	Bank and toe
Bank Stability	2	vertical sections, less than half slope, there appears to be fresh rock on bank
Radius of Curvature (R_c/w)	0	straight
Site Relative to Bend	1	straight
Geomorph	2	room to migrate on left bank
Vegetation Cover	2	40 - 50%
Tree Hazard	0	no trees
Soil Type (*2)	2	clays and silts
Velocity (*2)	2	4.2 ft/s (UNET model)
Wave Action (Wind/Boat)	2	low
Economic Factor (*2)	2	adjacent to small town of Princeton
Human Usage	4	weekly, road adjacent, paths down to water
Seepage Potential	0	no known seepage history
Tidal Fluctuation	0	not tidal

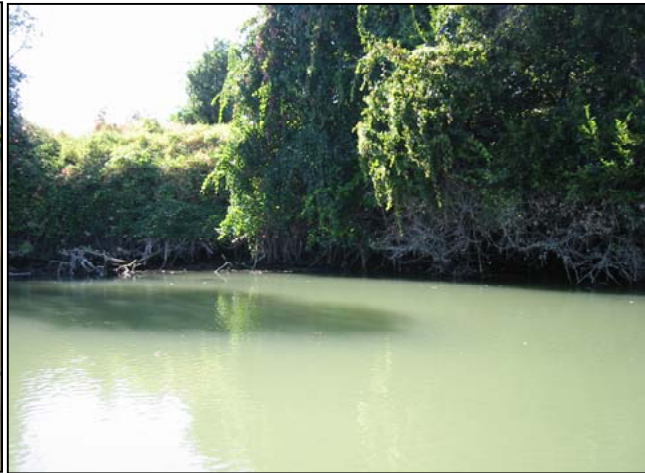
Elk Slough, RM 0.7

Criteria	Score	Notes
Bank Slope (*2)	4	1:1 slope
Berm Width (*2) - Estimated	5	no berm
Length of erosion	2	300 ft
Location of erosion	4	toe and bank
Bank Stability	2	vertical sections, less than half bank height
Radius of Curvature (R_c/w)	0	straight
Site Relative to Bend	1	straight
Geomorph	0	no migration expected
Vegetation Cover	0	80-90%
Tree Hazard	4	large trees with exposed roots
Soil Type (*2)	1	slays
Velocity (*2)	0	backwater, less than 2 ft/s
Wave Action (Wind/Boat)	2	low (only boatable durign high water)
Economic Factor (*2)	1	Farms
Human Usage	2	Seasonal usage
Seepage Potential	0	no known seepage history
Tidal Fluctuation	3	about 3 ft of tidal flux

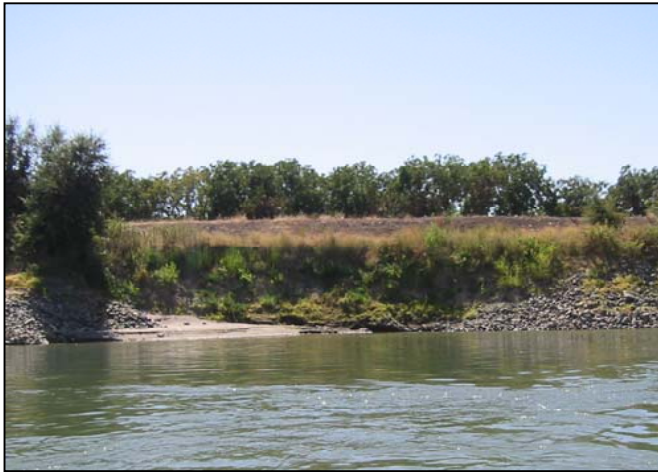
Sacramento River, RM 99.3R

Criteria	Score	Notes
Bank Slope (*2)	4	1:1 or less
Berm Width (*2) - Estimated	3	5 - 9 ft
Length of erosion	1	98 ft
Location of erosion	5	bank, toe, and below water
Bank Stability	2	vertical sections
Radius of Curvature (R_c/w)	4	$R/w = 1.1$
Site Relative to Bend	0	inside of a bend
Geomorph	0	no migration expected
Vegetation Cover	2	about 50 - 60 %
Tree Hazard	0	no trees
Soil Type (*2)	2	silty clay
Velocity (*2)	3	4.2 ft/s and eddy currents
Wave Action (Wind/Boat)	1	occasional
Economic Factor (*2)	1	Farms
Human Usage	0	none, too steep, not near public land
Seepage Potential	0	no known seepage history
Tidal Fluctuation	0	Not tidal

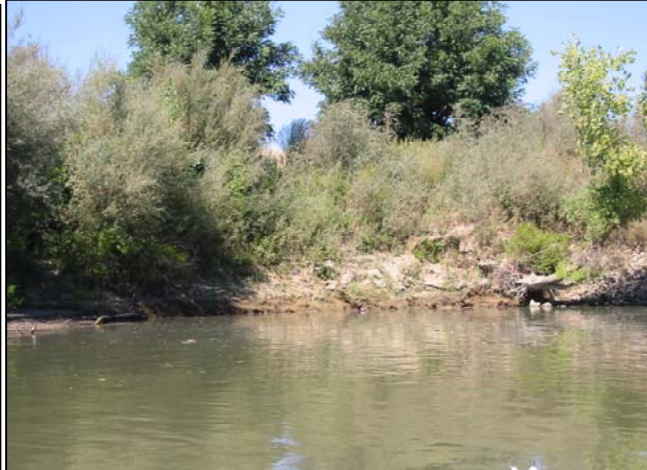
Sacramento River, RM 73R

Criteria	Score	Notes
Bank Slope (*2)	3	1.5:1
Berm Width (*2) - Estimated	3	5 - 10 ft of berm
Length of erosion	1	50 ft, rock protection on the upstream and downstream sides.
Location of erosion	4	toe and bank
Bank Stability	0	no visible vertical sections or caves
Radius of Curvature (R_c/w)	0	straight
Site Relative to Bend	1	straight
Geomorph	0	no migration expected
Vegetation Cover	1	75-80 %
Tree Hazard	1	one tree, young
Soil Type (*2)	2	silts and clays
Velocity (*2)	5	4.7 ft/s (UNET model) and eddy currents
Wave Action (Wind/Boat)	3	moderate
Economic Factor (*2)	1	Farms
Human Usage	0	not likely, private land
Seepage Potential	0	no known seepage history
Tidal Fluctuation	1	about 1 ft of tidal flux

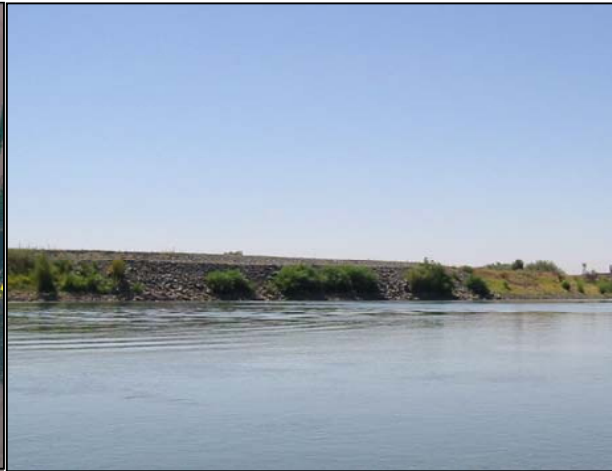
Sacramento River, RM 125.8L

New rock on this site, it does not appear to be an erosion site anymore. The rock appears to be falling into place and healing itself.

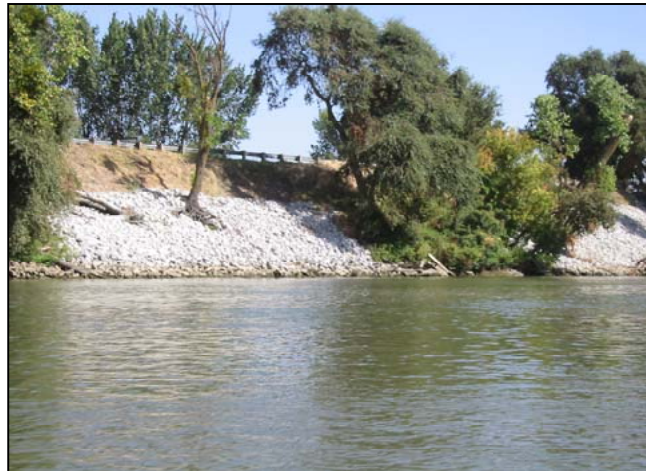
Sacramento River, RM 43.3R

Criteria	Pre-Rock	Post-Rock	Notes
Bank Slope (*2)	4	4	1:1 or less
Berm Width (*2) - Estimated	5	5	no berm
Location of erosion	5	5	toe and underwater, bank (still eroding underwater and at the toe with the rock)
Bank Stability	4	2	vertical sections, greater than half height (still some vertical sections with rock, but not as tall)
Site Relative to Bend	5	5	outside of a less than 90 degree bend
Vegetation Cover	2	4	40 to 60 % (with rock, less vegetation, removed what was there and didn't replant, less than 20%)
Tree Hazard	5	5	large leaning trees, visible roots (tree hazards are still present even with the rock)
Soil Type (*2)	3	3	sand
Velocity (*2)	4	4	5.4 ft/s (UNET model)
Human Usage	5	5	daily
Erosion Hazard	58	58	<input type="button" value="Calculate Erosion Hazard"/>
Flow on Inspection Day:

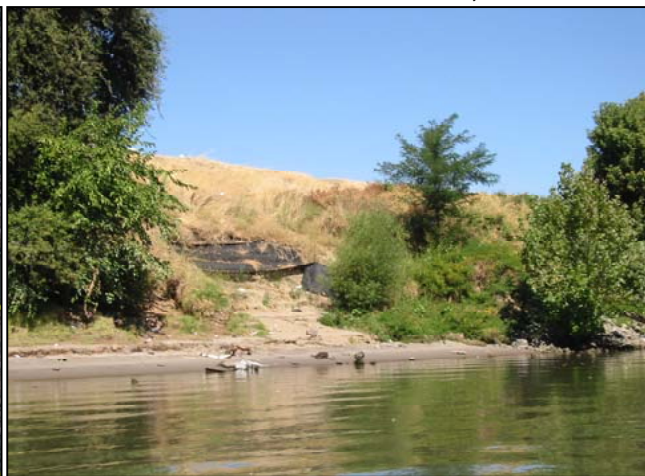
Sacramento River, RM 55.8R

Criteria	Score	Notes
Bank Slope (*2)	4	close to 1:1
Berm Width (*2) - Estimated	5	no berm
Location of erosion	2	into the lower bank
Bank Stability	4	vertical slope sections, more than half bank height
Site Relative to Bend	0	inside of a bend
Vegetation Cover	2	about 40 to 60% cover
Tree Hazard	3	Large trees
Soil Type (*2)	3	sand
Velocity (*2)	3	4.5 ft/s (UNET model)
Human Usage	4	weekly

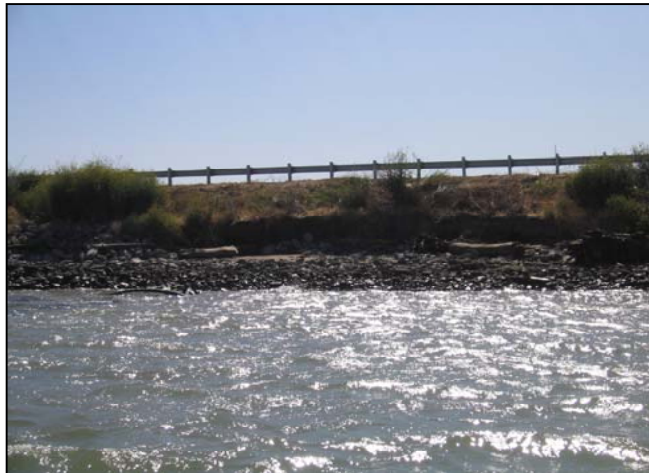
Sacramento River, RM 10.8L

Criteria	Score	Notes
Bank Slope (*2)	4	1:1 slope
Berm Width (*2) - Estimated	5	no berm
Location of erosion	2	All bank
Bank Stability	4	vertical sections more than half bank height
Site Relative to Bend	1	just about straight
Vegetation Cover	2	about 50 - 60 % cover
Tree Hazard	0	no trees
Soil Type (*2)	1	clays and rock at toe
Velocity (*2)	5	6.8 ft/s (UNET model)
Human Usage	5	Daily, trash, and shelter set up

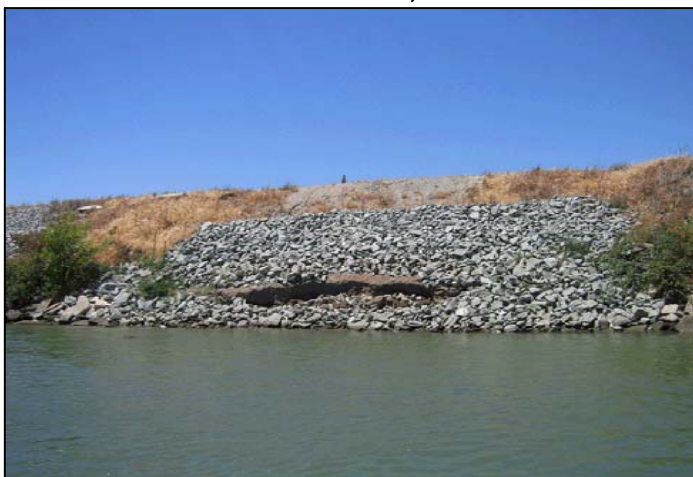
Sacramento River, RM 34.5R

Criteria	Score	Notes
Bank Slope (*2)	4	1:1 slope
Berm Width (*2) - Estimated	5	no berm
Location of erosion	2	lower bank
Bank Stability	2	vertical section less than half height, no caves, more rock was placed to fill in large holes from previous year. (photo from 2004)
Site Relative to Bend	1	straight
Vegetation Cover	4	less than 20%
Tree Hazard	0	no trees
Soil Type (*2)	3	sands
Velocity (*2)	4	5.6 ft/s (UNET model)
Human Usage	3	Monthly

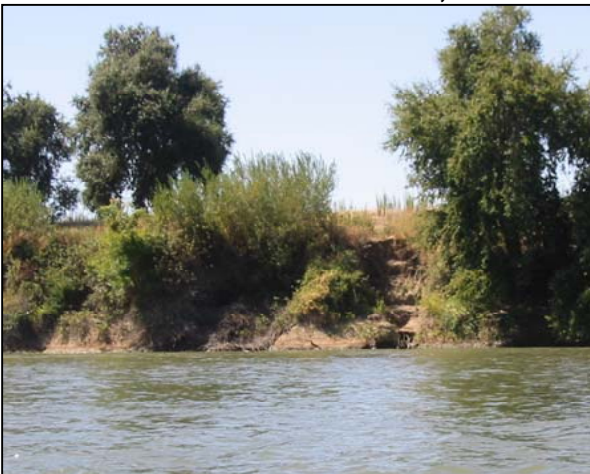
Sacramento River, RM 72.2R

Criteria	Score	Notes
Bank Slope (*2)	5	near vertical, won't support vegetation
Berm Width (*2) - Estimated	2	12 - 15 ft
Location of erosion	5	toe and underwater
Bank Stability	5	large holes, multiple vertical sections
Site Relative to Bend	3	outside of a slight bend
Vegetation Cover	1	60 - 70 %
Tree Hazard	5	large trees, exposed roots, leaning
Soil Type (*2)	2	silty clay
Velocity (*2)	3	4.7 ft/s (UNET model)
Human Usage	0	Farms

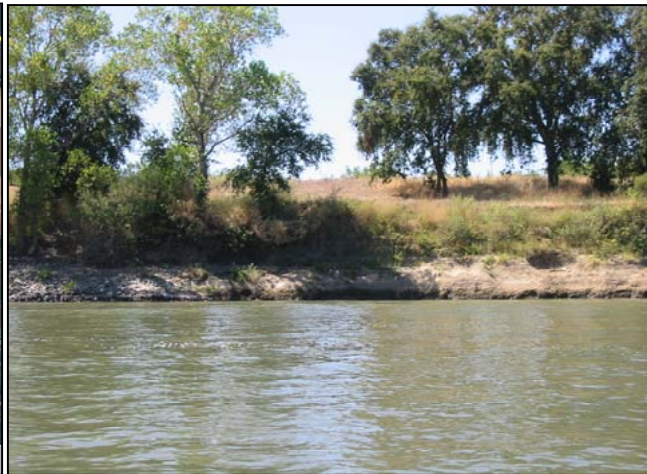
Sacramento River, RM 71-7R

Criteria	Score	Notes
Bank Slope (*2)	4	1:1 or less
Berm Width (*2) - Estimated	1	20+ ft
Location of erosion	5	toe and underwater
Bank Stability	5	lots of serious holes, many vertical sections
Site Relative to Bend	3	outside of a mild bend
Vegetation Cover	2	40 - 60%
Tree Hazard	5	large trees, visible roots, leaning
Soil Type (*2)	2	silts and clays
Velocity (*2)	3	4.7 ft/s (UNET model)
Human Usage	1	Farms

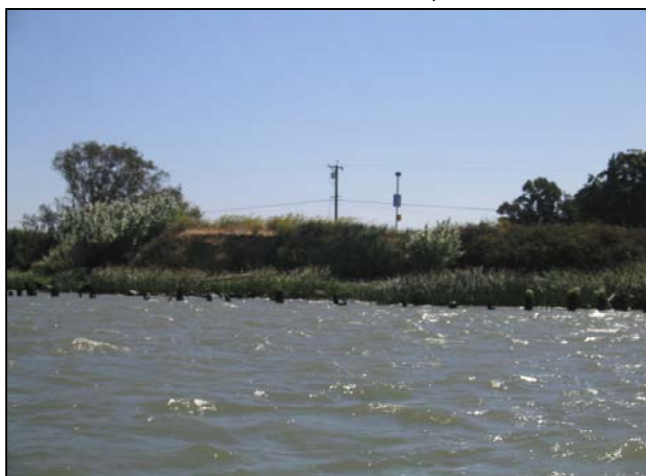
Sacramento River, RM 8L

Criteria	Score	Notes
Bank Slope (*2)	5	Vertical Bank
Berm Width (*2) - Estimated	3	8-10 ft (about at levee height)
Location of erosion	2	All Bank
Bank Stability	4	Vertical sections, greater than half the slope height
Site Relative to Bend	3	outside of gentle bend
Vegetation Cover	3	about 20 - 30 % cover
Tree Hazard	0	No trees
Soil Type (*2)	1	Clays
Velocity (*2)	3	4.9 ft/s (UNET model)
Human Usage	4	weekly, path down, but steep

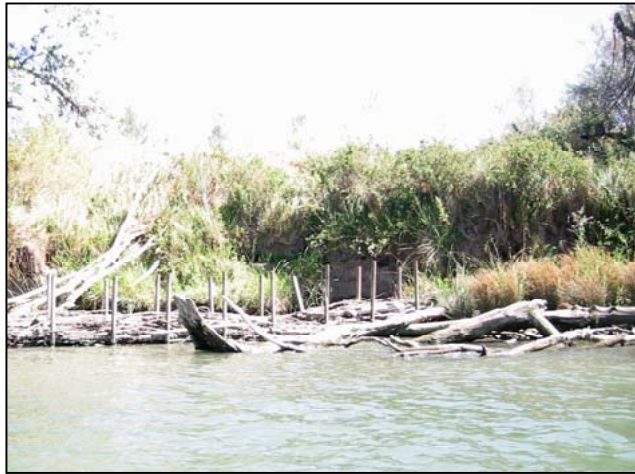
Sacramento River, RM 22.7L

Criteria	Score	Notes
Bank Slope (*2)	3	1.5:1 slope
Berm Width (*2) - Estimated	5	no berm
Location of erosion	3	Toe
Bank Stability	2	vertical sections, less than half slope height
Site Relative to Bend	1	straight
Vegetation Cover	2	about 60 %
Tree Hazard	5	big tree recently fell, trees leaning away from river, likely to slide in
Soil Type (*2)	3	Sand
Velocity (*2)	2	4.4 ft/s (UNET model)
Human Usage	1	Occassional

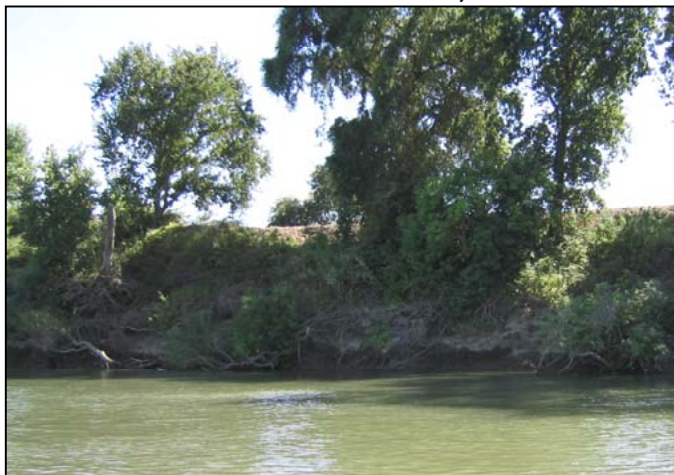
Sacramento River, RM 69.9R

Criteria	Score	Notes
Bank Slope (*2)	4	1:1 or less
Berm Width (*2) - Estimated	4	little berm
Location of erosion	5	toe and underwater
Bank Stability	2	vertical slopes, less than half bank height
Site Relative to Bend	1	straight
Vegetation Cover	0	80-90% cover
Tree Hazard	5	large trees, leaning, visible roots
Soil Type (*2)	2	silts and clays
Velocity (*2)	3	4.7 ft/s (UNET model)
Human Usage	0	none

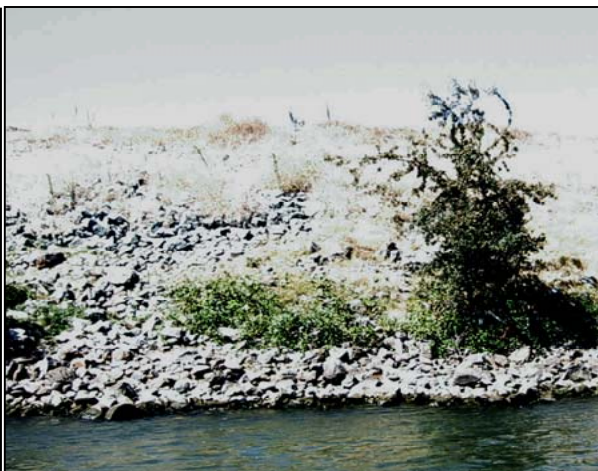
Sacramento River, RM 42.8R

Criteria	Score	Notes
Bank Slope (*2)	3	1.5:1
Berm Width (*2) - Estimated	5	no berm
Location of erosion	0	upper bank
Bank Stability	0	no vertical sections or caves
Site Relative to Bend	2	just downstream of a bend
Vegetation Cover	1	60 -65 %
Tree Hazard	1	young trees
Soil Type (*2)	3	sand
Velocity (*2)	4	5.4 ft/s (UNET model)
Human Usage	5	Daily

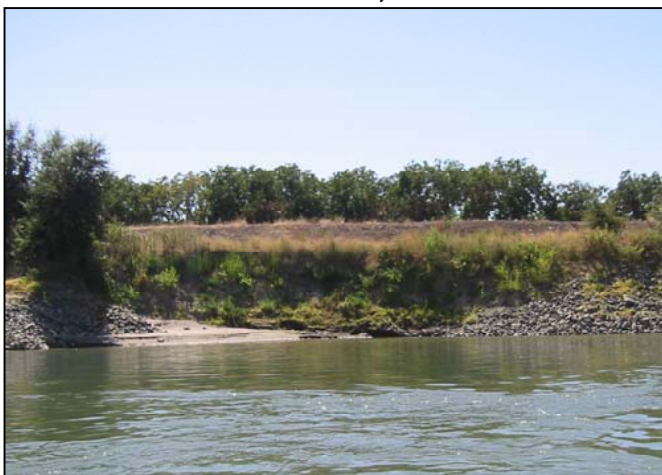
Sacramento River, RM 99.3R

Criteria	Score	Notes
Bank Slope (*2)	4	1:1 or less
Berm Width (*2) - Estimated	3	5 - 9 ft
Location of erosion	5	bank, toe, and below water
Bank Stability	2	vertical sections
Site Relative to Bend	0	inside of a bend
Vegetation Cover	2	about 50 - 60 %
Tree Hazard	0	no trees
Soil Type (*2)	2	silty clay
Velocity (*2)	3	4.2 ft/s and eddy currents
Human Usage	0	none, too steep, not near public land

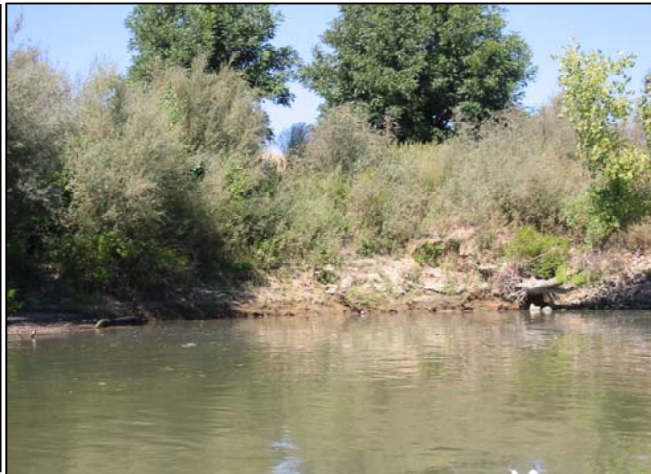
Sacramento River, RM 73R

Criteria	Score	Notes
Bank Slope (*2)	3	1.5:1
Berm Width (*2) - Estimated	3	5 - 10 ft of berm
Location of erosion	4	toe and bank
Bank Stability	0	no visible vertical sections or caves
Site Relative to Bend	1	straight
Vegetation Cover	1	75-80 %
Tree Hazard	1	one tree, young
Soil Type (*2)	2	silts and clays
Velocity (*2)	5	4.7 ft/s (UNET model) and eddy currents
Human Usage	0	not likely, private land

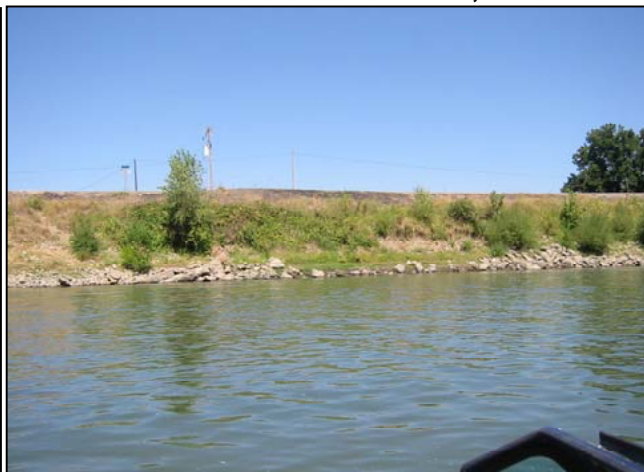
Sacramento River, RM 123.5L

Criteria	Score	Notes
Bank Slope (*2)	4	1:1 or less slope
Berm Width (*2) - Estimated	3	5 - 9 ft
Location of erosion	5	bank, toe, and underwater
Bank Stability	2	vertical section, less than half bank height
Site Relative to Bend	1	straight
Vegetation Cover	2	about 60%
Tree Hazard	0	no trees
Soil Type (*2)	1	clay
Velocity (*2)	3	4.6 ft/s
Human Usage	0	none

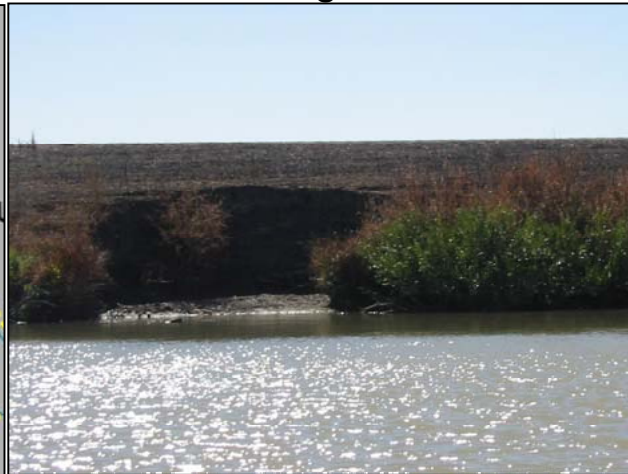
Cache Slough, RM 21.8R

Criteria	Score	Notes
Bank Slope (*2)	2	2:1 slope
Berm Width (*2) - Estimated	5	no berm
Location of erosion	4	lower bank and toe
Bank Stability	4	vertical sections, greater than half the bank height
Site Relative to Bend	1	straight
Vegetation Cover	4	burned, less than 20 %
Tree Hazard	0	one tree, not a problem
Soil Type (*2)	1	clays
Velocity (*2)	0	backwater, less than 2 ft/s
Human Usage	0	none, private land

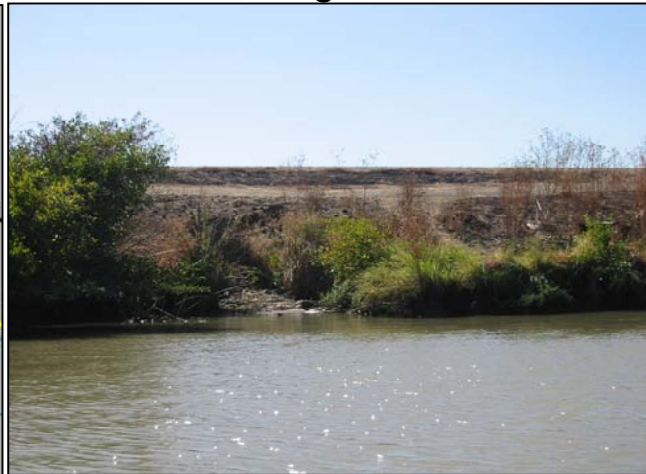
Cache Slough, RM 21.2R

Criteria	Score	Notes
Bank Slope (*2)	1	2.5:1 slopw
Berm Width (*2) - Estimated	5	no berm
Location of erosion	4	bank and toe
Bank Stability	2	vertical section, less than half bank height
Site Relative to Bend	1	straight
Vegetation Cover	3	30%
Tree Hazard	1	young trees
Soil Type (*2)	1	clay
Velocity (*2)	0	backwater, less than 2 ft/s
Human Usage	4	weekly, little campsite setup

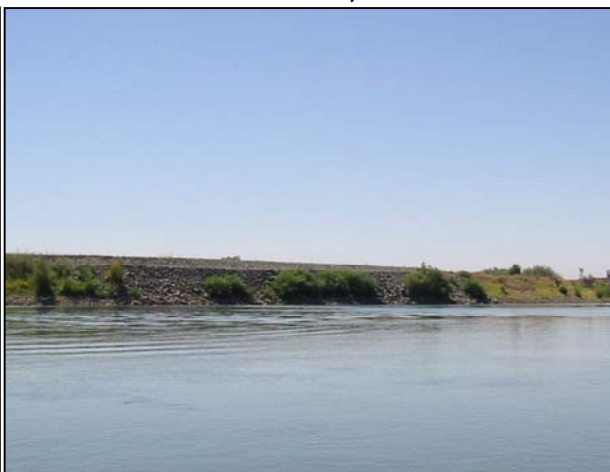
Sacramento River, RM 125.8L

New rock on this site, it does not appear to be an erosion site anymore. The rock appears to be falling into place and healing itself.

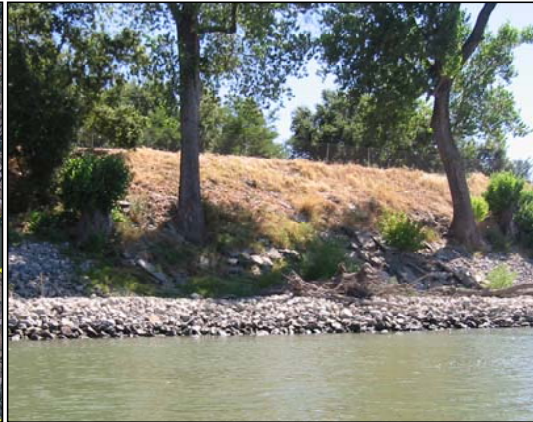
Criteria	Score	Notes
Bank Slope	4	1:1 slope
Berm Width - Estimated	5	no berm
Soil Type	3	sands
Velocity	3	4.5 ft/s (UNET model)
Economic Factor	20	Sacramento
Bank Stability	7	caves, treehazards, and slumping
Erosion Hazard	42	Flow on Inspection Day:

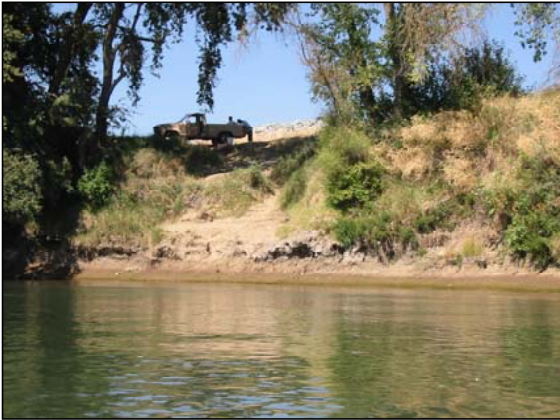
Criteria	Score	Notes
Bank Slope	4	1:1 or less slope
Berm Width - Estimated	3	0 to 15 ft
Soil Type	2	silts and clays
Velocity	3	4.7 ft/s (UNET model)
Economic Factor	18	Natomas
Bank Stability	7	beaver holes, tree hazards, seepage

Erosion Hazard 37

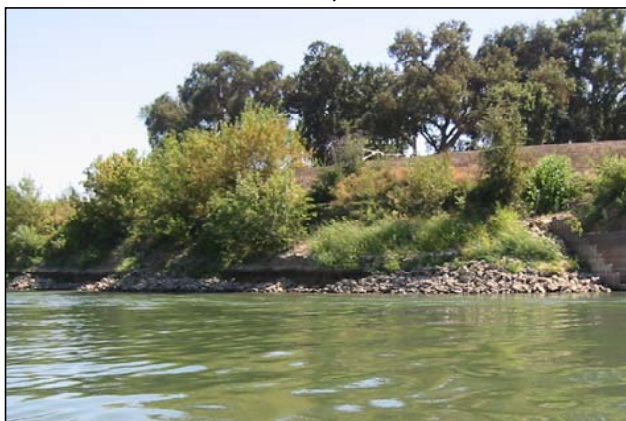
Sacramento River, RM 99.5R

Criteria	Score	Notes
Bank Slope	3	1.5:1 slope
Berm Width - Estimated	5	no berm
Soil Type	2	clays and silts
Velocity	2	4.2 ft/s (UNET model)
Economic Factor	19	Colusa Basin
Bank Stability	4	slumping
Erosion Hazard	35	Flow on Inspection Day:

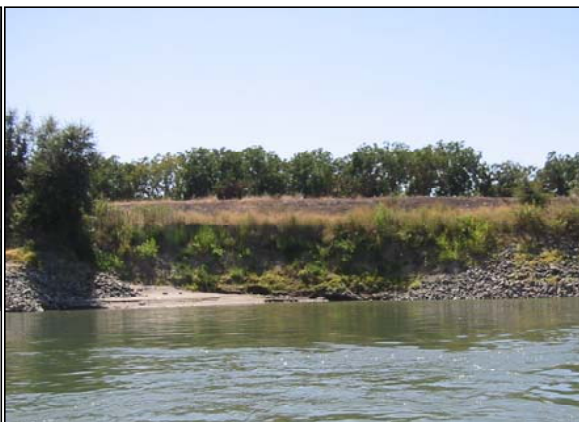
Criteria	Score	Notes
Bank Slope	4	1:1 or less
Berm Width - Estimated	3	5 to 9 ft
Soil Type	2	silty clay
Velocity	3	4.2 ft/s (UNET model) plus eddy currents
Economic Factor	19	Colusa Basin
Bank Stability	4	slumping
Erosion Hazard	35	Flow on Inspection Day:

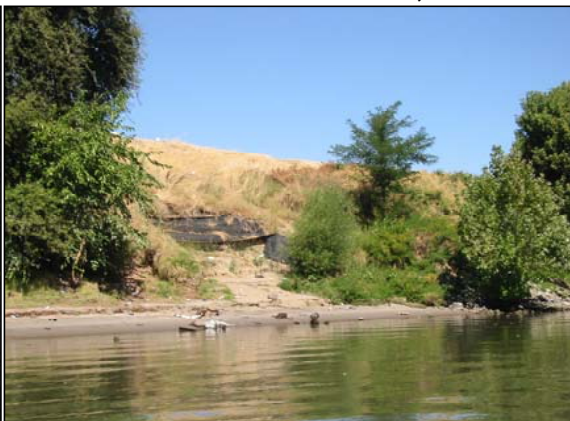
Criteria	Score	Notes
Bank Slope	4	1:1 slope
Berm Width - Estimated	5	no berm
Soil Type	3	sand
Velocity	3	4.5 ft/s (UNET model)
Economic Factor	11	South West Sacramento
Bank Stability	7	slumping, caves, and tree hazards
Erosion Hazard	33	Flow on Inspection Day:

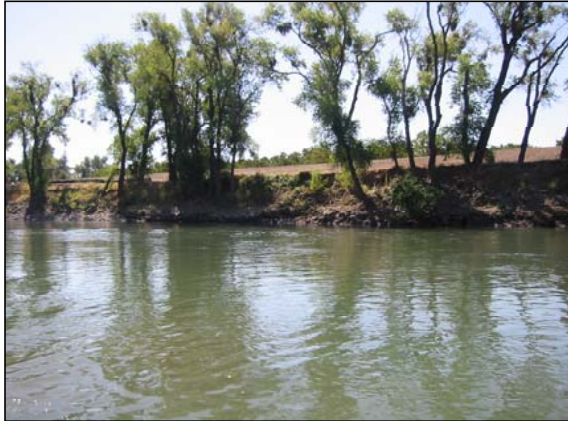
Criteria	Score	Notes
Bank Slope	3	1.5:1 slope
Berm Width - Estimated	2	10 to 12 ft
Soil Type	1	clays
Velocity	2	4.4 ft/s (UNET model)
Economic Factor	19	Colusa Basin
Bank Stability	6	tree hazards, slumping
Erosion Hazard	33	Flow on Inspection Day:

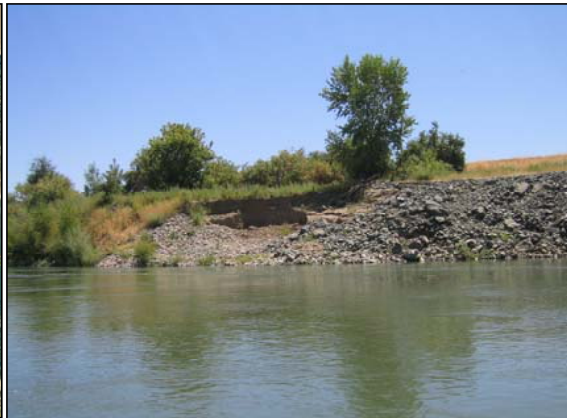
Criteria	Score	Notes
Bank Slope	5	near vertical
Berm Width - Estimated	1	20 to 30 ft
Soil Type	1	clays
Velocity	2	4.2 ft/s (UNET calculation)
Economic Factor	19	Colusa Basin
Bank Stability	4	slumping
Erosion Hazard	32	Flow on Inspection Day:

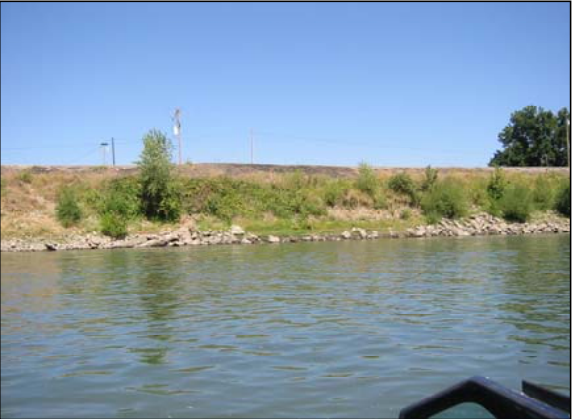
Site Photograph

(Score of 0 indicates no hazard, score of 48 maximum potential for levee failure)

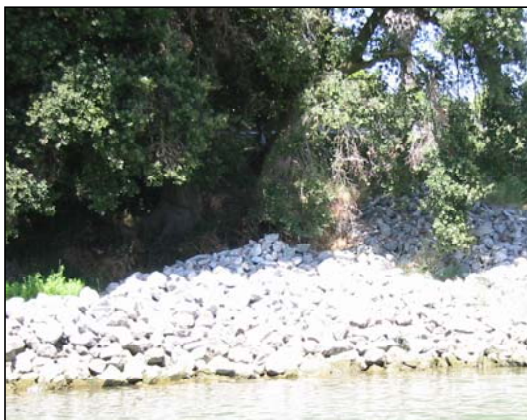
Site Photograph

Criteria	Score	Notes
Bank Slope	3	1.5:1 slope
Berm Width - Estimated	5	no berm
Soil Type	3	sand
Velocity	4	5.0 ft/s (UNET model)
Economic Factor	8	Grand Island
Bank Stability	0	no stability issues
Erosion Hazard	23	Flow on Inspection Day:

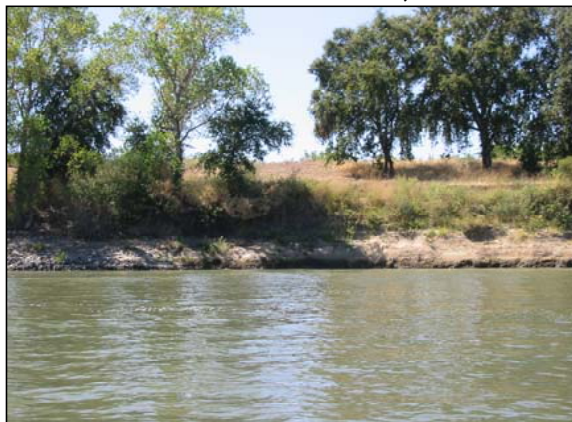
Site Photograph

Criteria	Score	Notes
Bank Slope	4	1:1 slope
Berm Width - Estimated	1	20 + feet
Soil Type	2	silts and clays
Velocity	3	4.7 ft/s (UNET model)
Economic Factor	6	Elkhorn
Bank Stability	7	tree hazards, minor slumping, caves
Erosion Hazard	23	Flow on Inspection Day:

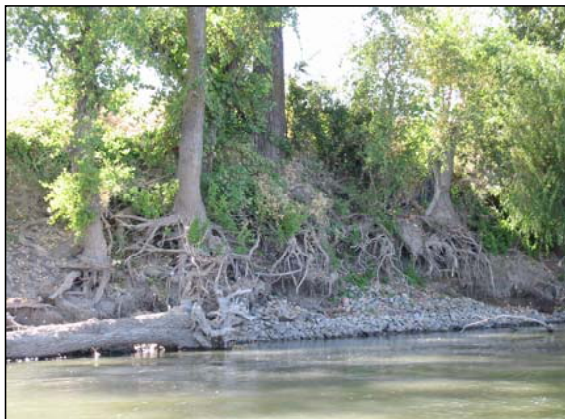
Site Photograph

Criteria	Score	Notes
Bank Slope	4	1:1 slope
Berm Width - Estimated	4	1 to 4 ft of berm
Soil Type	2	silts and clays
Velocity	3	4.5 ft/s (UNET model)
Economic Factor	2	Knight's Landing
Bank Stability	7	tree hazards, slumping, seepage, animal burrows
Erosion Hazard	22	Flow on Inspection Day:

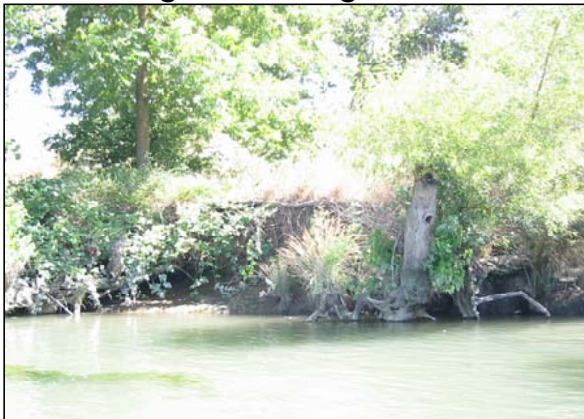
Site Photograph

Criteria	Score	Notes
Bank Slope	3	1.5:1 slope
Berm Width - Estimated	2	10 - 20 ft of berm
Soil Type	3	sand
Velocity	1	2 - 4 ft/s
Economic Factor	5	Tyler Island
Bank Stability	7	tree hazards, slumping, caves
Erosion Hazard	21	Flow on Inspection Day:

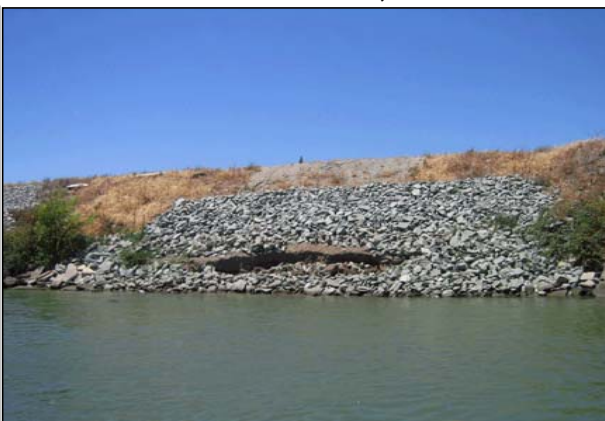
Site Photograph

Criteria	Score	Notes
Bank Slope	4	1:1 slope
Berm Width - Estimated	5	no berm
Soil Type	3	sand
Velocity	4	5.6 ft/s (UNET calculation)
Economic Factor	1	Merritt Island
Bank Stability	4	slumping
Erosion Hazard	21	Flow on Inspection Day:

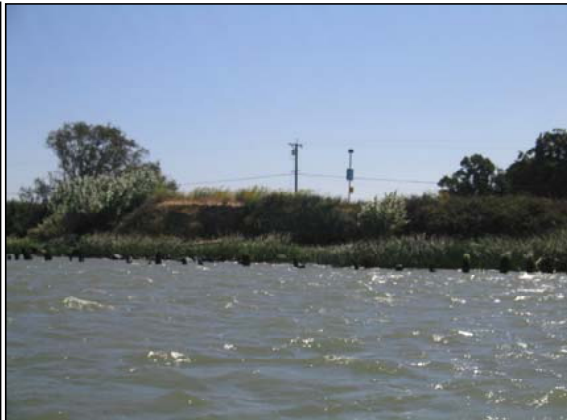
Site Photograph

Criteria	Score	Notes
Bank Slope	5	vertical
Berm Width - Estimated	3	8 - 10 ft (just below levee height)
Soil Type	1	vclay
Velocity	3	4.9 ft/s (UNET model)
Economic Factor	4	Sherman Island
Bank Stability	4	slumping
Erosion Hazard	20	Flow on Inspection Day:

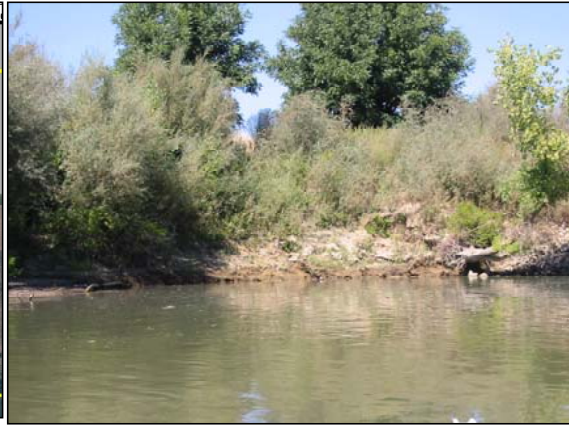
Site Photograph

Criteria	Score	Notes
Bank Slope	3	1.5:1 slope
Berm Width - Estimated	3	5 to 10 ft
Soil Type	2	silts and clays
Velocity	5	4.7 ft/s (UNET model) plus eddy currents
Economic Factor	6	Elkhorn
Bank Stability	0	no stability issues
Erosion Hazard	19	Flow on Inspection Day:

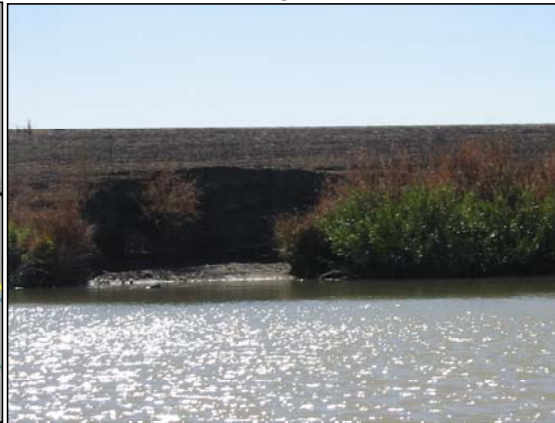
Site Photograph

Criteria	Score	Notes
Bank Slope	2	2:1 slope
Berm Width - Estimated	5	no berm
Soil Type	1	clay
Velocity	0	backwater, less than 2 ft/s
Economic Factor	1	Hastings Tract
Bank Stability	4	slumping
Erosion Hazard	13

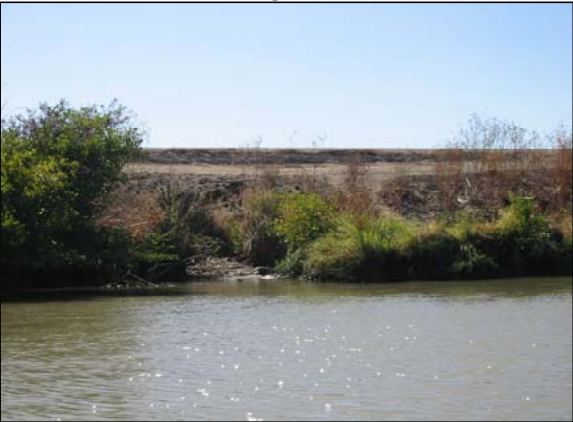
Site Photograph

Criteria	Score	Notes
Bank Slope	1	2.5:1 slope
Berm Width - Estimated	5	no berm
Soil Type	1	clay
Velocity	0	backwater, less than 2 ft/s
Economic Factor	1	Hastings Tract
Bank Stability	4	slumping
Erosion Hazard	12

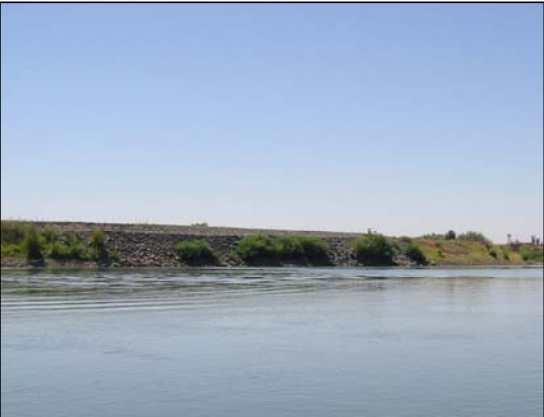
Site Photograph

New rock on this site, it does not appear to be an erosion site anymore. The rock appears to be falling into place and healing itself.

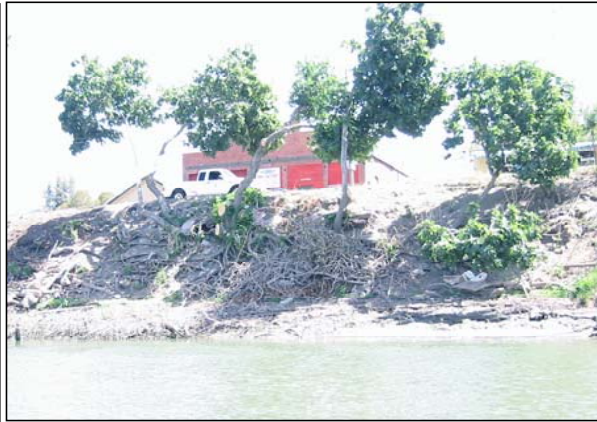
Site Photograph

Criteria	Score	Notes
Bank Slope	5	vertical
Berm Width - Estimated	5	no berm
Soil Type	3	sands
Velocity	3	4.9 ft/s (UNET model)
Bank Stability	7	tree hazards, slumping, tension cracks on road
Erosion Hazard	23	Flow on Inspection Day:

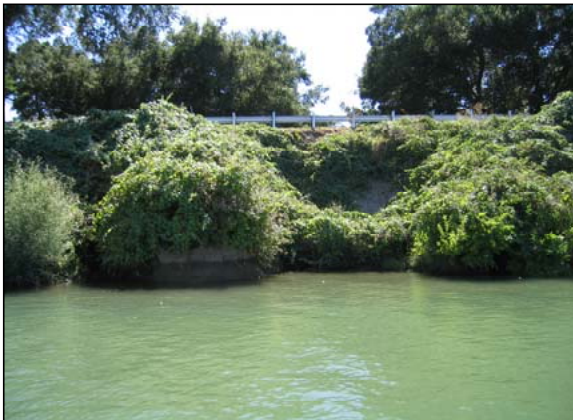
Site Photograph

Criteria	Score	Notes
Bank Slope	4	1:1 slope
Berm Width - Estimated	5	no berm
Soil Type	3	sands
Velocity	4	5.6 ft/s (UNET model)
Bank Stability	7	tree hazards, caves, slumping
Erosion Hazard	23
