APPENDIX

A.
Erosion Hazard Data Sheets
for
Methodology 1: 16 Physical Factors and One Economic
Factor

Erosion Hazard Data Sheets for Methodology 1: 16 Physical Factors and one Economic Factor

Sacramento River, RM 43.3R

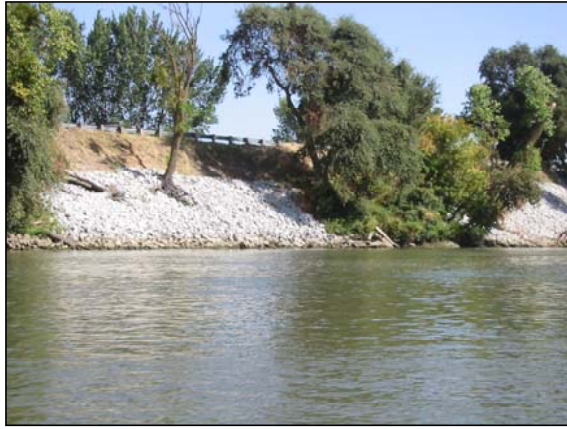
Site Photograph

Criteria	Pre-Rock	Post-Rock	Notes
Bank Slope	4	4	1:1 slope (even with added rock)
Berm Width - Estimated	5	5	no berm
Soil Type	3	3	sand
Velocity	4	4	5.4 ft/s (UNET model)
Bank Stability	7	6	tree hazards (still exist even with added rock), caves (filled in with rock), and slumping
Erosion Hazard	23	22	Flow on Inspection Day:

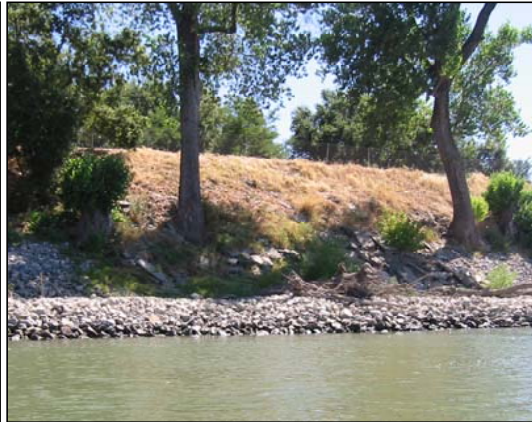
Site Photograph

Criteria	Score	Notes
Bank Slope	4	1:1 slope
Berm Width - Estimated	5	no berm
Soil Type	3	sands
Velocity	3	4.5 ft/s (UNET model)
Bank Stability	7	caves, treehazards, and slumping
Erosion Hazard	22	Flow on Inspection Day:

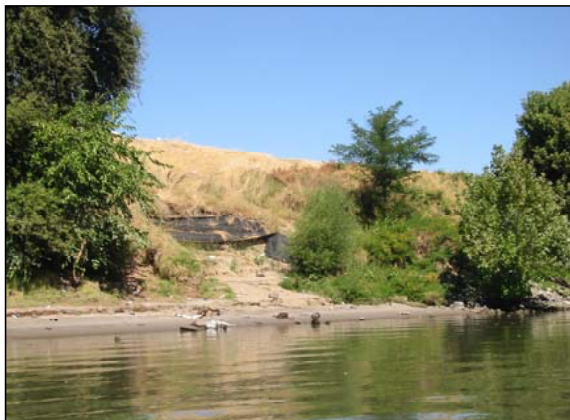
Site Photograph

Criteria	Score	Notes
Bank Slope	4	1:1 slope
Berm Width - Estimated	5	no berm
Soil Type	3	sand
Velocity	3	4.5 ft/s (UNET model)
Bank Stability	7	slumping, caves, and tree hazards
Erosion Hazard	22	Flow on Inspection Day:

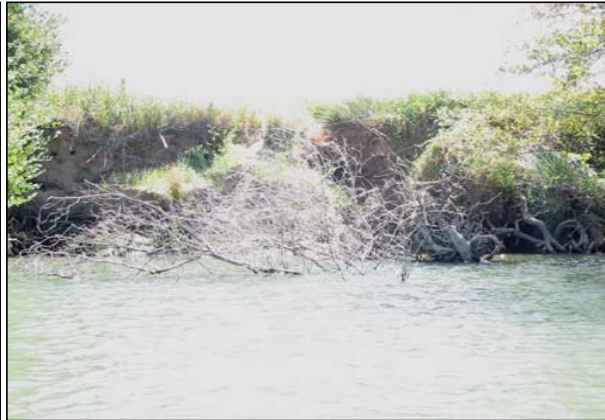
Site Photograph

Criteria	Score	Notes
Bank Slope	5	vertical
Berm Width - Estimated	3	0 - 20 ft
Soil Type	3	sand
Velocity	4	5.0 ft/s
Bank Stability	7	treehazards, caves, and slumping
Erosion Hazard	22	Flow on Inspection Day:

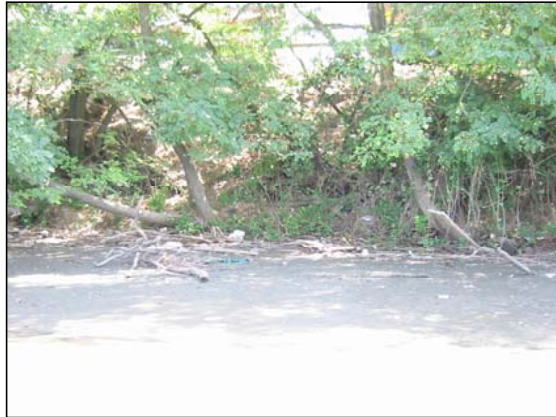
Site Photograph

Criteria	Score	Notes
Bank Slope	3	1.5:1 slope
Berm Width - Estimated	5	no berm
Soil Type	3	sands
Velocity	3	4.9 ft/s (UNET model)
Bank Stability	6	tree hazards, slumping
Erosion Hazard	20	Flow on Inspection Day:

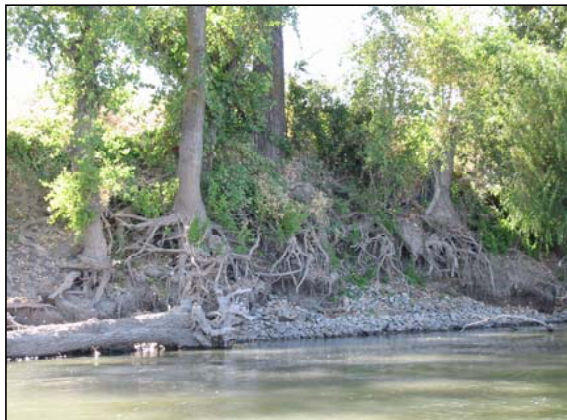
Site Photograph

Criteria	Score	Notes
Bank Slope	4	1:1 slope
Berm Width - Estimated	4	1 to 4 ft of berm
Soil Type	2	silts and clays
Velocity	3	4.5 ft/s (UNET model)
Bank Stability	7	tree hazards, slumping, seepage, animal burrows
Erosion Hazard	20	Flow on Inspection Day:

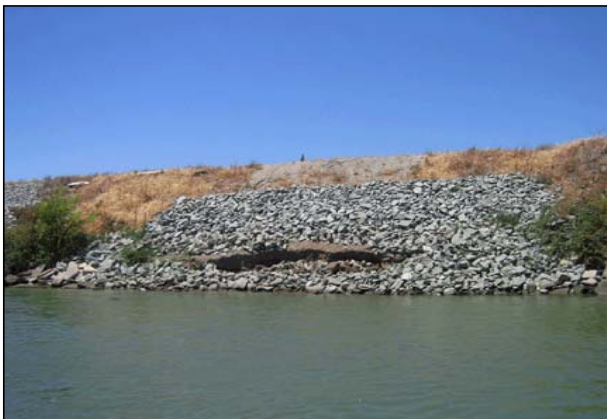
Site Photograph

Criteria	Score	Notes
Bank Slope	4	1:1 slope
Berm Width - Estimated	5	no berm
Soil Type	3	sand
Velocity	4	5.6 ft/s (UNET calculation)
Bank Stability	4	slumping
Erosion Hazard	20	Flow on Inspection Day:

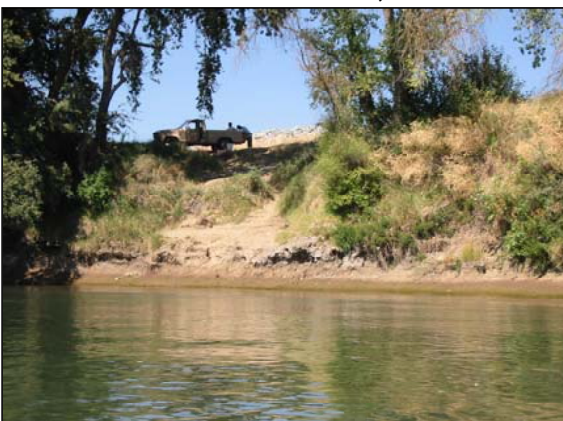
Site Photograph

Criteria	Score	Notes
Bank Slope	4	1:1 or less slope
Berm Width - Estimated	3	0 to 15 ft
Soil Type	2	silts and clays
Velocity	3	4.7 ft/s (UNET model)
Bank Stability	7	beaver holes, tree hazards, seepage
Erosion Hazard	19

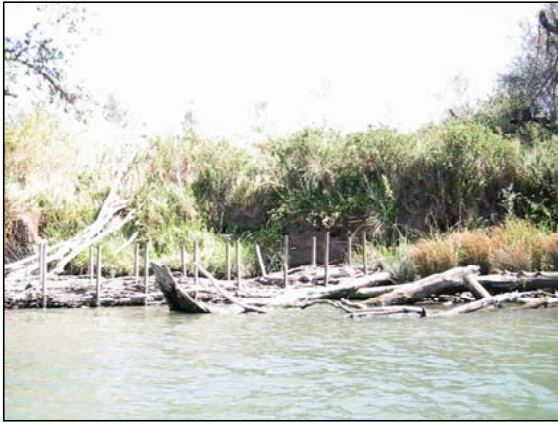
Site Photograph

Criteria	Score	Notes
Bank Slope	3	1.5:1 slope
Berm Width - Estimated	5	no berm
Soil Type	3	sand
Velocity	2	4.4 ft/s (UNET model)
Bank Stability	6	trees, slumping
Erosion Hazard	19

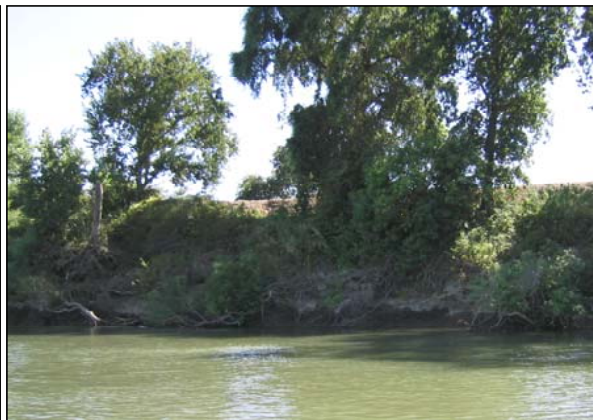
Site Photograph

Criteria	Score	Notes
Bank Slope	4	1:1 slope
Berm Width - Estimated	4	little berm
Soil Type	2	silts and clays
Velocity	3	4.7 ft/s (UNET model)
Bank Stability	6	slumping and tree hazards
Erosion Hazard	19	Flow on Inspection Day:

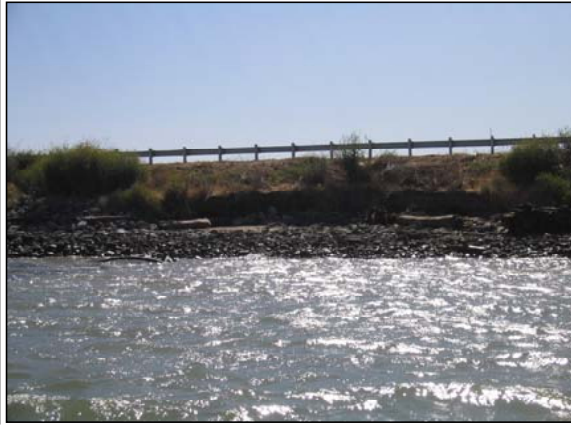
Site Photograph

Criteria	Score	Notes
Bank Slope	4	1:1 slope
Berm Width - Estimated	5	no berm
Soil Type	1	clays and toe rock
Velocity	5	6.8 ft/s (UNET model)
Bank Stability	3	tension cracks

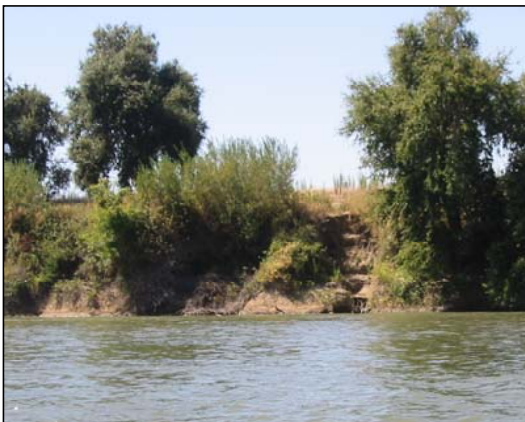
Site Photograph

Criteria	Score	Notes
Bank Slope	5	near vertical
Berm Width - Estimated	2	12 - 15 ft
Soil Type	2	silty clay
Velocity	3	4.7 ft/s (UNET model)
Bank Stability	6	tree hazards and slumping
Erosion Hazard	18	Flow on Inspection Day:

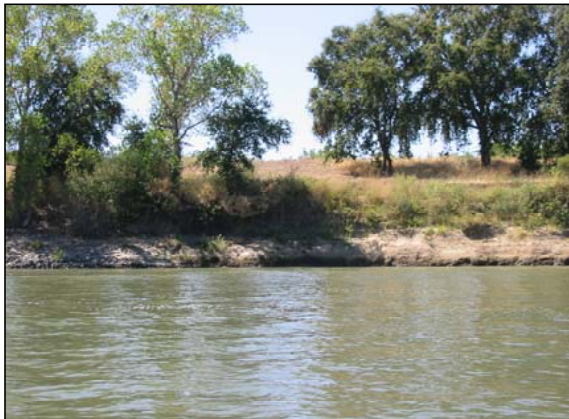
Site Photograph

Criteria	Score	Notes
Bank Slope	4	1:1 slope
Berm Width - Estimated	1	20 + feet
Soil Type	2	silts and clays
Velocity	3	4.7 ft/s (UNET model)
Bank Stability	7	tree hazards, minor slumping, caves
Erosion Hazard	17	Flow on Inspection Day:

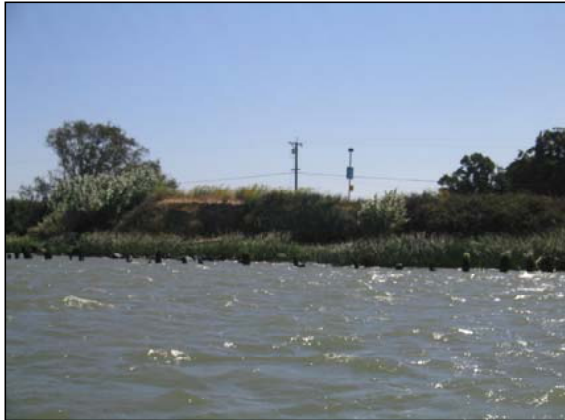
Site Photograph

Criteria	Score	Notes
Bank Slope	5	vertical
Berm Width - Estimated	3	8 - 10 ft (just below levee height)
Soil Type	1	vclay
Velocity	3	4.9 ft/s (UNET model)
Bank Stability	4	slumping
Erosion Hazard	16	Flow on Inspection Day:

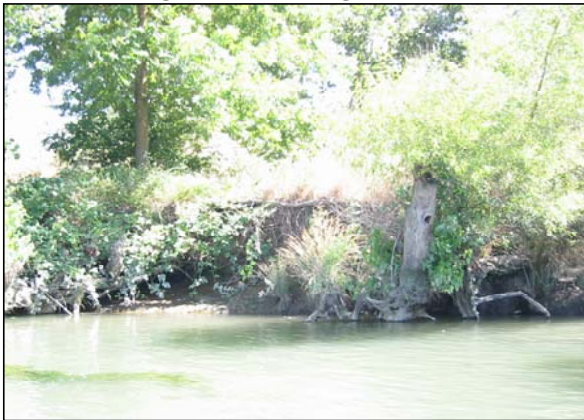
Site Photograph

Criteria	Score	Notes
Bank Slope	3	1.5:1 slope
Berm Width - Estimated	2	10 - 20 ft of berm
Soil Type	3	sand
Velocity	1	2 - 4 ft/s
Bank Stability	7	tree hazards, slumping, caves
Erosion Hazard	16	Flow on Inspection Day:

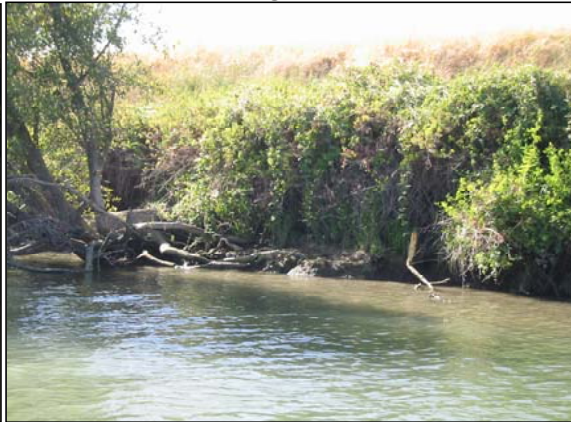
Site Photograph

Criteria	Score	Notes
Bank Slope	3	1.5:1 slope
Berm Width - Estimated	5	no berm
Soil Type	1	clays
Velocity	0	backwater, less than 2 ft/s
Bank Stability	7	tree hazards, holes, and slumping
Erosion Hazard	16	Flow on Inspection Day:

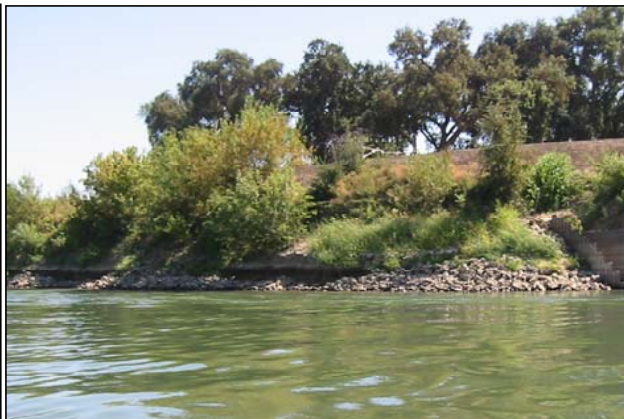
Site Photograph

Criteria	Score	Notes
Bank Slope	3	1.5:1 slope
Berm Width - Estimated	5	no berm
Soil Type	2	clays and silts
Velocity	2	4.2 ft/s (UNET model)
Bank Stability	4	slumping
Erosion Hazard	16	Flow on Inspection Day:

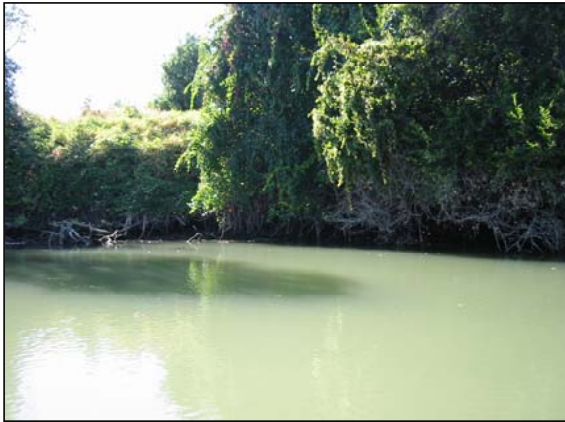
Site Photograph

Criteria	Score	Notes
Bank Slope	4	1:1 slope
Berm Width - Estimated	5	no berm
Soil Type	1	clays
Velocity	0	backwater, less than 2 ft/s
Bank Stability	6	tree hazards, slumping
Erosion Hazard	16

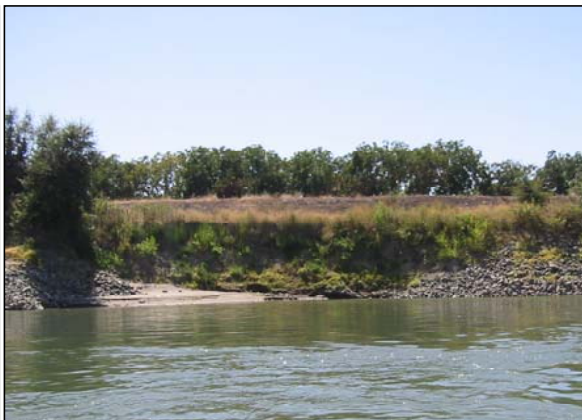
Site Photograph

Criteria	Score	Notes
Bank Slope	4	1:1 or less
Berm Width - Estimated	3	5 to 9 ft
Soil Type	2	silty clay
Velocity	3	4.2 ft/s (UNET model) plus eddy currents
Bank Stability	4	slumping
Erosion Hazard	16	Flow on Inspection Day:

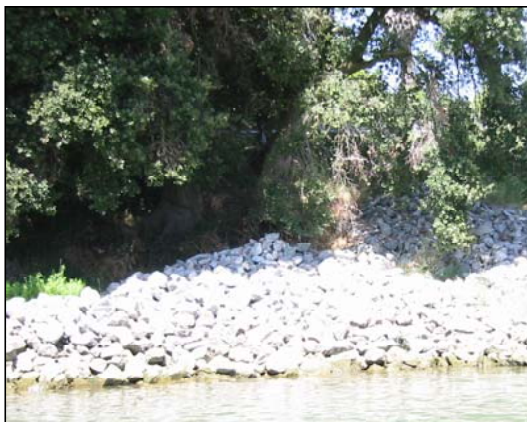
Site Photograph

Criteria	Score	Notes
Bank Slope	3	1.5:1 slope
Berm Width - Estimated	5	no berm
Soil Type	3	sand
Velocity	4	5.0 ft/s (UNET model)
Bank Stability	0	no stability issues
Erosion Hazard	15	Flow on Inspection Day:

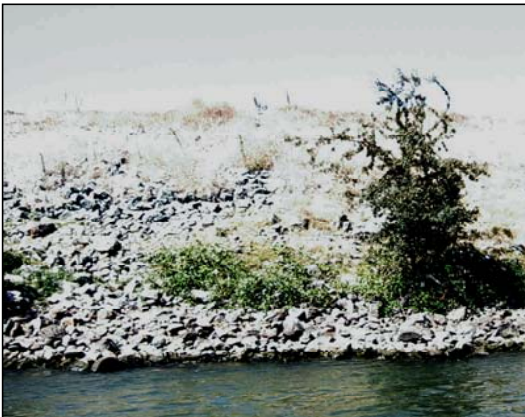
Site Photograph

Criteria	Score	Notes
Bank Slope	3	1.5:1 slope
Berm Width - Estimated	5	no berm
Soil Type	3	sand
Velocity	4	5.4 ft/s (UNET model)
Bank Stability	0	no stability issues
Erosion Hazard	15	Flow on Inspection Day:

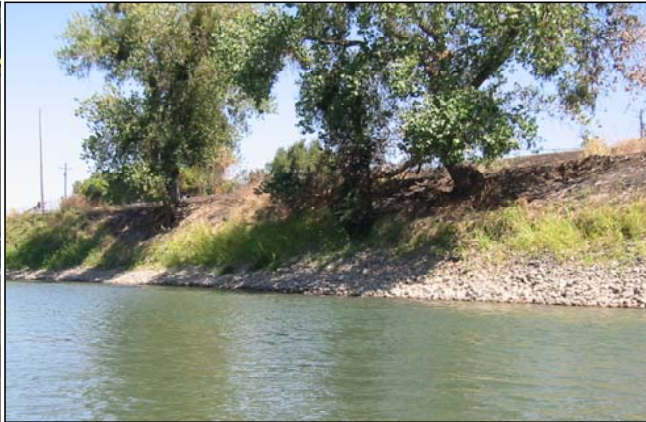
Site Photograph

Criteria	Score	Notes
Bank Slope	3	1.5:1 slope
Berm Width - Estimated	2	10 to 20 ft
Soil Type	1	clay
Velocity	3	4.5 ft/s (UNET model)
Bank Stability	6	tree hazards, slumping
Erosion Hazard	15

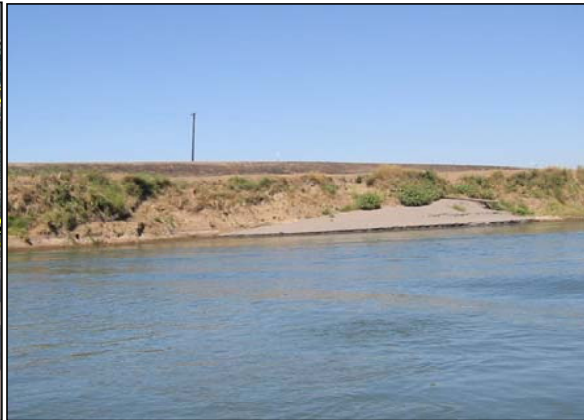
Site Photograph

Criteria	Score	Notes
Bank Slope	4	1:1 slope
Berm Width - Estimated	1	25 ft
Soil Type	2	clays and silts
Velocity	2	4.2 ft/s (UNET model)
Bank Stability	6	animal holes and slumping
Erosion Hazard	15	Flow on Inspection Day:

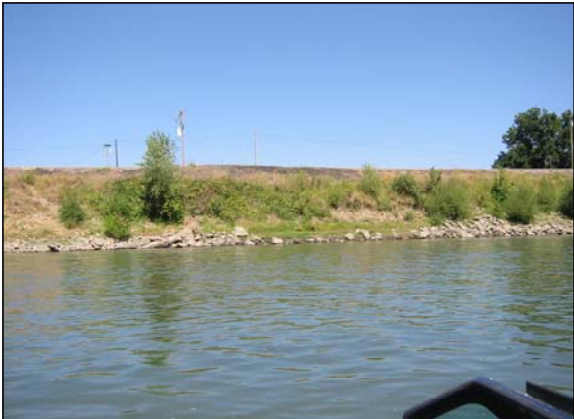
Site Photograph

Erosion Hazard	15	Flow on Inspection Day:
-----------------------	-----------	-------------------------

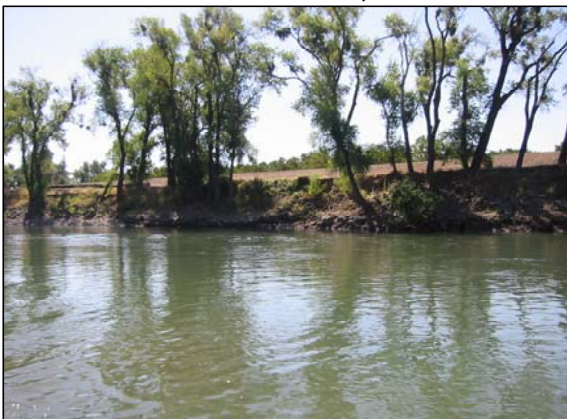
Site Photograph

Criteria	Score	Notes
Bank Slope	3	1.5:1 slope
Berm Width - Estimated	2	10 to 12 ft
Soil Type	1	clays
Velocity	2	4.4 ft/s (UNET model)
Bank Stability	6	tree hazards, slumping
Erosion Hazard	14	Flow on Inspection Day:

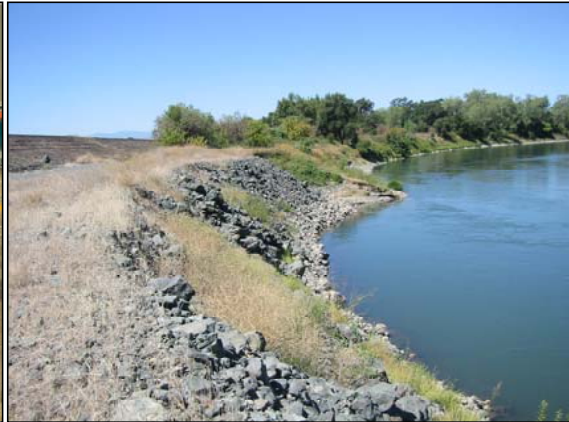
Site Photograph

Criteria	Score	Notes
Bank Slope	4	1:1 slope
Berm Width - Estimated	2	15 ft
Soil Type	2	clays and silts
Velocity	2	4.2 ft/s
Bank Stability	4	slumping
Erosion Hazard	14	Flow on Inspection Day:

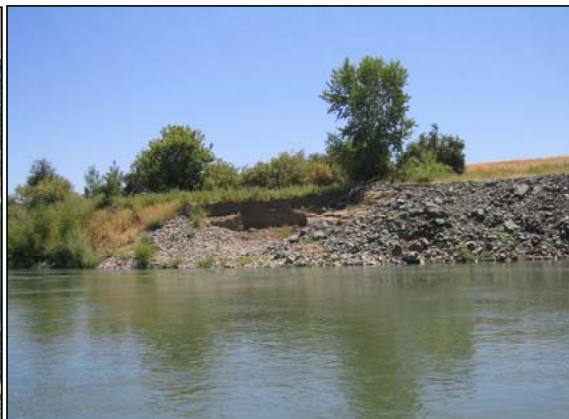
Site Photograph

Criteria	Score	Notes
Bank Slope	5	near vertical
Berm Width - Estimated	1	20 to 30 ft
Soil Type	1	clays
Velocity	2	4.2 ft/s (UNET calculation)
Bank Stability	4	slumping
Erosion Hazard	13	Flow on Inspection Day:

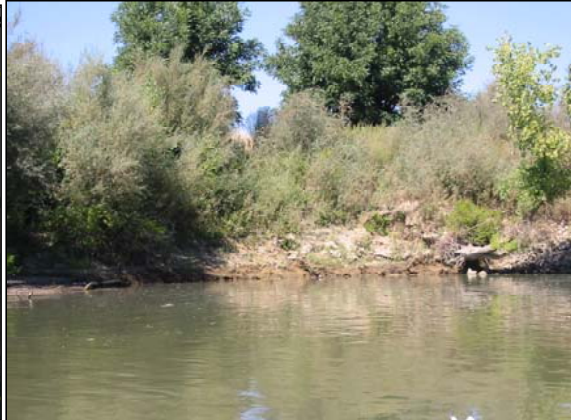
Site Photograph

Erosion Hazard	13	Flow on Inspection Day:
-----------------------	-----------	--------------------------------

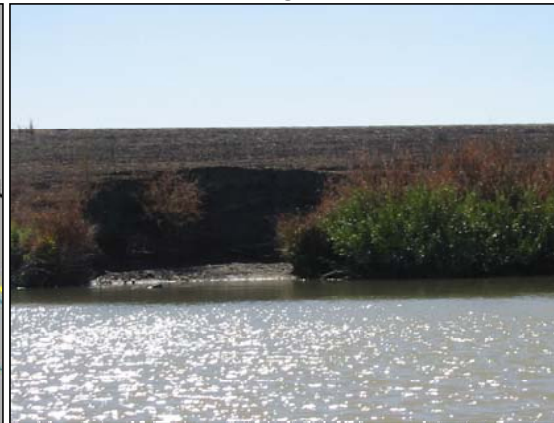
Site Photograph

Criteria	Score	Notes
Bank Slope	2	2:1 slope
Berm Width - Estimated	5	no berm
Soil Type	1	clay
Velocity	0	backwater, less than 2 ft/s
Bank Stability	4	slumping
Erosion Hazard	12

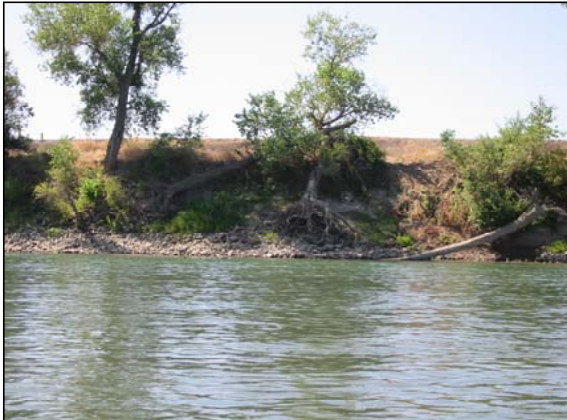
Site Photograph

Criteria	Score	Notes
Bank Slope	4	1:1 or less
Berm Width - Estimated	2	10 to 19 ft of berm
Soil Type	1	clays
Velocity	3	4.5 ft/s (UNET model)
Bank Stability	1	tree hazards
Erosion Hazard	11

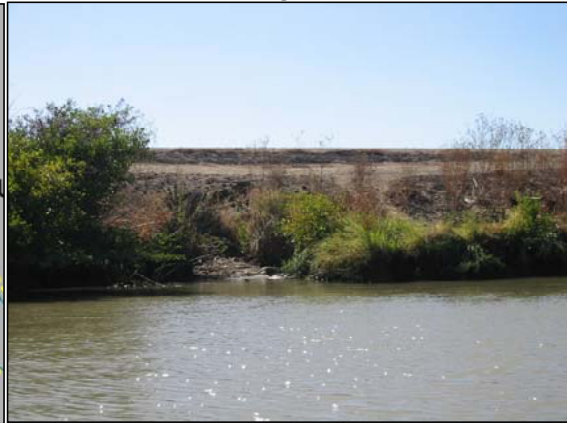
Site Photograph

Criteria	Score	Notes
Bank Slope	1	2.5:1 slope
Berm Width - Estimated	5	no berm
Soil Type	1	clay
Velocity	0	backwater, less than 2 ft/s
Bank Stability	4	slumping
Erosion Hazard	11

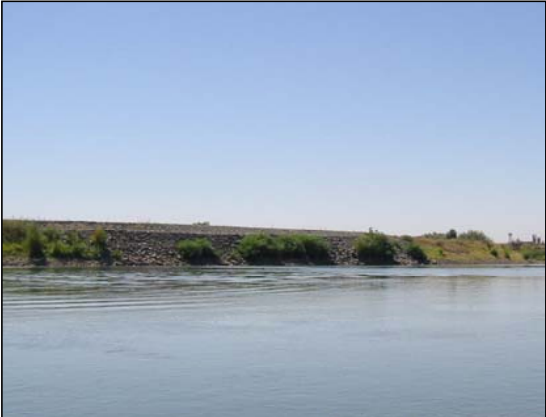
Site Photograph

New rock on this site, it does not appear to be an erosion site anymore. The rock appears to be falling into place and healing itself.

Erosion Hazard	0	Flow on Inspection Day:
----------------	---	-------------------------
