OPERATING EXPERIENCE SUMMARY

U.S. Department of Energy
Office of Environment, Safety and Health
OE Summary 2005-01
January 10, 2005

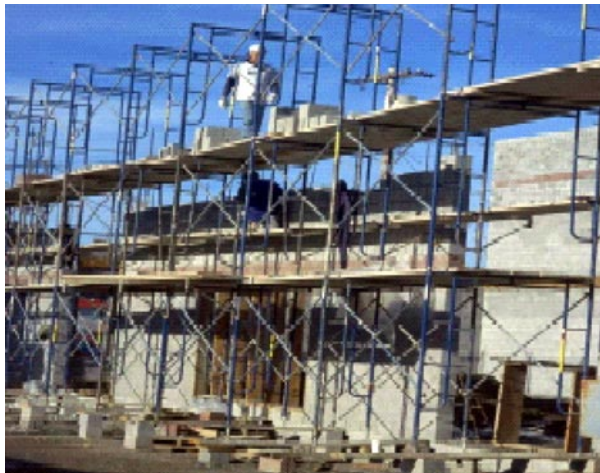
Figure 1-1. Typical worker on scaffold

On November 15, 2004, another near miss occurred at the Hanford WTP construction site when a worker on a scaffold dropped a 7-foot-long angle iron, which fell 55 feet and landed in an occupied area. As the angle iron fell, it hit a workstation at ground level, narrowly missing a worker. Investigators discovered that workers had become complacent about the yellow boundary tape and routinely crossed the boundary to perform work. In addition, the worker on the scaffold did not have complete control over the angle iron and had allowed it to slide and drop 10 or 12 inches before it actually fell. (ORPS Report RP--BNRP-RPPWTP-2004-0029)

On November 2, 2004, at Hanford’s WTP construction site, workers on a 30-foot-high scaffold dropped a scaffolding clamp, narrowly missing an employee on the ground. Investigators determined that the scaffold workers had not followed normal procedure and had loosened both sides of the clamp instead of just one, allowing the clamp to fall. Also, workers had crossed the yellow boundary tape into the area below overhead work and no one prevented them from doing so. (ORPS Report RP--BNRP-RPPWTP-2004-0026)

- Secure tools and materials to prevent them from falling on people below.
- Barricade hazard areas and post warning signs.
- Use toeboards, screens, or guardrails on scaffolds to prevent falling objects.
- Alternatively, use debris nets, catch platforms, or canopies to catch or deflect falling objects.
- Personnel working below should wear hard hats.

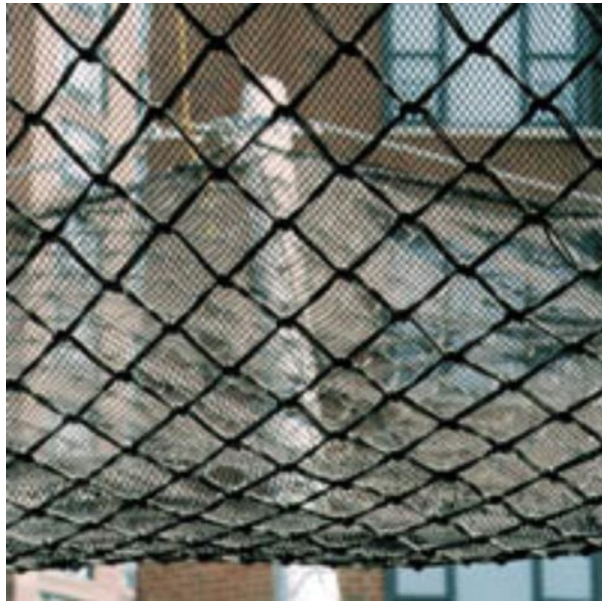
Subpart L of 29 CFR 1926 provides requirements for maintaining control of tools while working on scaffolds, including the use of toeboards and netting (Figure 1-2). It also requires installing barricades below work areas and requires employees to remain clear of the hazard area.

Figure 1-2. Typical debris net

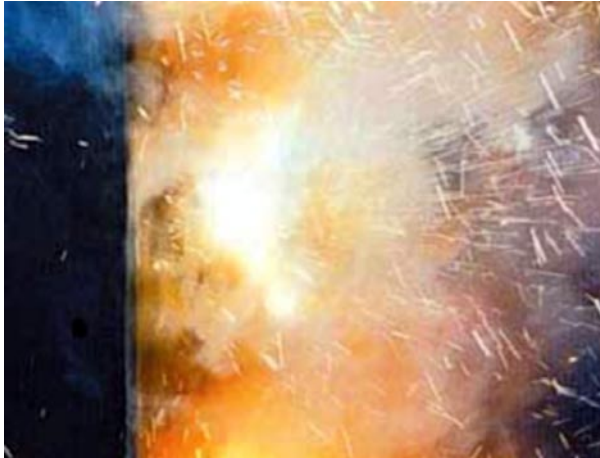
When insulation or isolation between energized conductors is breached or can no longer handle the applied voltage, an arc flash (Figure 3-4) can occur. The temperatures can reach 35,000° Fahrenheit, causing direct burns to the skin and igniting clothing.

Figure 3-4. An electrical arc flash test

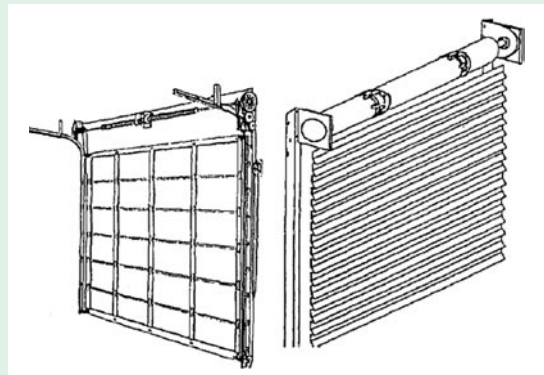
An overhead door (Figure 4-2a) is made up of a number of large panels that are hinged horizontally with rollers mounted at each end. The rollers ride in tracks attached to the building. These tracks run vertically to a certain point from the floor and then turn horizontally. As the door is raised, it is displaced overhead. The door's weight is counterbalanced with torsion springs attached to a steel shaft mounted to the wall above the door opening (see Figure 4-3). At the shaft ends are cable spools or drums that hold the cable that connects the shaft to the bottom of the door. Force is transferred to the cable, creating a lift that neutralizes the excessive door weight when the correct amount of torsion is placed on the spring. Turning the shaft that these springs are attached to will raise the door. The shaft of both the overhead door and rollup doors may be turned either electrically or manually.

Figure 4-2a and 4-2b. Overhead (left) and rollup (right) doors

A rollup door consists of a curtain of metal slats that roll up around a tube or a shaft as it is raised (see Figure 2b). This tube contains torsion springs, much like those used for the overhead door, which counterbalance the curtain weight. The metal slats comprising this curtain are variously shaped depending on the manufacturer, but all are relatively small to allow the curtain to roll into a small cylinder when raised. The curtain is attached to the shaft by several metal collars that bolt to the curtain, then wrap around the shaft and bolt to it. Both ends of the slats are inserted in tracks mounted to the building. Normally there is a chain-operated gear reduction assembly used to turn the shaft that raises the door. There are many assembly variations—direct gear, power-driven, and gear reduction, to name a few.

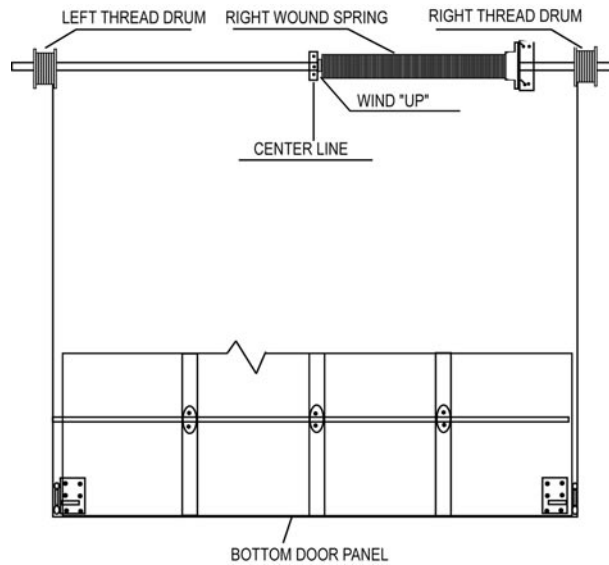
Figure 4-3. Overhead door counterbalance assembly

The site immediately reviewed all other active work control documents to verify that they contained adequate instructions on identifying potential hazards for work that involved or could involve stored energy. Three of 37 work packages reviewed did not adequately address stored energy issues and were updated accordingly.
