OPERATING EXPERIENCE SUMMARY

U.S. Department of Energy
Office of Environment, Safety and Health
OE Summary 2005-06
March 21, 2005

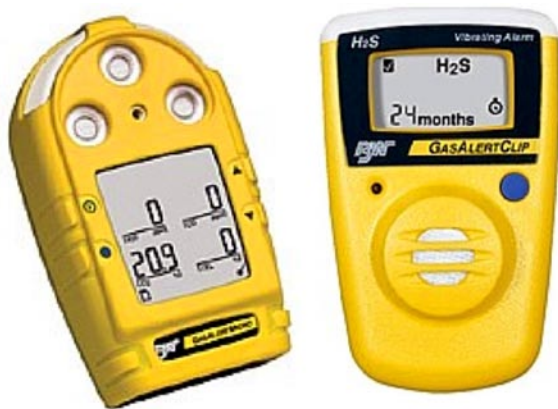
In the third event, Coast Guard members of a law enforcement team were inspecting a vessel carrying high-sulfur-content coal. Normally, the Coast Guard equips its team members with Gas Alert Clips or their Gas Alert Micros (illustrated in Figure 3-1); however, the team brought neither with them. The boarding officer and a ship's crewmember entered a small watertight hatch leading to the cargo area (an enclosed space). The boarding officer noticed a strange taste and smell, began to have difficulty breathing, and quickly left the space with the crewmember. The boarding officer, gasping for breath, stated that he felt disoriented and dizzy for about a minute.

Figure 3-1. Gas Alert Micro (left) and Gas Alert Clip detectors

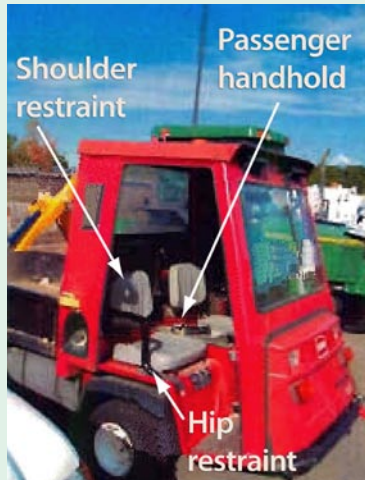
Two grounds employees were riding around the site in a newly purchased Toro Workman that had been delivered to the site about 2 weeks earlier. A rollover protection system (ROPS), seat belts, and hip restraints were standard, factory-installed equipment on the vehicle; but, unlike earlier Workman models, the ROPS on the new model was not equipped with shoulder restraints. Figures 4-1a and 4-1b show both models and how the safety features differ between the two.

Figure 4-1a. Older model Toro Workman used onsite

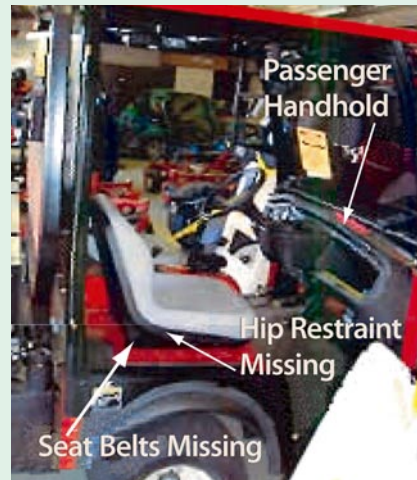
When the accident occurred, both the factory-installed seat belts and the hip restraints were missing from the vehicle. Two glass latching side doors had also been removed for comfort during warm weather and because of post-delivery concerns about potential carbon monoxide buildup in the cab if the vehicle was idling for any length of time. Figure 4-2 shows the vehicle at the accident scene.

Figure 4-1b. New Toro Workman 3200

The cab and heater ordered for the Workman 3200 were not factory-installed. Instead, they were installed by a regional distributor following procedures in a Toro-provided installation manual. The manual indicated that the seats and seat-mounting hardware were to be removed before installing the cab and heater, then re-installed in the reverse order. Although there were no seatbelts in the vehicle when the accident occurred, investigators did find evidence (missing/scratched paint) that the bolt securing the seatbelts had been installed at the factory.
