# OPERATING EXPERIENCE SUMMARY

**U.S. Department of Energy**  
**Office of Environment, Safety and Health**  
OE Summary 2005-07  
April 11, 2005

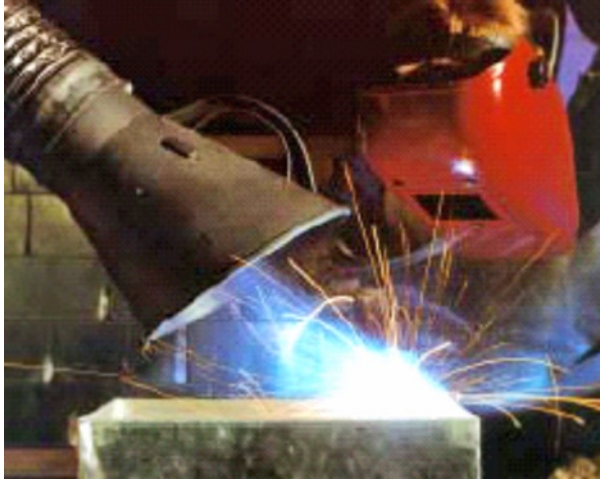
*Figure 1-1. Using local exhaust ventilation at the work piece*

the effectiveness of engineered controls and the use of adequate respiratory protection for welders. SMAW welding on stainless steel and high-chromium nickel alloys can produce high breathing zone exposures for CrVI. However, properly positioned exhaust ventilation can significantly reduce welder exposure.

- Use local exhaust ventilation and fume extraction welding guns to keep the breathing zone clear of particles and fumes.
- Ensure that exhaust-capture nozzles are properly placed and not too far from the workpiece, thus allowing fumes to remain in the breathing zone.
- Use a helmet and position the head to minimize exposure to fumes in the breathing zone.
- Wear appropriate respiratory protection.
- Use special care when welding in a confined space and provide additional ventilation/exhaust as necessary.
- Sample and monitor breathing air zone for concentration of contaminants.
- Read the MSDS for electrodes, and heed any warnings on the electrode container (e.g. electrodes containing chromium and manganese).
- Select materials that minimize chromium.

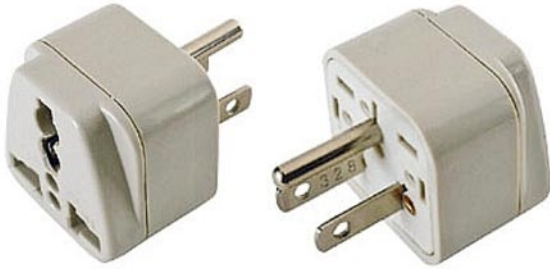
While investigators were still in the room, its occupant, a recently hired scientist who had visited Brookhaven before, returned. After the investigators explained what had happened, the scientist apologized and explained that he tried to obtain an adapter (Figure 2-3) but was unable to find one in local stores.

**Figure 2-3. A European-to-U.S. adapter**

The organization responsible for residence housing inspected all residence buildings for evidence of altered power cords or receptacles. The Laboratory issued a memorandum to all onsite residents informing them that power cords and receptacles are not to be modified. It also provided locations where approved adapters could be purchased. The memorandum will be included in welcome packets for onsite visitors as well.

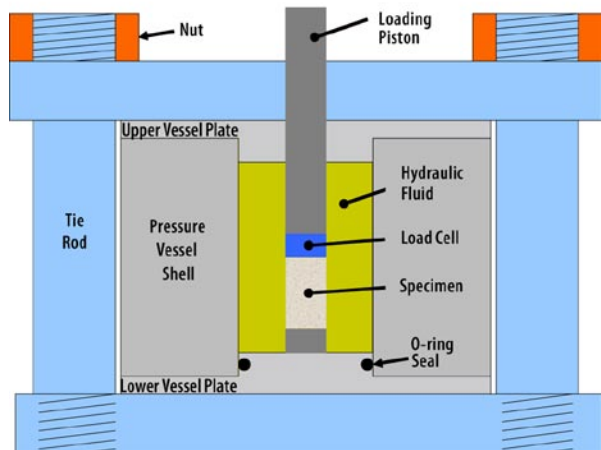
The steel pressure vessel stands about 30-inches tall, is 15 inches in diameter, was proof-tested to 71,000 psi and has a maximum allowable working pressure of 91,000 psi. The vessel consists of a shell, upper plate, and lower plate. During operation (sample testing), the upper and lower plates are clamped to the shell by 10 bolted tie rods. Sample material is placed inside the vessel shell (filled with hydraulic oil) and is pressurized by an intensifier. The sample can also be loaded in the vertical (axial) direction, using a loading piston that passes through the top of the pressure vessel and transferring vertical force from the reaction frame to the sample. Figure 3-1 is a diagram of the properly configured pressure vessel.

**Figure 3-1. Diagram of pressure vessel in normal configuration for sample testing**
