# OPERATING EXPERIENCE SUMMARY

U.S. Department of Energy  
Office of Health, Safety and Security  
OE Summary 2006-11  
October 6, 2006

## Inadequate Work Package Results in Water Hammer in Steam System

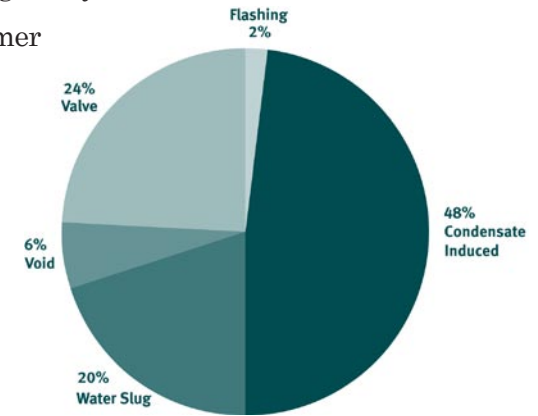
**Figure 1-3. Types of water hammer events**

Condensate-induced water hammer is the most frequently reported type of water hammer at DOE facilities. Figure 1-3 shows the distribution of water hammer occurrences reported in ORPS from January 1990 through July 2006.

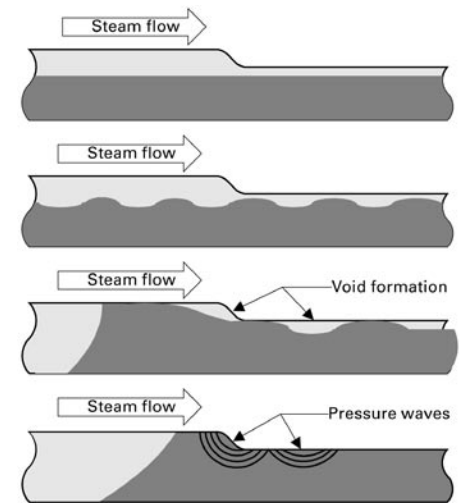
**Figure 1-4. Condensate-induced water hammer in a horizontal pipe**

Condensate-induced water hammer is caused by rapid condensation of steam by subcooled water. The most common type of condensate-induced water hammer is caused by steam flowing over subcooled water. The flow of steam causes ripples in the water surface. If these ripples touch the top of the pipe, a pocket of steam can momentarily be sealed off, which then condenses and collapses, causing a pressure wave (Figure 1-4).
