# OPERATING EXPERIENCE SUMMARY

**U.S. Department of Energy**  
**Office of Environment, Safety and Health**  
OE Summary 2004-08  
April 19, 2004

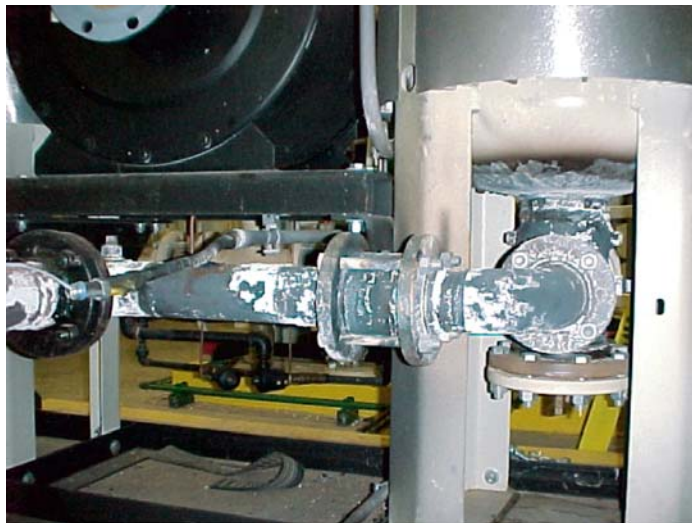
On August 28, 2003, at the Pantex Plant, vapors from accumulated oil in a compressed air system dryer ignited causing a fire inside the piping system. The fire self-extinguished when the oil was consumed. A utilities operator and his supervisor discovered the problem while responding to a low air pressure alarm in the compressed air facility. The supervisor, who heard air leaking and smelled hot paint, immediately called the fire department. Firefighters found no smoke or fire but several components of the compressed air system showed signs of extreme heat, such as burning paint from the lower section of the dryer, a filter housing, and connecting piping. A combination of no preventive maintenance and inattentive maintenance contributed to this incident. (ORPS Report ALO-AO-BWXP-PANTEX-2003-0043; final report filed January 12, 2004)

*Figure 3-1. Fire-damaged bottom of dryer and piping*

Investigators determined that an equipment problem was the direct cause of this event. Excessive oil traveled from the air compressor and accumulated downstream of the filter, receiver, and separator, which is designed to remove oil from the compressed air. Forced hot air (400°F to 425°F) was sufficient to ignite oil vapors in the piping near the downstream exit of the drying tower, resulting in a brief but hot fire. Investigators identified the following three contributing causes for this event.

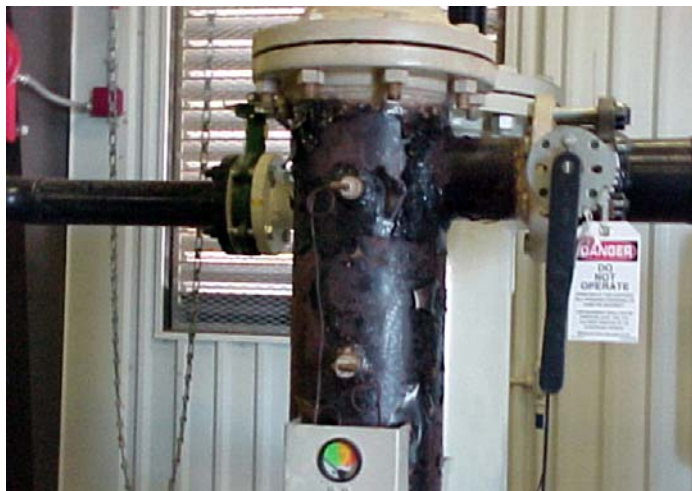
The fire burned from the lower portion of the tower in one direction and traveled through a check valve into the compressed air stream flowing from the east tower. The fire continued to burn through several gaskets in pipe joints and also traveled downstream into a particulate filter (Figure 3-2).

**Figure 3-2. Fire-damaged filter housing**
