Ruins Stabilization in the Southwestern United States

Publications in Archeology 10

National Park Service

U. S. Department of the Interior
Washington 1974

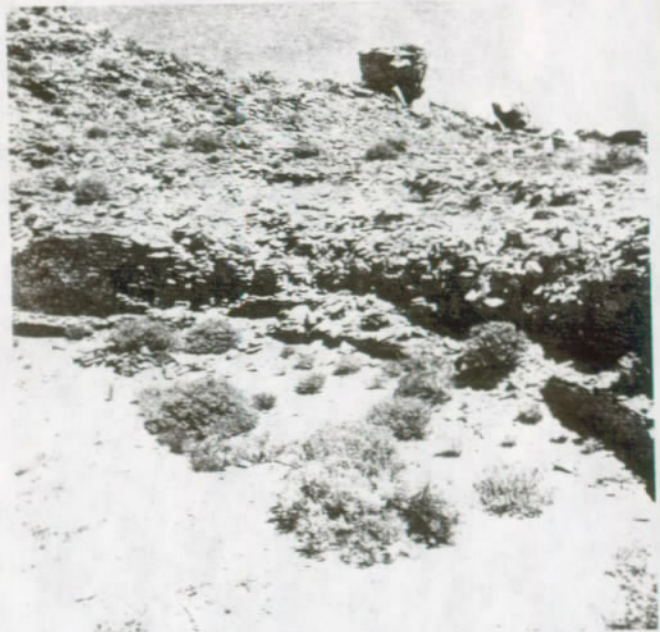
Regardless of the condition in which standing walls are found, it must be remembered that the entire depth of the wall is seldom exposed, and that the exposed portions—which form a base over which the stabilization is being done—have been subject to nearly all the forces listed above, i.e., surface weathering, construction over loose fill or partial walls, breakdown or theft of wood members, erosion at the base, buckling from pressure, excavation, and backfill (fig. 5).

FIGURE 5. Clearing of depressed areas leaves them open to surface runoff and rapid destruction. (The Great Kiva, Kin Nahasbas Ruin, Chaco Canyon National Monument, N. M.)

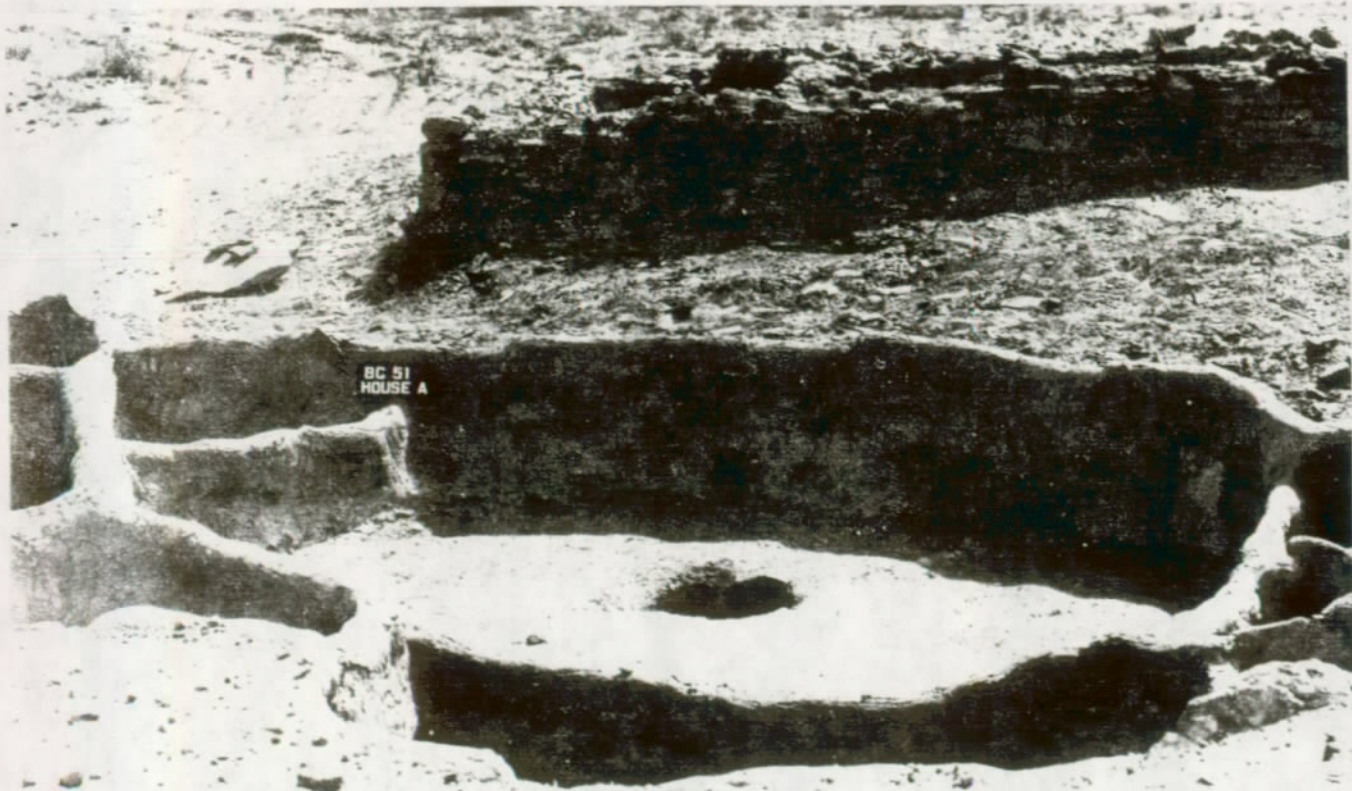
FIGURE 9. Soil-cement in heavy cross section; shown here for the repair of slab-house walls. (Basket Maker III pithouse, Site Bc-51, Chaco Canyon National Monument, N. M.)

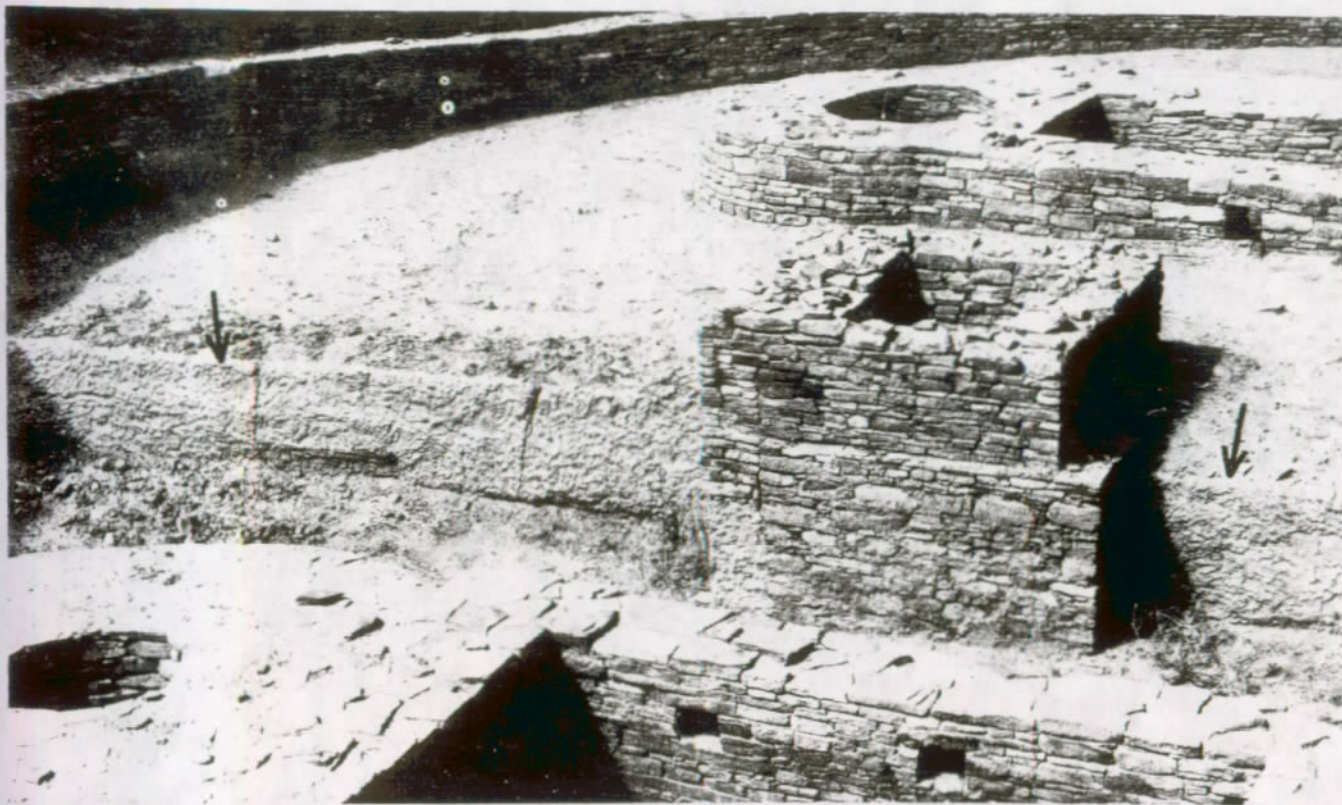
Soil-cement is particularly suited to large repair sections in monolithic soil structures, and is also valuable in stabilizing the sides or ends of cuts in excavations which must be left open for interpretive purposes (fig. 10).

FIGURE 10. Formed soil-cement in retaining sections of fill which must be stabilized to show portions of structures on varying levels. (Great Kiva in the plaza of Chetro Kettle Ruin, Chaco Canyon National Monument, N. M.)

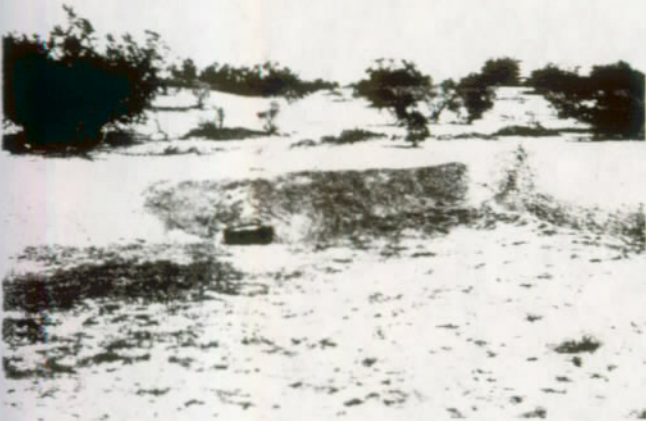
To date, applications of silicone water repellents have been made on the following structures: south wall of the "Big House" at Casa Grande and numerous walls in Compound A (figs. 13, 14) which had been previously covered with a soil-cement coating, and heavy soil-cement sections in Compound B. At Tumacacori the entire granary was treated and an application was made on the patched upper surface of the barrel-vault roof on the sacristy.

FIGURE 13. West wall of Compound A immediately after a rain. The light areas treated with silicone repelled water. The darker areas were untreated and absorbed moisture rapidly. (Casa Grande Ruins National Monument, Ariz.)

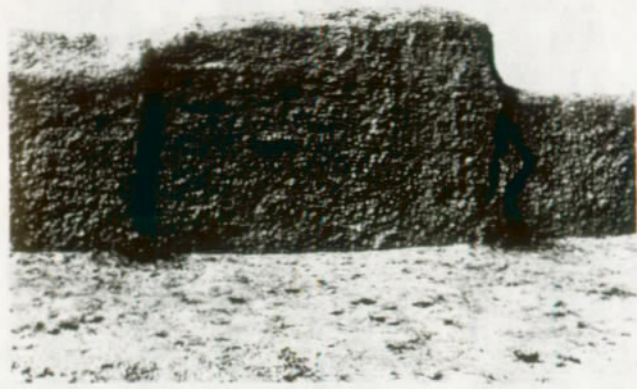
FIGURE 14. West wall of Compound A one year after the application of silicone waterproofing. Two hairline cracks were filled. The untreated smears of plaster have absorbed moisture, while the treated wall remains dry. (Casa Grande Ruins National Monument, Ariz.)

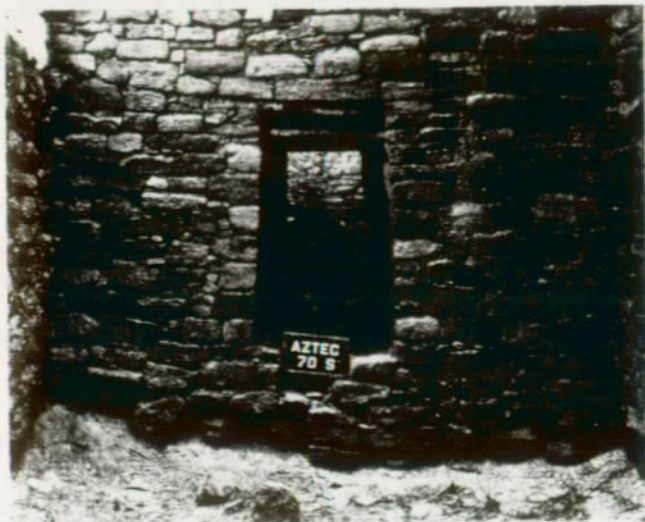
A similar evaluation was made of 19 walls (not retaining fill) constructed of and repaired with the same class of soft stone as in the 21 tested which retained fill. Fifteen remained in good condition. Four showed large wet areas where failure of drainage lines had impounded water (figs. 17 and 18).

FIGURE 17. Basal erosion from capillary moisture is particularly damaging in the interiors of excavated sites where drainage is poor. (West Ruin, Aztec Ruins National Monument, Ariz.)

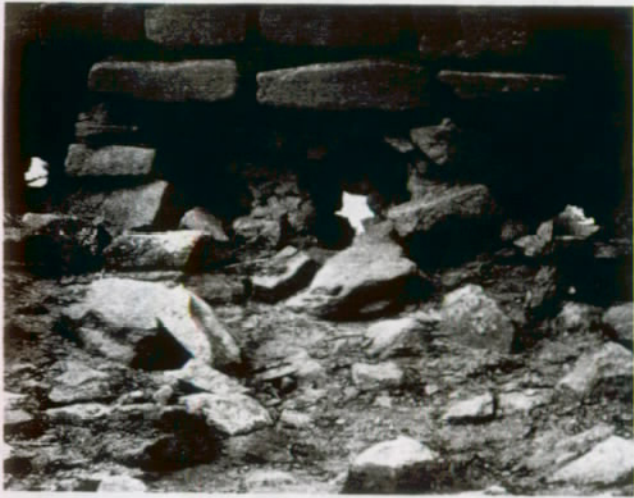
FIGURE 18. The severe undermining and basal erosion of a wall resulting from capillary moisture. If left untreated, such walls soon collapse. (West Ruin, Aztec Ruins National Monument, N. M.)

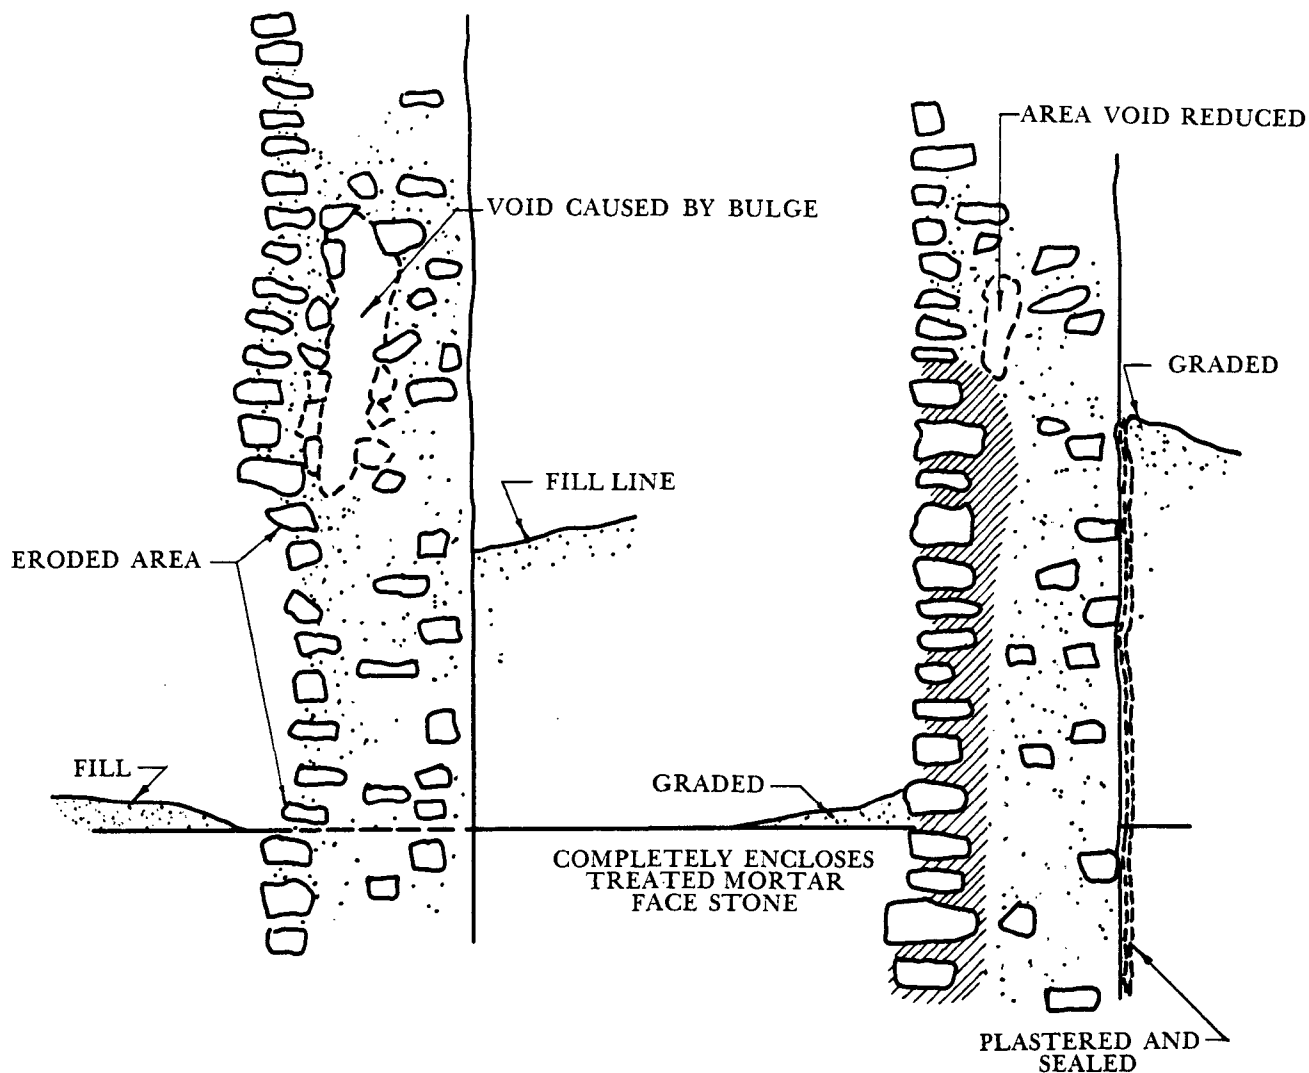
FIGURE 19. Field control of moisture erosion. Wall depicted in section at left before treatment; following stabilization at right.

In laying out stabilization for a wall deteriorating from moisture erosion, consideration must be given to any proposed changes in the fill level (fig. 19). Where the eroded wall also retains fill, the treated mortar should extend somewhat higher than the eroded area to insure against possible increases in the capillary rise. Thus, it is better to include too much rather than too little mortar in the area stabilized. While this might violate the precept of keeping the replacement of prehistoric or original material at a minimum, it is desirable that the replacement be made all at one time rather than over a period of years, as moisture works its way around too small a patch.

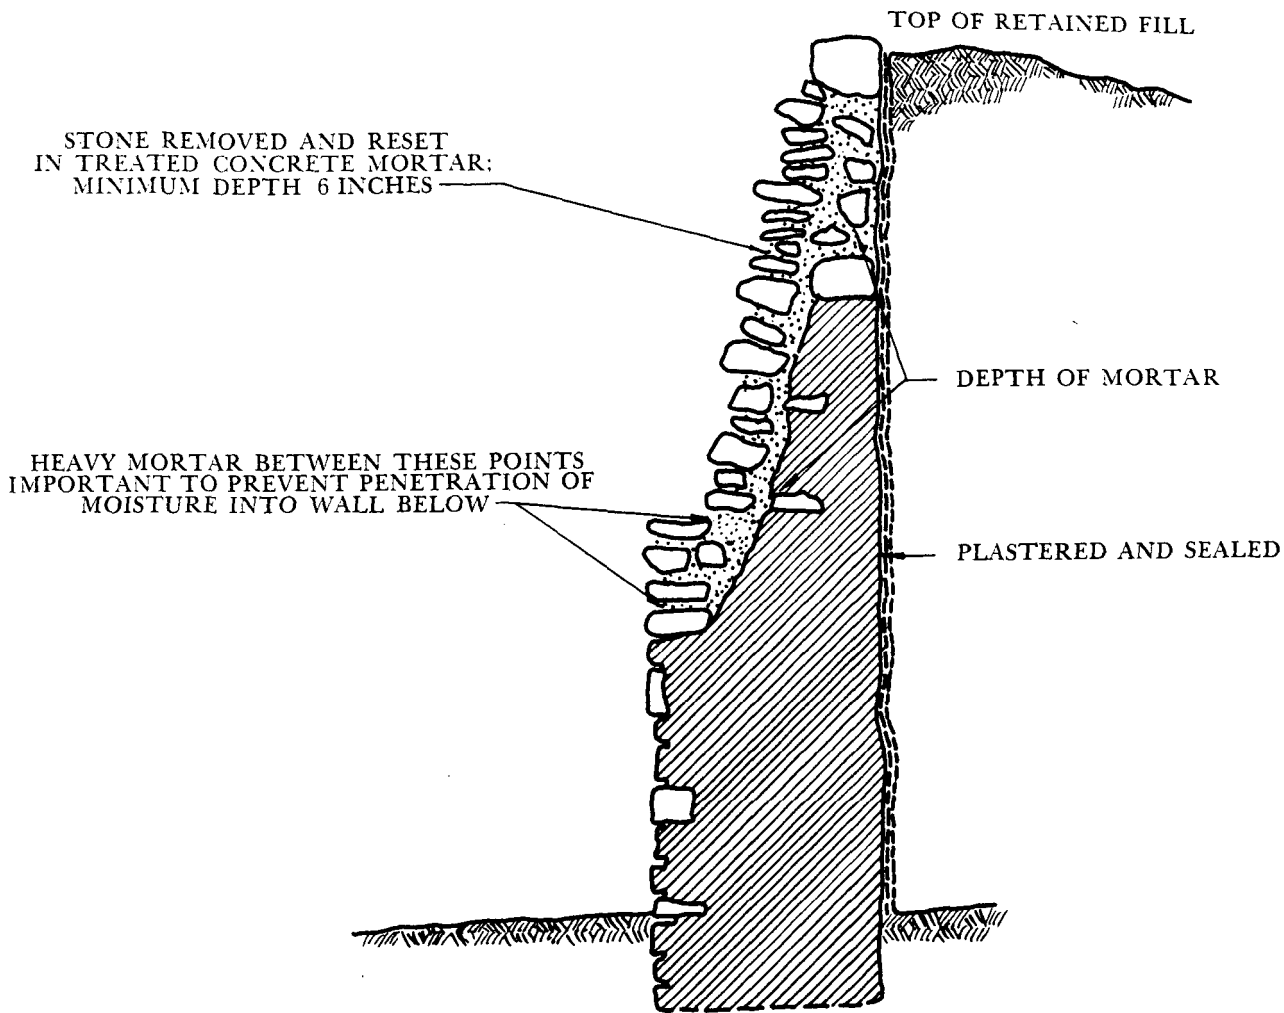
FIGURE 20. The application of waterproofed cement mortar to an oblique wall.

Relaying the oblique surface in a moisture-resistant cement mortar is more effective from the point of general appearance (fig. 20). The only drawback to this method is that large areas of the waterproofed mortar will be exposed. It is difficult, if not impossible, to color cement mortars containing emulsified asphalt. Special waterproof cements, however, can be colored.

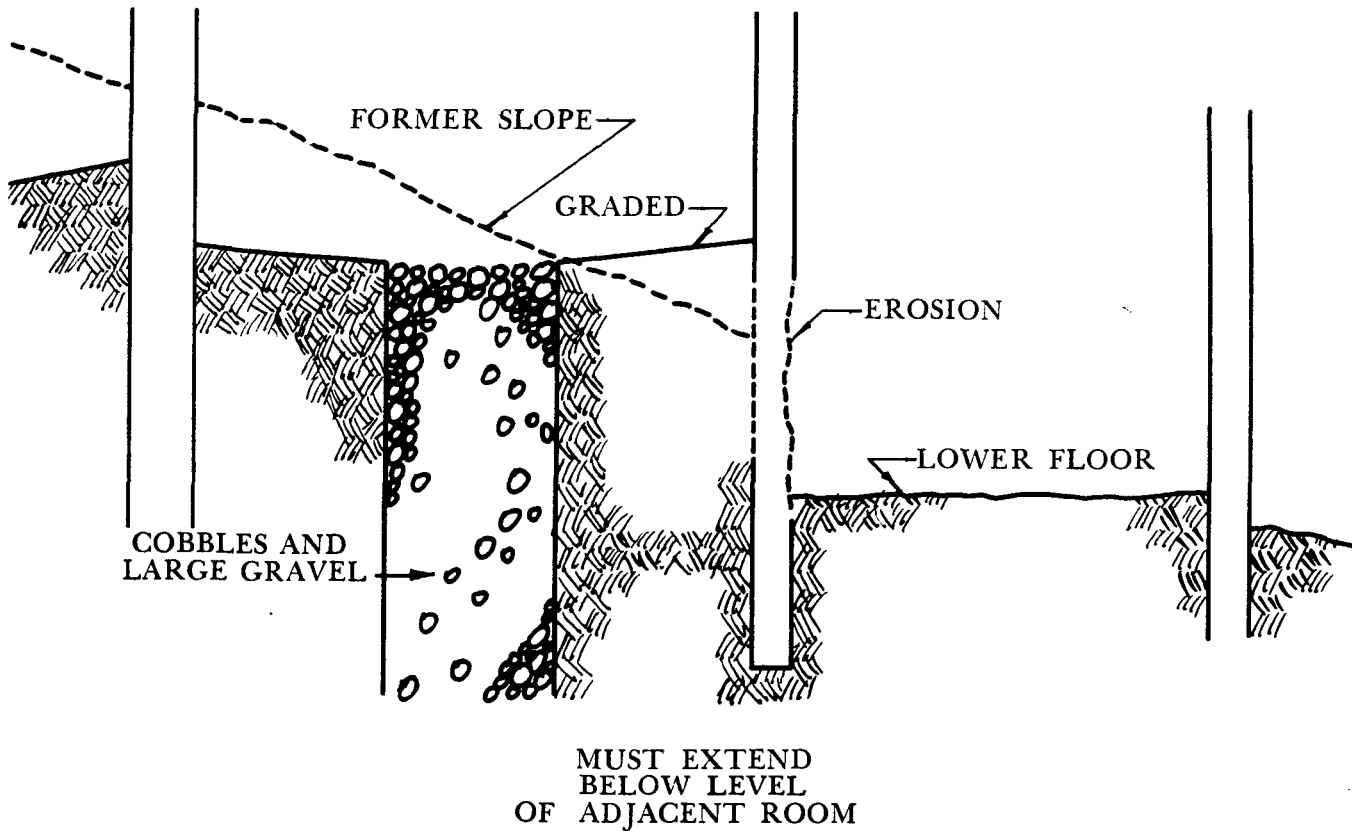
FIGURE 21. Construction of a dry-barrel (in section). Note that it has been carried well below the adjacent floor levels.

A dry-barrel is usually constructed at the center of a room or confined space (fig. 21). A circular hole 3 to 4 feet in diameter is dug to a depth which is at least 3 feet below the lowest level in adjoining rooms. The hole is then backfilled with random stone or gravel with fairly well graded material at the top to prevent the entrance of large amounts of silt or fine material. The surrounding surface is graded to the sides of the dry-barrel.

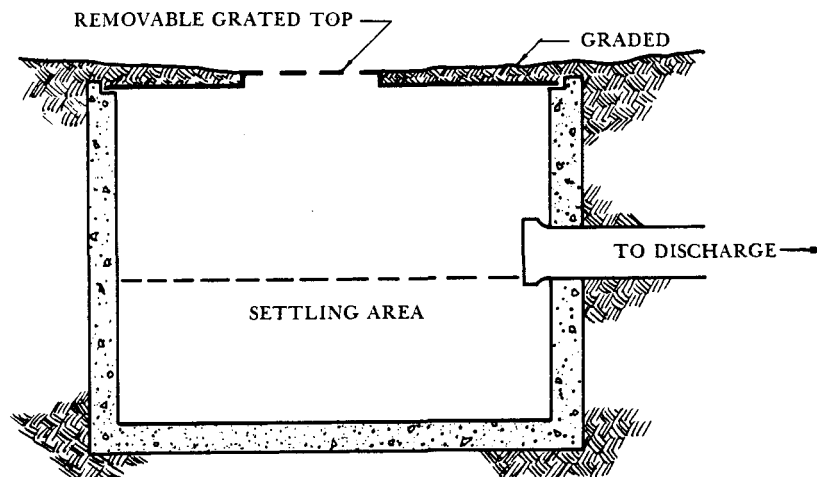
FIGURE 22. A settling type inlet for drain lines.

The preferred drain is one with a small concrete settling box covered with a grate, the tile line extending from the side of the settling box (fig. 22). Tile lines through walls are preferred to "weep holes," in spite of the fact that their appearance is not as satisfactory. Weep holes tend to admit water into the masonry unless very well constructed. While the necessities of appearance would seem to dictate concealed or very unobtrusive lines emptying from a small area, annual inspection of numerous sites has demonstrated that such lines are simply not maintained, and that an obtrusive line which empties surface water from an area provides far better protection than a concealed line which has become inoperative through accumulations of sand or cinders.

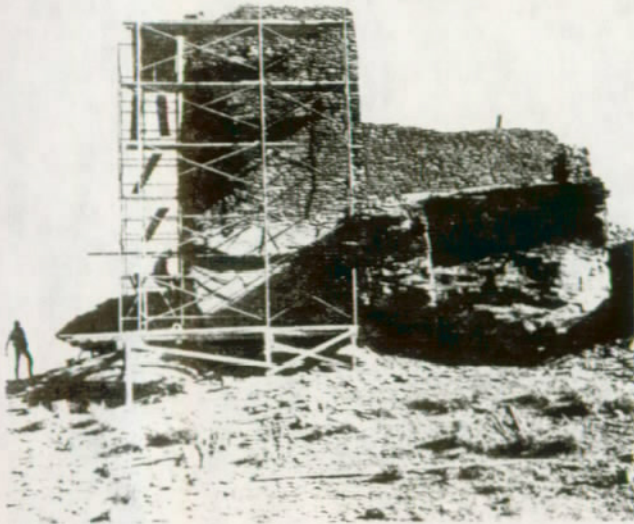
FIGURE 27. Scaffolding in place at completion of respalling and grouting large wall surfaces. (Wukoki Ruin, Wupatki National Monument, Ariz.)

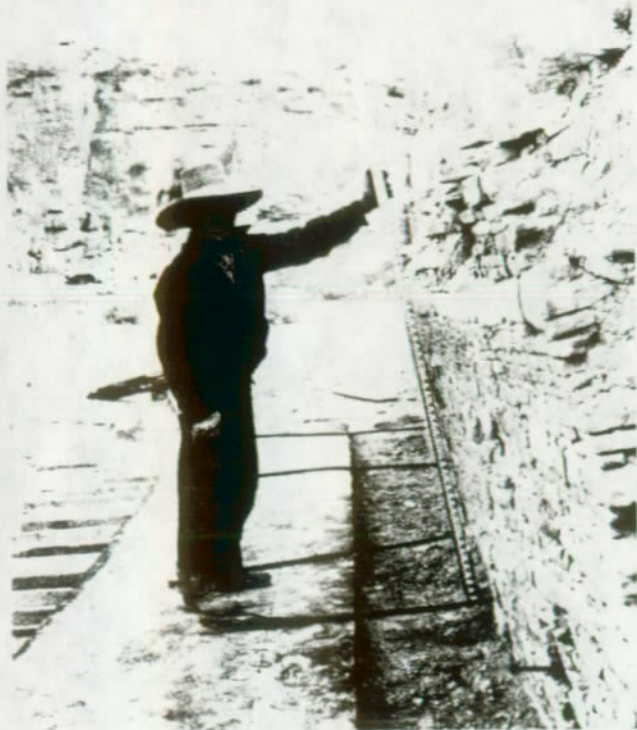
FIGURE 33. Beginning realignment. Cables have been placed through the base of the wall to be tied to the jacks. Note bolt, lower right, for holding frame against wall. (Pueblo Bonito, Chaco Canyon National Monument, N. M.)

Realignment of distorted, out-of-plumb walls is seldom practicable unless the wall is in otherwise good condition (figs. 33, 34, and 35). If the wall has to be realigned and is in poor condition, it must first be strongly repaired with a soil mortar. Do not repair the wall with cement or stabilized soil mortars. Considerable time, care, and equipment are required to realign a wall of any size. The general requirements are, first, that the wall must be completely formed on both sides and, secondly, that it be thoroughly damp if it is not to be cracked further or distorted in some other directions. The steps taken should include:

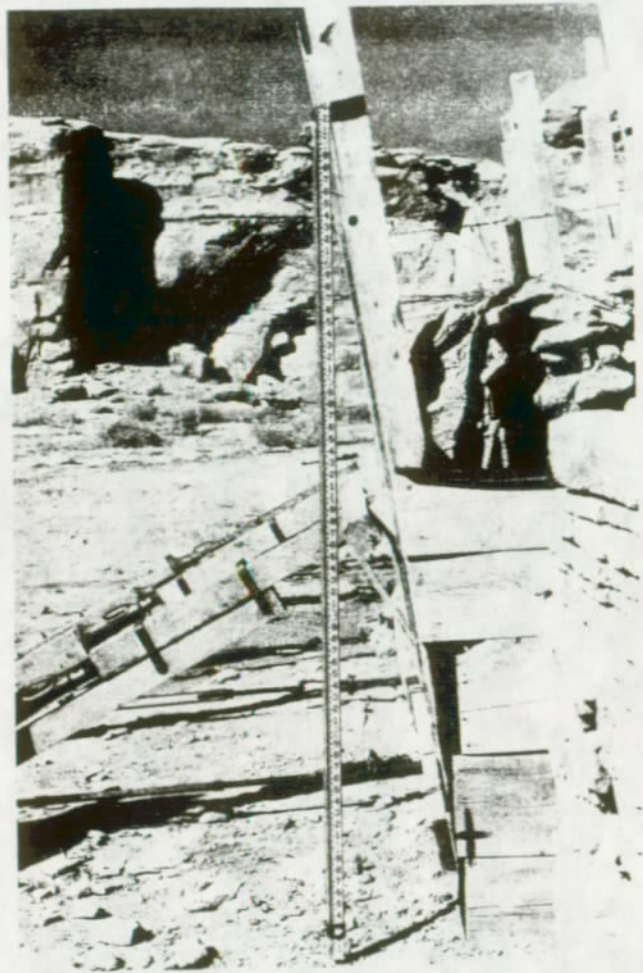
FIGURE 34. Realignment of wall depicted in figure 33. The framework is in place on both sides and is tied together. Frame lined with asphalt paper, space between frame and wall packed with sand. Note that the five screw jacks in sleeves bear against a 4 x 4 timber to distribute pressure.

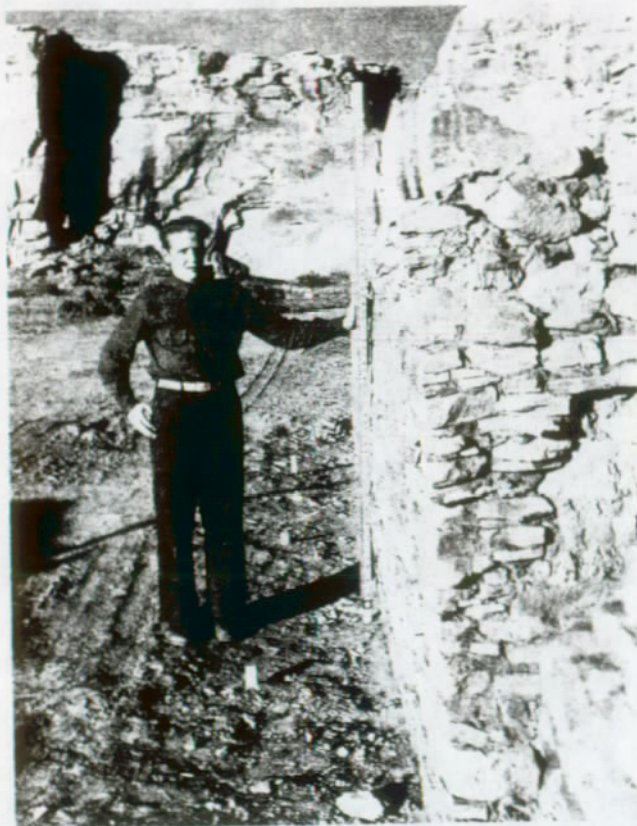
FIGURE 35. The wall depicted in figures 33 and 34 after pressure had been applied for three weeks by means of jacks in sleeves.

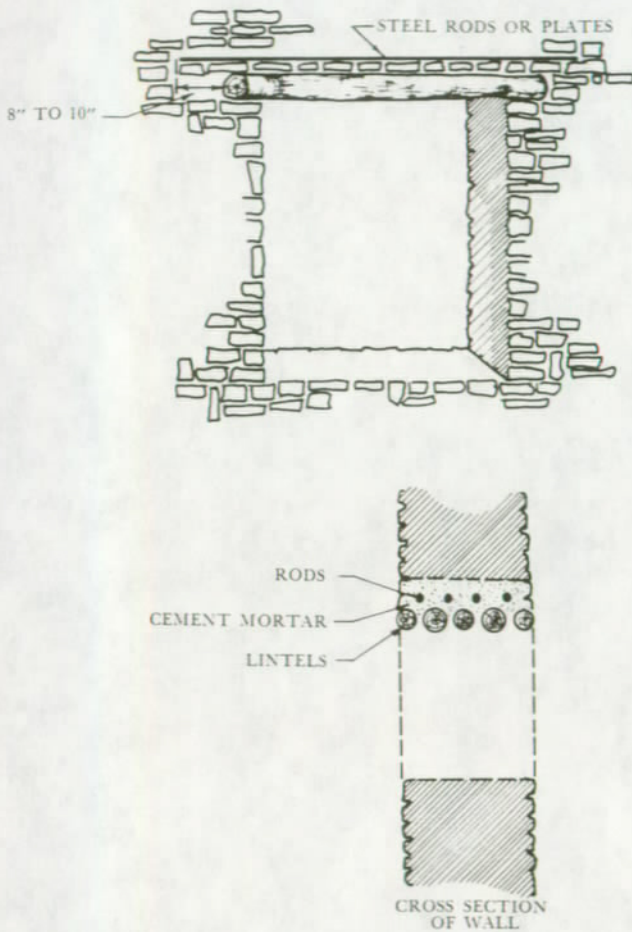
FIGURE 36. The placement of reinforcing in concrete mortar over pole lintels.

remove the timbers and replace them, either with wood or cast members. Rebuild the wall where necessary. Where wood is the replacing material, some reinforcing effort must be made. In short spans, steel plates may be set above the lintels. In longer spans the wall above the wood must be set in reinforced concrete mortar. In any case, the steps are the same (fig. 36):

2. Place the new lintel above the opening after the sides have been repaired; build up the masonry at the ends until it is slightly above the level of the new lintel.

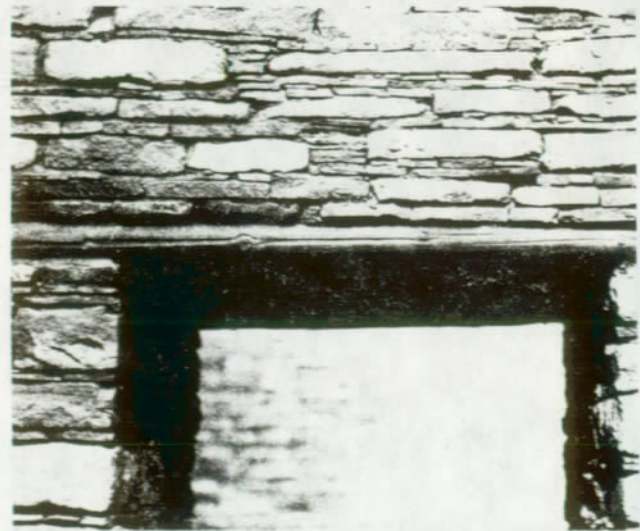
FIGURE 37. The cast concrete lintels have the same appearance as the originals from which they were cast. (Chetro Kettle Ruin, Chaco Canyon National Monument, N. M.)

masonry. The use of cast lintels and poles eliminates many of the above difficulties. They permit the replacement of wood with little disturbance; they provide a strong, rigid and very durable member. Cast lintels take the same surface and texture as the wood from which cast. With a little care they may be stained to faithfully reproduce the original (fig. 37).

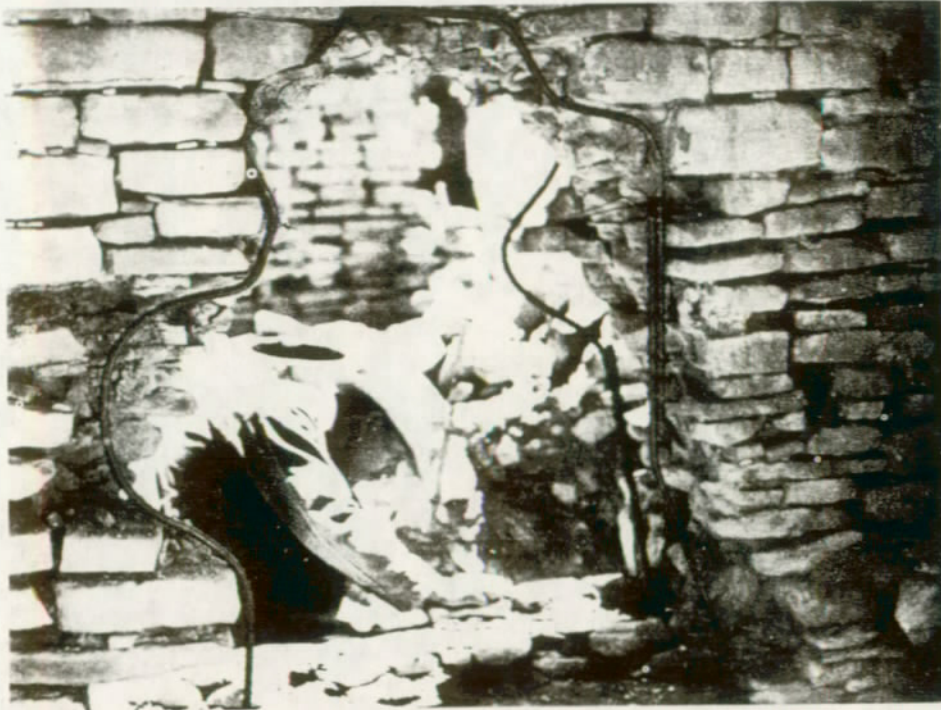
FIGURE 39. Integral members. Starting a reinforced arch section, rods have been bent to fit the contours of the break and are wired in place. The workman is laying the courses across the bottom of the break in concrete mortar to provide a solid base for the reinforced section. Above this level, masonry on the perimeter of the hole will be laid in concrete mortar which will also surround the steel rods. Masonry in the center of the hole will be laid dry or with a minimum of soil mortar; its only function will be to support masonry laid in cement until the latter has set. This dry masonry will then be removed. (Pueblo Alto, Chaco Canyon National Monument, N. M.)

outlines of the break. One piece goes on each side of the wall and just far enough inside the opening to allow a covering face of masonry. The two ends of each piece will rest on the masonry just laid across the bottom of the opening (fig. 39).

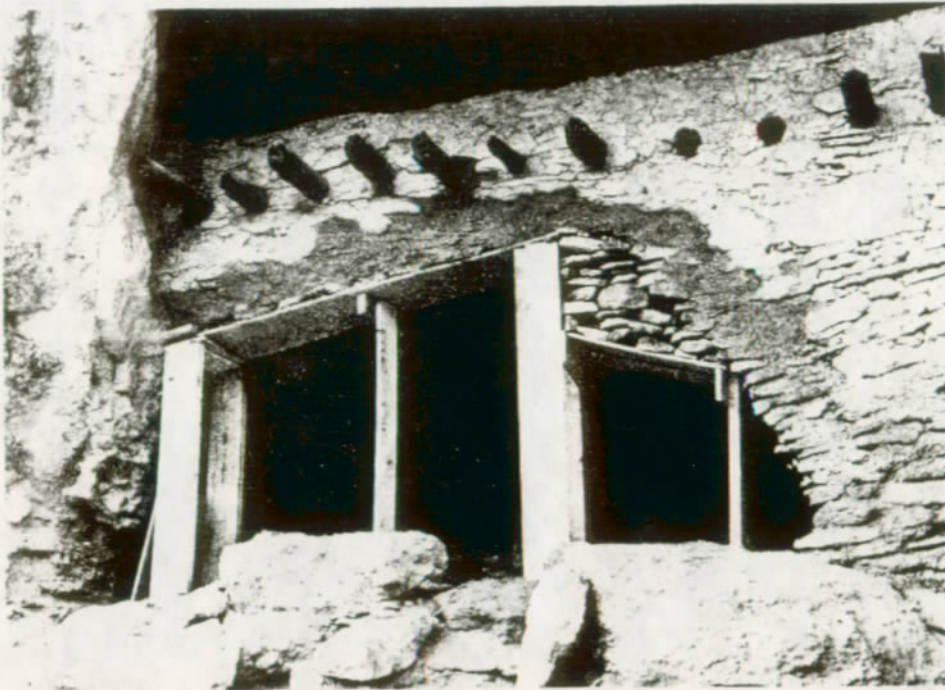
FIGURE 40. Integral member; a large reinforced arch section. The size of the break through the wall precluded filling the center with dry masonry as support, and the timber framework was substituted. The heavily reinforced band is socketed in the cliff wall at the left side, and based on bedrock at the right. The integral member has just been finished and the mortar has not yet dried. After the mortar has set the timber framework, the dry masonry at the right and that on top of the horizontal plank were removed. The large hole with its original outline remained. (Gila Cliff Dwellings National Monument, N. M.)

tected from further breakdown by the reinforced band (fig. 40).

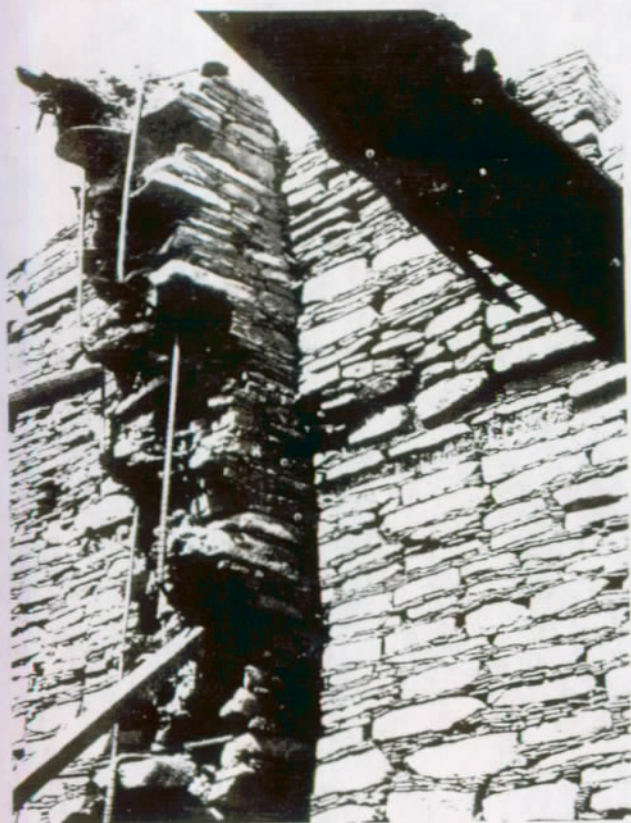
FIGURE 41. Integral members; steel in place for a narrow vertical section. The steel must be tied in securely to the cross wall at the top to provide support for the overhanging area. Some support will be required for the vertical strip of masonry as it is being laid, and until the concrete mortar has set. (Chetro Kettle Ruin, Chaco Canyon National Monument.)

The principal application of these members is to tie together sections of separated and out-of-plumb walls, to reinforce walls against which there is pressure of retained fill, to re-lay overhanging and precarious sections, and to provide support over horizontal logs (figs. 41, 42, and 43). Since conditions and structures vary so greatly, it is difficult to anticipate all possible applications. In general, the requirements are:

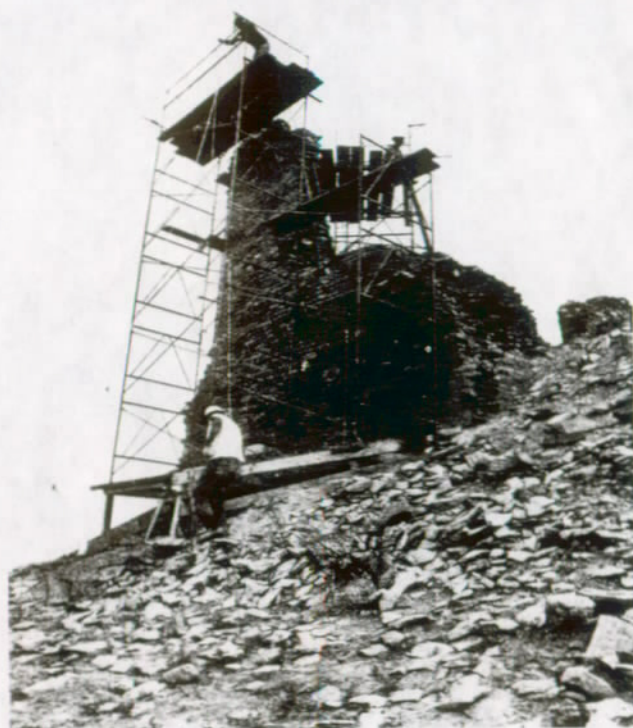
FIGURE 42. Reinforced integral members are important in the stabilization of spirelike structures such as this at the Tower Kiva, Kin Ya-a Ruin, Chaco Canyon National Monument, N. M. Considerable strength must be added without serious or objectionable alterations of the original profile.

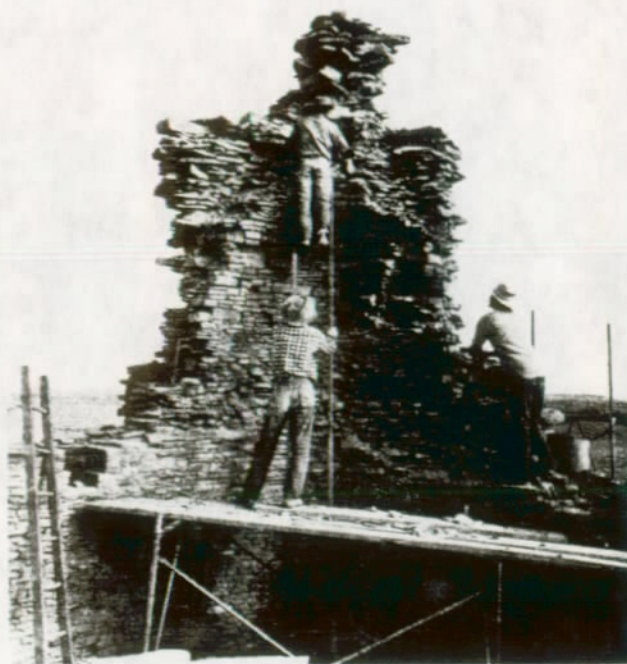
FIGURE 43. The placement of reinforcing in the third story portion of the structure shown in figure 42. The purpose is to reinforce heavily the vertical capping which will be placed up exposed ends of the wall to prevent further erosion, and to tie this part of the wall together.

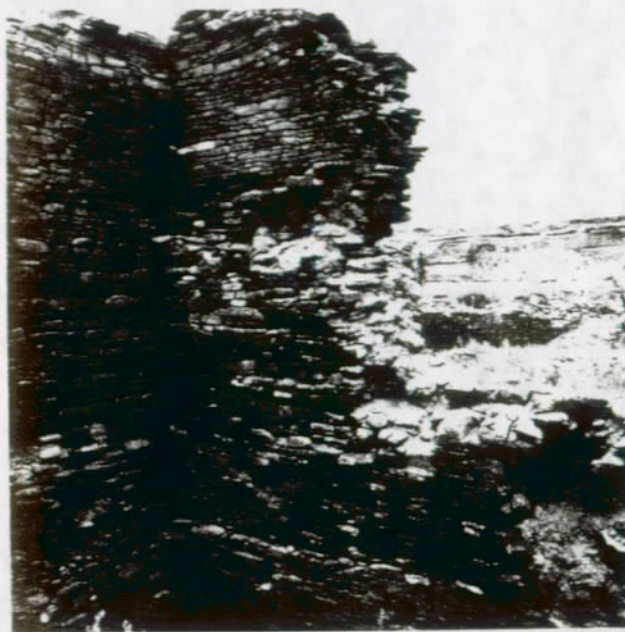
FIGURE 45. Patching of this hole at Pueblo del Arroyo will be combined with a short section of horizontal capping plus vertical capping for the exposed and weathered vertical rise of wall.

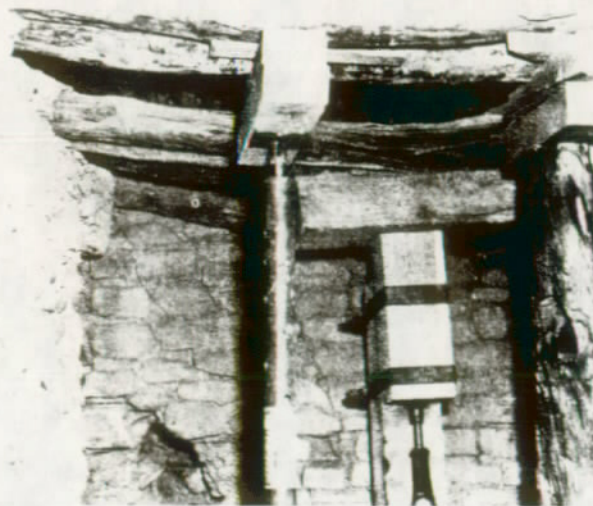
FIGURE 47. Temporary support of cracked and broken roof beams by means of jacks and timber props. Approximately 6 feet of overburden lay on this ceiling. The temporary supports were in place for several years before the overburden could be removed and a protective roofing constructed. (East Ruin, Aztec Ruins National Monument, N.M.)

From this and similar experience with difficult roofs evolved the coverings designed for and installed over 14 prehistoric ceilings in the East Ruin of Aztec during 1957 (figs. 47 and 48). These were in an unexcavated site where the only previous protective measure taken was the temporary bracing of cracked and broken timbers.

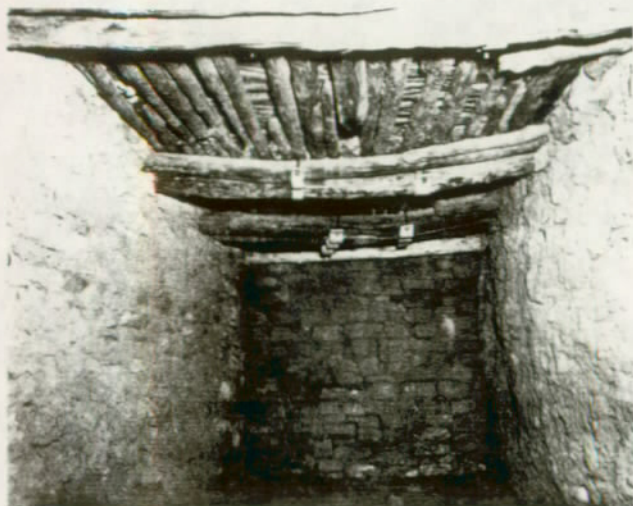
FIGURE 48. The ceiling shown in figure 47 after removal of the overburden and construction of a slab roof which protected the ceiling and permitted support of broken beams. The bolts are fastened in the slab above, and were taken up enough to transfer most of the weight from the old ceiling beams to the new roof.

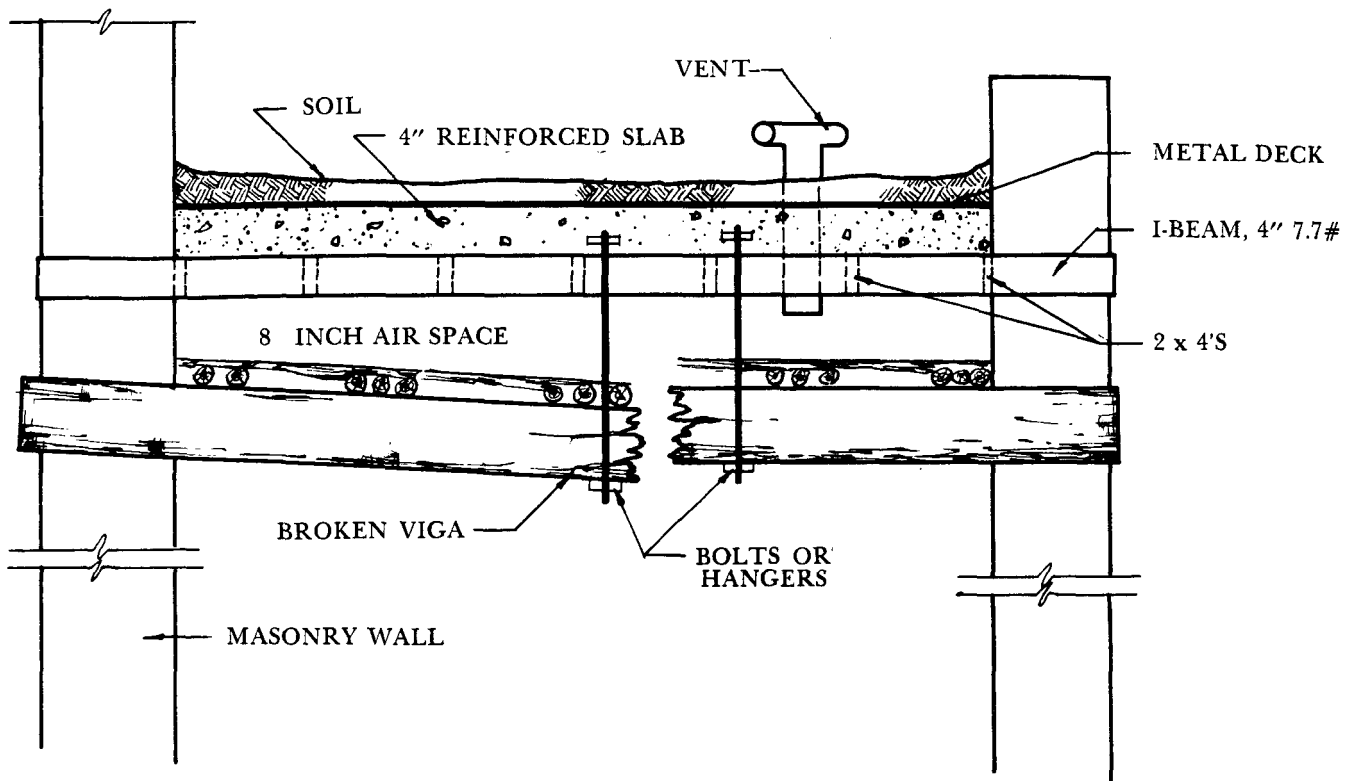
FIGURE 49. Typical roof covering and support employed at Aztec Ruins National Monument.

The general design of slab-type roofings are shown in figures 49, 50, and 51. No part of the new roofing may be supported by the aboriginal ceiling either during or after construction. This requires that the construction be self-supporting during the time that the concrete is being poured. Ordinarily, concrete forms for floors and decks are supported during pouring by vertical members from below, and the supports and forms are removed after the concrete has set. However, this is not possible in the placement of slabs over existing roofs where the space between the new slab and the old ceiling is usually less than a foot, and there is no means of access between the two.

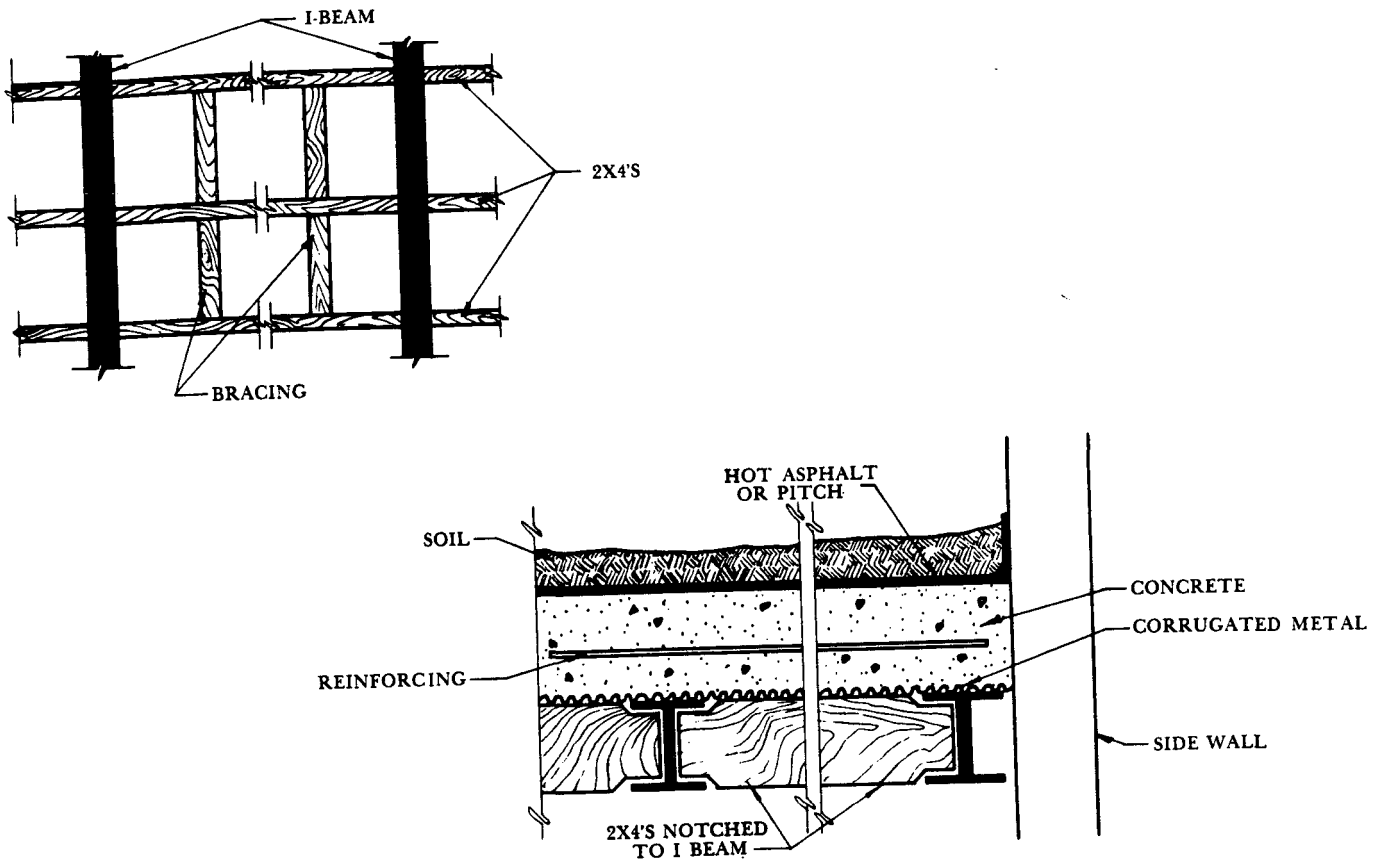
FIGURE 50. Details of roof supports (in section) at Aztec Ruins National Monument.

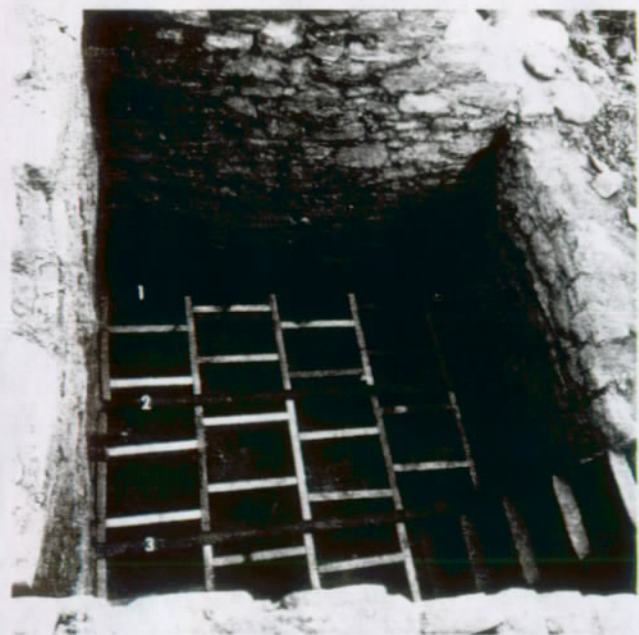
FIGURE 51. Construction of a slab covering. The numbered members are I-beams run through heavy masonry walls. The longitudinal members are 2 x 4's inset in the I-beams as purlins. Corrugated metal decking will be nailed to the wood as a base for a concrete slab. A covered vent will be provided through the concrete. Drainage will be provided by tile line through the wall at the right. (East Ruin, Aztec Ruins National Monument, N.M.)

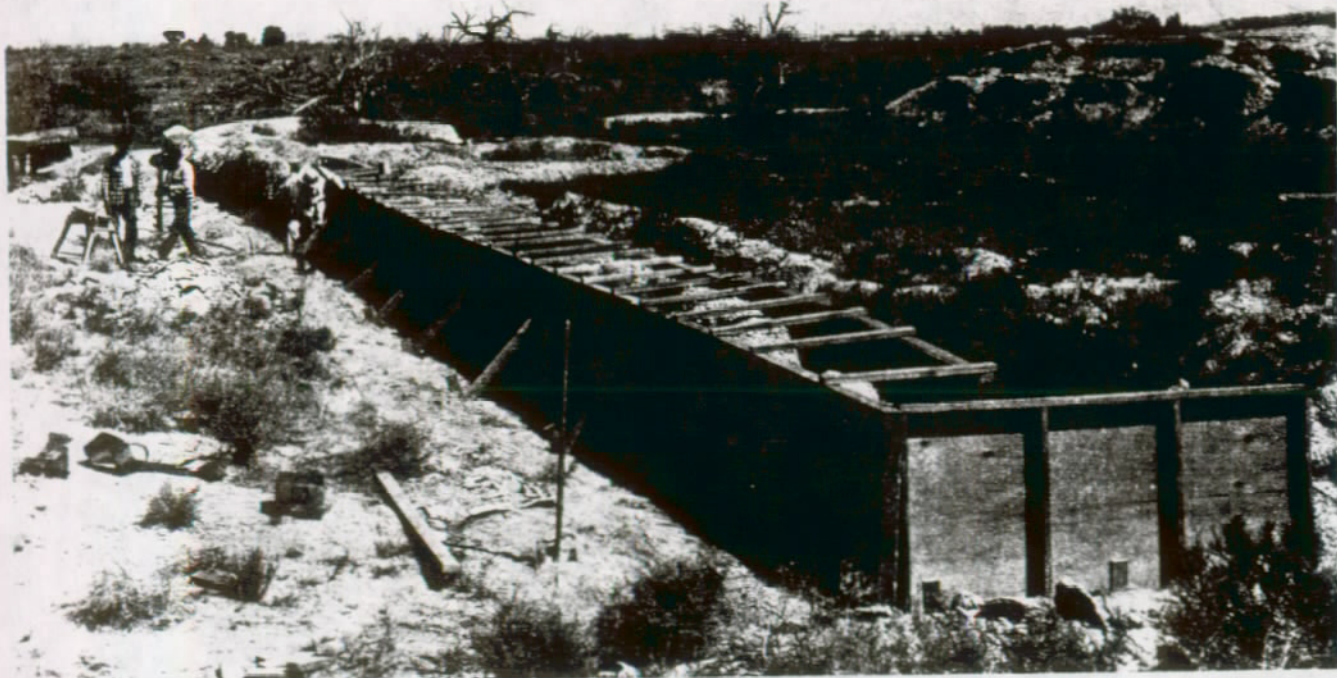
FIGURE 52. Placement of forms for stabilization of a wall with caliche-based soil cement. The forms are braced at the sides and tied at the top. (Compound B, Casa Grande Ruins National Monument, Ariz.)

In all caliche walls, i.e., those of high lime soil content encountered in Compound B, weathering had greatly reduced the original width above the surface of the ground. Both sides of the wall were trenched until the original width was reached at depths up to 18 inches. Forms of heavy plywood, reinforced with 2x4's, were then placed at the edge of the wall rising vertically from the uneroded subsurface line (fig. 52). The space between the remaining wall surface and the forms was wide enough so that the caliche-cement would be sufficiently thick to stand by itself, and not be dependent on the aboriginal wall for support. General requirements for placing concrete forms were followed; they were oiled, and securely braced.
