Ruins Stabilization in the Southwestern United States

Publications in Archeology 10

National Park Service

U. S. Department of the Interior
Washington 1974

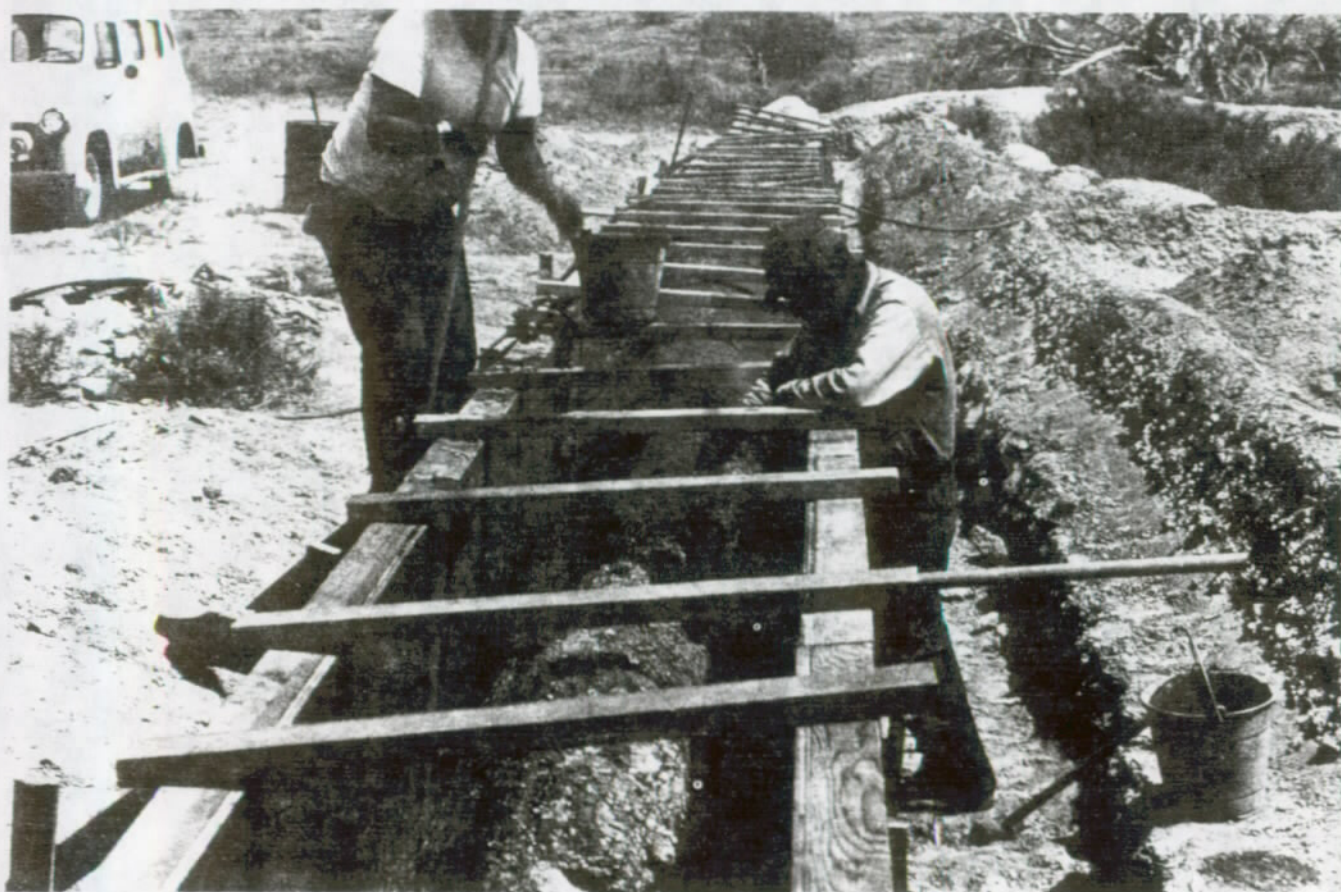
FIGURE 53. The start of placing caliche-cement mix over the wall depicted in figure 52. Note that the forms follow the irregular line of the wall.

The prehistoric wall was dampened and the mix placed between it and the form (fig. 53) well tamped in place to fill undercut spots. It was placed at a depth sufficient to cover the rise of the wall face and was then sloped to conform to the irregular, sloping surface of the wall top. After curing, the forms were removed and when completely dry the entire surface was treated with silicone water repellent (fig. 54). This use of heavier, self-supporting coverings of native materials parallels the already proven use of heavy sections of soil-cement in the repair of pit houses and for making facings in cuts in soft fill (figs. 9 and 10).

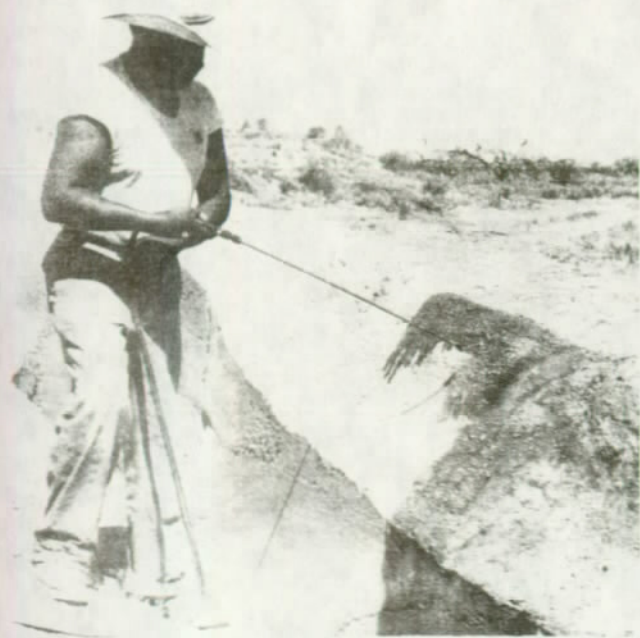
FIGURE 54. The application of a silicone water repellent. It is applied in a coarse stream, sufficient to produce a rundown of from 6 to 8 inches. (Casa Grande Ruins National Monument, Ariz.)

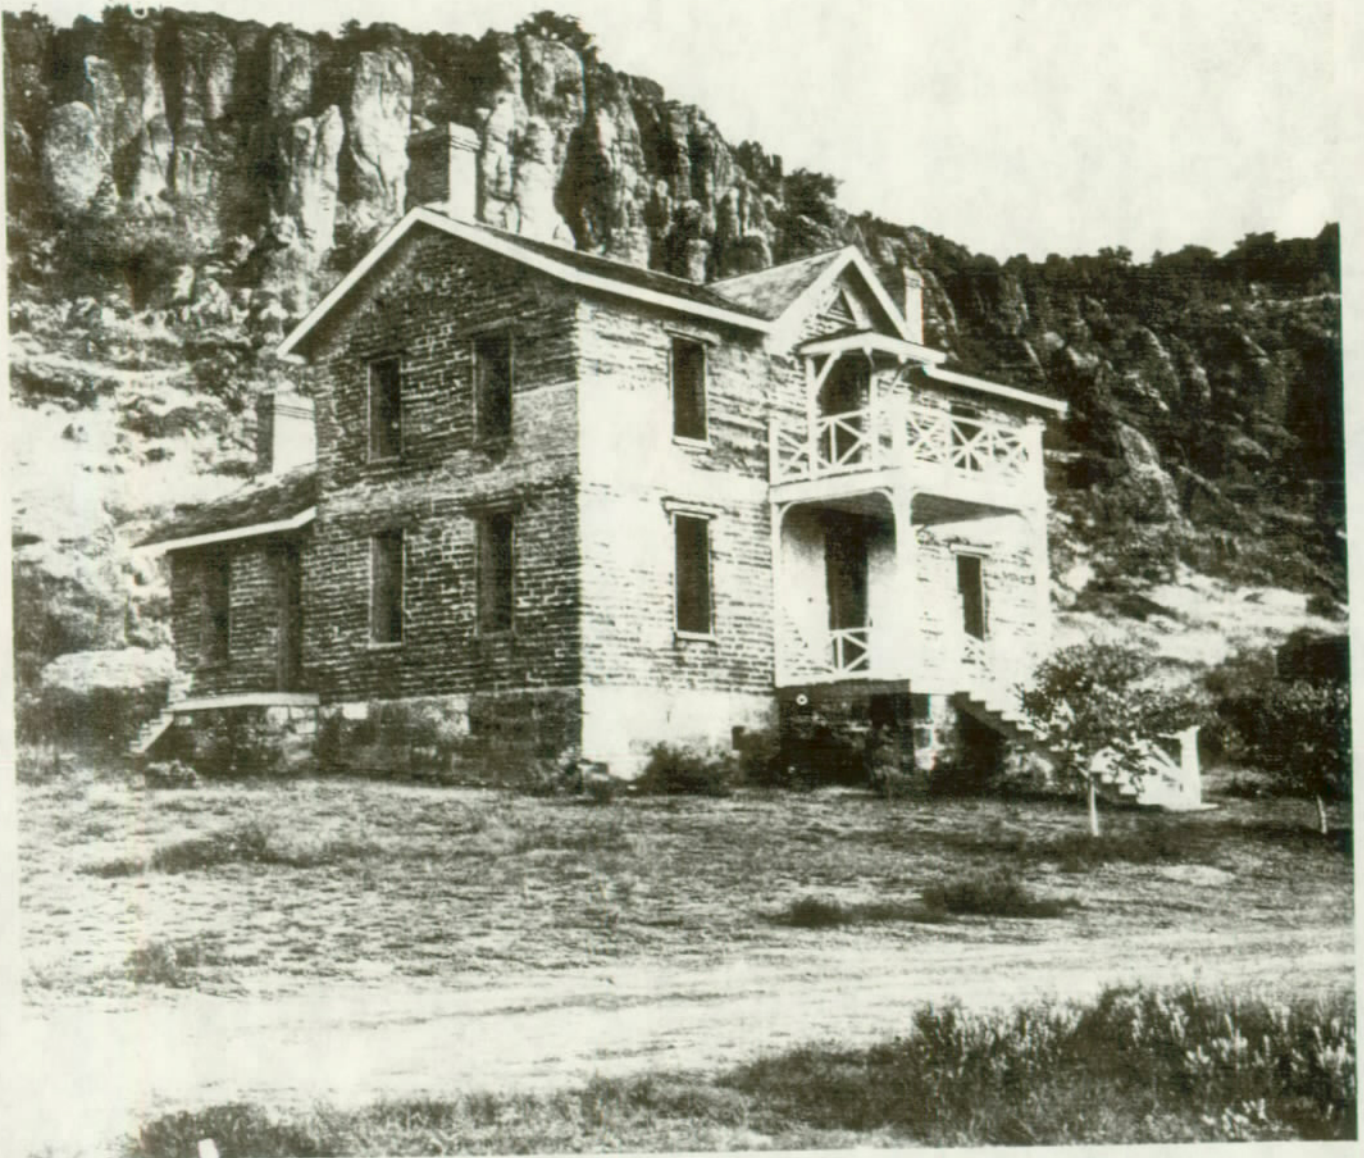
FIGURE 57. The completed stabilization and modified restoration of building HB-14, Fort Davis National Historic Site. Compare with figures 55 and 56.

This construction restored the exteriors of two 2-story buildings to their original appearance. The tops of the walls, weakened by erosion, were rebuilt and capped with reinforced concrete-bearing beams to support new roofs. Where exterior faces of adobe walls were severely weathered, a masonry veneer was added to rebuild the wall section to its original thickness using soil-cement units colored and textured to match the existing adobes. New wood porches were added to the exterior entrances, and doors and windows restored to the openings to secure the buildings. Thus the structures are interpreted as part of the historic scene. A self-guiding trail provides access and supplies necessary for interpretation.

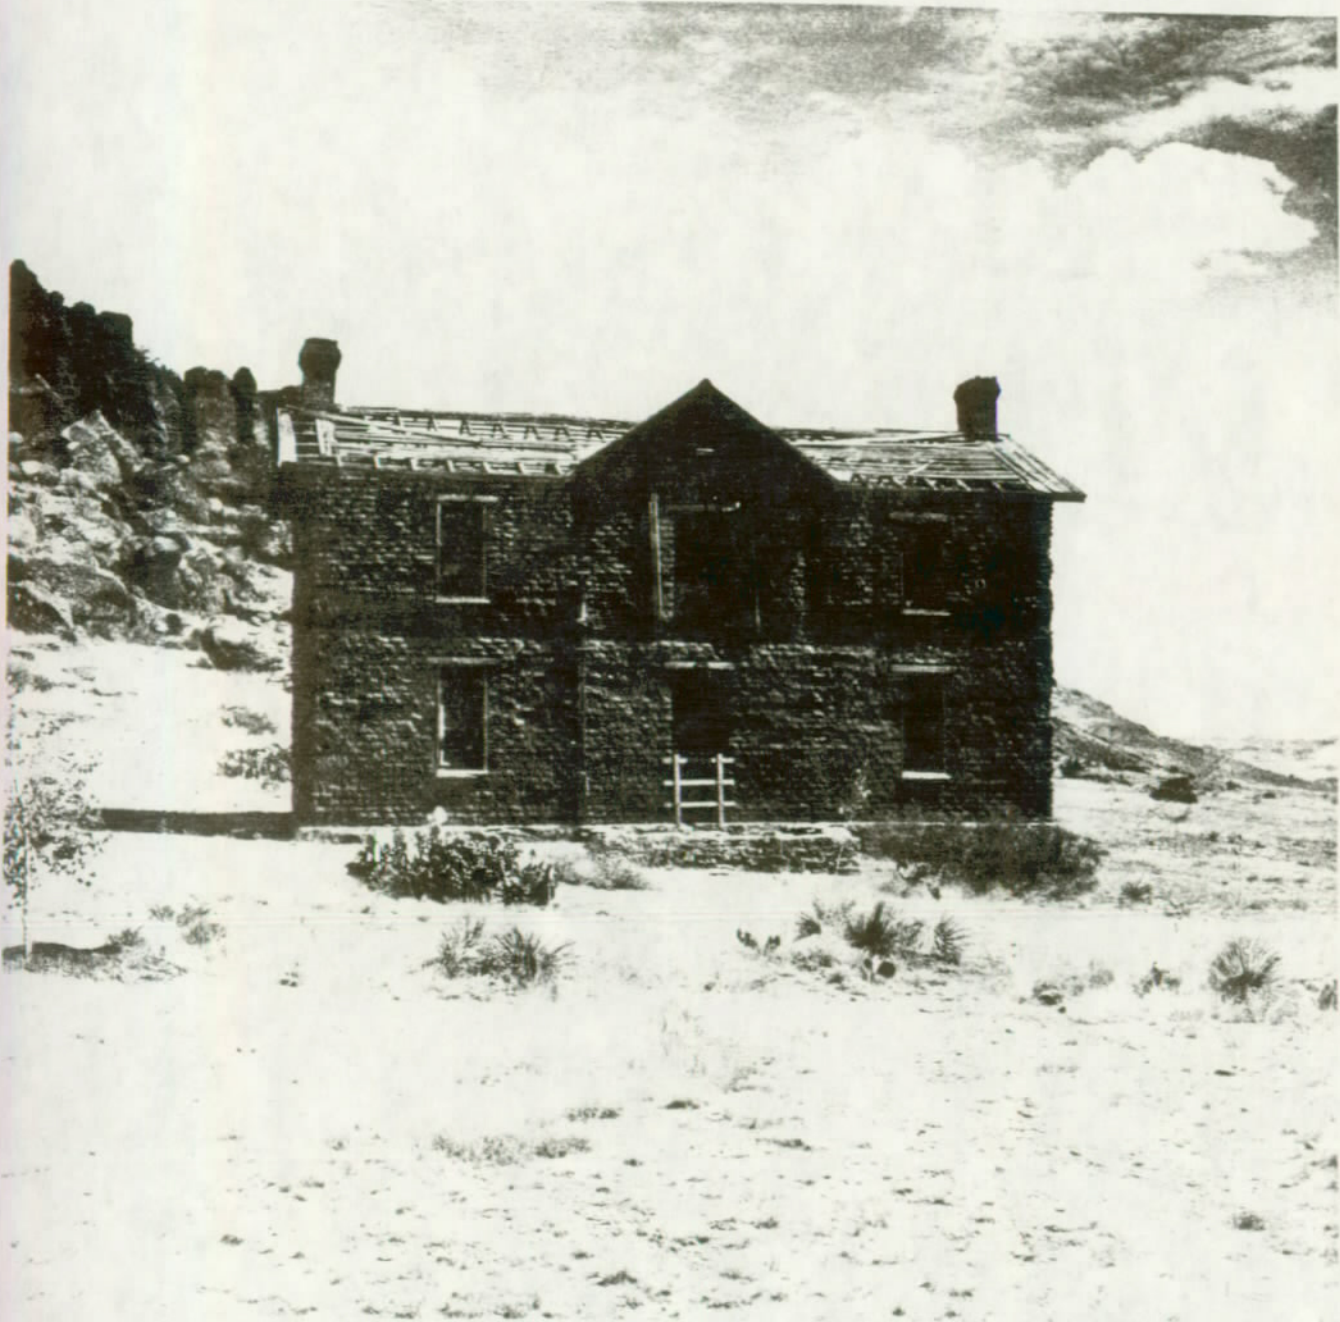
FIGURE 58. Building HB-15, a non-commissioned officers quarters at Fort Davis National Historic Site, before combined stabilization and modified restoration work was accomplished by the National Park Service.

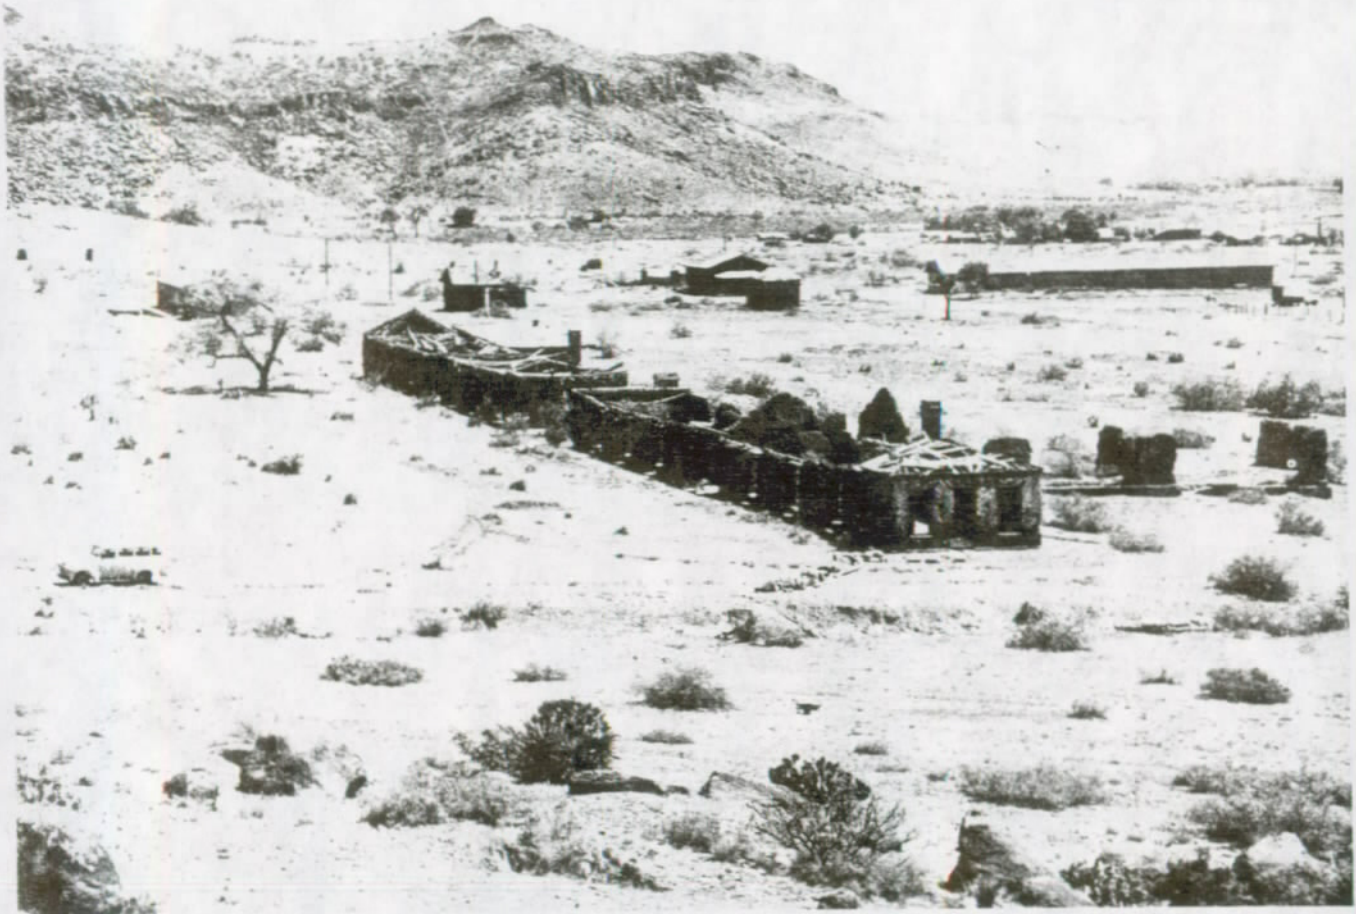
FIGURE 60. The 1870 enlisted men's barracks (in right foreground), Fort Davis National Historic Site. The photo was taken in 1960, before National Park Service status. Historic documents, drawings, and photographs provided ample evidence on which to base a restoration.

The visitor center at Fort Davis is an adaptive restoration. The 1870 enlisted men's barracks, which was a roofless, ruinous shell in 1964, was left virtually intact and a modern veneer of soil-cement bricks built around it. Some sections of original adobe walls were pared down so that the veneer would make up the original width. Bearing beams and integral support were provided for the modern though authentic roof. The restored portion of the exterior was faithfully preserved in both form and detail, while the interior was converted to modern, functional use (figs. 60 and 61). A small, glass-enclosed framework on the interior of the restored barracks shows an original portion of adobe wall for viewing by visitors.

FIGURE 61. A view of the Fort Davis barracks after restoration. The ruinous shell seen in figure 60 was veneered with hand molded soil cement bricks, 4" x 4" x 12". They were made with one part portland cement (untinted), three parts unwashed sand, and three parts native soil. The bricks laid in masonry mortar with rough joints, set with spalls, were wire-brushed. Original walls were pared down where required to accommodate the veneer brick and to retain original wall dimensions and thickness. Bond beams were installed at roof line to support the restored, hipped, shingled roof. The soil cement brick walls were painted with white cement paint, although originally they were whitewashed. The building is used functionally today as the Visitor Center. Cost of the restoration: \$129,000 or \$12.90 per square foot.

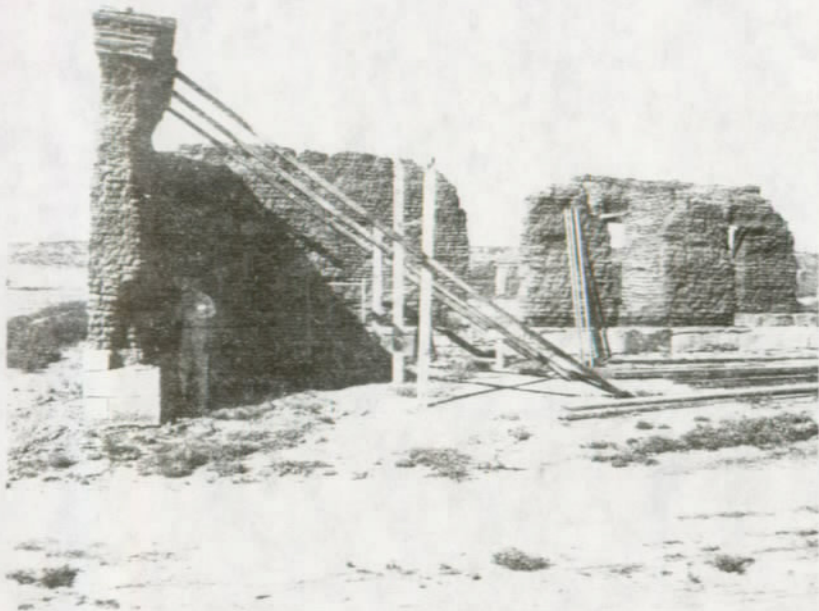
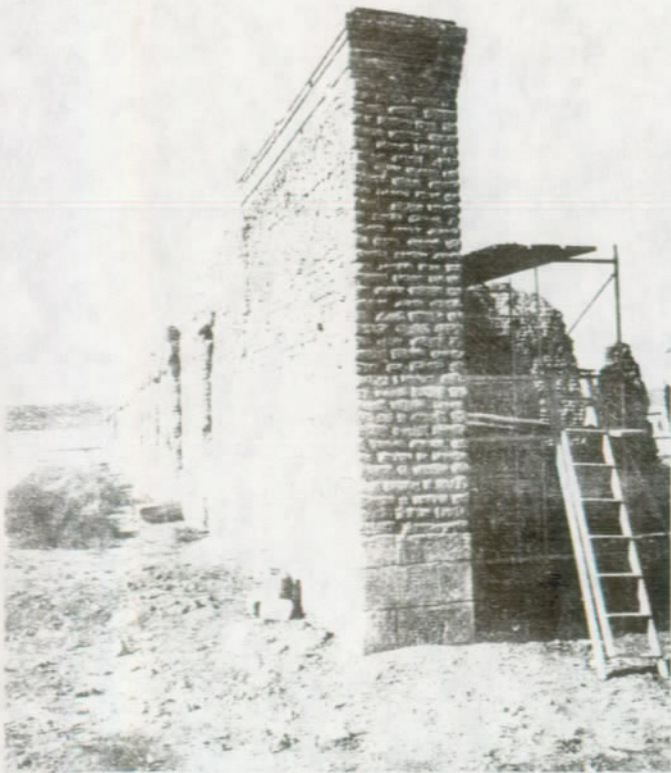
↙
BUILDING 3-330,
ROOM 331,
WING WALL,
BEFORE
STABILIZATION

↖
BUILDING 3-330,
ROOM 331,
WING WALL,
AFTER
STABILIZATION

FIGURE 64. All ruins stabilization records should include before and after pictures attached to separate sheets such as the ones above for Fort Union National Monument.

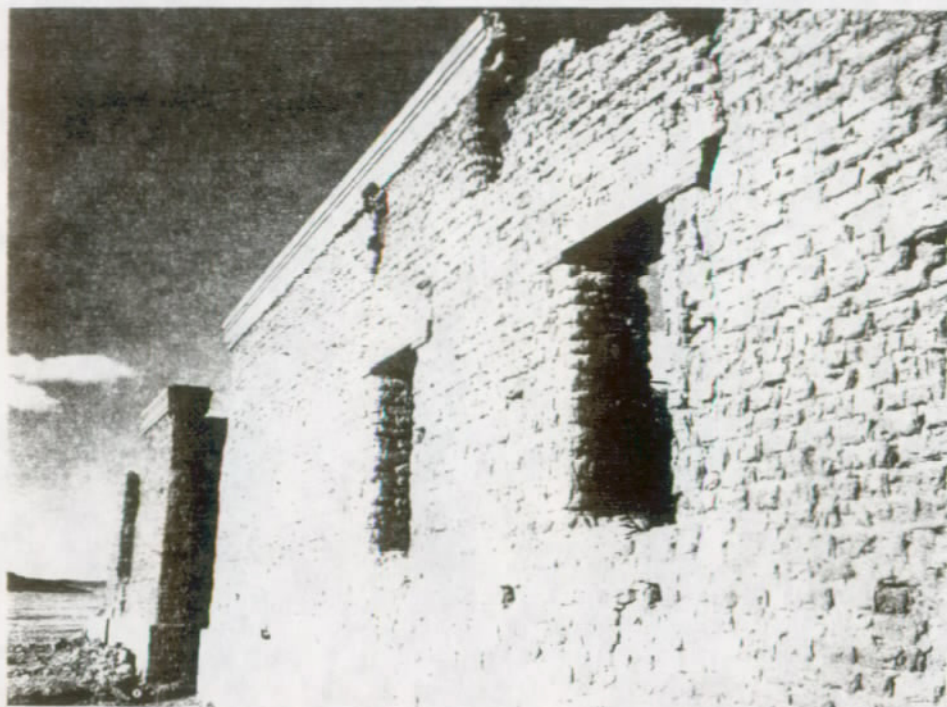
FIGURE 65. Building 3-450 (left) and building 3-440, west walls and coping, before stabilization. Fort Union National Monument.

An angle-iron framework, whose components were welded together, was then erected in the channels of both walls. The supporting base plate of 1/8" x 2" strap iron was placed in the lowest horizontal channel of all walls, and rests directly on the rock wall foundations. The vertical members (of 1/8" x 2" angle-iron in the west wall, and 1/8" x 1 1/4" angle-iron in the abutting wall) are supported at their lower ends by the strap iron. All other horizontal members except those at the top of the walls are 1/8" x 3/4" angle-iron.

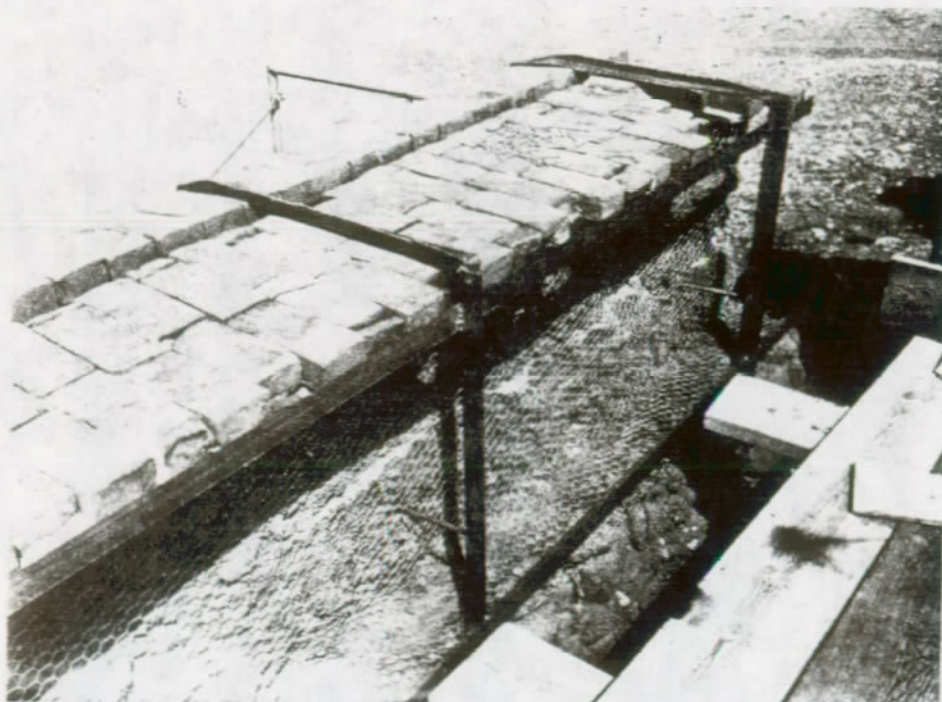
FIGURE 66. Building 3-440, coping on west wall, during stabilization, Fort Union National Monument.

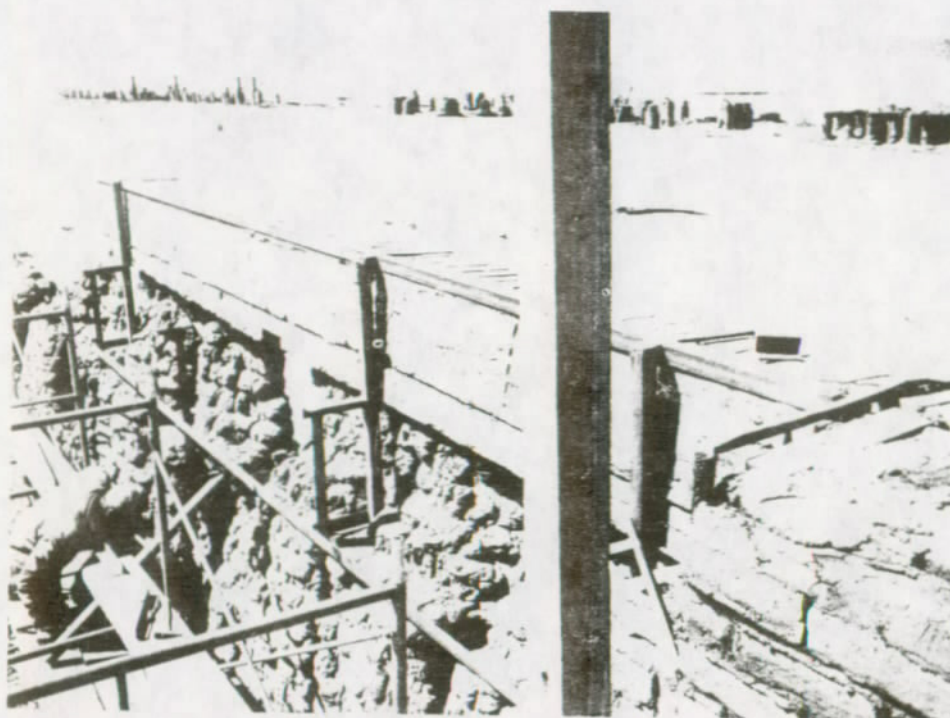
FIGURE 67. Building 3-440, coping on west wall, during stabilization. Fort Union National Monument.

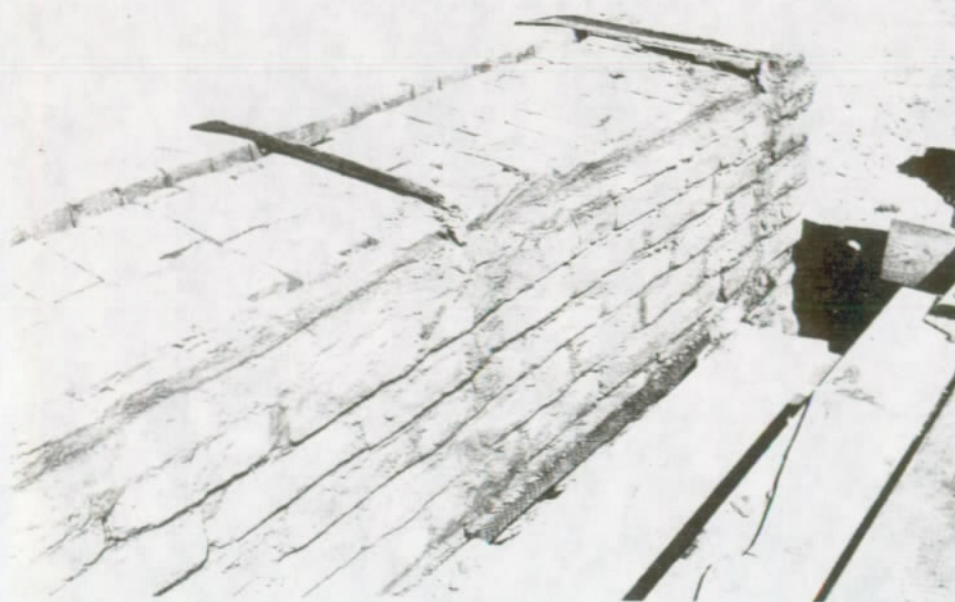
FIGURE 68. Building 3-440, coping on west wall, during stabilization. Fort Union National Monument.

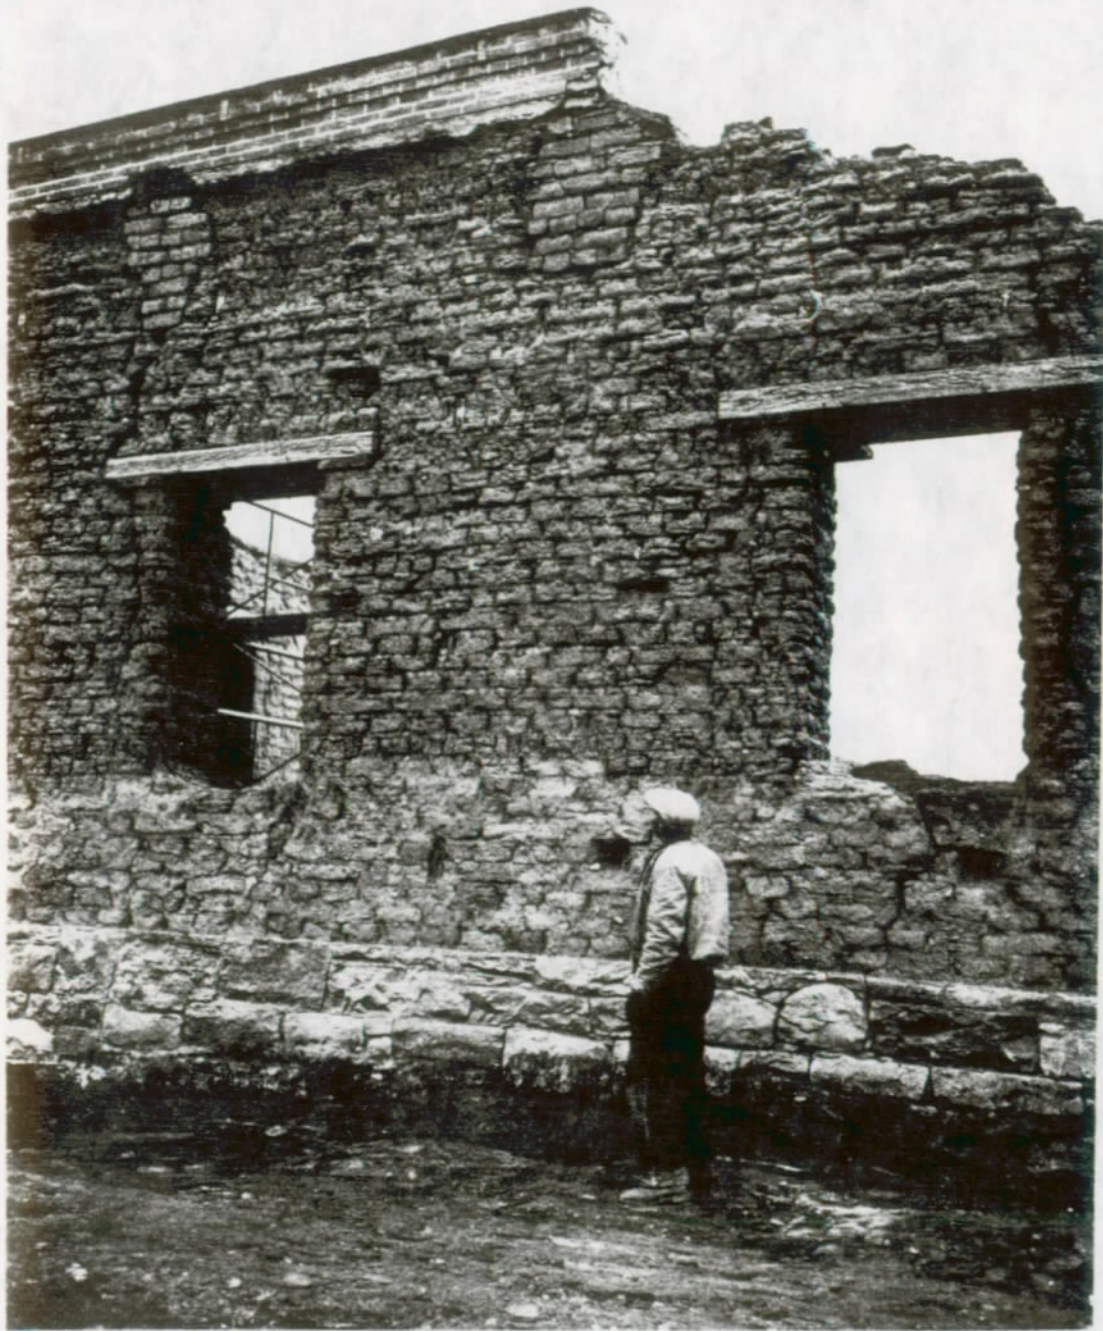
FIGURE 69. Building 3-440, west wall and coping, during stabilization. Fort Union National Monument.

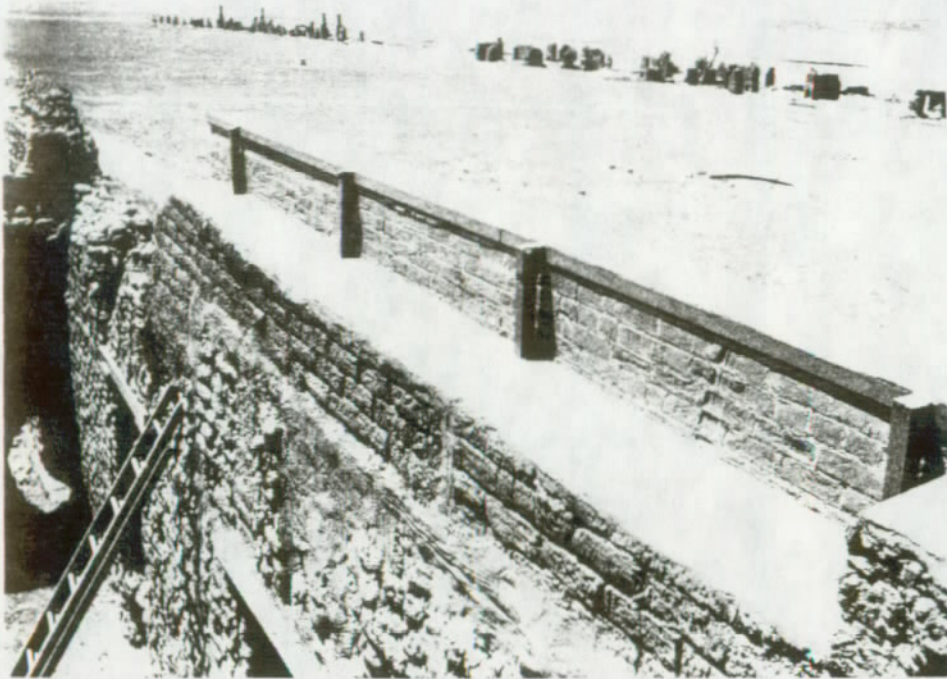
FIGURE 70. Building 3-440, south half of coping on west wall, during stabilization. Fort Union National Monument.

The south half of the coping is more massive in construction than the north half, and there is no veneer or brick over the inner (east) portion of the adobe wall. Although the method of securing the coping at the top of the angle-iron framework is similar to that used to support the north half of the coping, more rigid construction was necessary because the vertical supports are free-standing for the top 22", approximately. Also, these top sections are offset to the west a distance of 10" from the vertical axes of the lower portions in such a manner as to place the side of the upper portions against the coping.

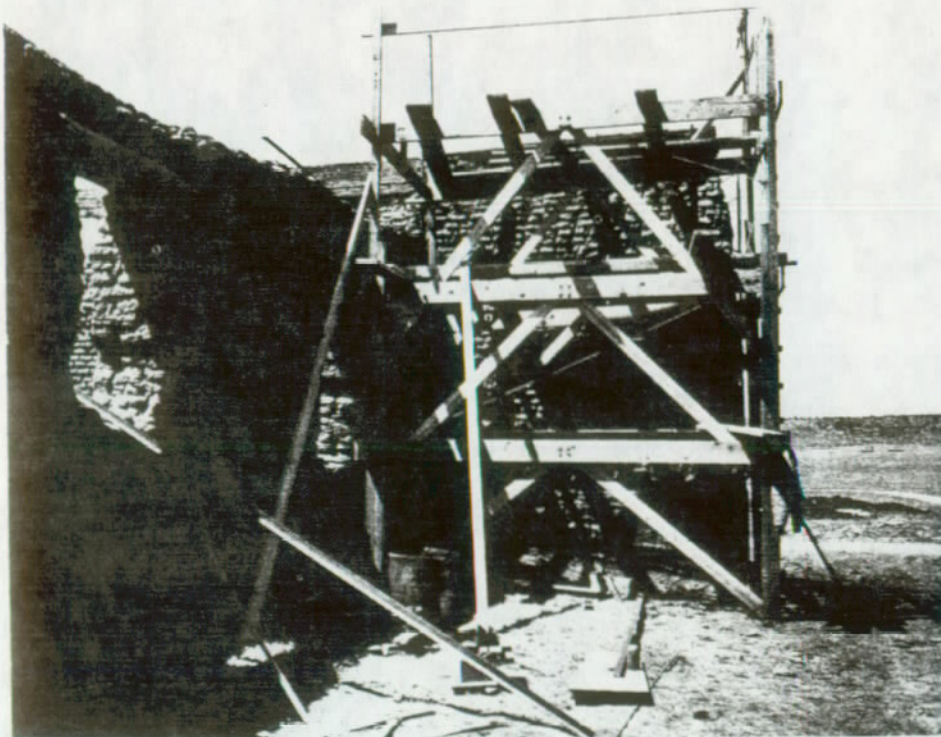
FIGURE 71. Building 3-440, northwest wing wall, during stabilization. Fort Union National Monument.

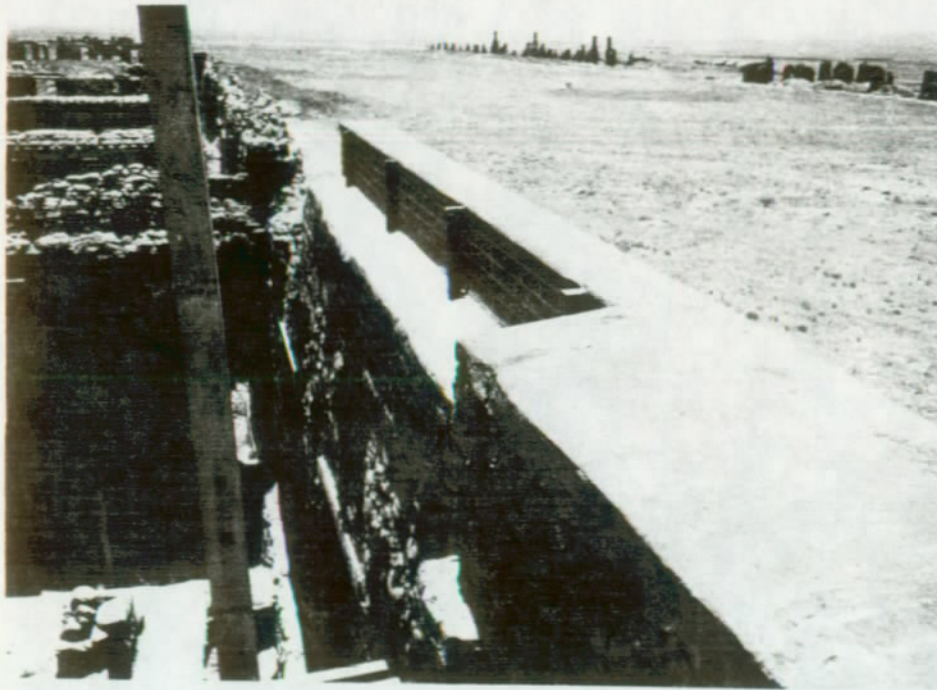
FIGURE 72. Building 3-440, coping on west wall, after stabilization. Fort Union National Monument.

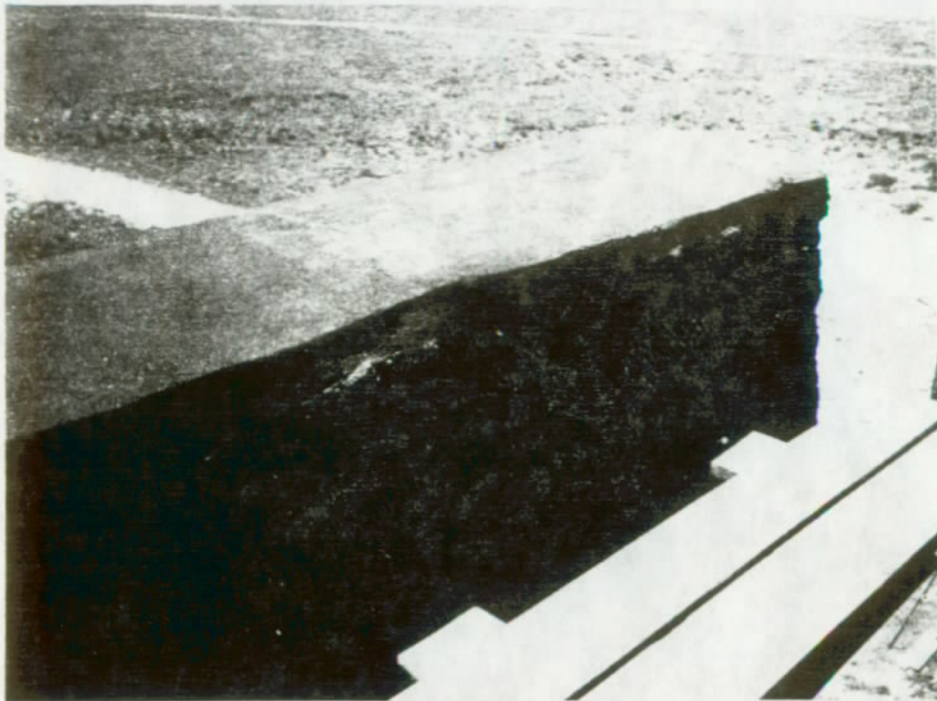
FIGURE 73. Building 3-440, coping on west wall, after stabilization. Fort Union National Monument.

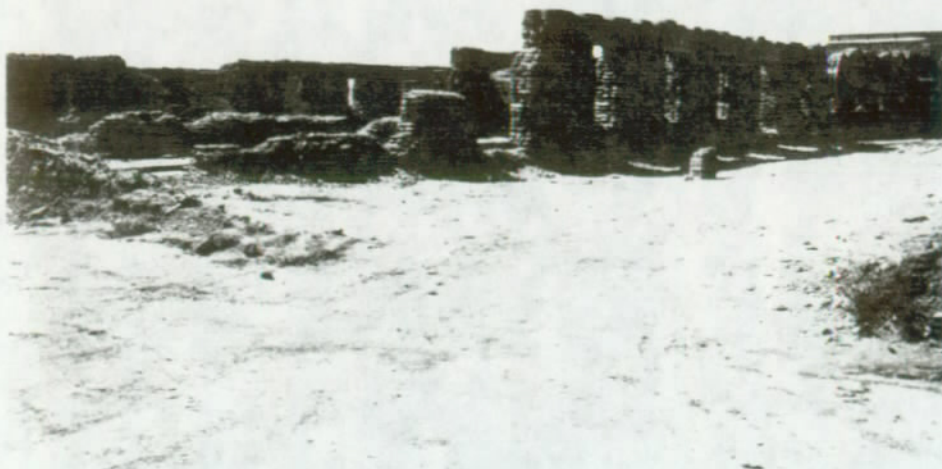
FIGURE 74. Building 3-440, from the northeast, after stabilization. Fort Union National Monument.

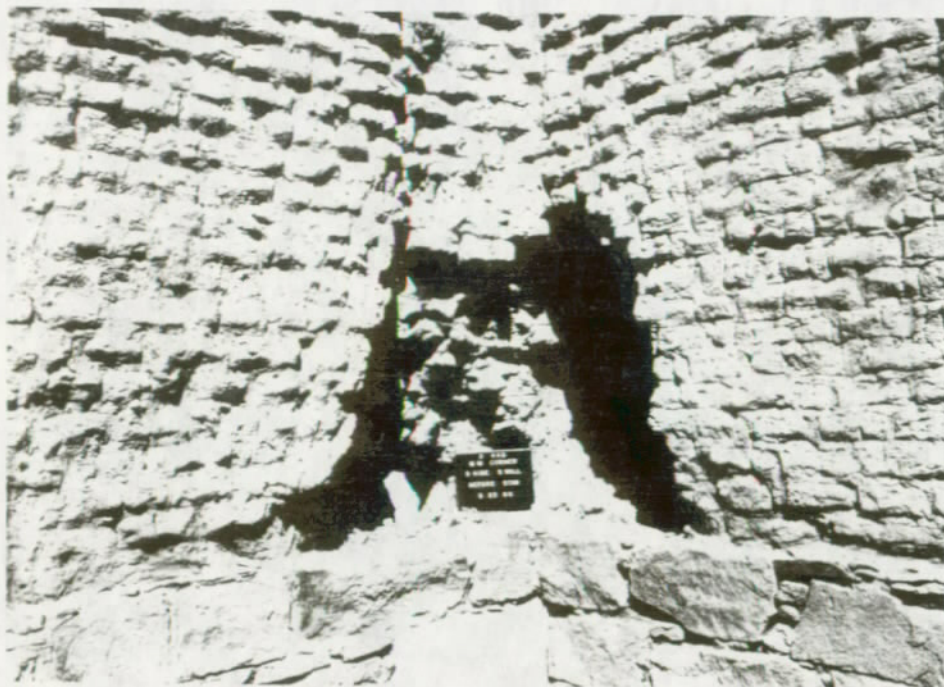
FIGURE 75. Building 3-440, southwest corner, before stabilization. Fort Union National Monument.

of 1/8" x 2" angle-iron. The rectangles formed were incorporated into the wall proper, by rebuilding this section with soil-cement brick up to and through the rectangles. (The upper sections of wall had eroded out, leaving the coping balanced on just a few inches of adobe.) Two large holes in the wall under the coping were also filled with soil-cement brick.

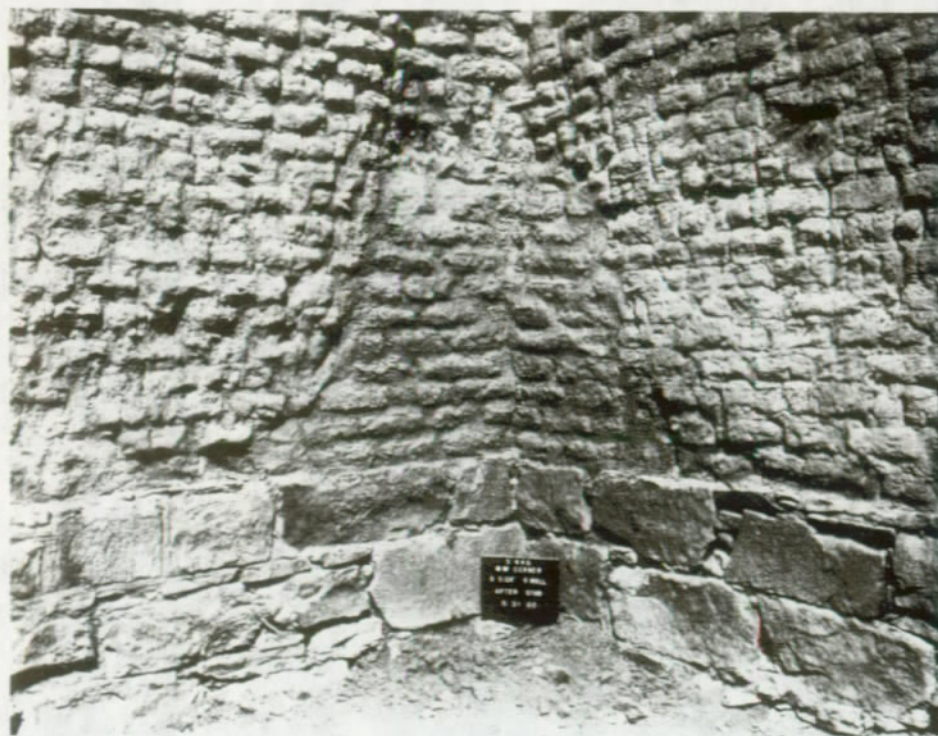
FIGURE 76. Building 3-440, southwest corner, after stabilization. Fort Union National Monument.

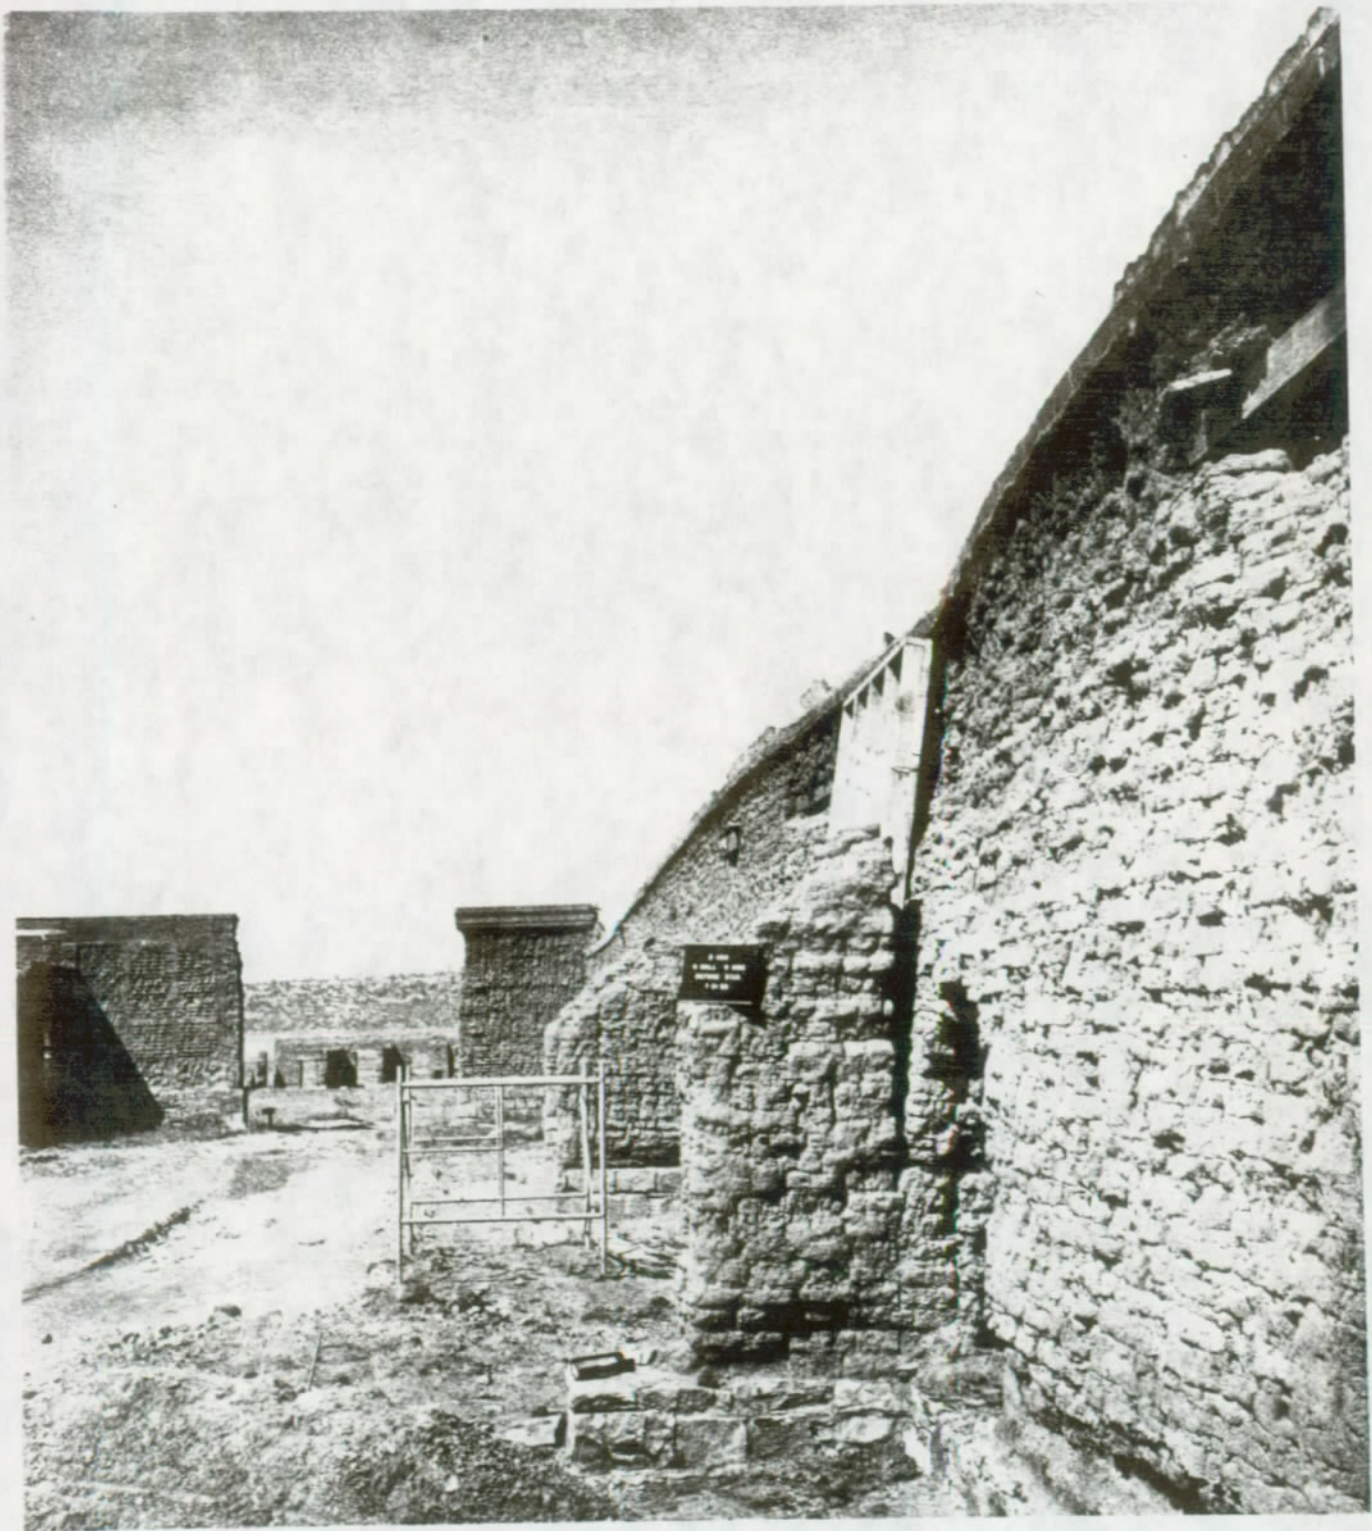
FIGURE 77. Building 3-450, Room 451, south side of south wall, before stabilization. Fort Union National Monument.

Materials, construction, and technique in making repairs or accomplishing job: *South wall: A portion of the south wall was realigned in order to prevent collapse. The section, near the east end of the wall, bowed to the north about 12" at the top. Four wooden forms were completed and put in place on the bulge, two on either side of the wall. They were lined with asphalt roofing felt, wired together through the wall with No. 9 black wire, and then the space between form and wall was packed with damp sand. Two mine roof jacks and one heavy-duty jack were used to move the wall. The jacks push against the wall by means of long sections of 2" pipe (mine roof jacks) and 4" x 4" timber (truck jack). After pushing the wall into plumb the jacketing was removed from both sides of the wall and stabilization was begun by placing six upright steel members, and two horizontal members of the same material, with a steel strap along the bottom seated upon the stone foundation. The wall's brick coping is being held in place by seven steel rods looped about it and welded to the steel members on the wall's north side. The steel on the north side of the wall is secured by rods through the wall that are held in place by short steel straps. A hole in the wall was filled with regular adobes, cracks were grouted, steel was covered with adobe, the coping was secured, and adobes were laid along the top of the wall preliminary to capping.*

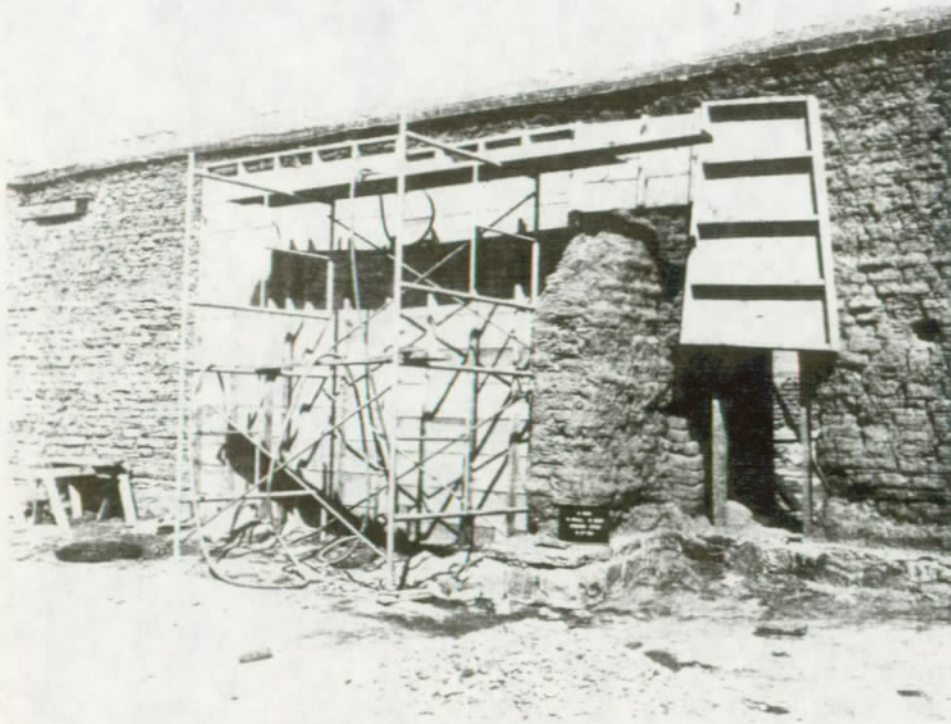
FIGURE 78. Building 3-450, Room 451, south side of south wall, during stabilization. Fort Union National Monument.

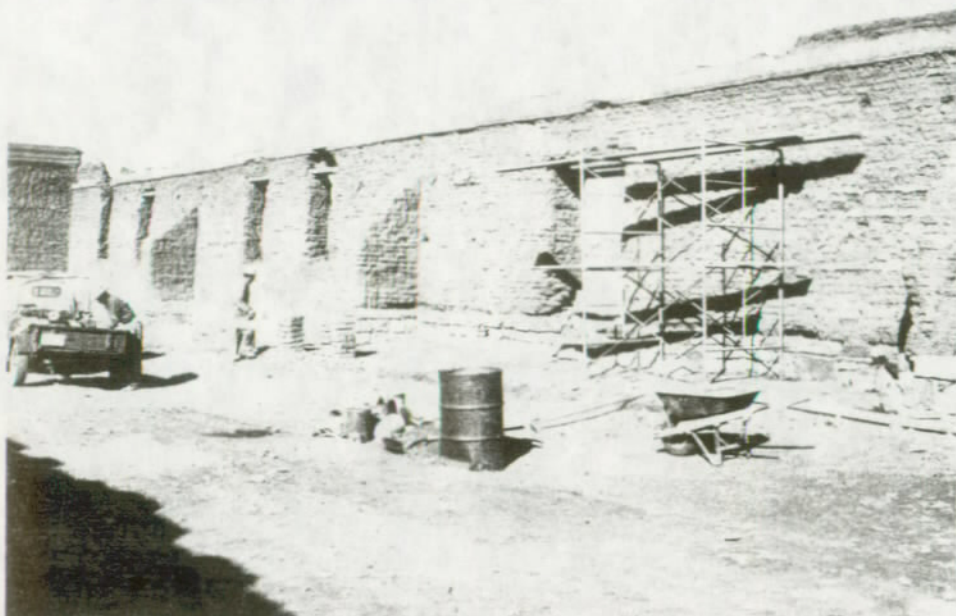
FIGURE 79. Building 3-450, Room 452, south side of south wall, before stabilization. Fort Union National Monument.

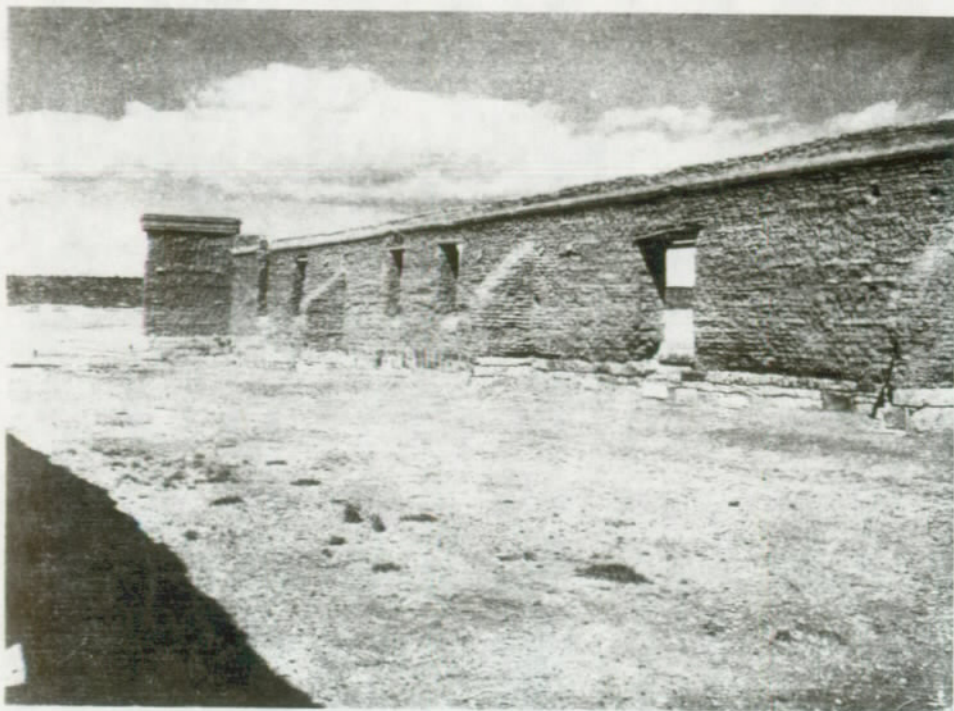
FIGURE 80. Building 3-450, Room 452, south side of south wall, after stabilization. Fort Union National Monument.

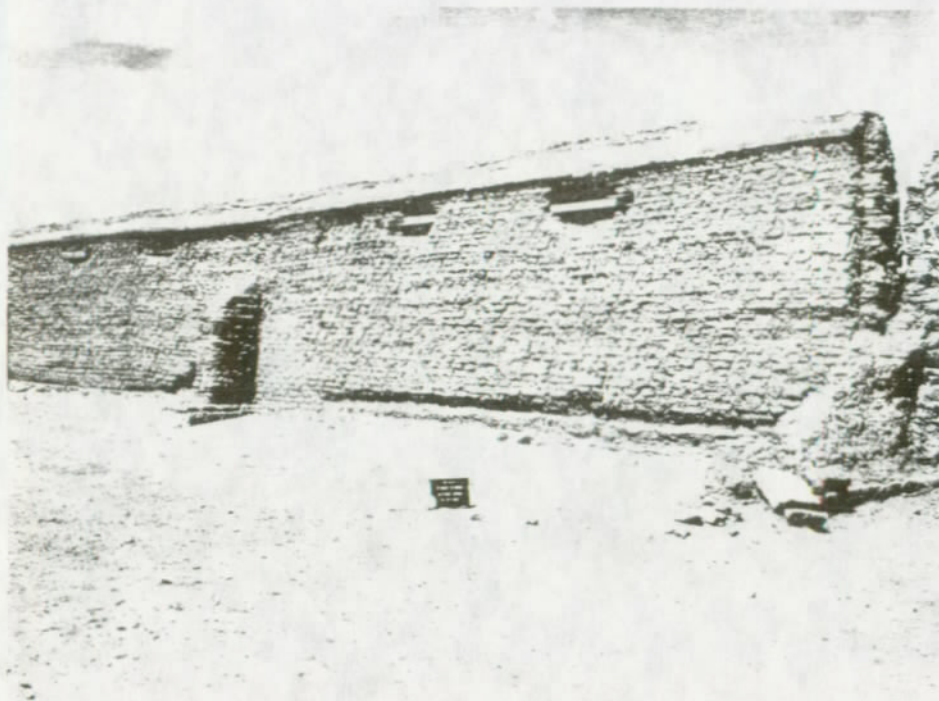
FIGURE 81. Building 3-450, Room 451, south side of south wall, after stabilization. Fort Union National Monument.
